**Street Route Accessibility Audit
For
Blessington & District Forum**

Accessibility Audit

BLESSINGTON MAIN STREET, CO WICKLOW

For Blessington & District Forum

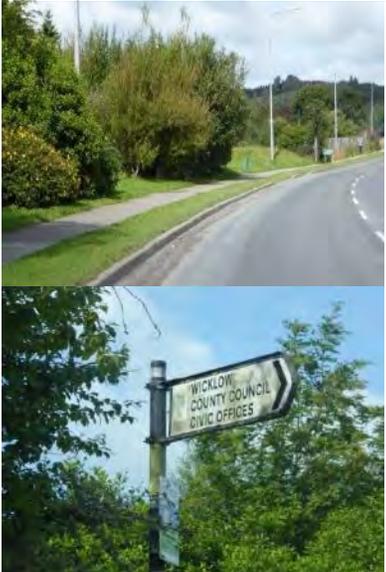
Ref.	Item/Location	Observation	Photo	Relevant Guidance / Recommendation	Priority
1.1	Signage to WCC Offices	When approaching the Council Offices from Main Street the sign indicating the offices is not visible as it is concealed behind trees

<p>BS 8300-1: 2018 Sxn 8.3.1 Information and Signage.</p> <p><i>NOTE 2 Regular cleaning and maintenance of signage and information panels is necessary to ensure that they remain clearly legible.....</i></p> <p>BS8300-1:2018 A.2.3 Signage and information All signs and information boards need to be kept clean so that the visual contrast is maintained and they are easily identifiable and readable. This is particularly important for people who are blind and partially sighted.</p>	1

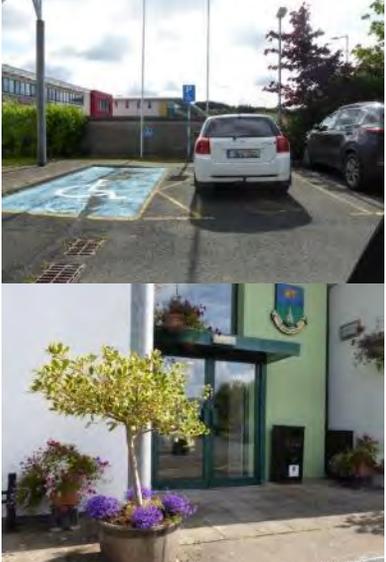
1.2	Parking and Entrance to WCC	<p>As with all designated parking bays throughout the town the spaces in the Council car park do not meet current guidance in terms of size, markings and space for transfer to both sides and rear and there is no designated set-down area. Up to 2009 guidance for designated perpendicular bays was for a bay of minimum size 4.8m x 2.4m with a 900mm transfer zone on one side only. Since 2010 the guidance has been for a minimum bay of 4.8m x 2.4m with a 1.2m marked transfer zone to both sides and to the rear.</p> <p>Whilst the building was not audited it was noted that the glazed entrance doors did not have adequate manifestations</p>

It is recommended that the Council Offices are audited, in line with the Disability Act, and action taken to ensure that they become an exemplar of good practice for public facilities	2

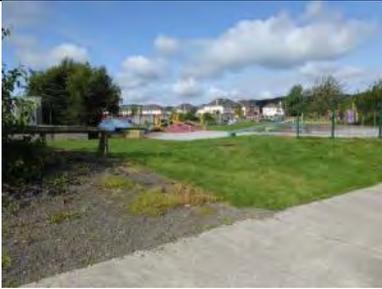
1.3	Pedestrian route to Playground from Oak Drive adjacent to Aldi entrance	Approaching from Main Street there is no direct pedestrian access to the playground without walking a considerable distance around the outside. Worn areas of grass indicate a desire line and that people take a short cut across the grass but this route is inaccessible for buggies and people with mobility impairments

Consider providing an accessible route to the playground in this location	1

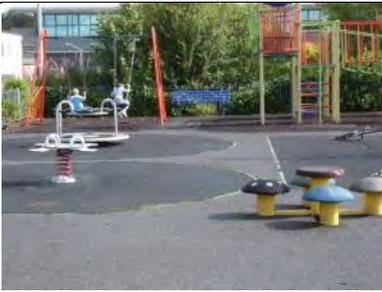
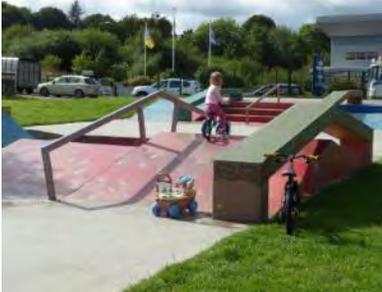
1.7	Children's play area and skate park	The children's play area and skate park are also excellent facilities with a wide range of equipment and several seating areas for adults. However, no wheelchair friendly equipment was noted or sensory activities which might suit specific needs of children with sensory and motor co-ordination challenges or the needs of children on the autistic spectrum

Community Parks and Playgrounds – Intergenerational Participation through Universal Design is a recent research report by the Centre of Excellence in Universal Design which should be referred to for an understanding of the complexity, challenges and benefits of providing fully inclusive play facilities. This should be considered in any future developments. Refer also to Greystones for inclusive children's play facility.	2

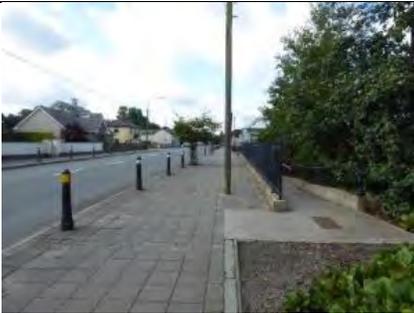
1.9	Ramp to Aldi	A telegraph pole at the top of the ramp leading to Aldi is located approx. 600mm from the inner edge of the path which could be hazardous to persons with vision impairments.

<p>TGDM 2010: 1.1.3.1 (d) street furniture, such as lighting columns, signposts, litter bins, seats, etc., should be located at or beyond the boundaries of the access route; BS 8300-1 8.2.2.1 Hazard protection within an access route Any feature which could constitute a hazard should wherever possible not project into or be located within an access route. However, if this is unavoidable, hazard protection should be provided</p>	3

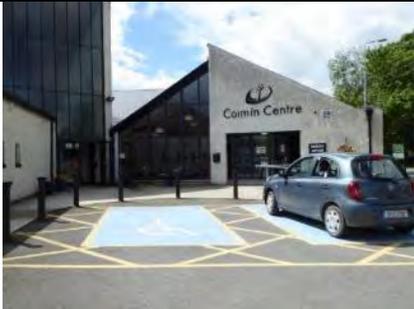
Ref.	Item / Location	Observation	Photo	Relevant Guidance/ Recommendation	Priority
2.1	Coimín Centre	There is a good example of designated accessible parking bays at the Coimín Centre which are clearly demarcated on the ground, with access zones to both sides and rear out of circulation routes. There is also good ramped and stepped access to the side.

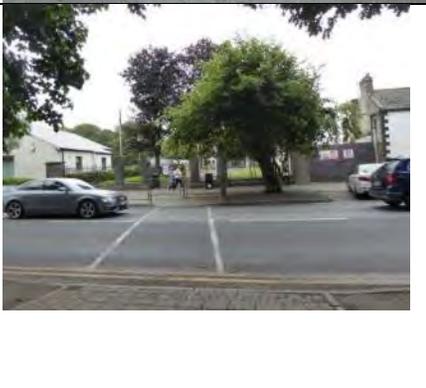
Provide a correctly designed crossing at this point complete with necessary dished kerbs, road markings and tactile paving	1
2.5	Tactile Paving at St. Mary's	An uncontrolled and an unmarked road crossing is located at the school gate. There is no tactile blister paving on either side.

TGDM 2010 1.1 Approach to buildings other than dwellings (f) the danger of inadvertently walking into a vehicular route should be minimised by providing a separate pedestrian route. Otherwise, tactile paving should be used to provide warning and guidance for people with vision impairment (refer to 1.1.4); See recommendation above	1

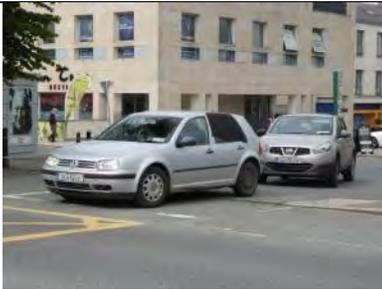
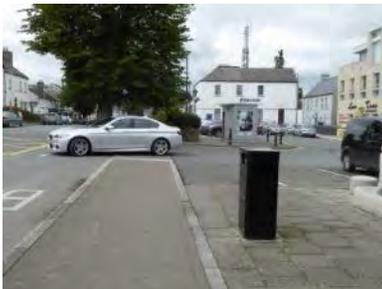
<p>(refer to 1.6.3);</p> <p>* Extract from the Traffic Signs Manual</p>	
3.3	Tactile Paving	<p>There is no tactile paving at the junctions of the main footpath and the carriageway. The brick footpath paving carries across the two junctions but it is unclear who has priority. The road markings appear to give vehicles priority hence tactile hazard warnings should be provided.</p>		<p>TGDM 2010:1.1.3.1 General (f) the danger of inadvertently walking into a vehicular route should be minimised by providing a separate pedestrian route. Otherwise, tactile paving should be used to provide warning and guidance for people with vision impairment (refer to 1.1.4);</p> <p>See 3.1 above</p>	1

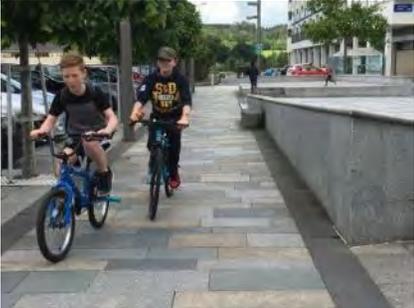
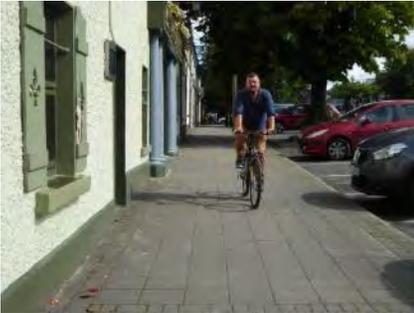
3.16	Cycle Paths	<p>There is no cycle path anywhere in the centre of the town and people with the result that both adults and children were found to cycle on the footpaths.</p>

<p>The provision of cycle paths is strongly recommended both to promote healthier lifestyles and reduce car dependency and also to cater for the many visitors and tourists who now visit by bicycle or who may wish to rent bicycles as part of the Greenway initiative.</p>	2

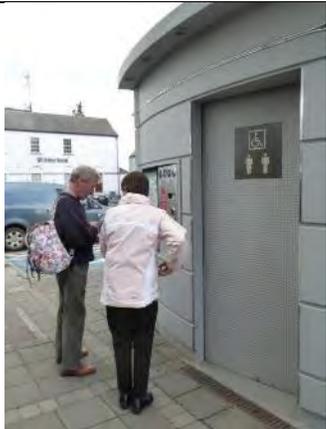
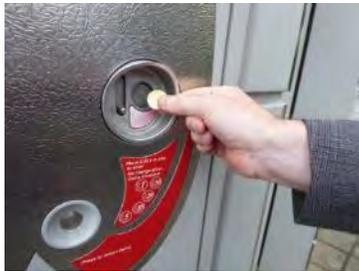
<p>3.17</p>	<p>Public WC</p>	<p>The automated WC was out of order twice during audit inspections and not inspected but visitors were noted struggling with the instructions which were hard to follow.</p> <p>There is no Accessible Change Facility in the town which would facilitate an adult or child with profound or multiple disabilities that needs a toilet facility</p>

<p>BS8300-1:2018 A.1.4 Signage Temporary signs and information are particularly important where facilities such aspublic toilets are temporarily out of service. In these cases signs need to be located at points where people can choose an alternative so that they do not have a wasted journey.</p> <p>Refer to Changing Places Ireland for Guidance on Accessible Change facilities or to BS 8300-2:2018.</p> <p>The provision of an Accessible Change Facility would be of great benefit for those who need one and its provision should be registered with Changing Places Ireland and highlighted when promoting Blessington as an inclusive tourist destination.</p>	<p>2</p>

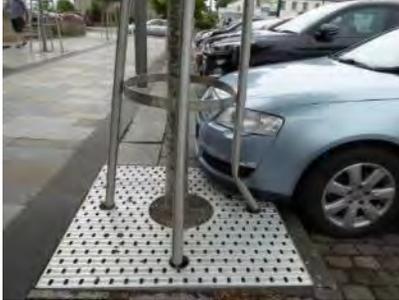
4.4	Tree Guards & Grilles	Tree guards have been damaged by parked cars

The location of trees and tree guards needs to be considered in the context of an overall upgrade of the urban environment	3

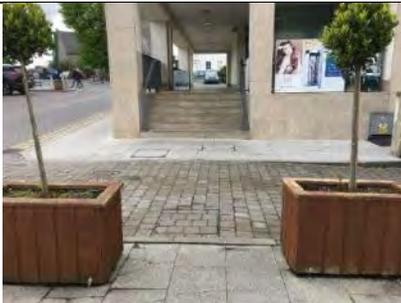
help people with vision impairment appreciate the extent of the stair and identify the individual treads;	
4.7	Unmarked crossing opposite the steps	When approaching from the west there is an unmarked crossing with cracked and uneven paving. For wheelchair users once one reaches the opposite side one has to proceed on the carriageway due to the steps and the narrow footpath to the left.

BS8300-1:2018 8.1 Access routes <i>...Street furniture, flower tubs, litter bins and signposts are all intended to improve the environment but, whether free-standing or projecting from a building, they are hazardous if not carefully designed and positioned.</i>	2

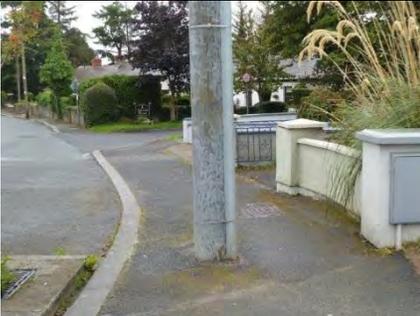
Increase to minimum standards as part of an overall upgrade of pedestrian routes	2
5.10	Hazards on footpath on south side of Kilbride Road	On the footpath leading to the old health centre the surfaces are rough and hazards such as this lamp post are located in the middle of the path

Highlight lamp post with reflective bands and improve footpath as part of overall upgrade and as a minimum before the old health centre site is developed	2
