Underwater Archaeological
Impact Assessment, Avoca
River, Arklow Flood Relief
Scheme Licence No. 17D0078
(ADCO, Brady, 2020a)

**Underwater Archaeological Impact Assessment
Avoca River, Arklow Flood Relief Scheme
17D0078**

31/03/2021

ARUP for Wicklow CC

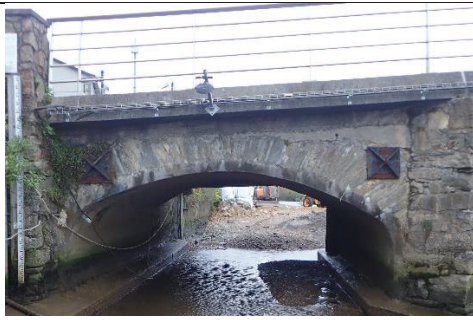
<p>Arch 1</p>	<p>The voussoirs are clearly visible and have been repointed. Metal tie rods are inserted through both sides of the arch. The original parapet has been replaced with concrete. The arch is 4.87m wide.</p>

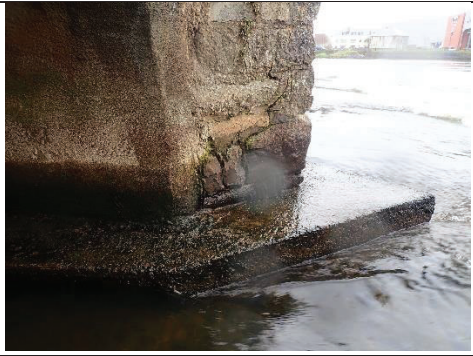
<p>Pier 1</p>	<p>In common with all the piers, the pier base is buried in a modern concrete curtain that measures c. 300mm wide and deep. The pier is otherwise well preserved and measures 1.72m wide.</p>

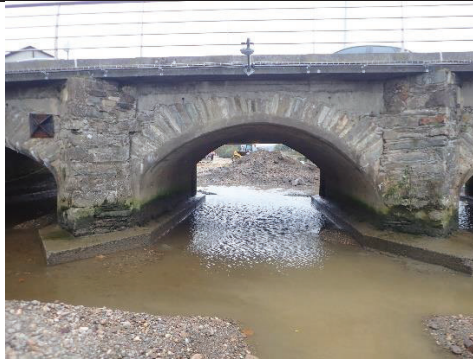
<p>Arch 2</p>	<p>The arch is slightly higher than those on either side and this explains why the concrete replacement parapet above comes so close to the arch ring. There are no tie rods inserted through Arch 2. The arch is 4.85m wide</p>

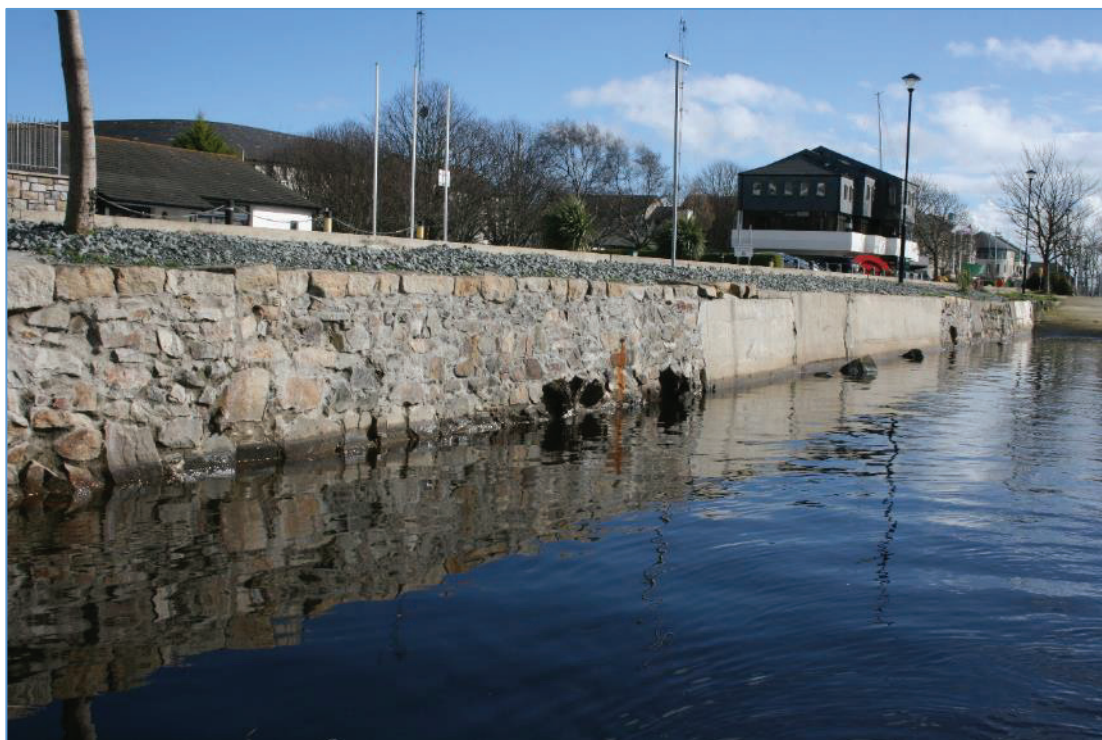
Plate 24: View along the North Quay stone wall showing patches of repair and replacement by concrete.

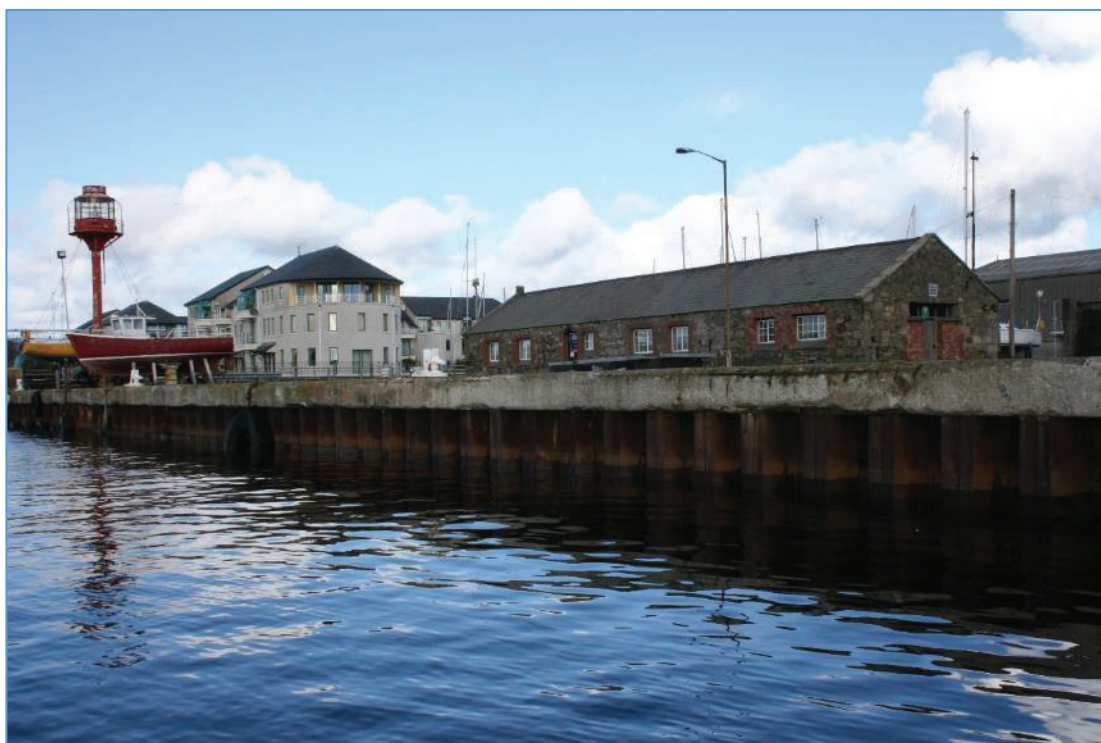
Plate 28: Sheet-piling now defines the remainder of the North Quay downstream of the marina.

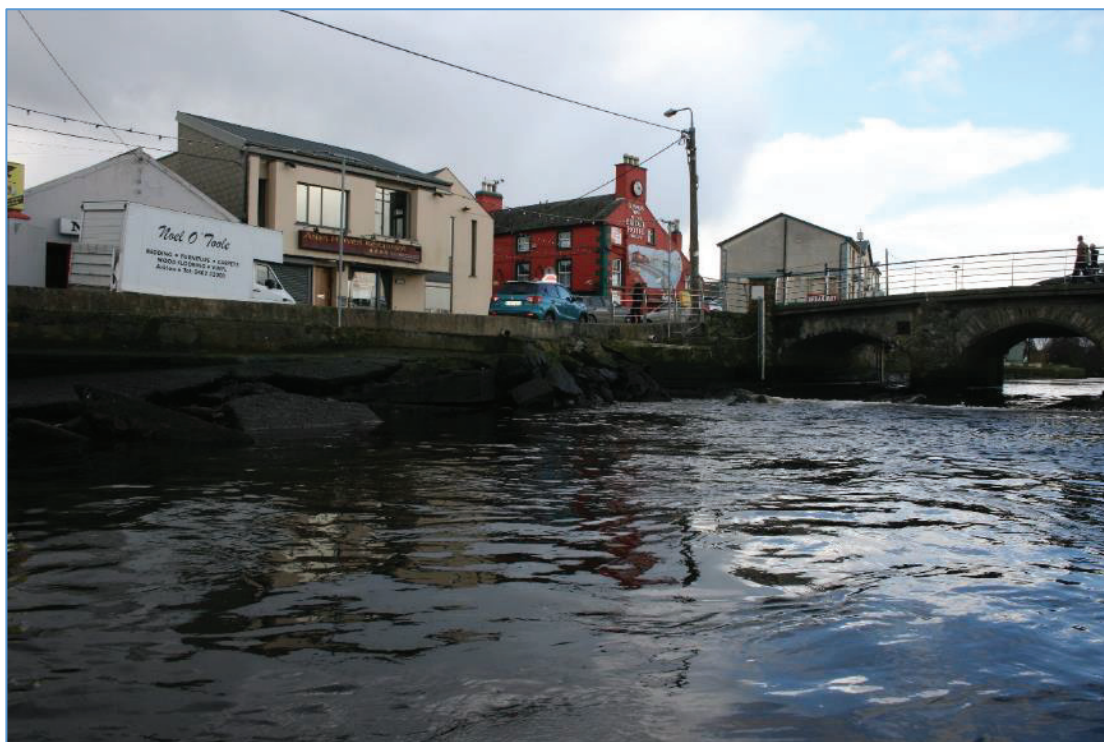
Plate 30: View of the now ruined Coal Quay.

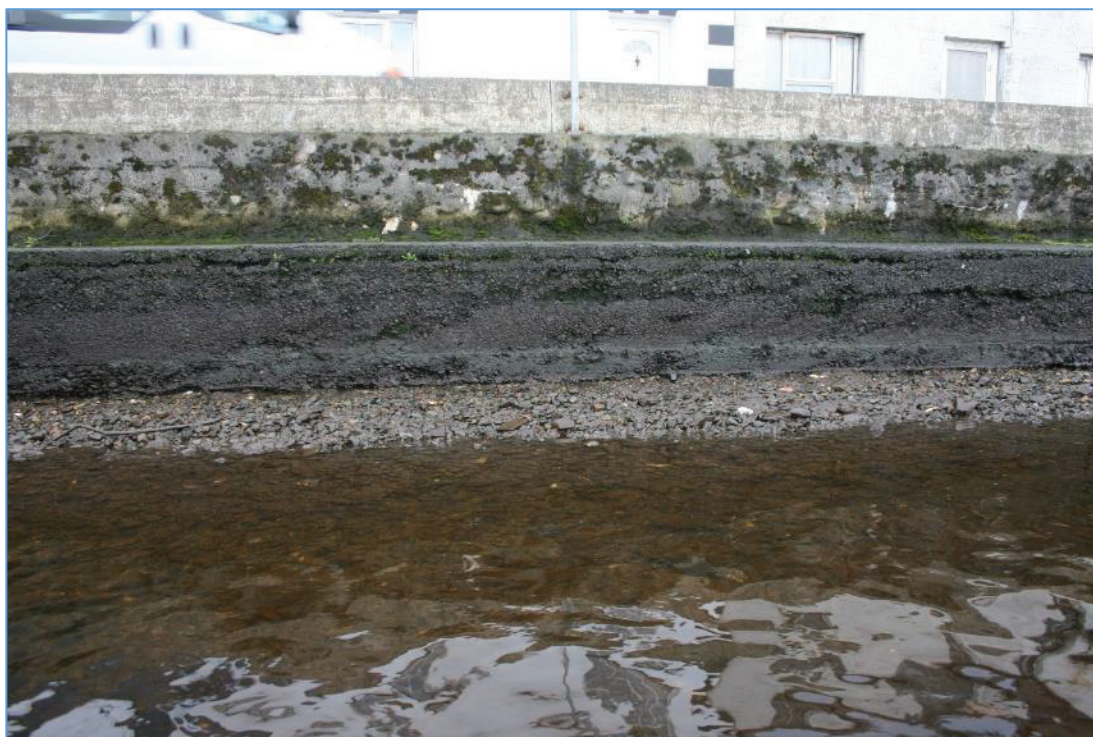
Plate 32: View of South Quay showing the stone wall and later concrete additions.

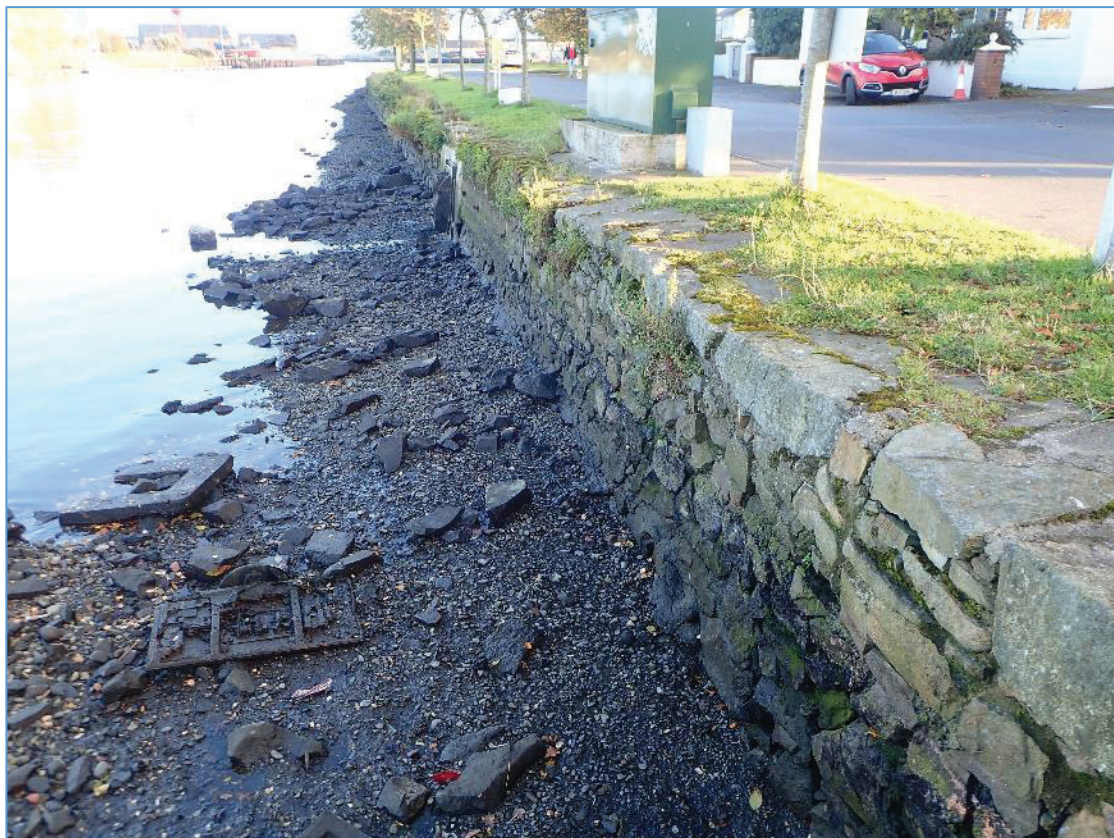
Plate 34: View on South Quay looking downstream, showing the surviving visible element of the original stone structure.

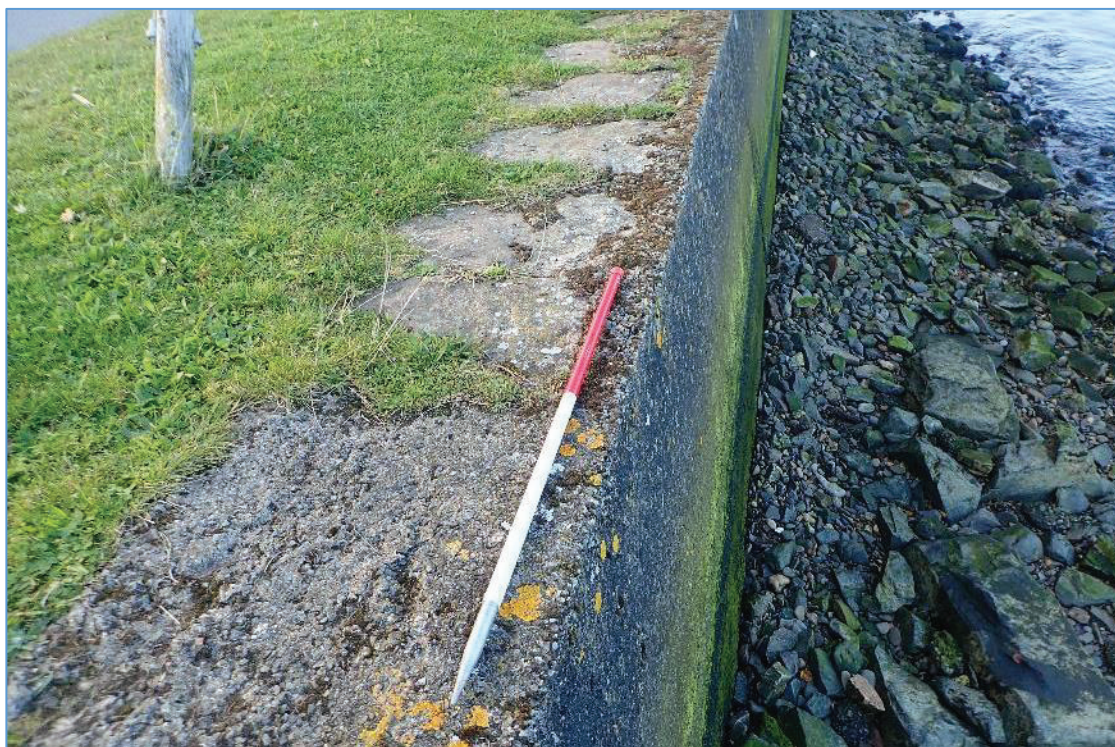
Plate 37: View of South Quay looking upstream showing where the original stone façade becomes masked by later concrete render.

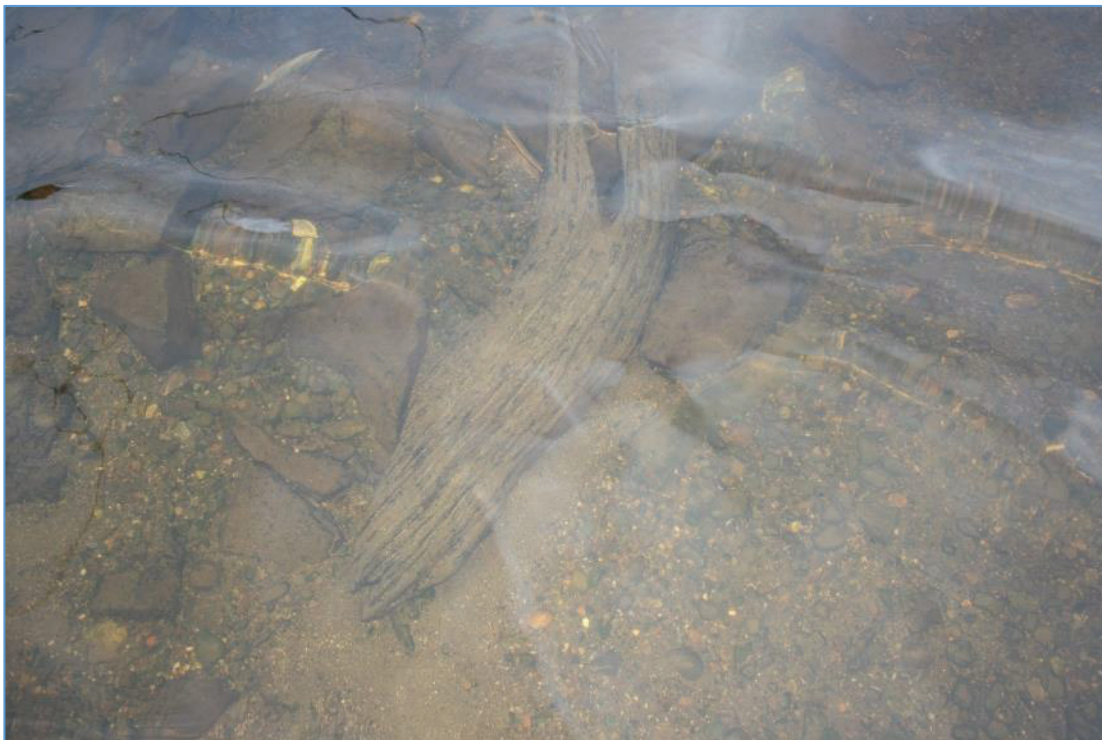
Plate 46: View showing the nature of the riverbed surface downstream of Arklow Bridge close to South Quay, where the small pebbles and stone predominate. Loose tree branches and other wash-in debris occur in some profusion.

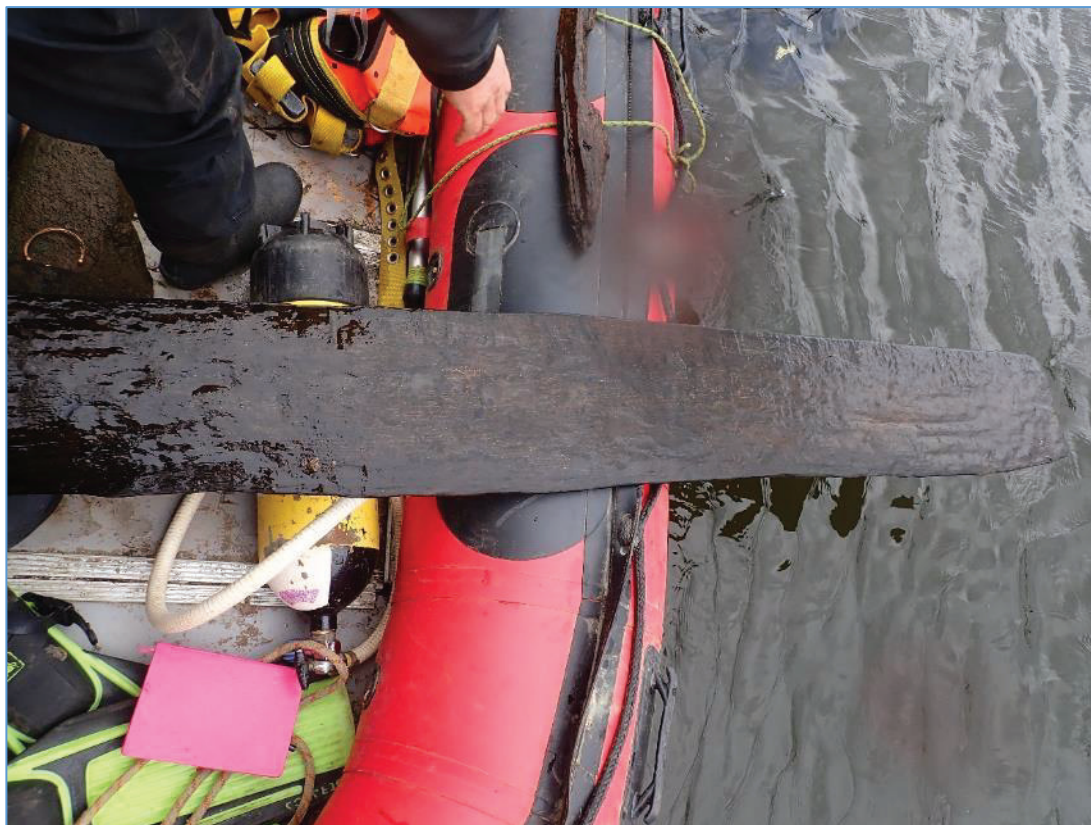
The timber is long and narrow and tapered slightly at both ends, one end of which is fractured (Plates 51–52). It measures 20mm thick and is not rectangular in section. There are no dowel holes or other evident fixings.

Plate 51: View of timber plank, F08.

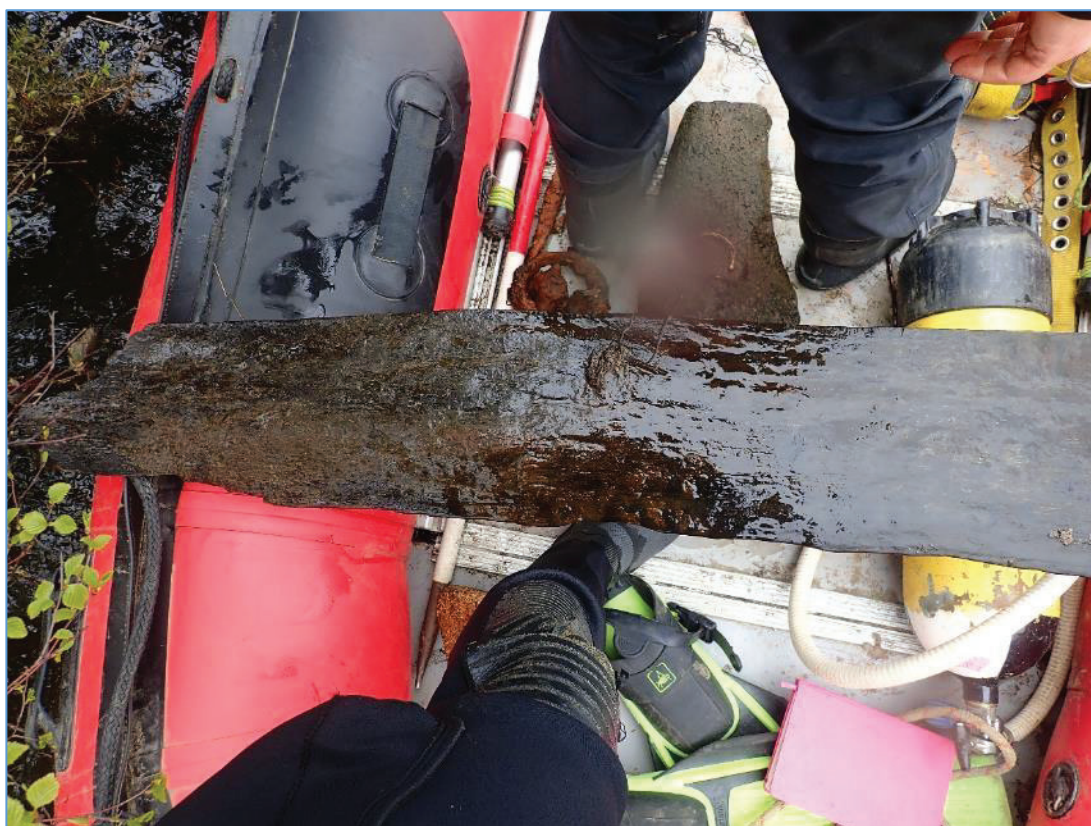
Plate 52: View of timber plank, F08.

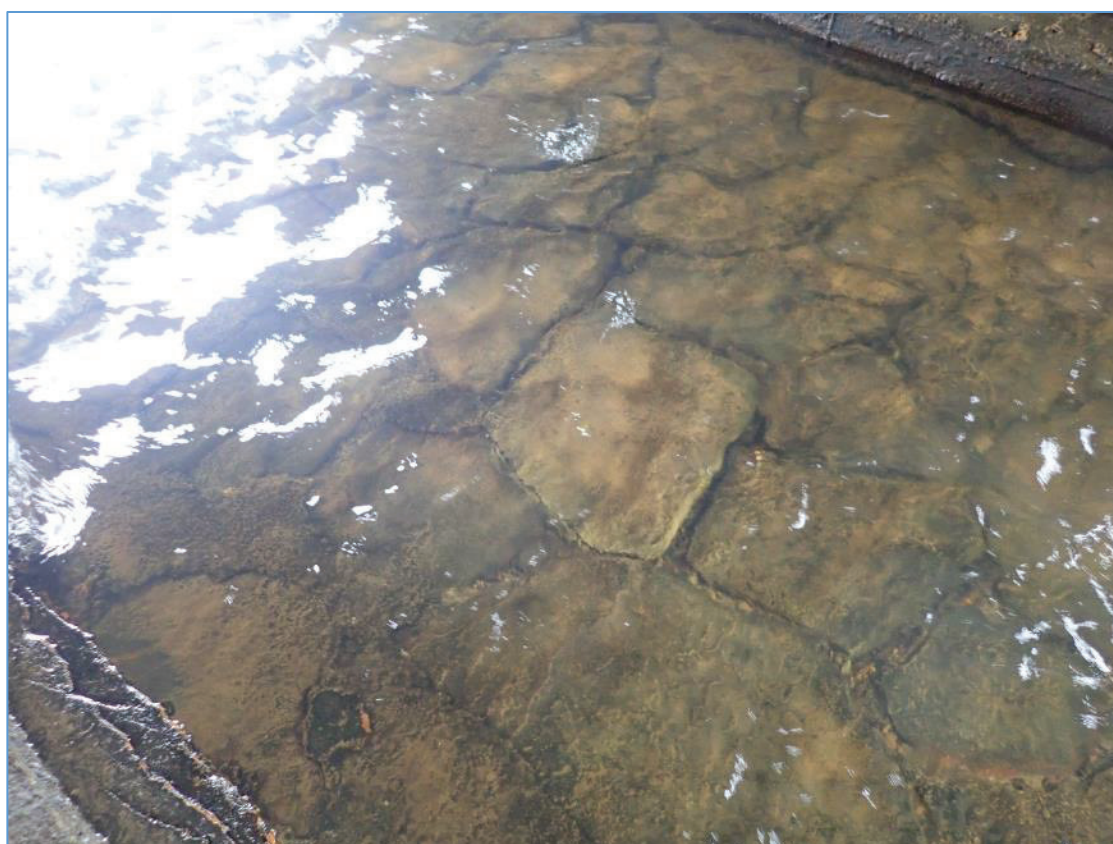
Plate 58: View of stone scour apron set between the bridge piers, Arch 19.

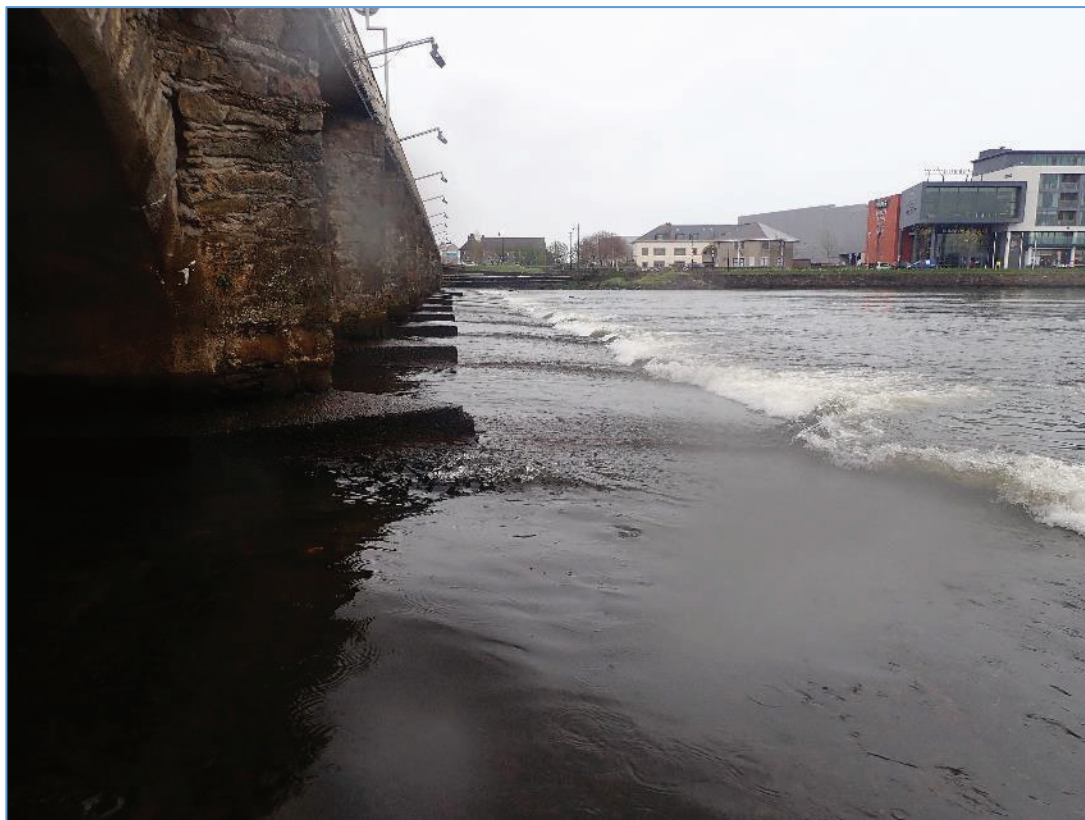
Plate 59: Stone scour apron added to the downstream side of Arklow Bridge, forming a glaciais feature.

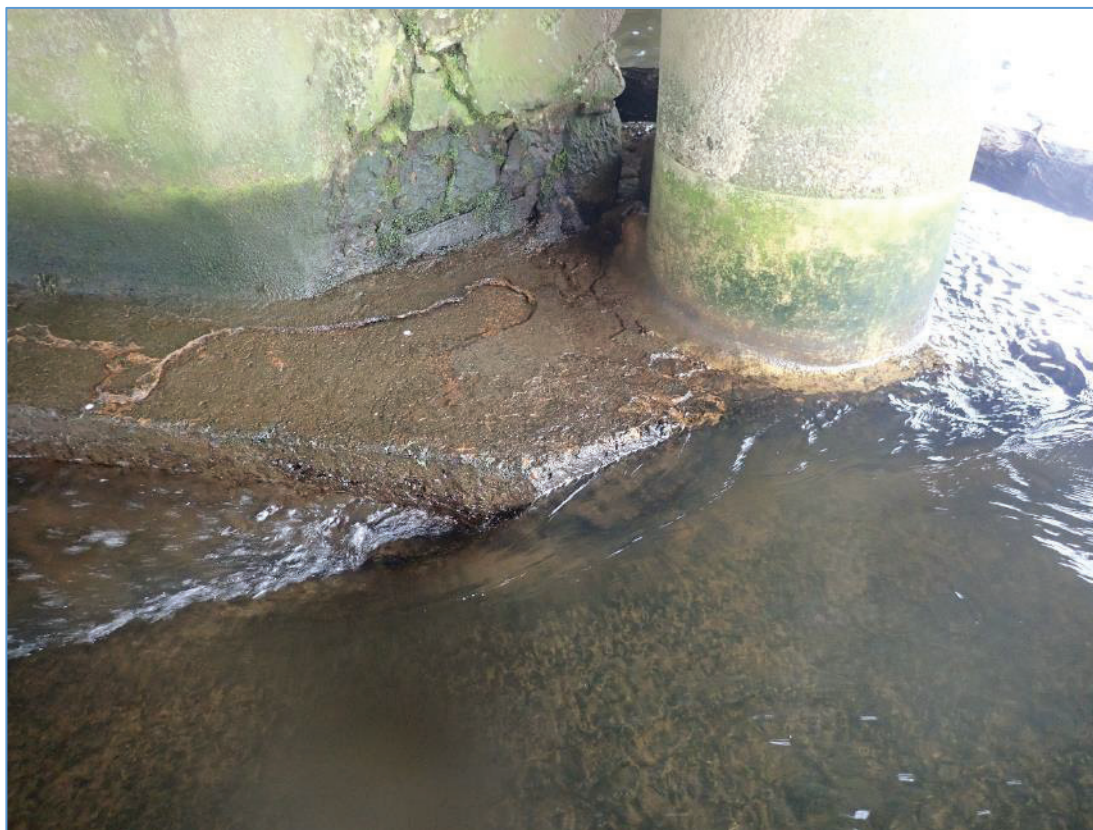
Plate 62: Detailed view of the junction of the 1960s work with the stone bridge.

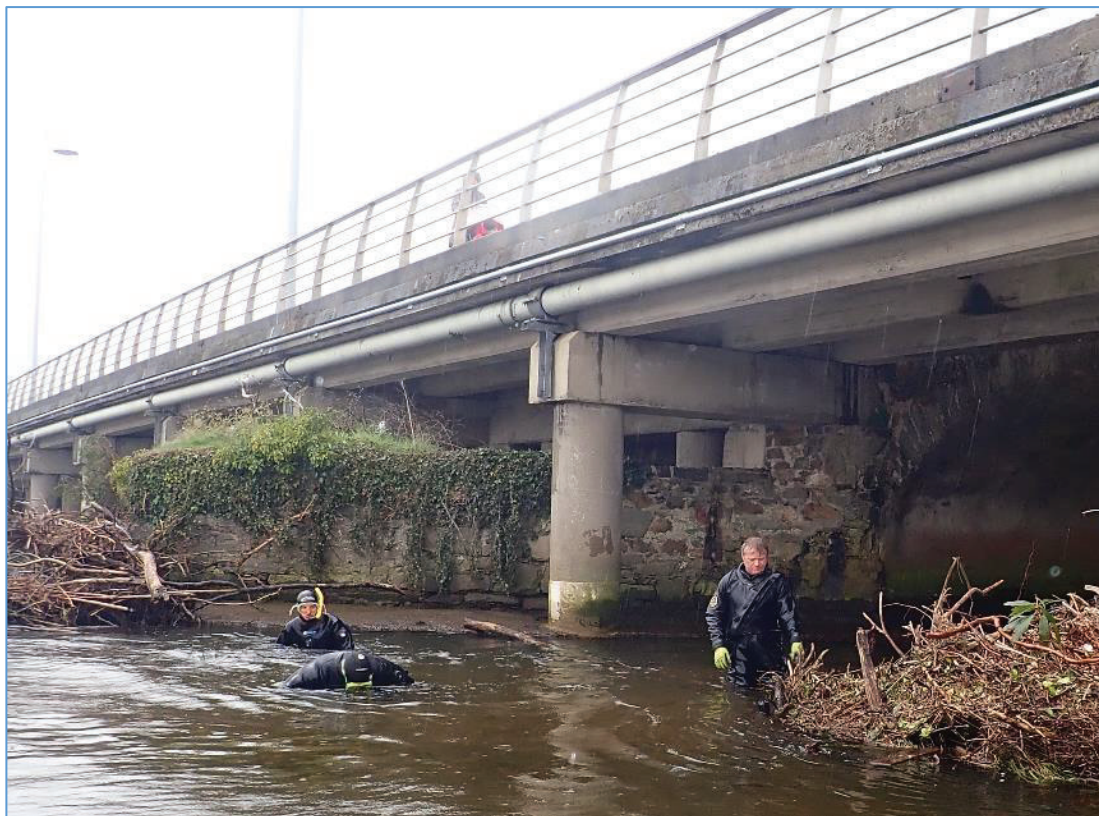
Plate 63: View showing the junction of the 1960s work with Pier 10.

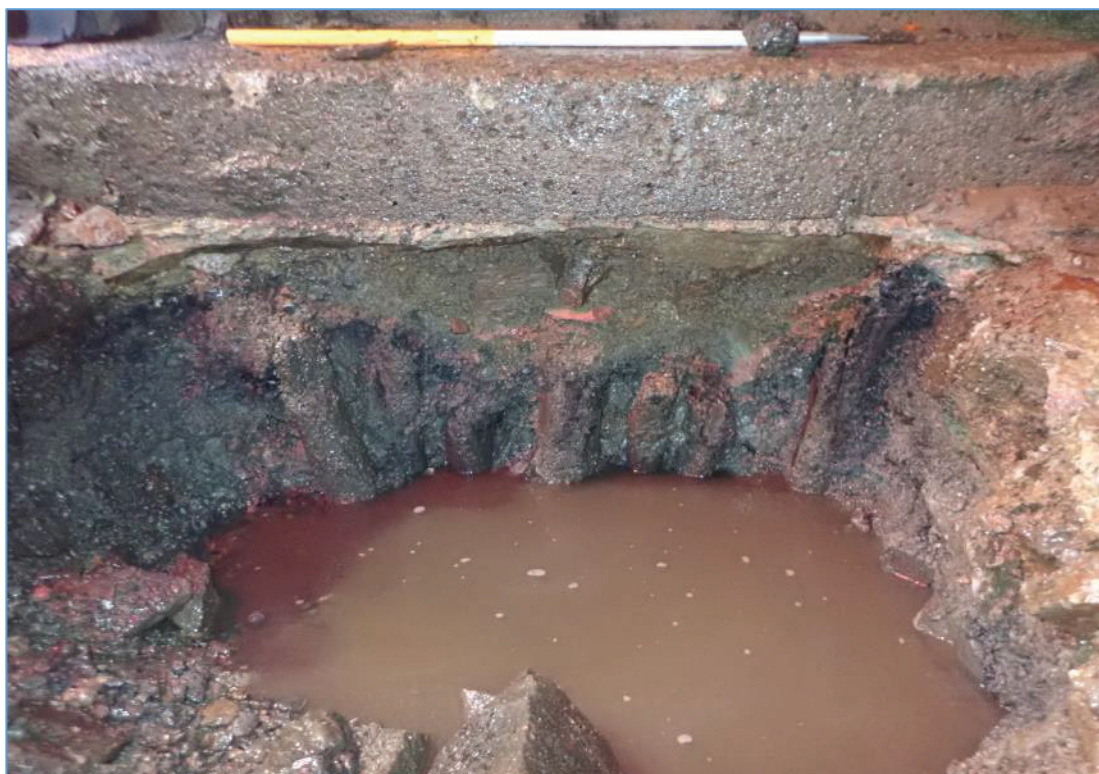
The findings at the bridge piers either side of the stone apron present additional insight. A concrete surround is added to the stone piers and postdates the stone apron, representing modern underpinning works. Removal of the apron at the bridge piers revealed a sequence of timbers in four of the seven instances. The timbers comprise mostly round-sectioned soft woods, but some rectangular-sectioned pieces were also observed (Plate 64). The timbers represent starling piles. Such timbers were used as a protective measure against scour and were set around the base of bridge piers. In one instance (Pier 1, Trial Pit TP-02) it was possible to observe the stone that is inside the line of starlings, and this is interpreted as evidence for the plinth of the bridge pier.

Plate 64: TP-04 at Pier 4. Excavation reveals a line of starling piles under the stone apron.
