**ARCHITECTURAL HERITAGE
ASSESSMENT
OF
“CHOLERA HOUSE”,
GREENHILLS ROAD,
WICKLOW**

BALLYGUILMORE ACTIVE TRAVEL SCHEME

ON BEHALF OF: WICKLOW COUNTY COUNCIL

JULY 2023

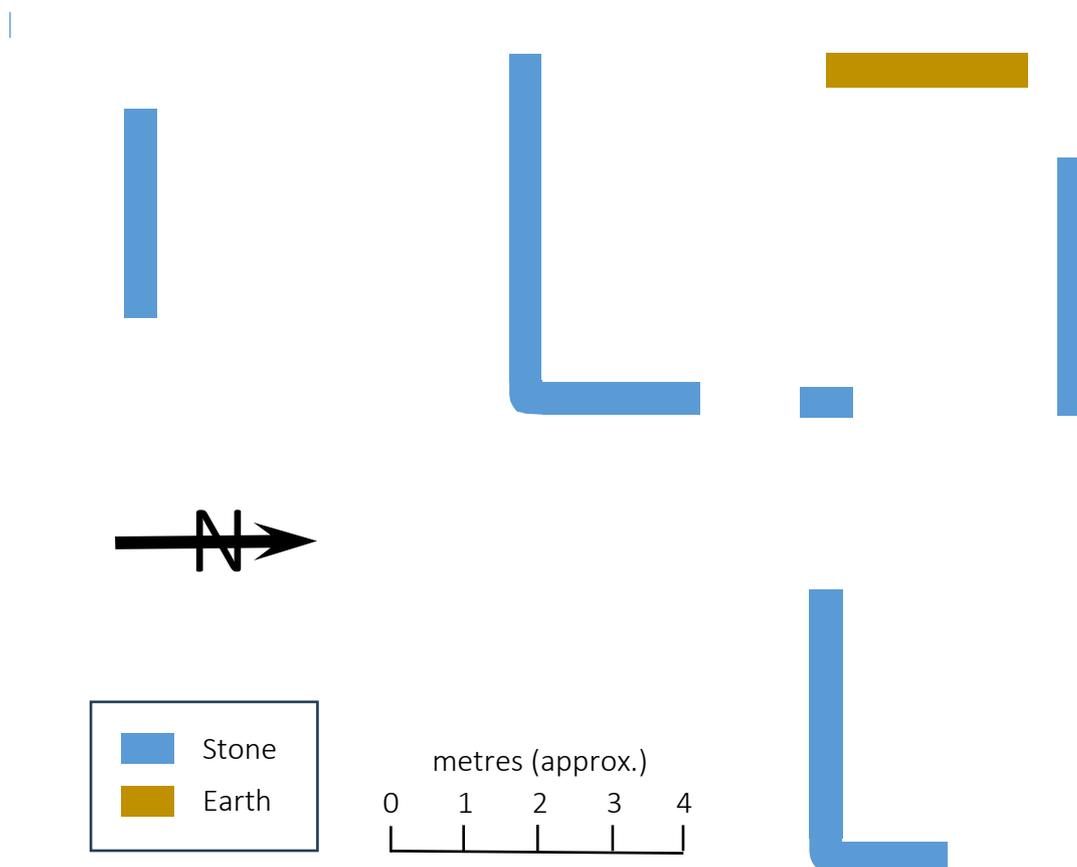
Figure 4: Sketch plan of surviving elements of Cholera House

The site of the Cholera House is very overgrown with brambles, ivy, nettles and other vegetation and it is difficult to discern many of the surviving elements of the building. The sketch above is not to scale but shows the approximate layout of the remaining parts of the walls, with west at the top and Greenhills Road off the top of the sketch. The wall on the right-hand side is estimated, as its presence can be seen, but the extent is uncertain. The sections running horizontally in the sketch are also estimated.

The majority of the surviving walls are of stone, predominantly laminated stone such as mica schist or shale, with some granite stones. The section of wall that is closest to the road is of mud, or earth and is gradually disintegrating.

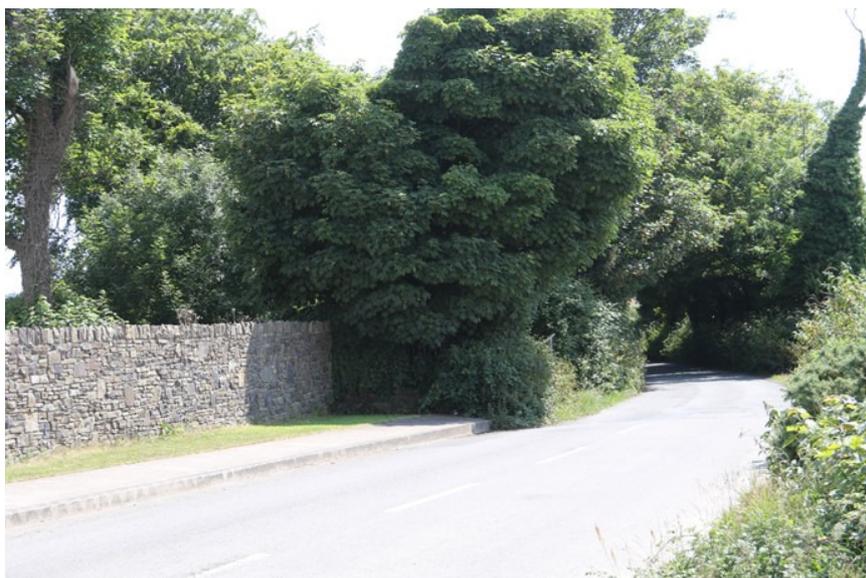
Plate 1: View toward Cholera House across Greenhills Road

The Cholera House is located near the north-western corner of a field, to the south of a gateway and access leading from Greenhills Road to the field. The photograph below indicates the dense growth of ivy, brambles, elder and other vegetation on and around the remnants of the building. Dense coverage of ivy conceals much of the remaining walls, while the brambles and other vegetation restrict movement in the vicinity of the ruin. As noted above, the listing in the record of protected structures states that “Up to c.1990’s (*sic*) it had a corrugated roof and was used as cattle sheds.” No remnants of corrugated iron were noted on the site and nothing remains of the roof.

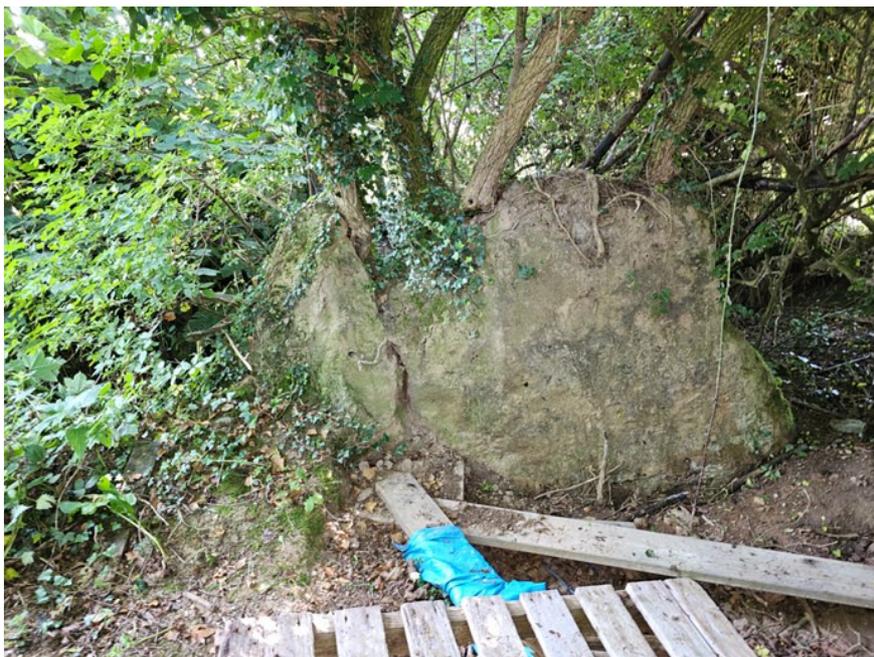
Plate 3: Remnant of western wall

The western wall of the house is the wall closest to the public road. This wall is of mud, or rammed earth and has largely been washed away by the weather. A section of this wall remains, about 2.7 metres long and 1.5 metres high, although, as the photograph above shows, the remnant is very uneven in shape. To the south of this remnant there is a raised area of ground, like a low bank, and this may represent the collapsed remnant of the rest of the wall. Where parts of the stone walls are visible, they are built with rubble stone, using a laminated stone such as shale or mica schist, though there is some granite included. The surviving elements are mere fragments, with only limited sections rising to full height.

These works are to take place extremely close to the very fragile remnants of the house, the closest part of which will be the rammed earth western wall seen in plate 3 above and which is in very fragile condition. The proximity of the works makes it difficult to erect protective fencing to ensure that no encroachment can take place beyond the work area.

- Erection of protective fencing
To avoid damage to the protected structure no works should be undertaken in the vicinity of the ruin except those absolutely necessary for the implementation of the road widening and provision of footpath. Provided crews are adequately briefed and trained there should be no necessity for protective fencing. The limits of the work area should be marked out with aerosol site marking paint, leaving the largest distance possible from the upstanding remains of the protected structure. No members of the work crew or public should cross that line.
- Physical contact during construction

Training and other measures are to be undertaken to ensure that no operative, no machinery or other equipment encroaches beyond the marked work area toward the ruin. Removal of vegetation is to be removed only up to the defined work area only. Under no circumstances are the elder bushes that are growing adjacent to the walls of the ruin to be trimmed, cut or removed as they are likely to be physically attached to the wall.

- **Vibration during the works**
Work practices are to be designed so as to minimise vibration and other causes of movement of the ground. No machinery is to be brought within 3 metres of the boundary of the work area except for the buckets on the extended arms of machines with the machines kept beyond that limit. In removing the bank by machine toothed buckets are not to be used as these will snag roots and pull them, with possible impacts on the ground in the vicinity of the ruin. Roots may be cut by hand or with power saws but not pulled.

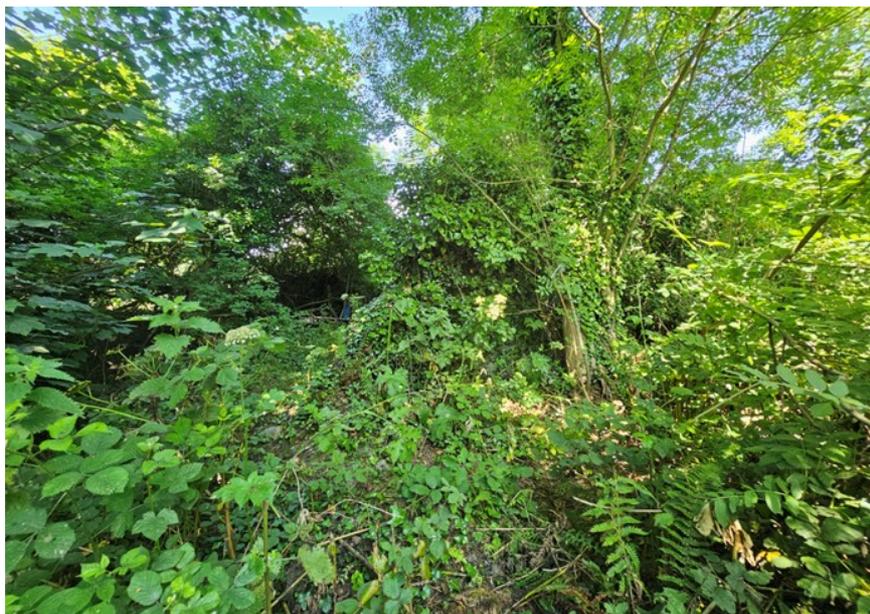
Plate 5: Typical view of wall of house

The view above represents the state of a significant amount of the walls, where they are barely visible due to dense growth of vegetation. In some cases, the presence of a wall is only confirmed by pushing a rod into the vegetation to see if there is any hard surface beneath the ivy.

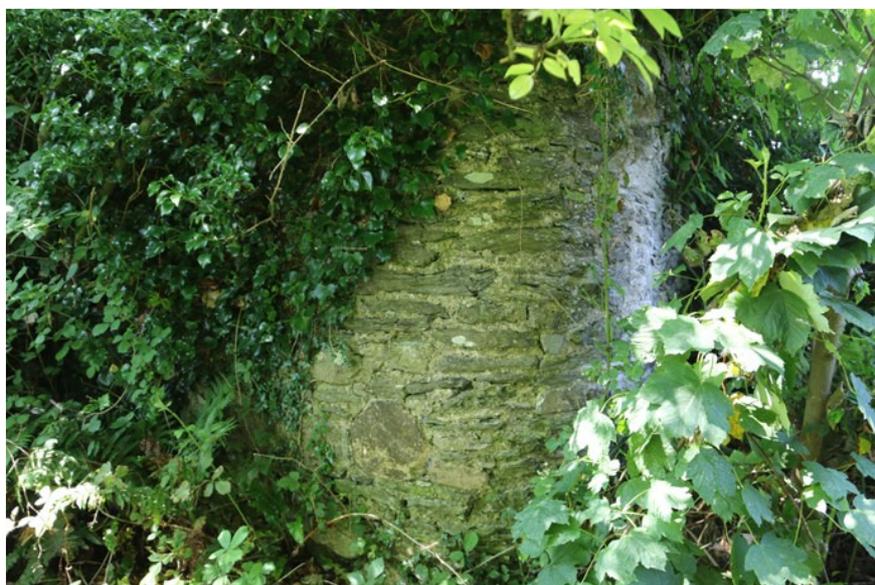
Plate 6: South-east corner of main part of house

The house may be described as having a main section with a rear return projecting to the east and another room located to the south. The south-eastern corner of the main house is visible and is seen in the photograph above. This is of rubble masonry as described above, though it is in better condition than other parts of the visible walls. There is a curve at the corner and a similar curve is noted at the south-eastern corner

of the return. These curves were probably introduced as the small size of the stones would not be suitable for constructing an angled corner of acceptable strength.
