Arklow Bridge, Structural
Report on Existing Masonry
19 Arch Bridge and advice
Regarding Impacts of Proposed
Flood Alleviation Scheme on
Bridge

Conservation Engineering Report Arklow Bridge, Arklow, Co Wicklow

April 2021

Issue 4

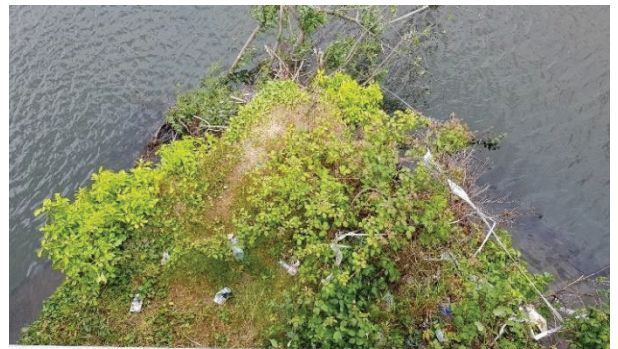
Vegetation growth is excessive to the top of the central pier and is also gaining a foothold to some areas of the vertical masonry

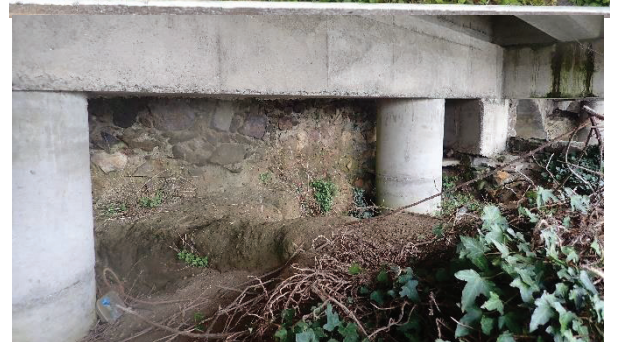
Mortar loss to the tidal range of the piers was observed. Continued unaddressed mortar loss leads to individual stones falling and eventually structural failure.

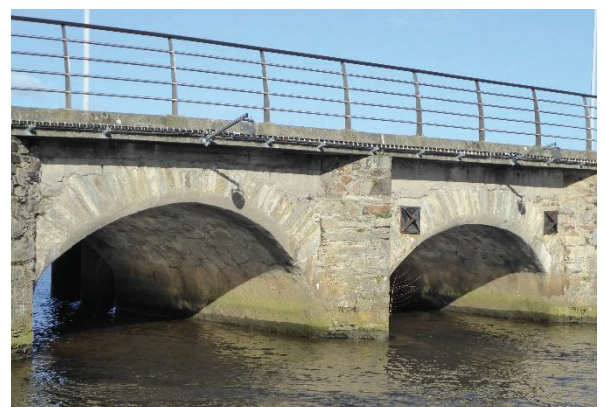
Loose stonework was observed to the weather tops of piers this is also associated with excessive vegetation. Both will lead to loss of masonry and degradation of the historic record as well as excessive water flow through masonry resulting in leaching of the mortar.

The underside of the arches have been extensively shot-creted. This is potentially obscuring the issues it was applied to address including possible loss of mortar between the voussoir stones of the arch and thus the integrity of the arches

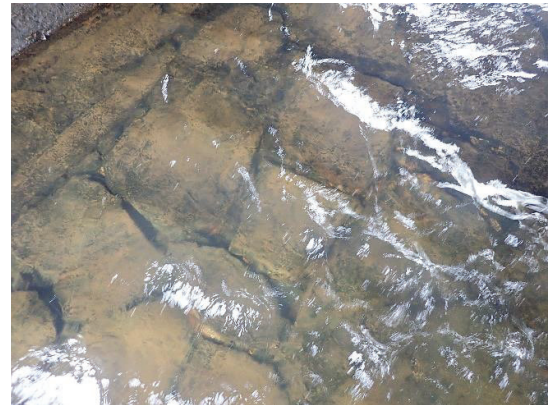
The previous tying works through arches 1; 3; 5 and 6 are beginning to show signs of corrosion

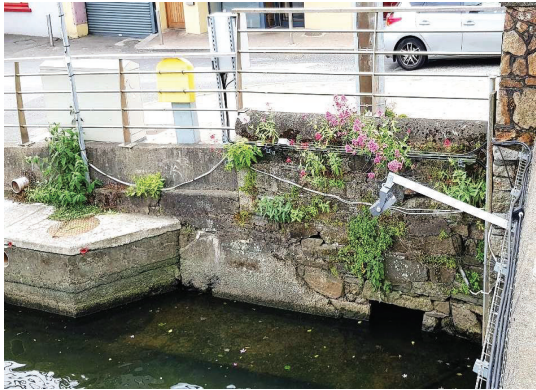
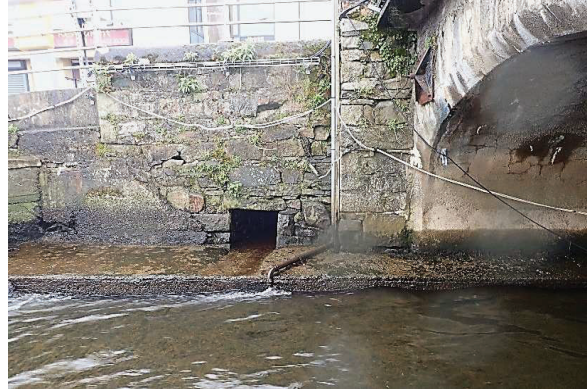
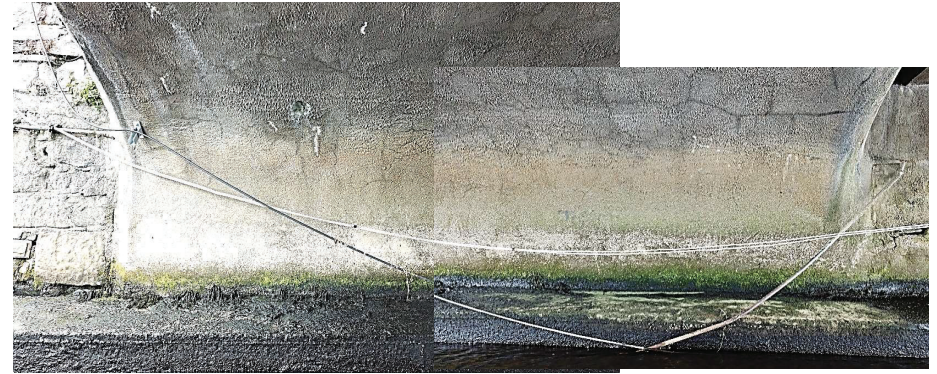
Sequence of photos showing south embankment and various interventions. The opportunity presents for enhancing earlier stonework, removing vegetation that has the potential to damage the masonry; repointing and re-presenting this south embankment as a strong robust masonry structure.

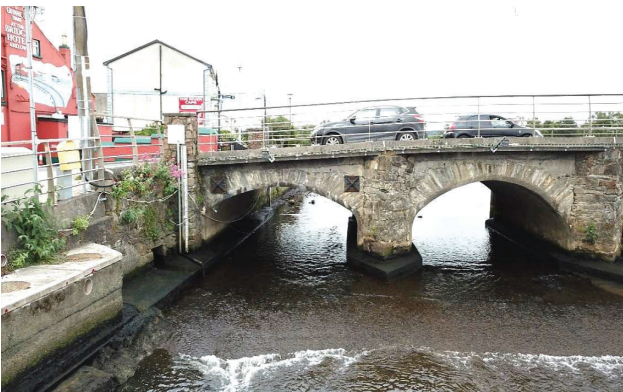
South Embankment and Span No1

Note large random shaped stone blocks in river bed at each and every arch. Most of these will be excavated out of the river bed as part of the river bed lowering scheme. The opportunity in span 1 and 19 presents itself to reinstate in span 1 above new sewer and retain and

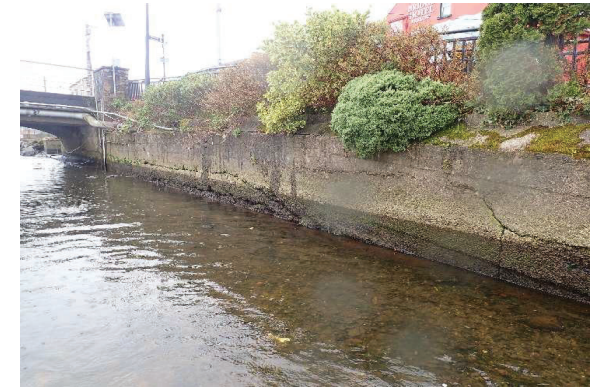
South Bank - west, upstream side. This bank will be altered as part of the process of inserting new Main sewer.

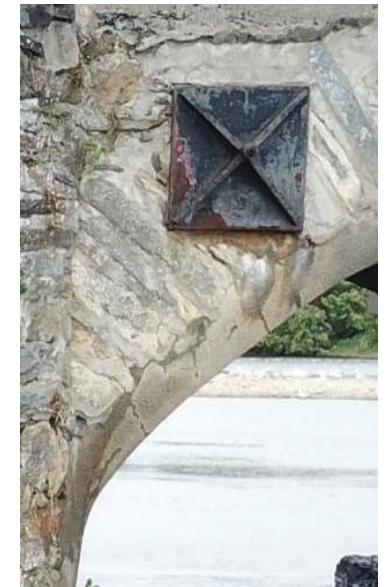
Pattress plate

Condition of these plates needs to be checked and new paint system applied at minimum. The difficulty will be confirming the condition of the hidden faces against the stonework and the bar running through the bridge. Recommendations - gain closer inspection to assess condition and exact make-up, and also any building of masonry behind plates.

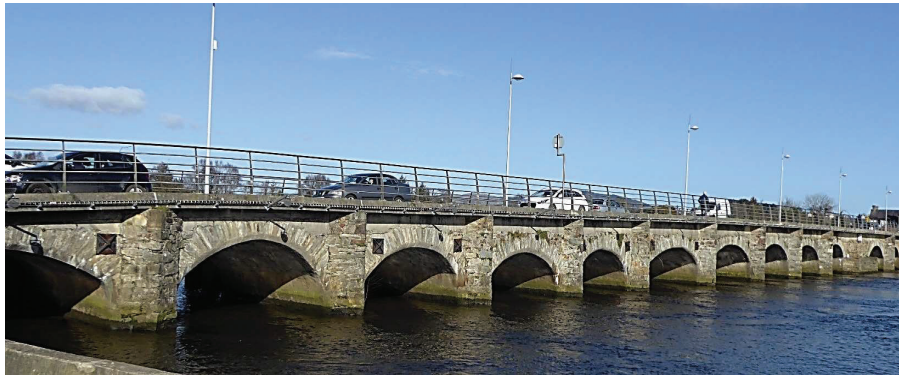
Note lime leaching to some arches in the form of white Calcium carbonate deposits. This signifies loss of fabric from deep within the arch masonry and indicates water penetration through the deck.

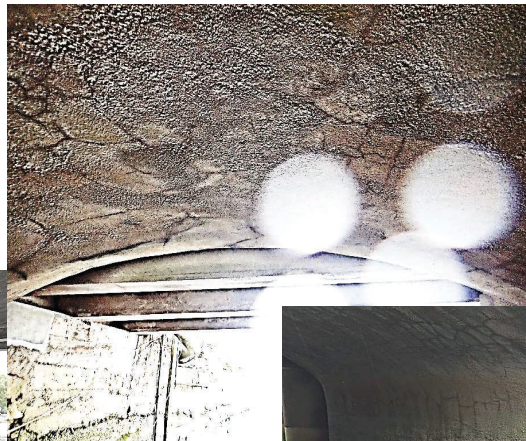
Underside of arch concrete sprayed - possible during the masonry works in 1982 or the later the Larson works of 2013, now crazing. All loose and crazed render should be removed to allow close inspection of original fabric and repair by re-packing all empty, leached out mortar joints.

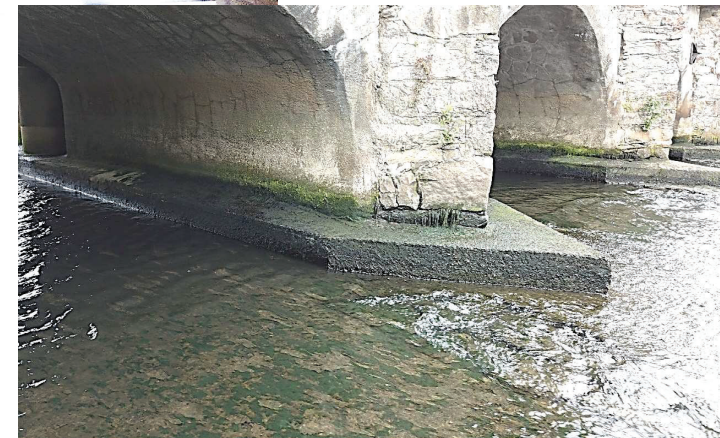
Typical downstream detail - significant erosion of pointing from breakwater masonry above concrete apron. This will require re-pointing and re-seating of any loose stones work. Repoint and repair will also allow for a clean up of gunite overspray and give an enhanced visual of the historic masonry.

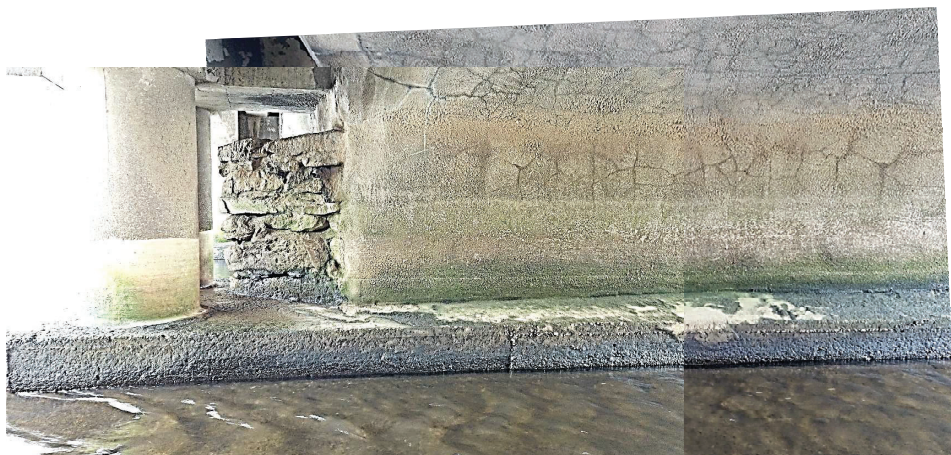
Typical upstream detail of historic bridge under canopy of newer section - significant erosion of pointing from breakwater. This will require re-pointing and re-seating of any loose stonework.

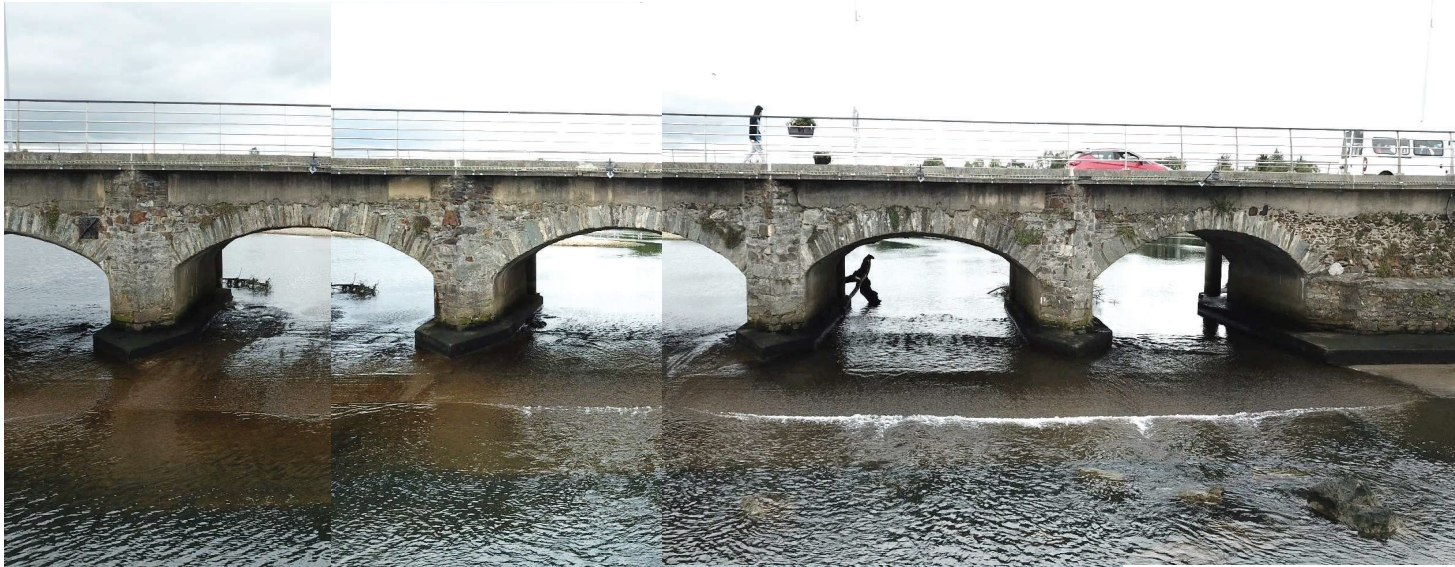
Vegetation growth on masonry requires containment. This growth is a clear indicator that repointing at minimum is required

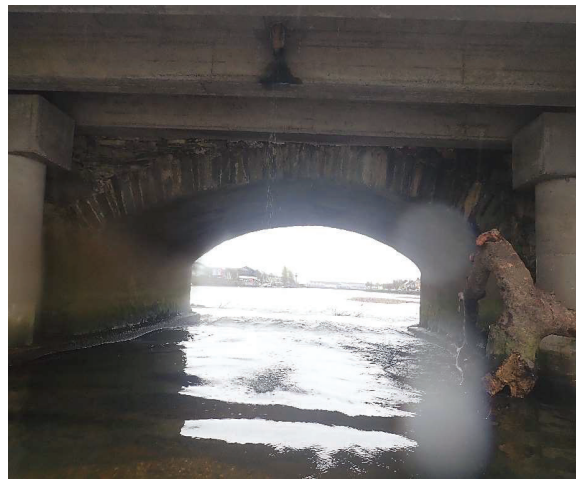
Attrition from floating debris is damaging stonework. Tree trunks etc catch between newer piers and historic masonry.

Proposed new debris trap upstream should alleviate this issue

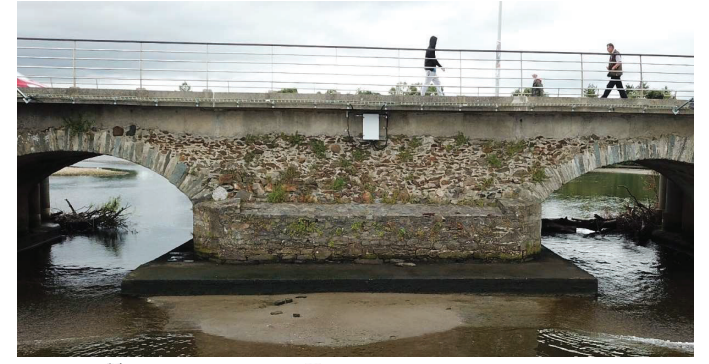
Significant vegetation growth including woody stemmed plants.- This extent of vegetation implies that significant erosion to the masonry has occurred and is ongoing. The vegetation needs to be eradicated and masonry repairs including a new capping detail installed. It is likely that a significant depth of capping stone work needs to be carefully recorded, removed and reinstated in mortars as specification

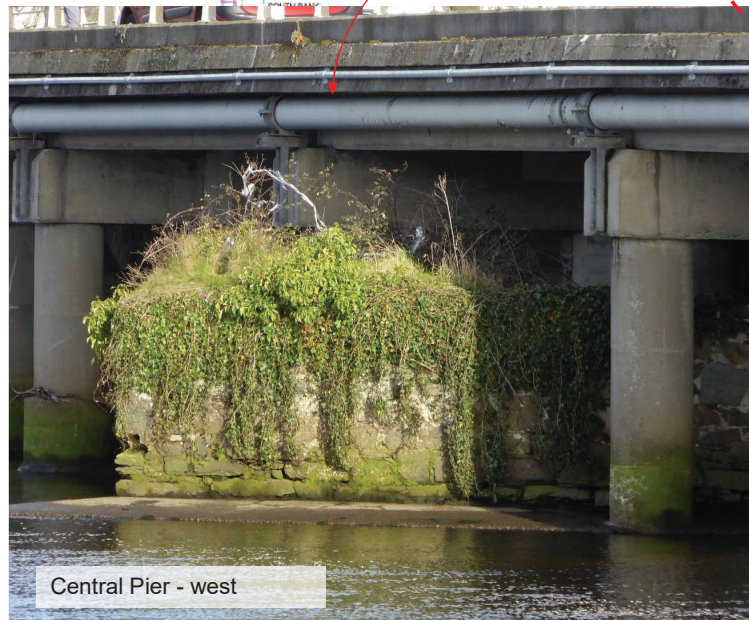
Central Pier - west

Vegetation growth on masonry requires containment. This growth is a clear indicator that repointing at minimum is required

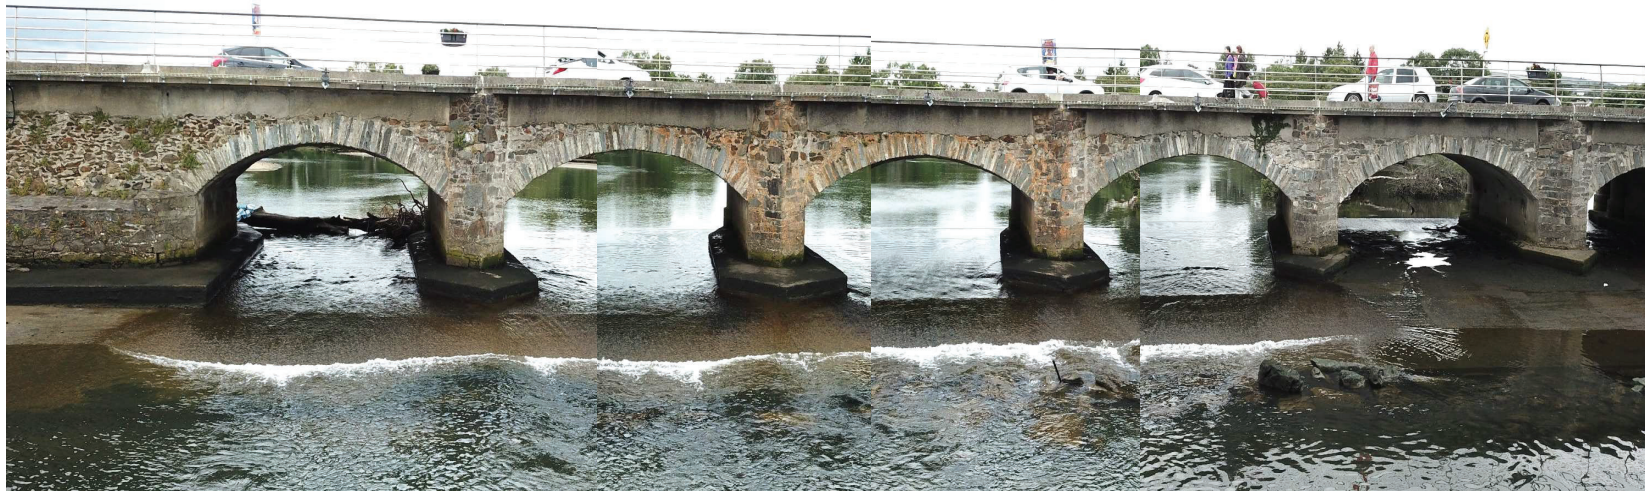
Mortar erosion from upstream face of masonry requires re-pointing

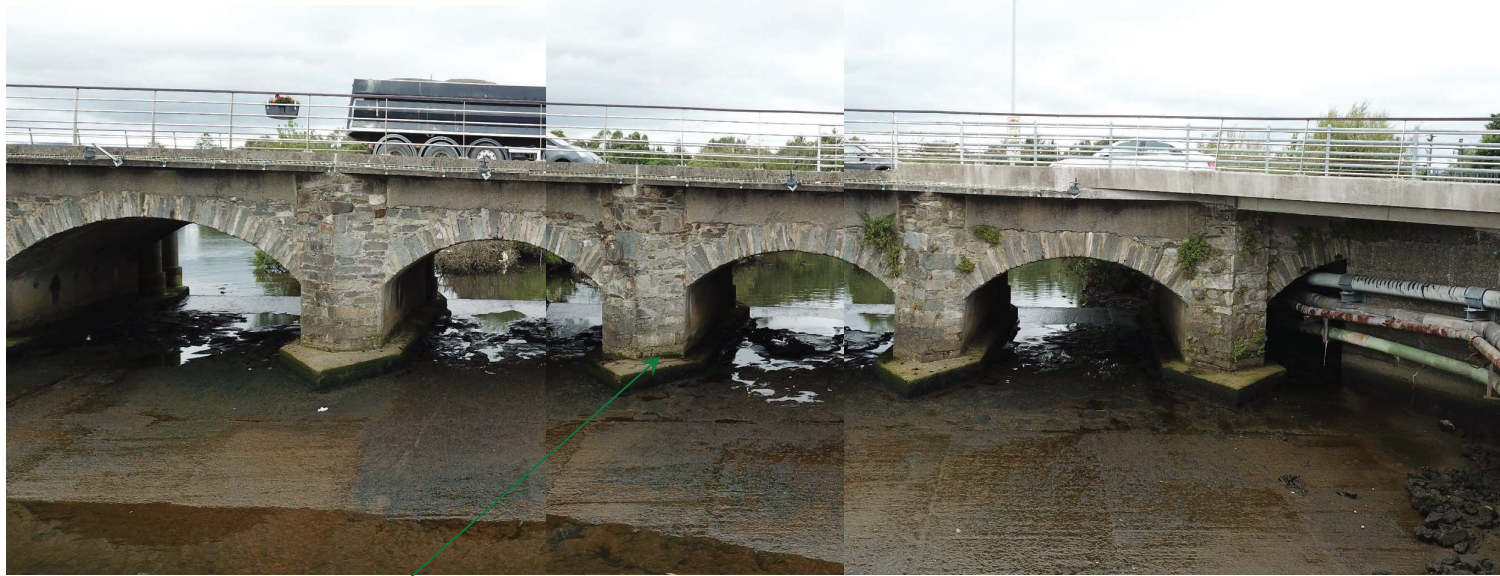
Mortar washout on tide line. repoint using hydraulic or hot lime and pozzolan mixes. Below tideline, repoint using natural

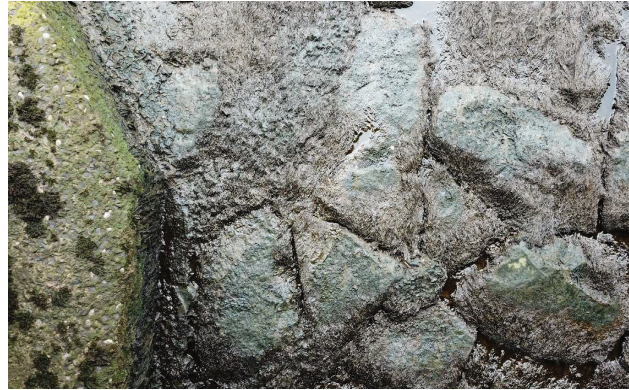
These blocks to the base of the river are likely to be long stones placed point down to form interlocking anti-scour bed. However those excavated 2019 to arches 1-4 were quite shallow and possibly from non original works. Nonetheless this detail should be retained where possible in the vicinity of arch 19 and repaired as necessary to retain as much of historic form as possible.

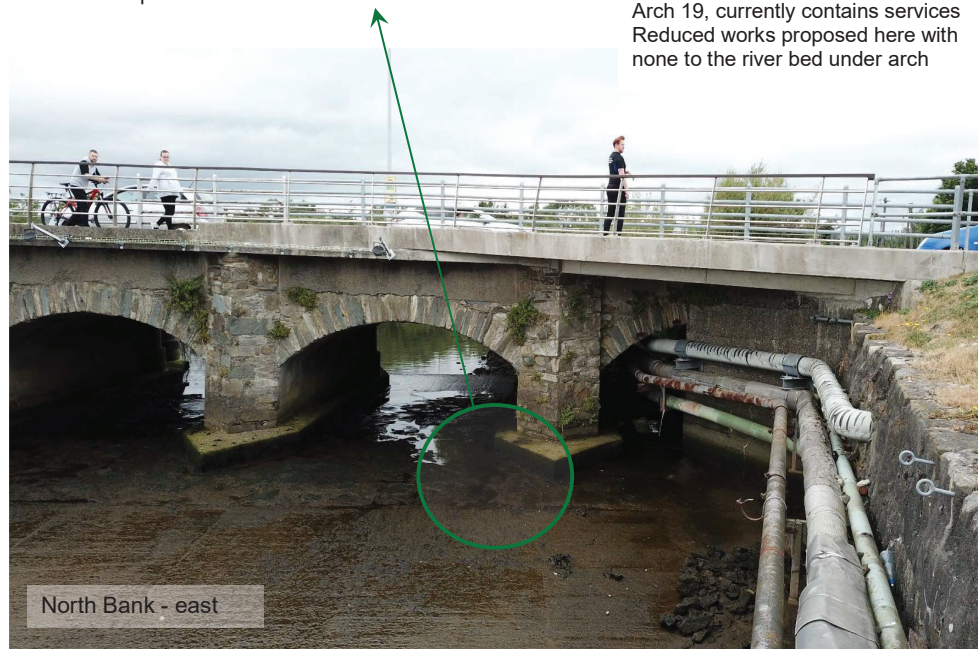
Arch 19, currently contains services
Reduced works proposed here with none to the river bed under arch
