Conservation Engineer Report on Abbey Grounds

Project: Abbey Grounds, Wicklow Town
Client: Wicklow County Council
Reference: 21-19 Rev 1
Date: 5 October 2021

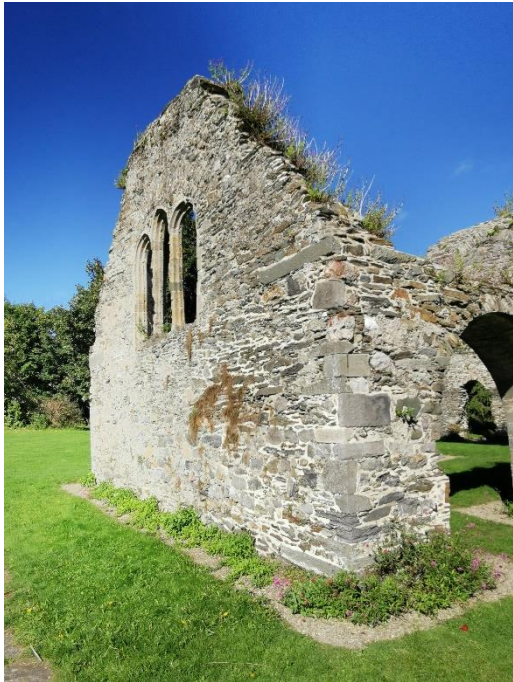
With regards to the Southern gable ended wall, some vegetation growth has re-established along the top of the remaining wall. See photograph 1. It is recommended that at the start of the proposed works the vegetation is carefully cut back and roots treated using eco plugs, as they die off the roots carefully removed and localised repointing in lime mortar.

Photograph 1: Southern Gable wall to Friary

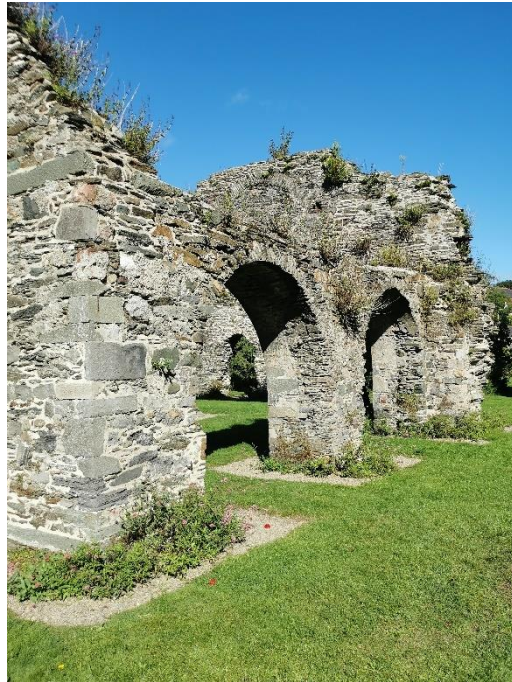
The eastern wall has two arches within the wall, see photographs 2 and 3. There is vegetation starting to re-establish on this wall as well and the same treatment policy needs adopting as for the southern wall. The most northern of the two arches has minimal masonry cover over the crown of the arch and has displaced over time. See photograph 4. To the underside of this arch there are some stone voussoirs that are showing signs of starting to detach from the arch. See photograph 5. We recommend that underneath of this arch is cordoned off immediately due to the risk of stonework falling. The remedial work we would recommend is pinning of the stones that are loose on the underside of the arch using stainless steel dowels. The arch will require

Photograph 2: Eastern wall with two arches

propping during this work to reduce risks of any failure occurring during the pinning works. The holes formed from the pinning can be filled using a mixture of lime mixed with the stone dust collected from the drilling.

We would recommend that some additional masonry is added to the top of this arch to improve the arch action in terms of increasing compressive forces to help keep the arch together.

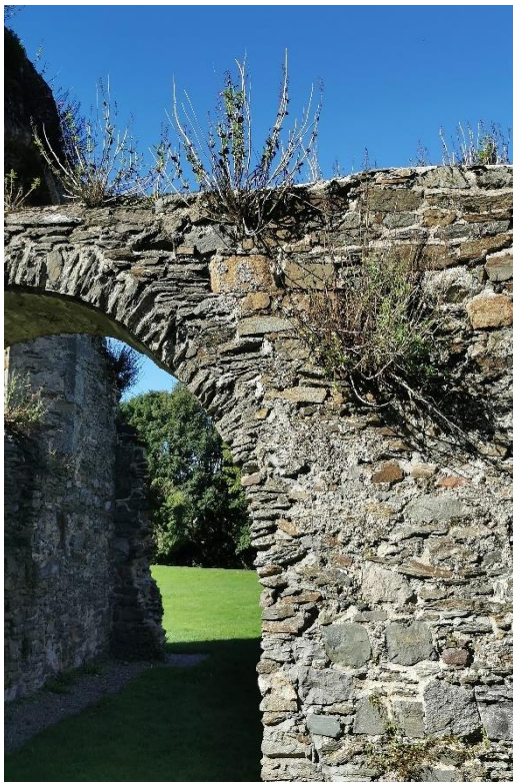
Photograph 3: Vegetation growth

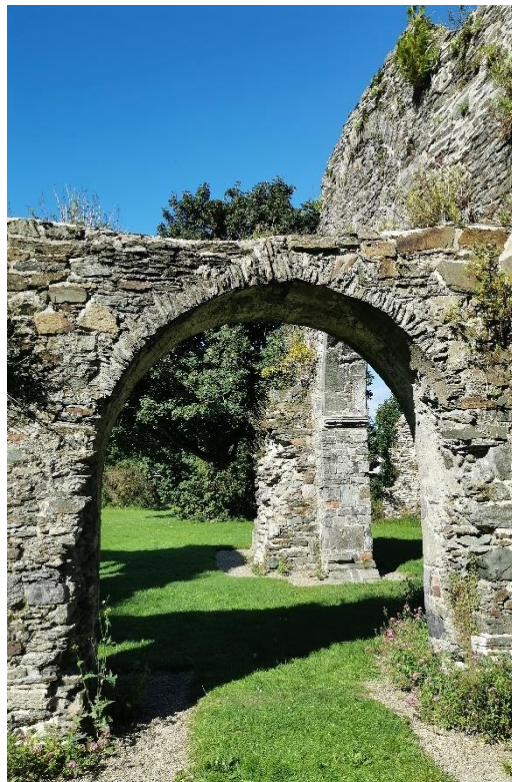
On the eastern most wall there are two stone arches of which the one furthest north requires some structural intervention work. There is some misshaping of the arch from movement and some of the voussoirs to the underside have come loose and are now at risk of falling, possibly leading to the arch to potentially collapse. The area underneath requires cordoning off until such time as remedial works can be undertaken. The remedial works will consist of temporarily propping the arch but allowing such access to the loose stones that they can be pinned into stonework above by adding stainless steel pins that will then have the ends covered over with lime mortar mixed with stone dust from drilling for the pins. An additional course of stonework to match the stonework already in-situ should be added on top of the arch to increase the compressive load on the arch which will improve arch action and re stabilise this section of wall.

Photograph 4: Northern of two arches with misshaped barrel

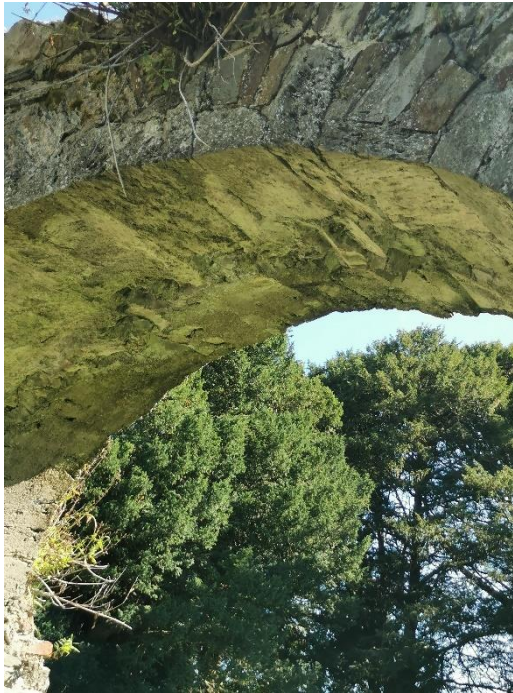
Photograph 5: Loose stones to underside of arch

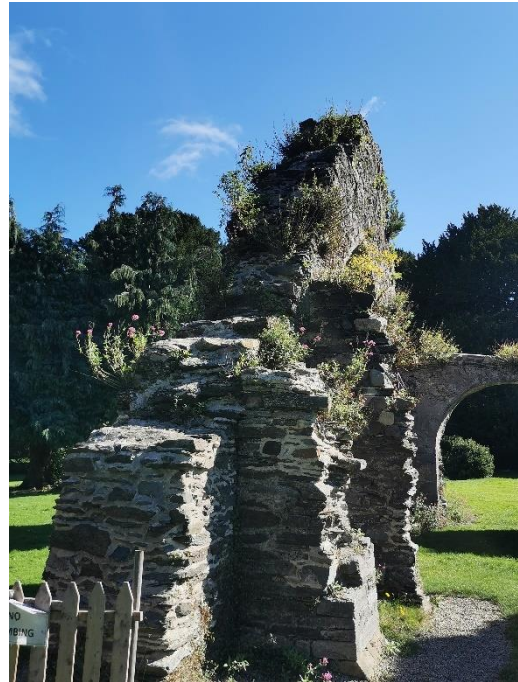
The middle wall traversing west to east and the northern most wall are in a reasonably good condition structurally but do require vegetation removal in the same way as the southern wall. See photographs 6 and 7.

Photograph 6: Mid wall running east to west showing vegetation growth

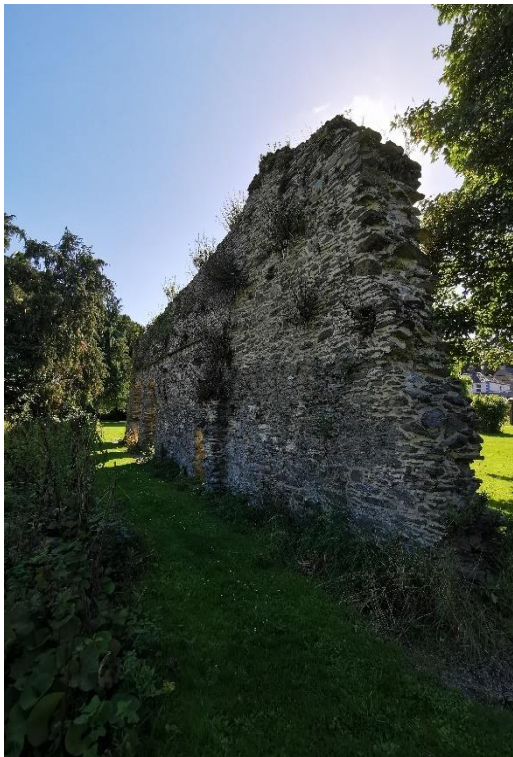
Photograph 7: Northern Friary wall with vegetation growth

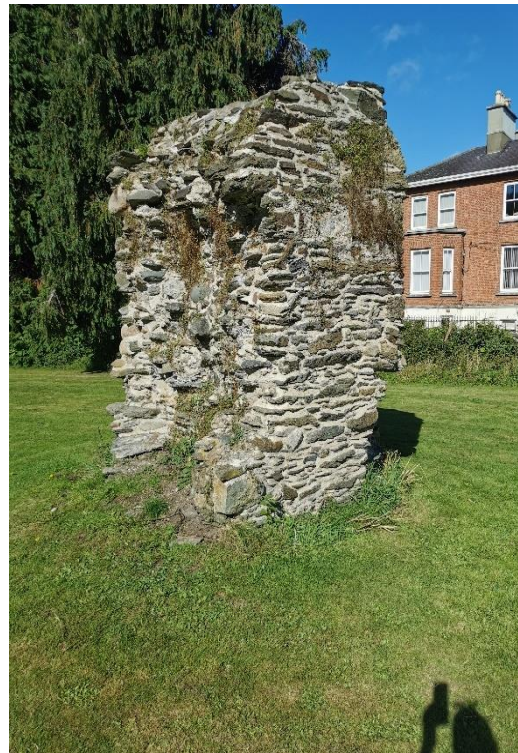
The stump of wall that sits a small distance away from the main Friary ruins requires vegetation removal and repointing with lime mortar locally where any roots once killed off using 'eco plugs'

Photograph 8: Wall stump with vegetation growth

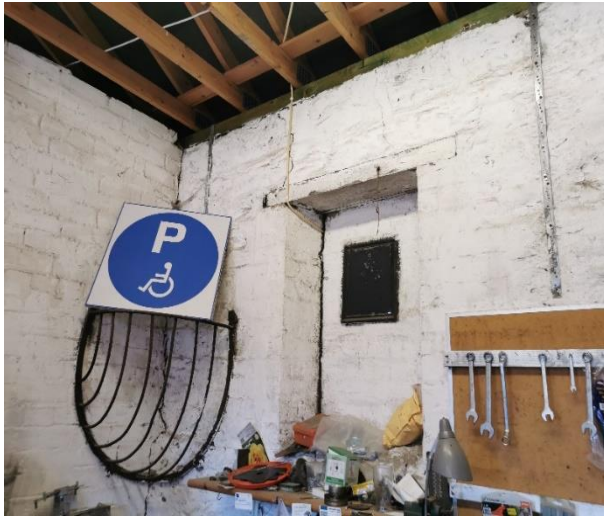
Internally the stone wall that is approximately at a third from the west gable end has detached from north and south walls to coach house. The cracking that was reported on previously in the external facades does occur internally at the same locations as well. See photographs 9-14. The couch house has been re-roofed with a modern truss rafter roof that is strapped to the walls. See photographs 15 and 16. Due to the strapping being visible we would propose that internally we would use galvanised strapping to tie the transverse internal wall to the north and south walls and the northeast corner of the eastern gable end. See photograph 17. For the cracks in the west gable wall and the north wall it is likely that a similar type of strapping will be required but this can only be undertaken once the results of some crack monitoring are known as there may be a need for more substantial structural works in terms of potential localised underpinning.

Photograph 9: Coach house internal wall separating from outer walls

An internal masonry wall between the north and south external walls has become detached and needs to be strapped back to these walls using galvanised wall steps at 1m centres. Strapping will also be required to the northeast corner internally as some detachment of these two walls has also occurred. There is also some dislodged masonry around the main coach house double doors that needs to be reset.

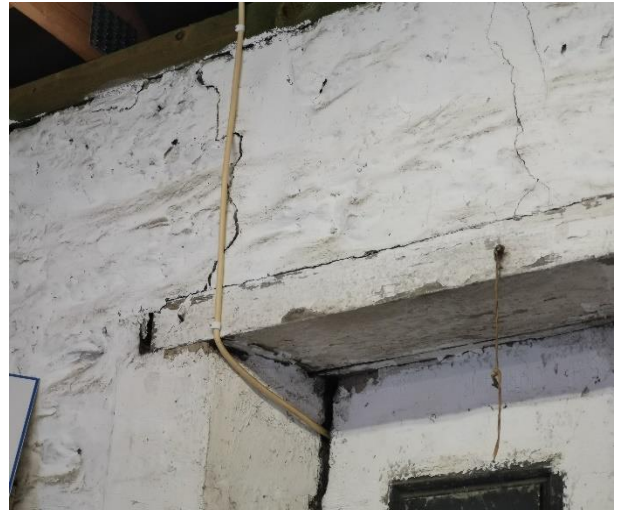
Photograph 10: Crack at weakest point in wall

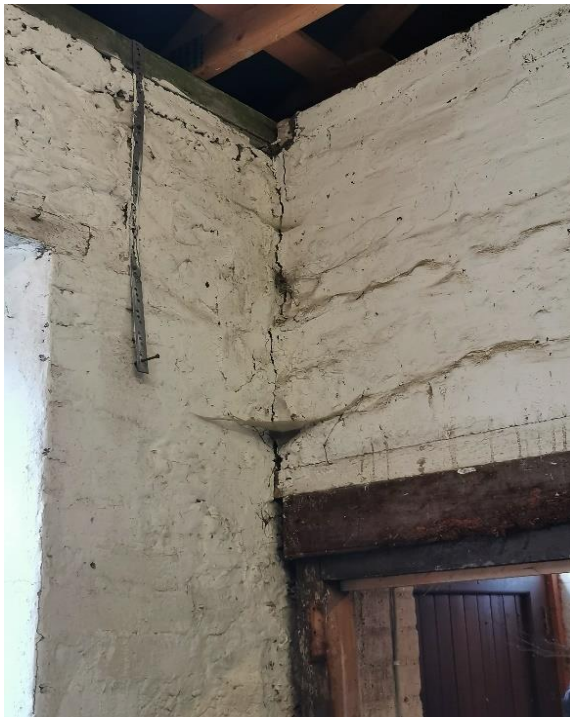
Photograph 11: Separating of internal wall from external wall

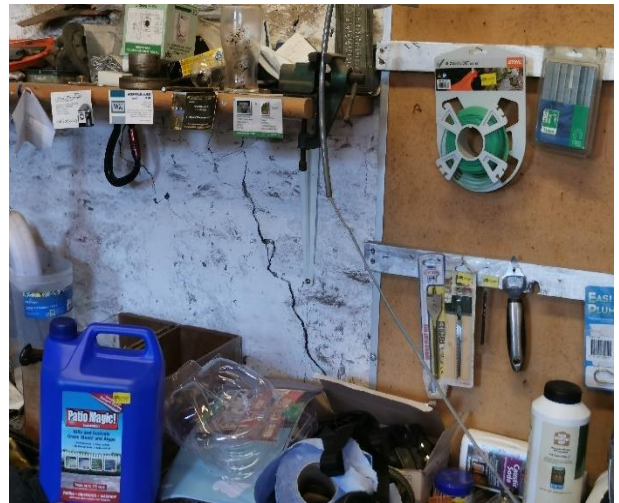
Photograph 12: Crack in north wall mirrored from outside

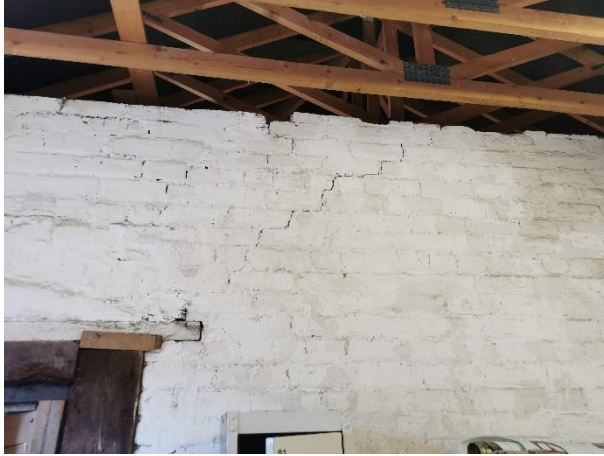
Photograph 13: Cracking to wall

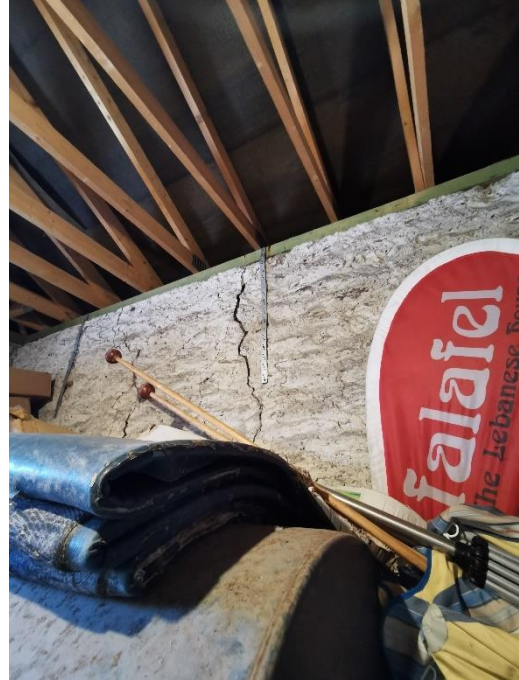
Photograph 14: Cracking to inside face of wall

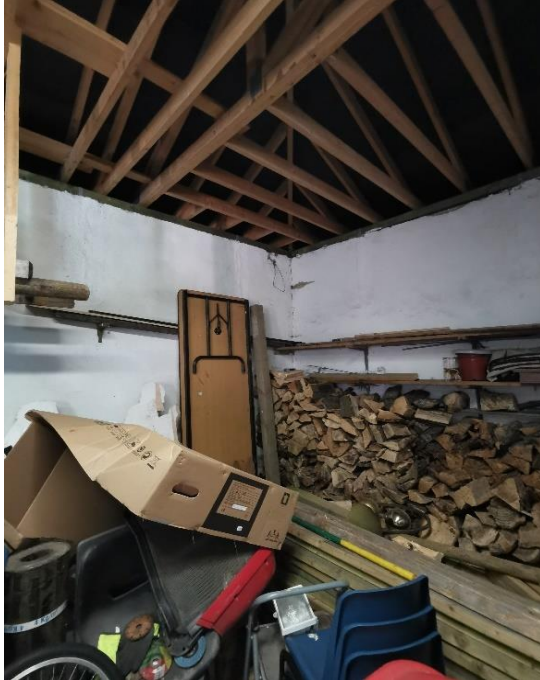
Photograph 17: Northeast corner of wall separating at corner from one another

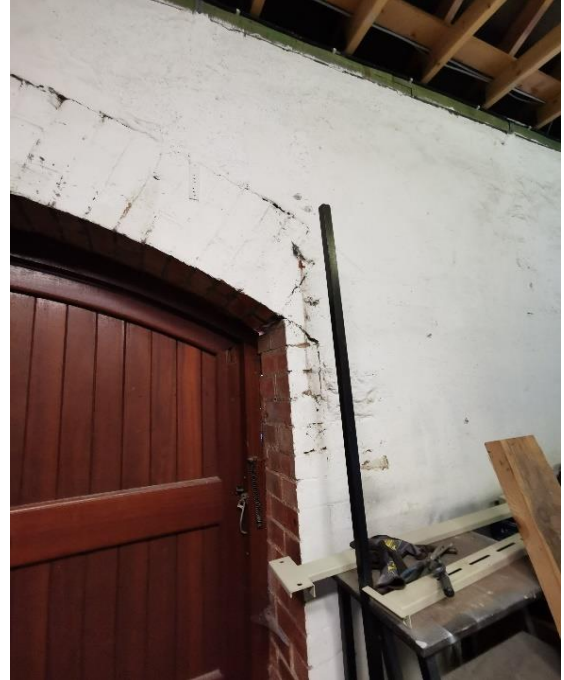
At the coach house entrance there is a section of brickwork that appears to have been possibly stuck and become dislodged. See photograph 18 This brickwork should be re set. The brickwork arch over springs from a point behind the dislodged brickwork so there is no structural issue with removing the affected brickwork and re-setting it.

Photograph 18: Masonry dislodged

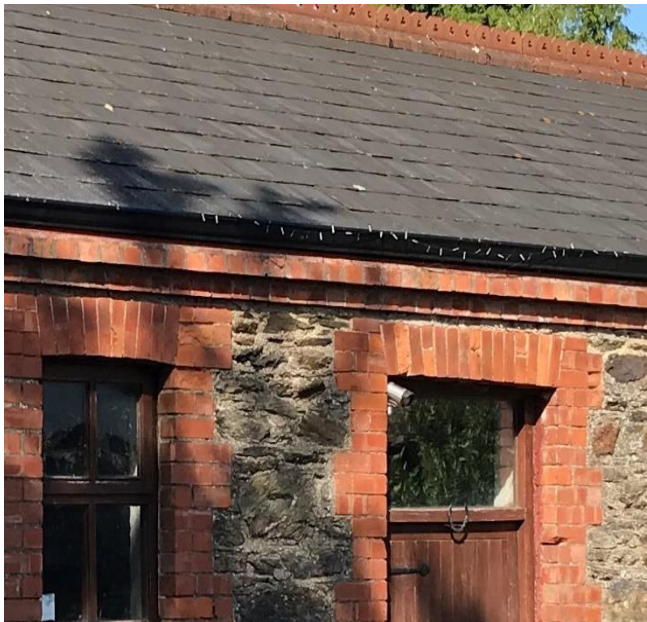
From the external inspection it was noted that some of the original brickwork features have some areas where the face of the brickwork has 'blown' a dentil repair can be undertaken to these areas to prevent further damage and loss of material. See photograph 19

Photograph 19: Feature brickwork with facing blown

Some feature brick work around window and door reveals has lost some of its facing material and dentil repairs should be undertaken to stop further loss of the softer inner part of the brick.

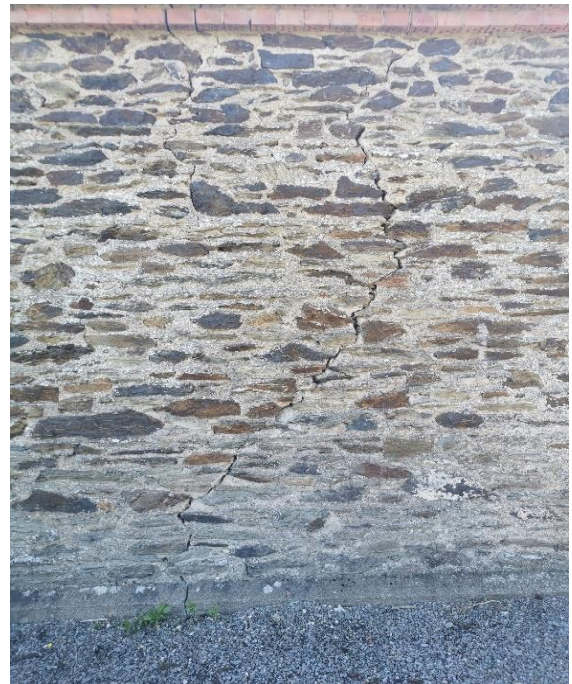
On the west gable end we placed 3 sets of pips and took initial readings of both the crack width and the distance between the pips. See photographs 20 - 23. On the north facing wall we placed another 3 sets of pips and took initial readings. See photographs 24 - 27. The initial readings are contained in table 2.2.2

Photograph 20: Vertical crack in west elevation to coach house

These cracks require monitoring over a period of time to determine if the cracks are historic. If no significant movement is now occurring, then they can just have remedial tying details applied by using stainless steel 'helifix helibar' remedial crack stitching. If there is significant movement still occurring, then there may be the need for some localised underpinning.

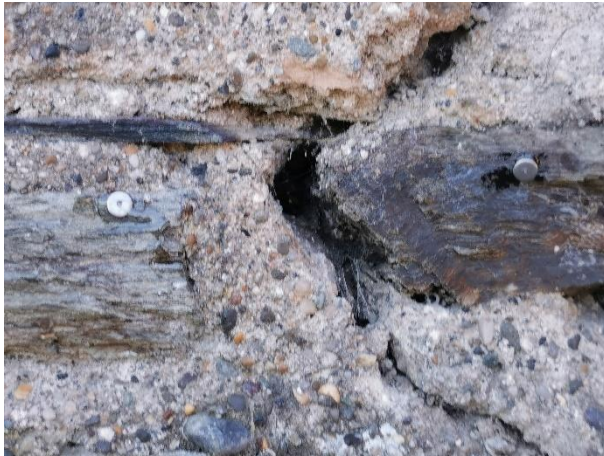
Photograph 21: Crack monitoring pips location 1

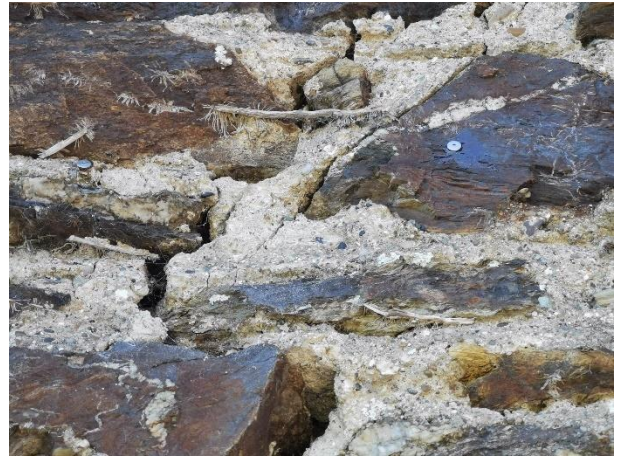
Photograph 22: Crack monitoring pips location 2

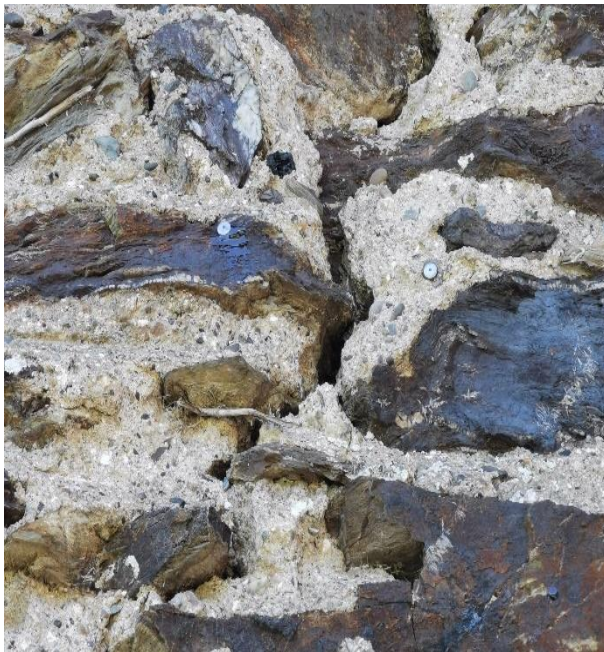
Photograph 23: Crack monitoring pips location 3

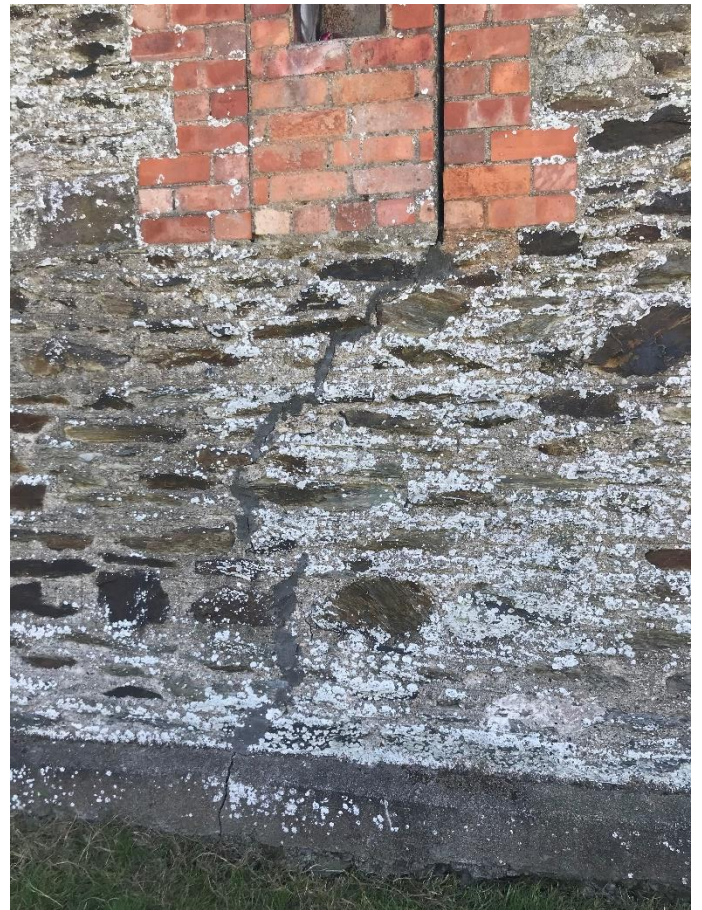
Photograph 24: Cracking in north elevation to coach house

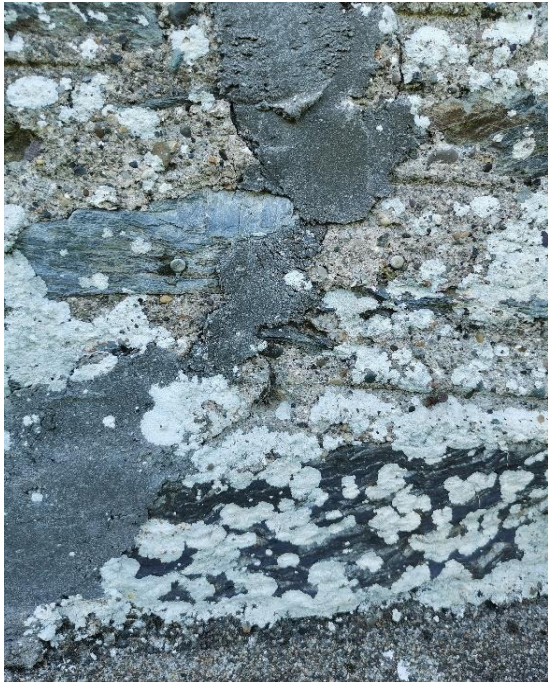
Photograph 25: Crack monitoring pip location 4

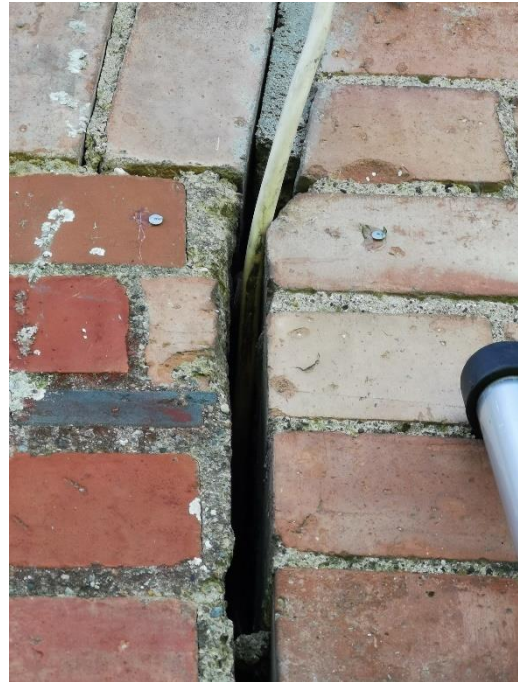
Photograph 26: Crack monitoring pip location 5

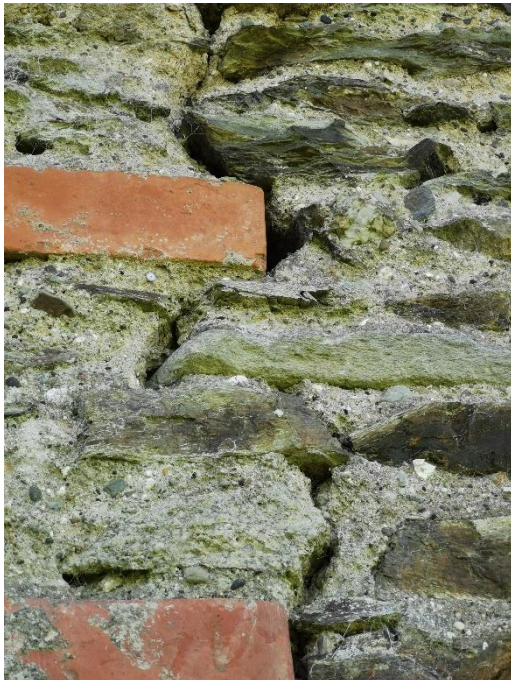
Photograph 29: Crack monitoring pip location 6

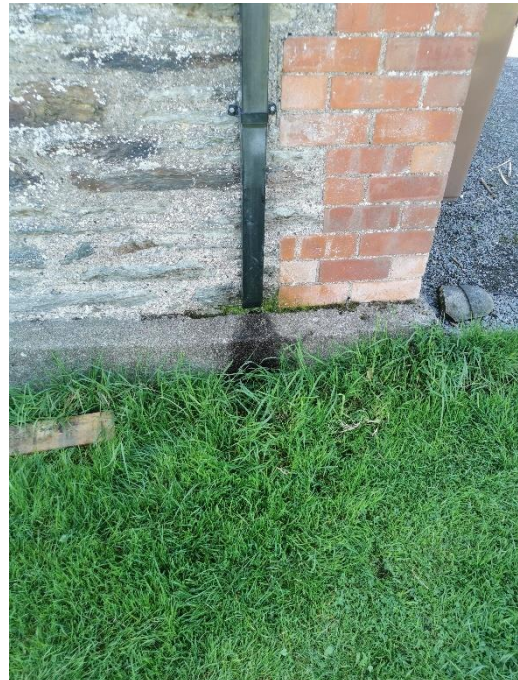
It was noted that to the western end of the north facing external wall a rainwater down pipe is damaged at the bottom and is allowing water to exit onto the plinth for the wall. See photograph 28. This could be a potential issue in relation to the cracking in the walls and possible movement occurring as rainwater may be softening the ground locally especially with the downpipe currently broken at it's base. This needs additional downpipe added and ideally a gulley with underground storm drainage added to direct the rainwater from the back of the coach house into a soak pit. This would apply to both downpipes on this elevation.

Photograph 28: Rainwater pipe missing end piece and allowing water to exist directly onto plinth to North elevation of coach house

It was noted that rainwater downpipes on the north elevation discharge at the base of the wall which will not be helping the situation regarding the cracking identified. These rainwater outlets need to drain into gulley's and a storm sewer laid to a soak pit located a minimum of 5m from the Coach House.

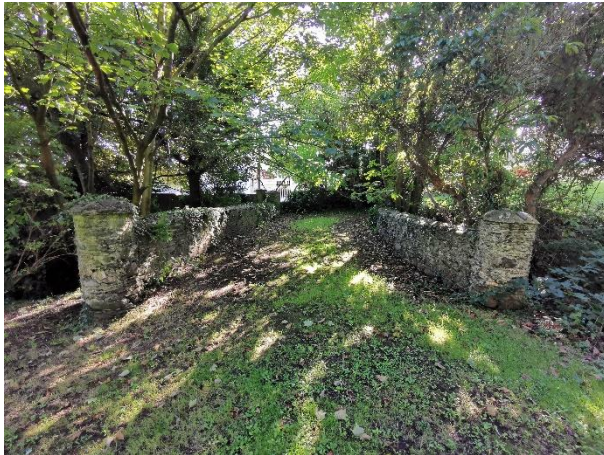
Just to the rear of the Abbey / Priest's house there is a masonry arch bridge that crosses the river that forms the Eastern boundary to the site. This masonry structure has stone parapets that require vegetation growth removal with pinning of loose stonework and repointing. See photographs 29 - 32. Any large roots should be treated with 'Eco Plugs' to kill them off rather than potentially damaging masonry further trying to remove them without killing them first.

Photograph 29: Stone arch bridge with stone parapets

To the south corner of the site there is an existing single span masonry arch bridge that as part of the proposals for the Abbey Grounds that will act as a route into the grounds from the East. The parapet walls to this bridge require vegetation removal with some stone pinning and the top section of capping stones re setting as well as repointing in lime mortar.

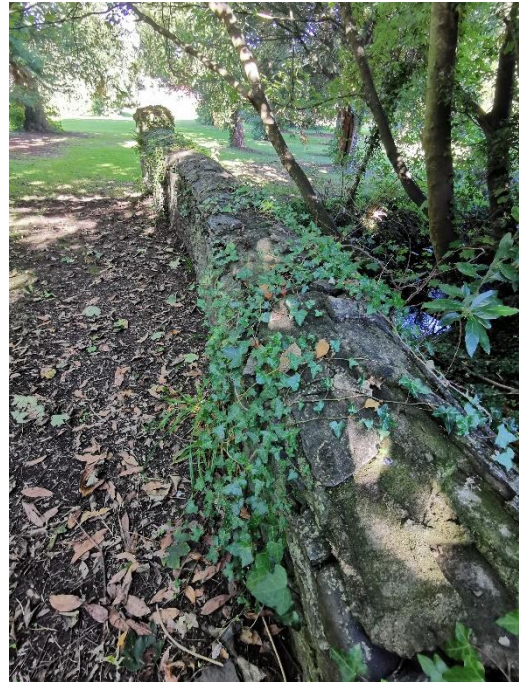
Photograph 30: Vegetation growth on parapet

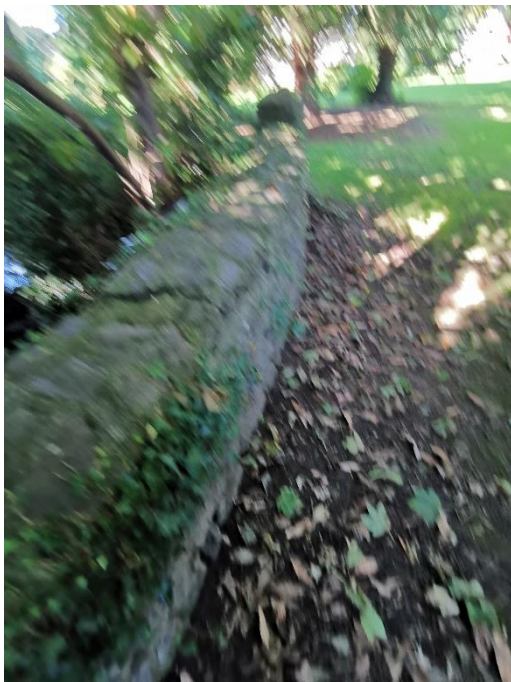
Photograph 31: Vegetation on parapet

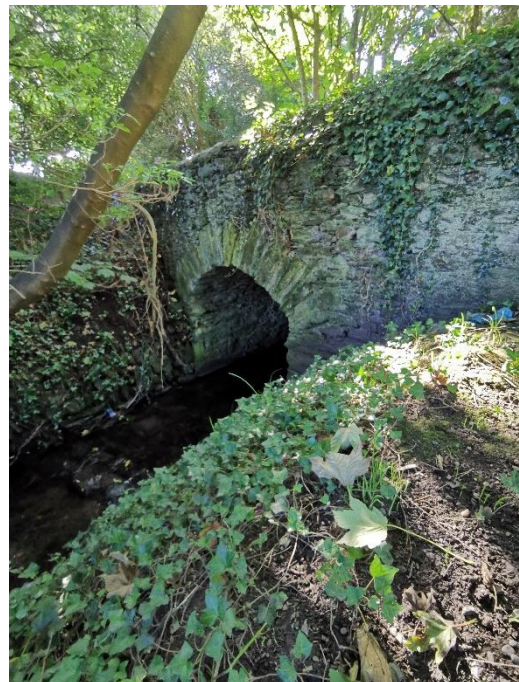
Photograph 32: Stone arch bridge

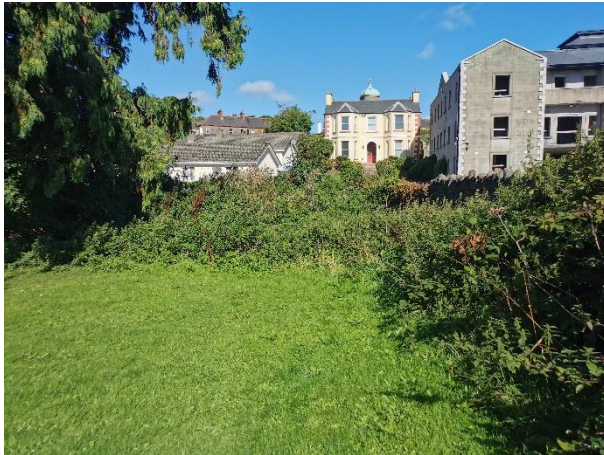
The rest of the internal wall faces were mostly covered in vegetation and could not be fully inspected. See photographs 33 and 34. Significant vegetation growth requires removal and large roots into the wall treated with 'Eco Plugs'. Once the vegetation has been cut back, we recommend a further inspection to determine the locations where stone pinning is likely to be required and probable pointing.

Photograph 33: Overgrown vegetation to boundary wall

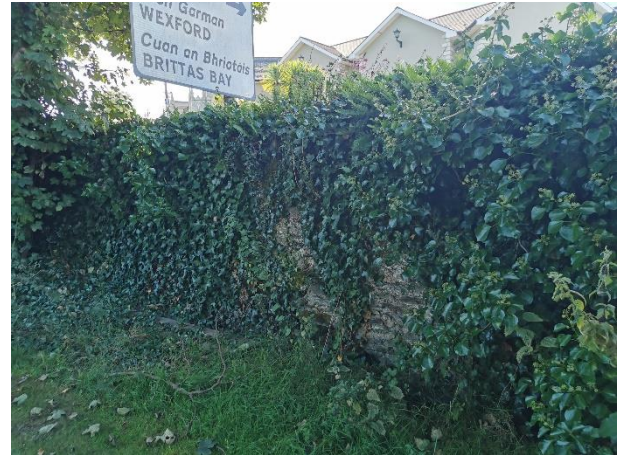
Photograph 34: Vegetation growth on boundary wall

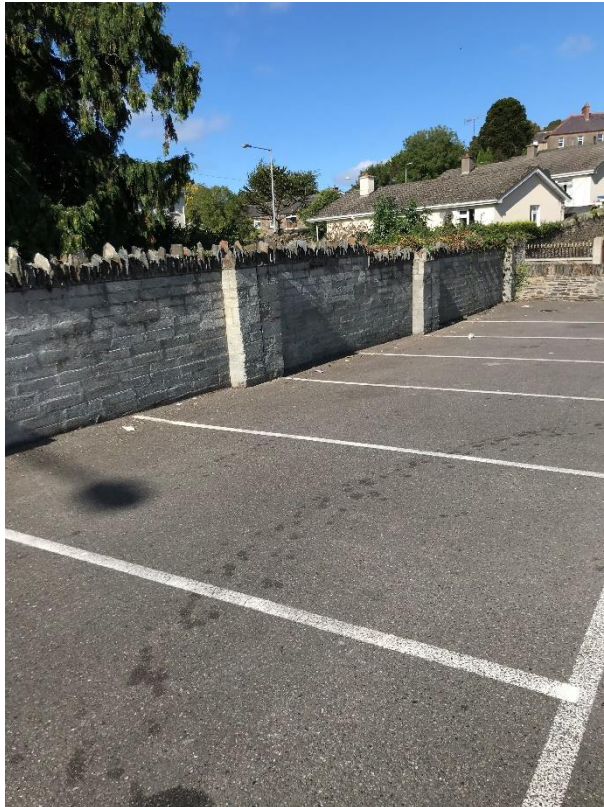
From the carpark on the other side of the river a block wall topped with stonework has been constructed. We suspect some of the capping stonework is probably from an earlier wall. See photograph 35. On Wentworth Place part of the wall was reconstructed in recent times due to it collapsing during a localised flood event. See photograph 36.

Photograph 35: Blockwork boundary wall with stone capping within car park

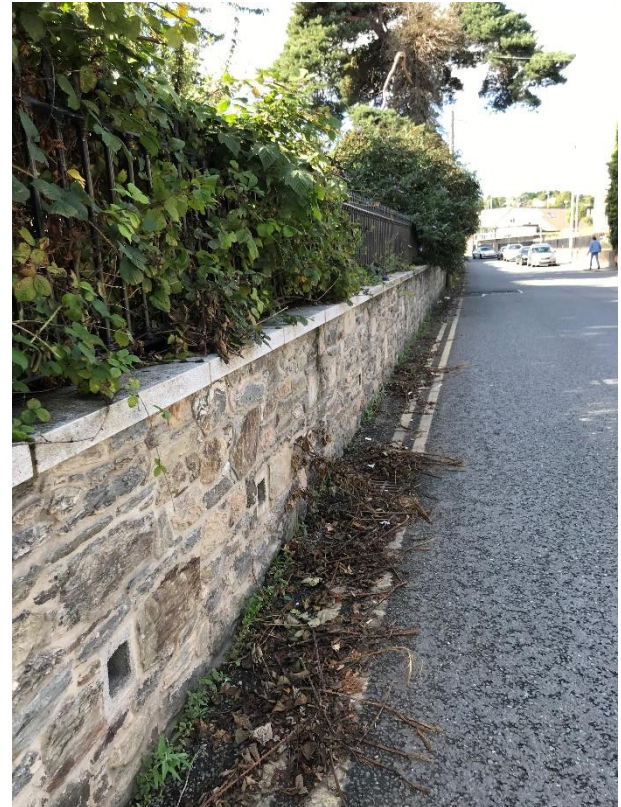
Photograph 36: Reconstructed section of boundary wall to Wentworth Place

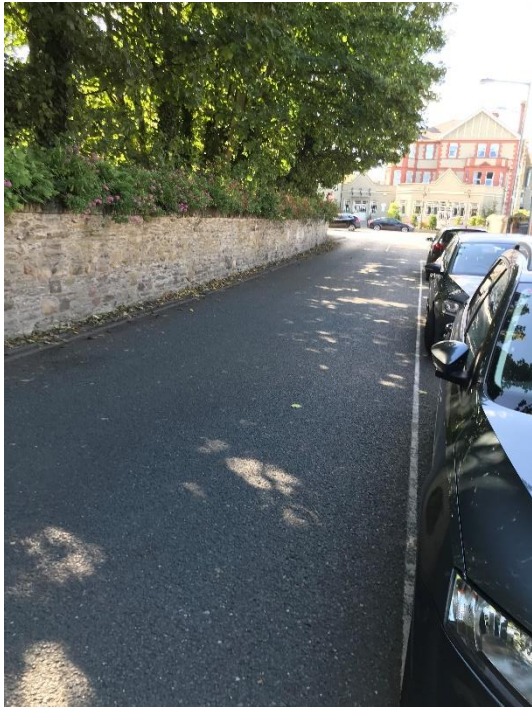
At the end of Wentworth Place, where it meets up with Abby Street the wall has a significant lean out towards the road. See photograph 37. The lean coincides roughly with where two mature trees are found within the ground very close to the wall. With regard to the second of these trees away from the corner where Wentworth Place meets Abbey Street, the lean was found to be 100mm over 600mm. The lean of the wall where the tree is located inside the grounds nearly in the corner, the lean is 60mm over 600mm. Once we are onto Abbey Street, the lean is reduced to 20mm over 600mm and this reduces to virtually plumb further south along Abbey Street.

From the location of the lean and cracking with respect to two mature trees within the Abbey Grounds close to this section of wall it is apparent that the trees are the cause of the lean. We recommend that these two trees are removed otherwise the wall is likely to continue to lean and will fall onto the road. As it stands the reaction of the centre of gravity of the wall with its current lean is only just within the middle third, so it is very close to potential collapse.

Photograph 37: Boundary wall looking up Wentworth Place towards Abbey Street

Due to the severity of the lean and the space that is available within the Abbey Grounds we would recommend some concrete 'Kelly blocks' are placed approximately 2m from the wall a timber waler added below the stone capping level on the Wentworth place side fixed into mortar joints in the wall and tied back to the 'Kelly blocks' with cables. The long-term solution is to remove the trees. Allowing roots to die back naturally and to incrementally pull the wall back by building a timber framework around the wall that can be pulled back slowly. As the mortar joints open they are to be filled with lime mortar. This has been successfully used elsewhere in Ireland and the UK. The full lean will not need to be pulled back as with the root degradation this will also naturally allow the wall to have some restoration in plumbness.

The long-term solution is to use a novel, but tried and tested method used both in Ireland and the UK of pulling the wall back to within 50% of its current lean. This will require encasing the wall and pulling the encasing back slowly. Any joints that open up will required filling with lime mortar. Once completed the two vertical cracks can be crack stitched. It is also likely that as the root systems die back that some of the remaining 50% of lean will also restore itself.

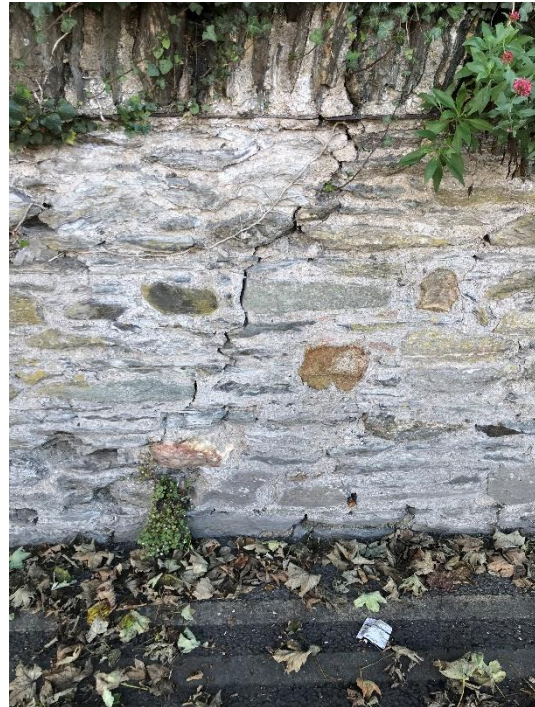
Along this section of wall, it was also noted there are two significant cracks. See photographs 38-41. From a recent survey it was found that the internal and external levels are very much the same, so the lean is not attributable to the wall acting as a retaining wall at this location. See level survey in Appendix B by DTA.

Photograph 38: Crack in boundary wall opposite Wentworth Grove

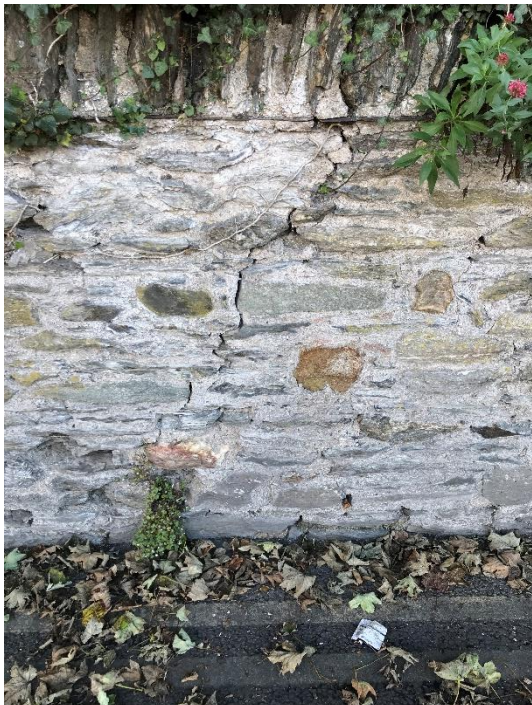
Photograph 39: Second Crack in boundary wall close to Wentworth Place Abbey Street junction

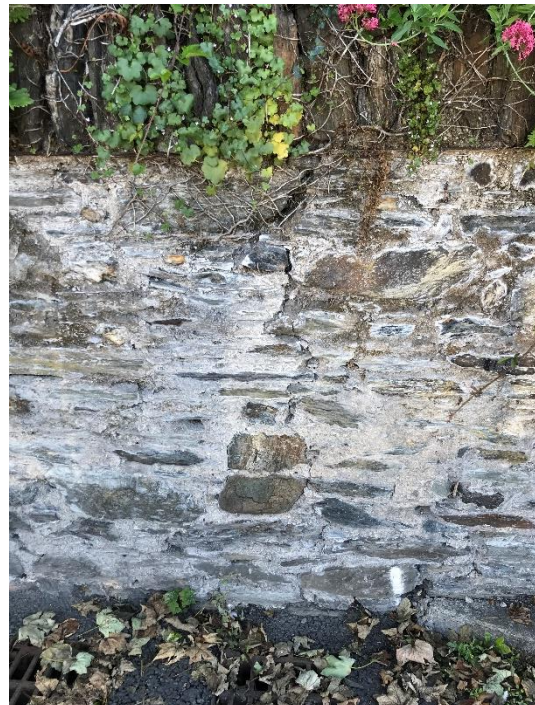
Photograph 40: Lean of wall and vegetation growth

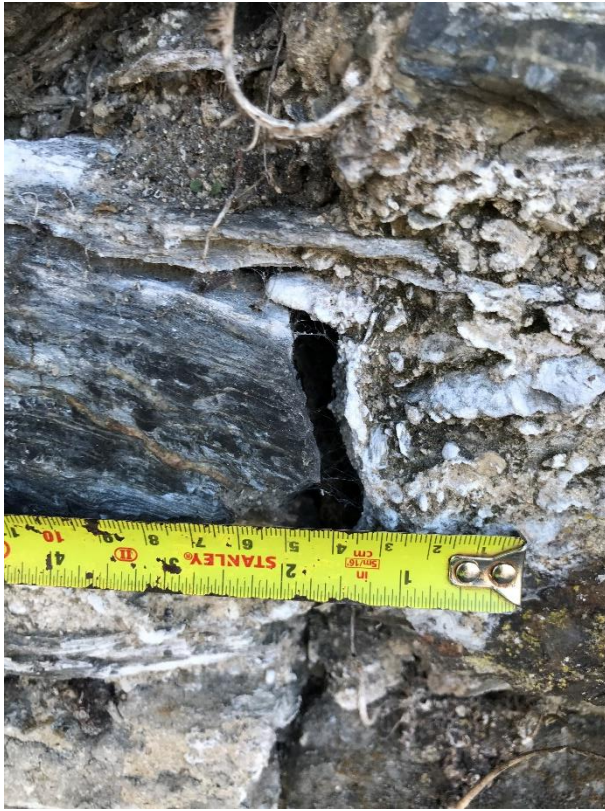
Photograph 41: Crack close up

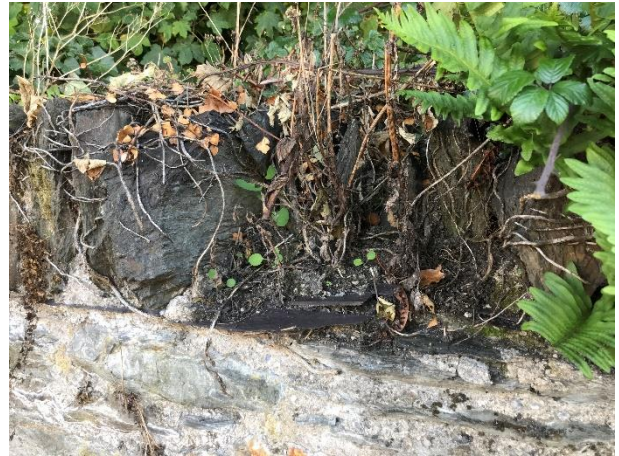
From the inspection of the wall outside the Abbey Grounds it was noted that there are a few areas where some of the capping stonework is missing. See photograph 42. This should be reinstated along with any slate bed that may also be missing.

Photograph 42: Missing parapet perpend stones
