Blessington Greenway

Stage 1 Road Safety Audit

Project number: 60617025 Doc Ref: 60617025-RSA1

August 2023

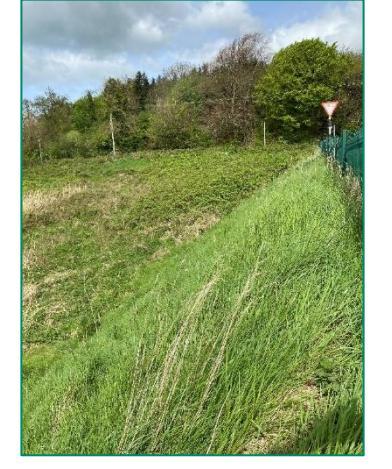
Figure 5-4 – Approach gradient to Blessing bridge

5.2.1. Probl	em	and the second se
Location:	Blessington Bridge	
Drawing:	60617025_SHT_DD_BLGWY_142- Blessington	
Summary:	Visibility for Greenway users on the approach to the Blessington Bridge	
Descriptio	n:	
		Figure 5-4 – A

The approach to the Blessington Bridge will connect to the footpath on the eastern side of the Blessington Bridge, During the site inspection it was observed that the slope on the approach to the abutment of the bridge would be quite steep. The Blessington Bridge Road is elevated above adjacent ground level at this location. There is no footpath or verge provision on the western side of the Blessington Bridge Road to facilitate NMUs. As the Greenway will rise to connect to the bridge, it is unclear to the auditors if there is sufficient visibility to Greenway users from vehicles travelling on the carriageway.

Appropriate gradient levels on the approach to the Blessington Bridge Road should be provided, as well as appropriate signage and visibility requirements at the connection location.

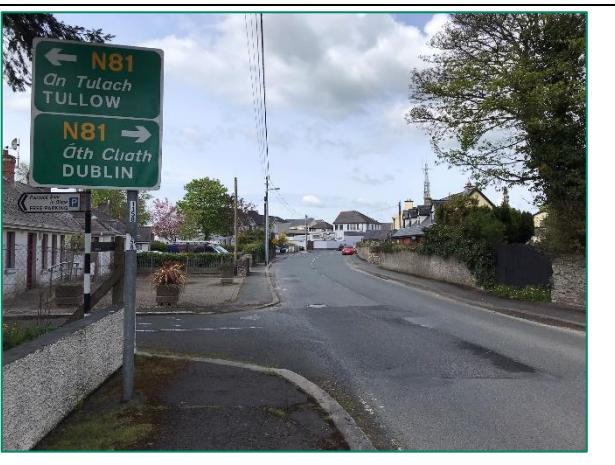
Figure 5-5 – Lack of NMU Crossing Provision

5.2.2. Problem			
Location:	Connection onto Kilbride Road		
Drawing:	60617025_SHT_DD_BLGWY_142- Blessington		
Summary:	Lack of crossing provisions		
Descriptio	n:

The existing connection between the access road and the Kilbride Road has no provisions for pedestrians crossing. No road crossing provisions are proposed along the Kilbridge Road for non-motorised users. The lack of appropriate crossing facilities can lead to shared footpath user crossing at undesignated location, which could result in a pedestrian/vehicle collision.

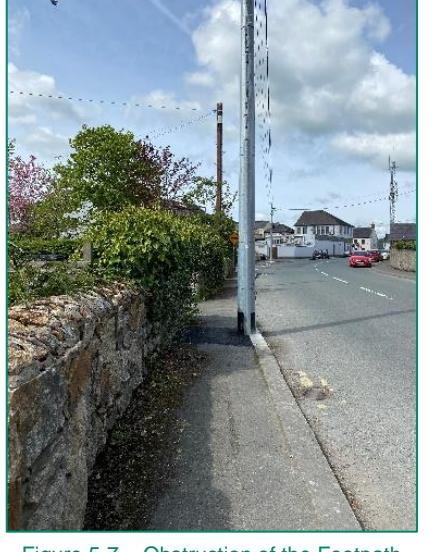
Figure 5-7 – Obstruction of the Footpath

5.2.4. Problem		
Kilbride Road		
60617025_SHT_DD_BLGWY_142- Blessington		
Street lighting pole restricts footpath width		
n:

On the existing footpath on the Kilbride Road, a street lighting/electricity pole is located on the footpath at the edge of the carriageway. This pole further restricts the usable width of the narrow footpath. The obstruction of the footpath will present a difficulty for some users. This may lead to Greenway user entering onto the carriageway, which can lead to pedestrian/vehicle collisions.

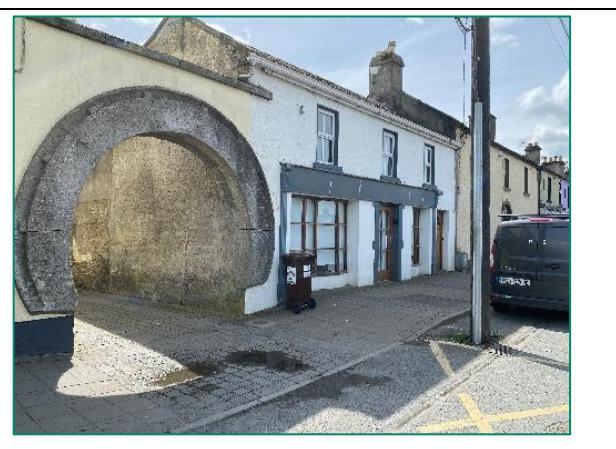
Figure 5-8 – Lack of Vehicular Access

5.2.5. Probl	em
Location:	Main Street
Drawing:	60617025_SHT_DD_BLGWY_142- Blessington
Summary:	Vehicular Access locations across footpath
Descriptio	n:

Along Main Street it is proposed to have a two-way cycle lane, on the eastern section of the road. On this section of road there is car parking provision and vehicular accesses crossing the existing footpath. The proposal does not show provisions to maintain these vehicular accesses. The lack of proper delineation of the vehicular entrance can lead to cyclists being unaware of the potential access manoeuvres into and from these access points, which can lead to cyclist/vehicle collisions.

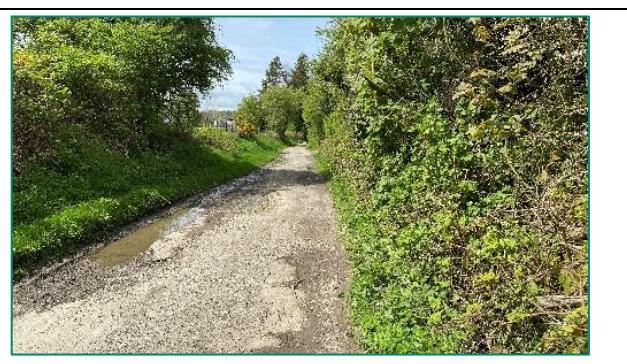
Figure 5-13 – Unsuitable Road Surface

Location:	Burgage Moyle Road – Chainage 5+000
Drawing:	60617025_SHT_DD_BLGWY_142- Blessington
Summary:	Unsuitable road surface
Descriptio	n:

During site inspection it was observed that the local road, Burgage Moyle Road, is potholed and extremely uneven which is unsuitable for many forms of cycles. As Greenway users will be directed to use this road as a connection link, the lack of proper road surface may lead to cyclists avoiding this road and bypassing this section by travelling on the section of N81, where there is no footpath provision, to link back into the Greenway. This can lead to cyclists cycling on the national secondary road where the posted speed limit is 100km/h which could result in cycle/vehicle collisions.

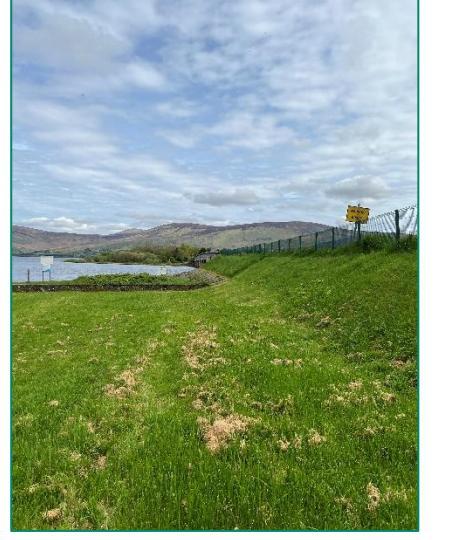
Figure 5-17 – Visibility at Valleymount Bridge

5.3.2. Problem				
Location:	Southern End of the Baltyboys Greenway section			
Drawing:	60617025_SHT_DD_BLGWY_142.8			
Summary:	Visibility for Greenway users on the approach to the Bridge			
Descriptio	n:

The southern end of the Baltyboys section will connect to the western side of the Valleymount Bridge and carpark. The Greenway connects directly to the R758. The R758 is elevated above adjacent ground level at this location, and it was observed that the embankment slopes are steep. There is no footpath or verge provision on the Valleymount Bridge to facilitate NMUs. As the Greenway will rise to connect to the R758, west of the bridge, it is unclear to the auditors if there is sufficient visibility to vehicles travelling on the R758.
