APPENDIX C

Greystones/Delgany Local Area Plan- Local Biodiversity Areas

20th February 2006

Researched and Compiled by Altemar, Marine and Environmental Consultants
Submitted by: Bryan Deegan (bryan@altemar.ie)

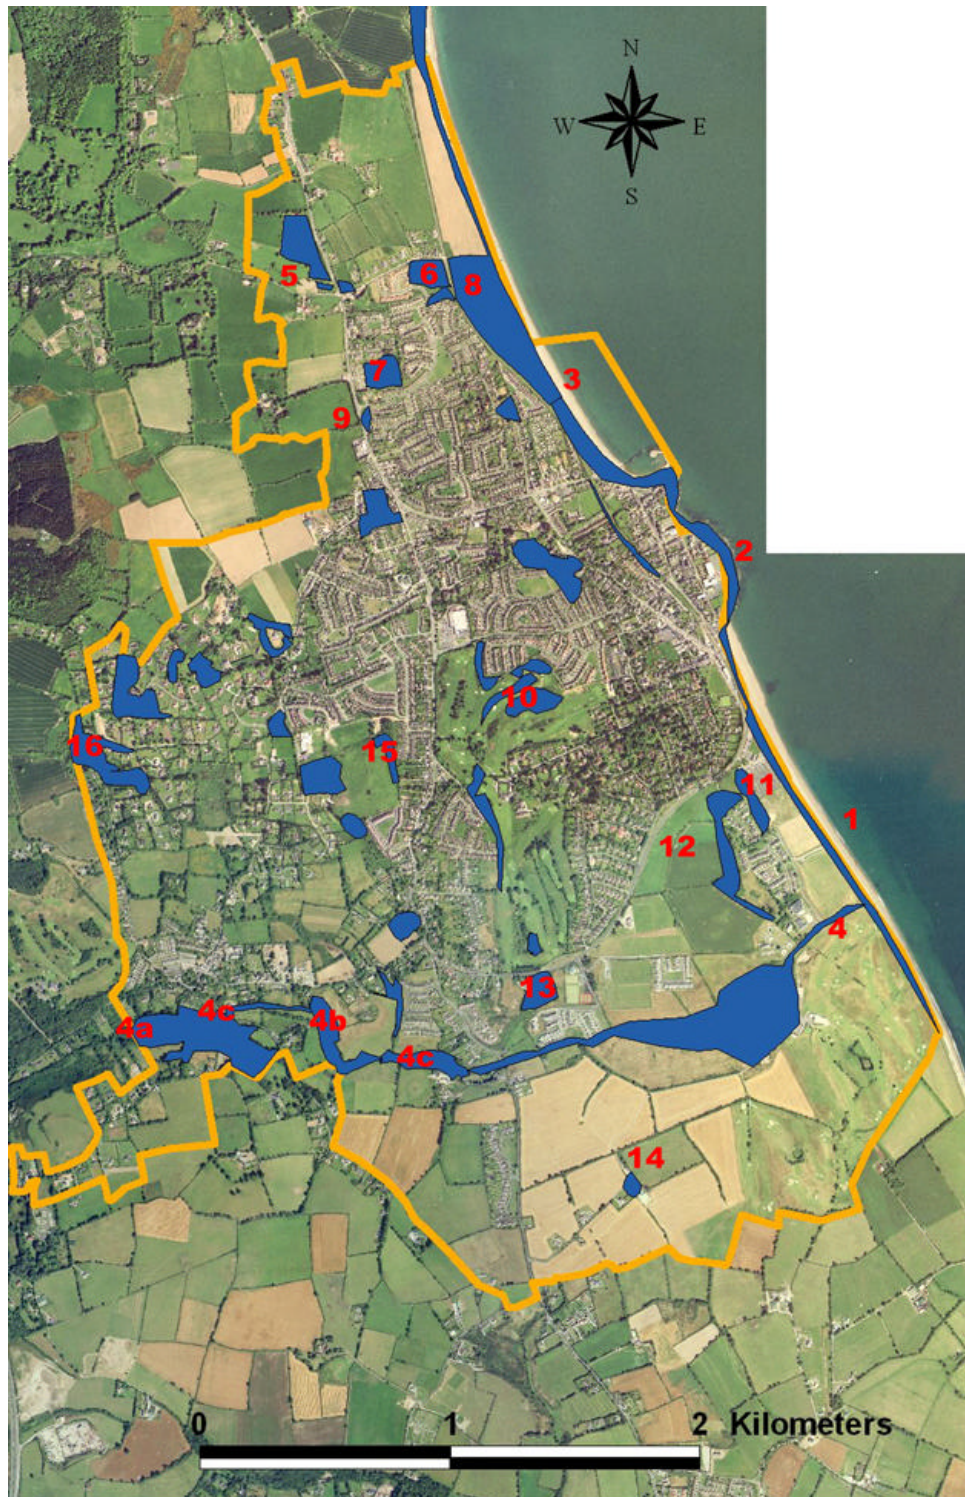
Figure 2a Areas visited (blue) Local Biodiversity Areas identified with initial boundaries (numbered).

Following examination of aerial images (from 2000), 6" maps and discussions with National Parks and Wildlife Service/ Central Fisheries Board Staff the following areas (in blue) were selected for further study (Figure 2). Of the 25 areas highlighted and visited, 16 were deemed to be of importance to local biodiversity and 9 were dismissed as either being subsequently developed or were of low importance to biodiversity. The 16 areas of significant importance to local biodiversity are shown in figure 2 (a,b) and listed in Table 1.

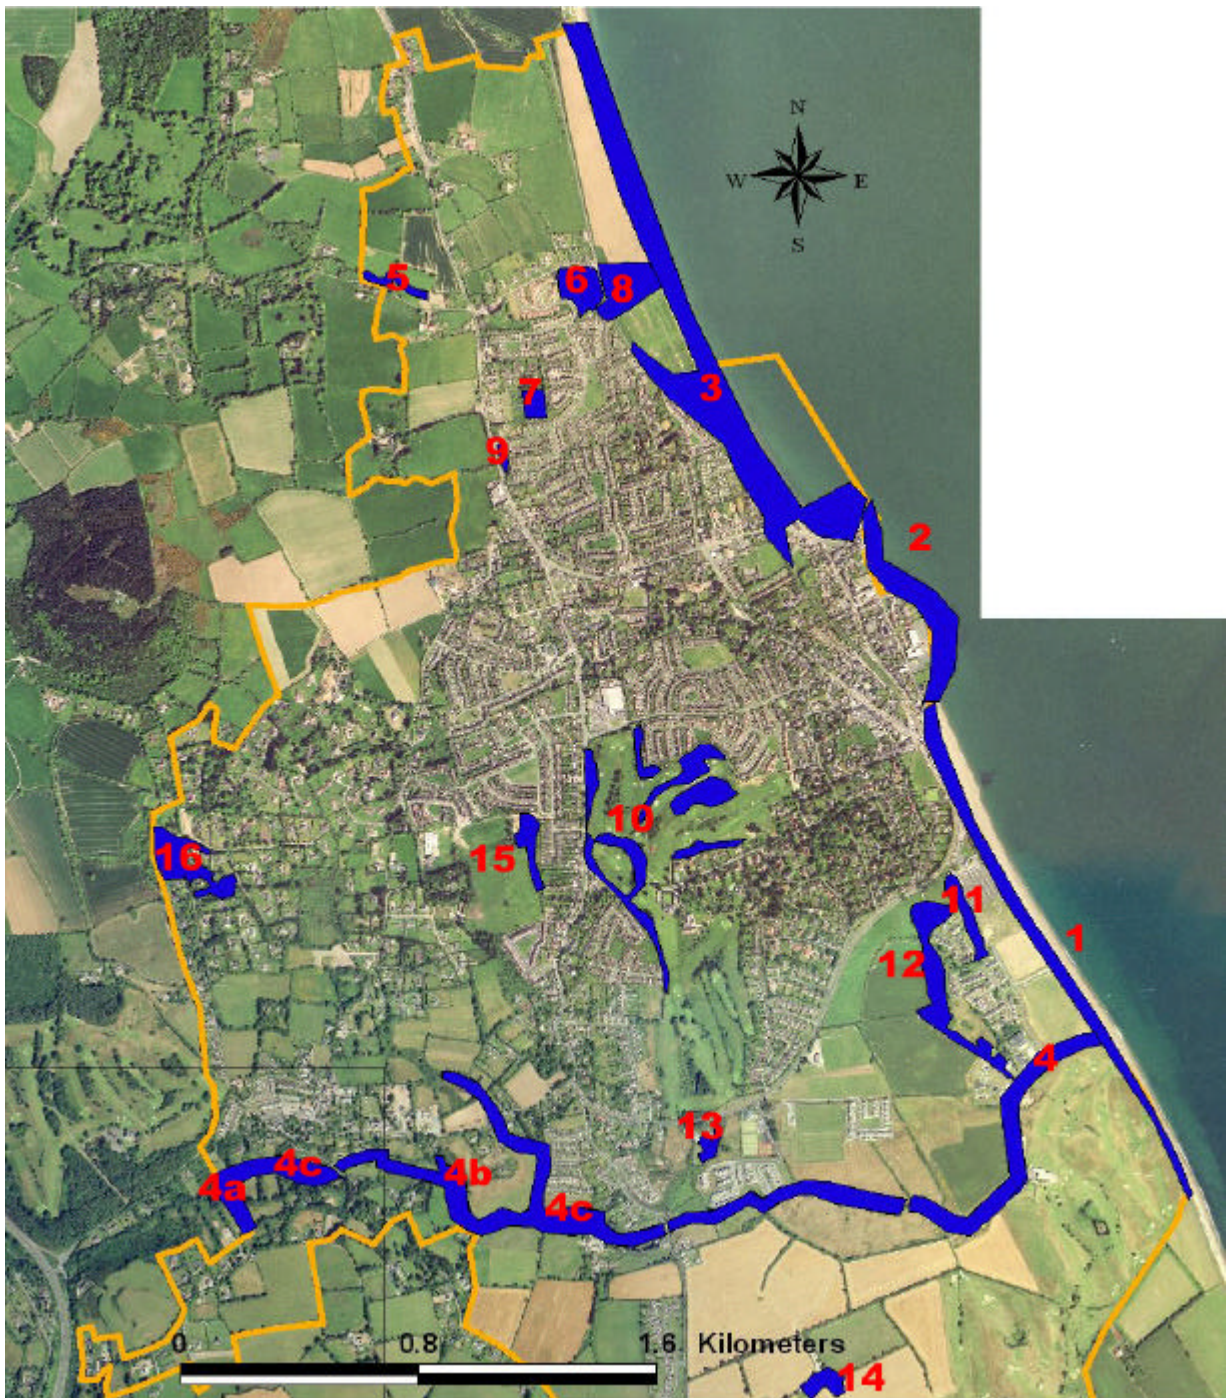
Figure 2b. Final extent of Local Biodiversity Areas including buffer zone on Three Trout Stream

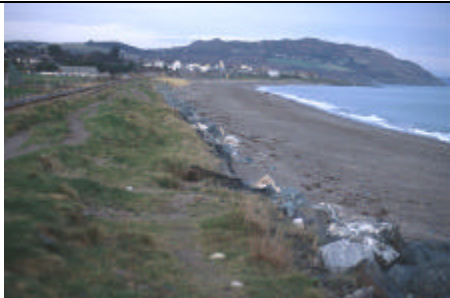
Site No.	Townland/site name	Habitats present (Fossitt 2000)	Faunal/ Flora Species present or likely	Possible Threats	Relative Biodiversity importance	
1	Seashore to and including railway from south to Rocky outcrop (329839/21224 4)	CC1 Seawalls Piers and Jettys BL2 Earth Banks ED2 Spoil and Bare Ground LS2 Sandy Beach BL1 Stone Walls and other Stonework FW3 Canals	Seabirds (Gulls, Turnstones) Foxes	Human/canine disturbance Terrestrial litter Marine Pollution (oil, litter) Sea-level rise/ severe storms could impact	Low

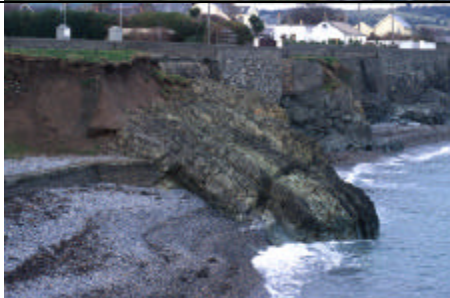
2	Rocky outcrop to (329839/21224 4) Greystones Harbour	LR1 Exposed Rocky Shores CS3 Sedimentary Cliffs CB1 Shingle and Gravel Banks	Sand martins	Erosion of sea cliff. Human and canine disturbance at the top of the cliff.	Medium

On the boulderclay cliffs (CS3) behind the rocky cove at Carrig Eden (329666/21602) a possible nesting site for sand martins is located. No other noteworthy species or habitats were found in this area.

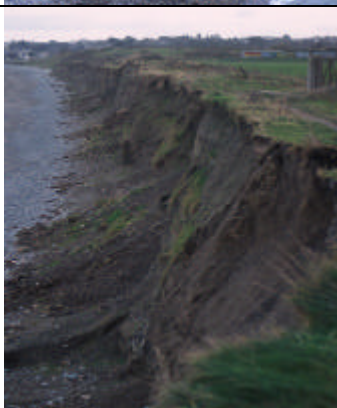
3	North of Greystones harbour and part of Bray Head SAC	CB1 Shingle and Gravel Banks CS3 Sedimentary Cliffs HH1 Dry Siliceous Heath GS2 Dry Meadows and Grassy Verges	Sand Martin Peregrine Falcon Kestrel	Erosion of sea cliff. Human and canine disturbance at the top of the cliff.	Medium

North of Greystones Harbour is a stony beach (CB1 above and below strandline). Birds observed in this area included great Black backed gull, cormorant, ringed plover, juvenile herring gulls, turnstone and oystercatcher. This beach continues northwards into the Bray Head SAC and is likely to be a result of the erosion of the boulder clay cliffs north of the harbour. The littoral and sublittoral areas of the proposed marina were examined by Aquafact International Services in 2000. Aquafact found very few faunal species and none that were deemed to be rare or sensitive or “listed under any sort of designation as requiring protection”.

The terrestrial habitat along the cliff top is dry coastal heath and grassy verges, broadly corresponding to Fossit’s (2000) classification of HH1 and GS2, the heath occurs as a mosaic grading into scrub (WS1) which is dominated by Bramble (*Rubus fruticosus*), and grasses (*Agrostis canina* and *A. stolonifera*). Gorse (*Ulex europaeus*) also occurs frequently within this area. Land use at the site consists of recreational use. A well-worn path is located along the cliff for much of the site and is regularly used for walking. Severe erosion of the sea cliffs is having an obvious impact on this marginal area. A model of the erosion of these cliffs from the Greystones Harbour EIS (3rd January 2006) estimates that these cliffs will recede 20m at the toe of the cliff, and even more on the upper cliffs, over the next 30 years. As a result this habitat is likely to disappear. Sand martins nest in these cliffs each summer. However the nest site changes annually depending on where the cliffs have been eroded.

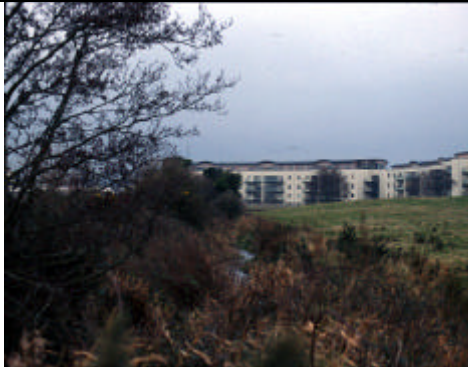
4	Three Trout Stream and surrounding area (entire length from boundary to the sea)	GS4 Wet Grassland GM1 Marsh WS1 Scrub ED3 Recolonising Bare Ground WN1 Oak Birch Holly woodland WL2 Treelines GA2 Amenity Grassland FW1 Eroding Upland Rivers FW2 Depositing Lowland Rivers BL1 Stone walls and other stonework WL1 Hedgerows	Sea Trout Common Eel Heron Mallard Stickleback Oak Willow Birch Dipper	Encroachment from development leading to accidental and intentional damming Litter Removal of treeline /scrub Siltation of gravel bed Pollution (organic/non organic)	Medium/ High

The stream enters the sea between Charlesland driving range and golfcourse (330407/211099). Going upstream the stream initially passes under the railway and follows concrete banks either side of which is a 5m wide low scrub corridor, between golf course to the south and driving range to the north. Brent Geese (150 approxamately) and oystercatchers were observed on the driving range. Following the bridge beside the sewage treatment works (330218/211038) taller scrub and steeper banks develop. The field on the north bank of the stream (centre point 329947/210748) is substantially lower than that of the golf course on the other side of the stream, and is poorly drained grassland (GS4) and is possibly open to seasonal/periodic flooding. Despite a steep incline 3-4m at the northern end of this field the wet grassland continues up the slope indicating a high water table. Significant littering of the stream is evident at the bottlebank/waste centre of the golf club (330104/210608).

A culverted stream enters Three Trout Stream just prior to an apartment complex (329952/210483) where the wildlife corridor has been removed for 100m. The Three Trout Stream is blocked by a fallen tree with builder's waste (timber, styrofoam, flooring, signs etc.) forming an impasse to fish at 329869/10513. Following on from the dual carriageway bridge at 329779/210531 the wildlife corridor widens to 10 m on the northside of the stream which contains willio sp, elder, gorse and holly. On the southside scrub has been removed and replaced by fencing. This has been vandalised to provide access to the stream. Littering including building waste is evident here also. Possible seasonal flooding up to 5m from the stream is evident at 329395/210601.

Encroachment of housing and littering from (329348/210591) to (329019/ 210517) is clearly evident east of Three Trout Bridge, and impacts strongly on local biodiversity. Following the bridge at 328951//210465 and additional site of possible flooding is found on the north bank of the stream where the corridor is 2-3m wide. A substantial area of marsh (GM1) (70m x200m) with very high water table is located on the south side of the river at Farankelly House (328689 210473). The field on the north side of the river contains wet grassland (GS4) for approximately 40 meters from the stream.

- Development of new houses and encroachment of by current inhabitants has removed the scrub and trees along the bank of the river making the river more vulnerable to extreme summer temperatures (reducing oxygen content) and an increases in particulates (clogging gravel beds). It is essential to the stream that the practice of scrub removal from either side of the bank is halted immediately and in areas that it has been removed, e.g. Charlesland, that these are replaced with similar native species. It is strongly recommended that a minimum of a 20m buffer zone of native vegetation, from each bank, is maintained along the bank of the stream and its main tributary, which would be extended where relevant to incorporate additional wooded/scrub/marsh areas (Figure 4). This would be deemed essential to protect the stream from extreme summer temperatures and reduce the threat of particulate material ending up in the stream, which would clog up spaces in gravelbed. It is also suggested where possible that an additional 3m of grassland/amenity area is maintained outside the buffer zone providing a “flyzone” for bats and Owl species. In areas where dense scrub (nor briar dominated) and tall trees have already been established that these are retained. Flushes of particulates due to construction, as observed during field work, should be avoided as it can cause fish mortality/irritations on fish gills and block gravel beds.

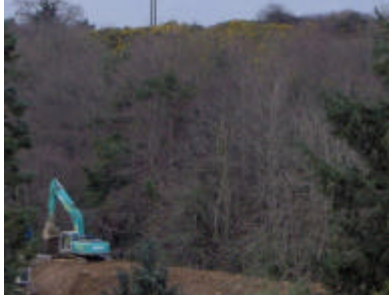
4a	Glacial meltwater channel	FW1 Eroding Upland Rivers WL2 Treelines((Enda Mullen NPWS Pers Comm.)	Mainly of Geological interest	Development of site and drainage upstream resulting in loss of habitat and water that feeds stream	Medium	
4b	Oak, birch and holly woodland bordering Three Trout Stream	WN1 Oak, birch and holly woodland	Birch Oak Holly	Removal of trees and scrub resulting in loss of habitat	Medium

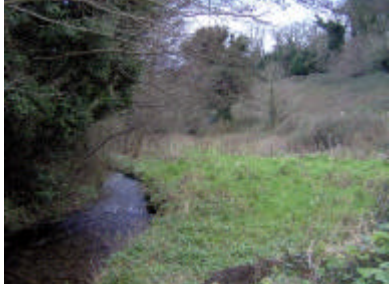
4c	Marsh areas that border Three Trout Stream	GM1 Marsh	Possible frog breeding areas and important floral habitat	Removal/drainage of habitat.	Medium

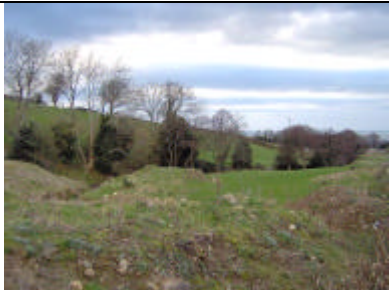
5	Small stream at Redford Bridge (328170/213579)	FW1 Eroding Upland Rivers WS1 Scrub	Holly Birch Willow Ash	Development/removal or small stand of native scrub	Low

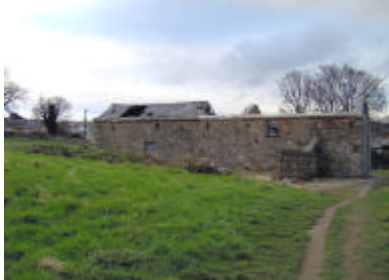
6	Ruins of Captain Tarrants Farmhouse and St. Crispins Cell, Rathdown 328692/ 213663	WS1 Scrub BL1 Stone walls and other stonework	Bats Barn Owl (?) Willow sp. Bramble Gorse	Development of the site would lead to loss of habitat/ nesting site/ loss of prey habitat Vandalism and human disturbance of buildings is evident. Loss or roof covering	Medium

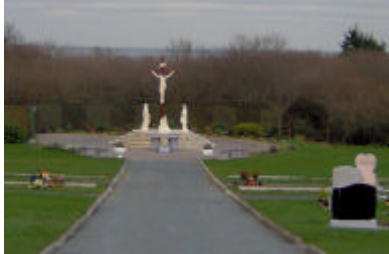
7	Redford Bridge Graveyard 328462/213222	WS1 Scrub BL1 Stone walls and other stonework	Large Stand of Willow sp.	Development. In Littering is already a problem	Low/ Medium

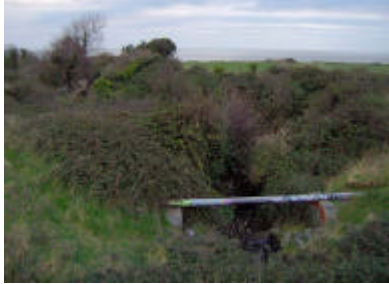
8	Stream from Redford Bridge to shore 328649/213500 to 328920/213625	FW1 Eroding Upland Rivers WS1 Scrub (20m wide) and 150m wide gorse dominated close to shore BL1 Stone walls and other stonework	Willow sp Bramble Ash Ivy Wide gorse area	Development would lead to loss of trees/pollution. Littering is already a problem	Low/ Medium

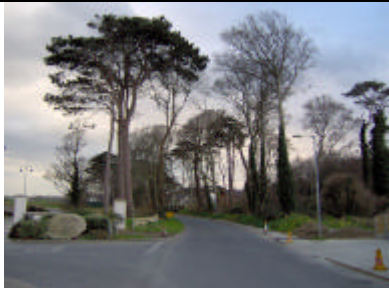
10	Greystones Golf Course	WS1 Scrub (Gorse dominated) WD5 Scattered Trees and Parkland	Gorse Oak Bats	Removal of broadleaf trees, hedgerows and scrub areas resulting in loss of habitat.	Low/ Medium	
11	Treeline west of DART carpark (329996/21140 6)- (329893- 211620)	WL2 Treeline	Scots Pine Beech Bat species	Development/felling resulting in loss of trees	Low/ Medium

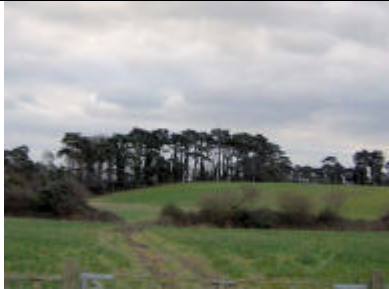
12	Treeline between R762 and sewage treatment works (330062/21101 4)- (329798/21187) -(329793 211558)	WL2 Treeline	Scots Pine Ash	Development/infrastructure resulting in loss of treeline and scrub areas.	Low/ Medium

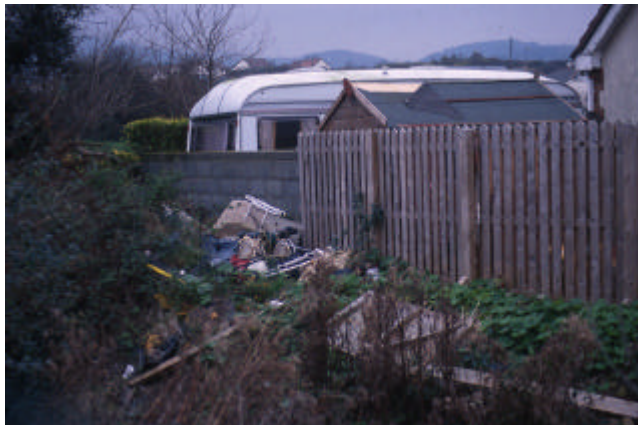
Encroachment of housing and
dumping along the
Three Trout Stream

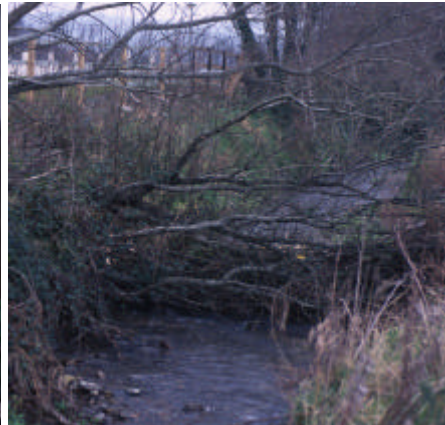
First obstruction to stream
(image taken from downstream)

- The stream is currently impassable for migrating fish at a minimum of three points. It is essential that these structures are removed as quickly as possible.

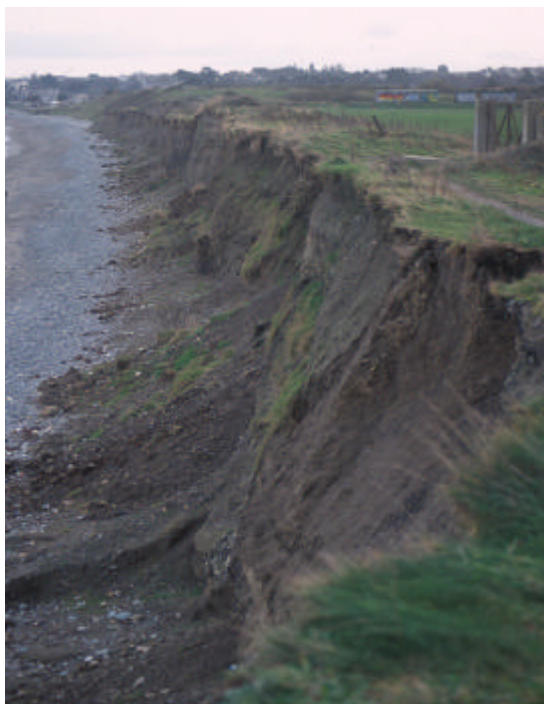
Boulder Clay and Cliffs north of Greystones (Left)

The potential impacts of the proposed marina on the coastal zone need to be adequately assessed. The potential for the increased erosion of the cliffs within the SAC area needs to be reviewed.

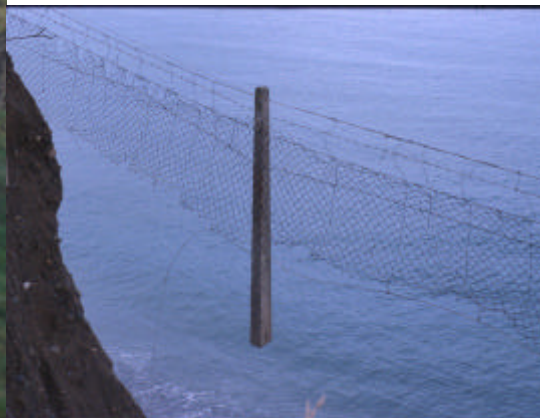
Fence post hanging in mid air due to erosion of sedimentary sea cliffs (Below)

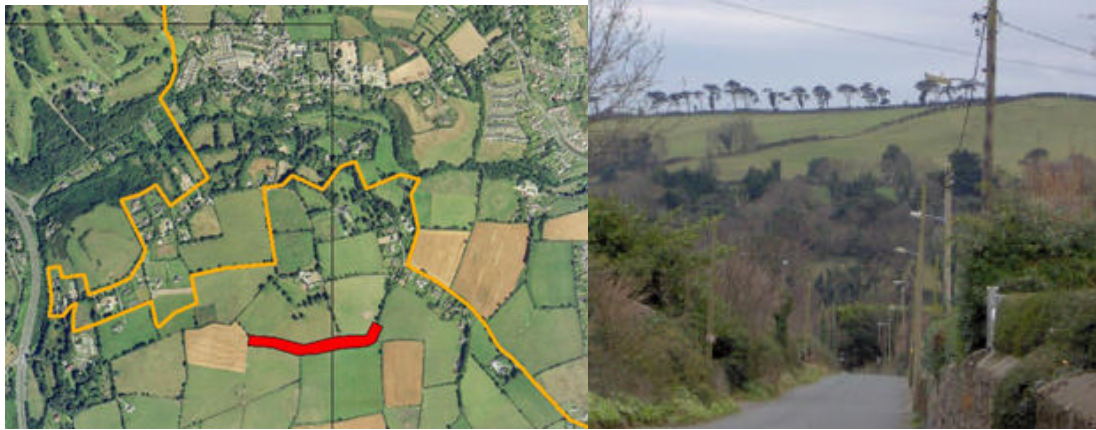
Prominent treeline of Scots pine just outside LAP area (viewed from Kindlestown)

- An Expansion of the western edge of the LAP by 40 m to include glacial melt water channel
- An expansion of the LAP area to include the prominent tree line of Scots Pine on hill east of Drummin (observed from N11 and LAP area) (See figure 5)
