Road Safety Audit

Road Safety Audit
Stage 1
for
BRAY SUSTAINABLE TRANSPORT BRIDGE
BRAY, CO WICKLOW

Date: September 2020

Report produced by: Road Safety Matters Ltd

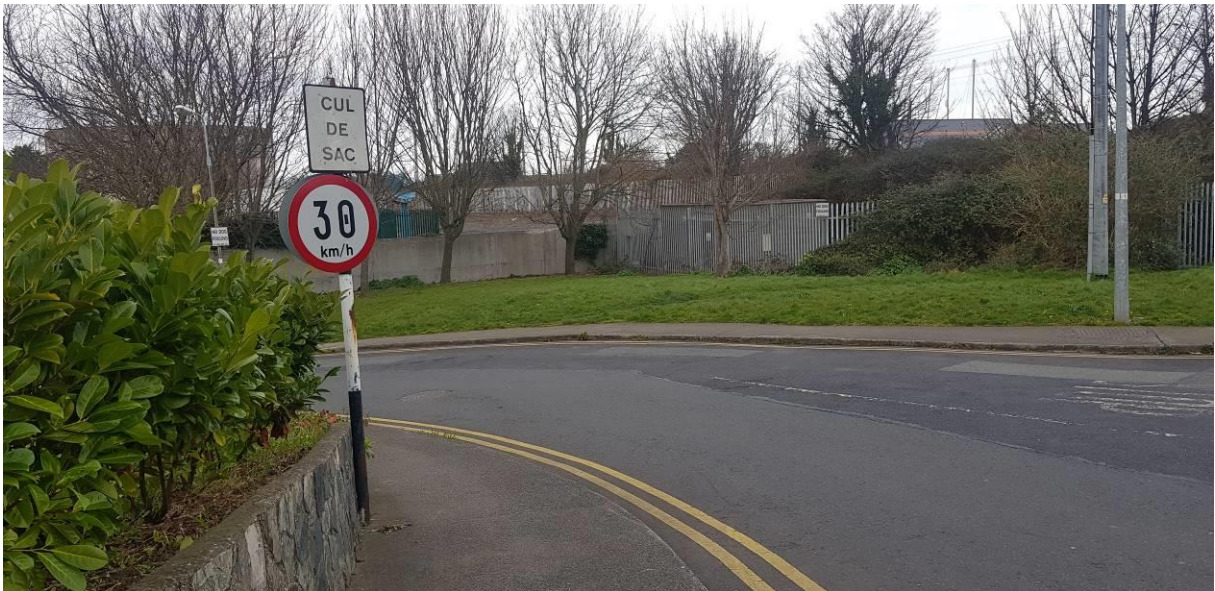
Figure 3: 30 km/hr speed limit posted adjacent to Junction 2

The current speed limit posted at the site varies between 50 km/hr on the new Dublin Road connection at Junction 1 to 30 km/hr on entry to the Seapoint Court residential development adjacent to Junction 2, as shown in figures 3 and 4. Links which are subject to differing speed limits can lead to confusion and misinterpretation by road users leading to an increased risk of inappropriate speeds and resultant collision risks for motorists and VRUs. The vertical visibility drawing indicates a design speed of 50 km/hr. Design speeds usually reflect a speed higher than the proposed speed limit to allow for some margin of error in respect of vehicles exceeding posted speed limit, which is commonplace, particularly on links where there is no provision for physical traffic calming measures, and where there is a risk the link may be used as a rat run to avoid congestion on alternative routes.

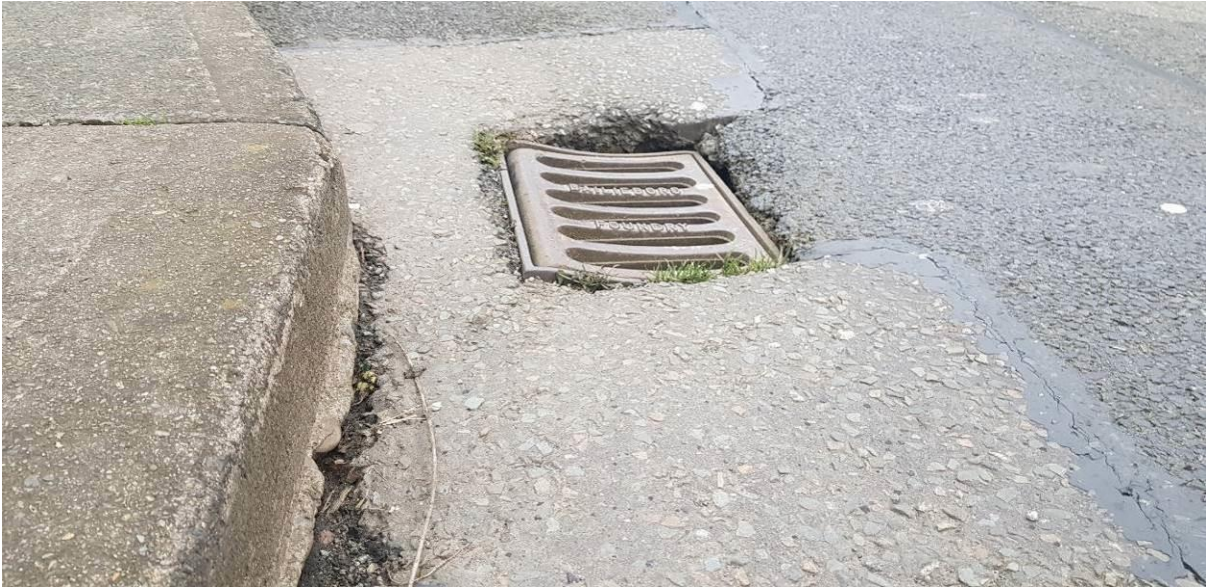
Figure 5: Sunken Gully at Location of Kerb Setback, Junction 2

Blocked and sunken gullies were noted adjacent to Junction 2 at the scheme tie-ins, as shown in figures 5 and 6, which could impact on the effectiveness of surface water runoff on the new layout. Blocked or sunken gullies can present a hazard for all road users, particularly two-wheeled vehicles. Poor surface condition was also noted adjacent to Junction 2, as shown in figure 7, which can contribute towards ponding.

The condition of existing drainage at tie-ins should be reviewed. All new or displaced gullies should be flush with the surrounding surface, and kept out of the desire line for two wheeled vehicles and pedestrians. Surface condition should also be reviewed at scheme tie-ins with pavement renewal and repair where necessary, and with new or displaced manhole covers to be flush with the surrounding surface and kept outside the desire lines for VRUs where possible.

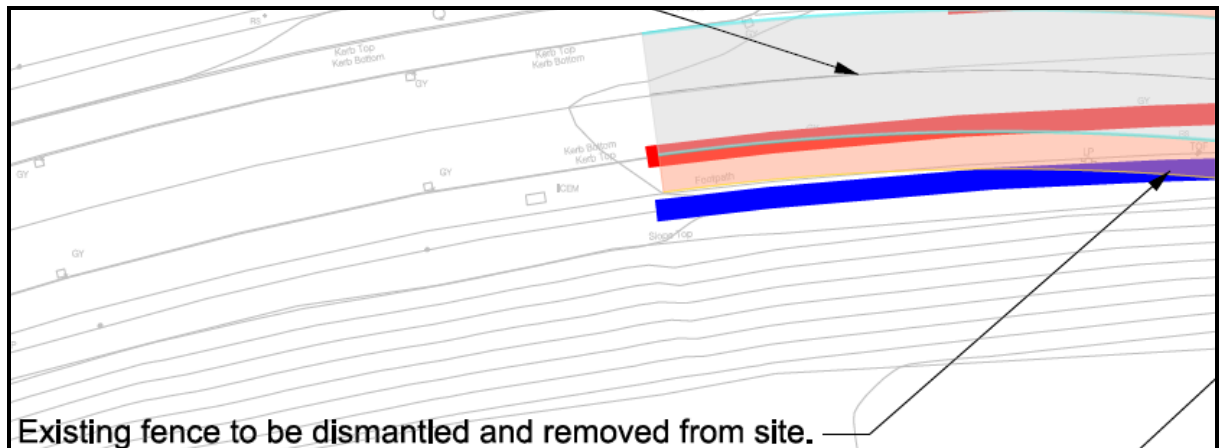
Figure 8: Fencing removed adjacent to embankment

There were no details provided in respect of treatment of the edges of the cross section for the proposed road in terms of fencing or retaining walls, particularly adjacent to VRU facilities at locations where significant level differences will arise between the carriageway level and the adjacent land. The site clearance plans indicate that fencing will be removed from approximate ch 35-70m, as indicated in figure 8, and there is no provision for replacement fencing. Existing fencing at this location is shown in figure 9, which prevents pedestrians, including children, from accessing the embankments and exposed water hazards.

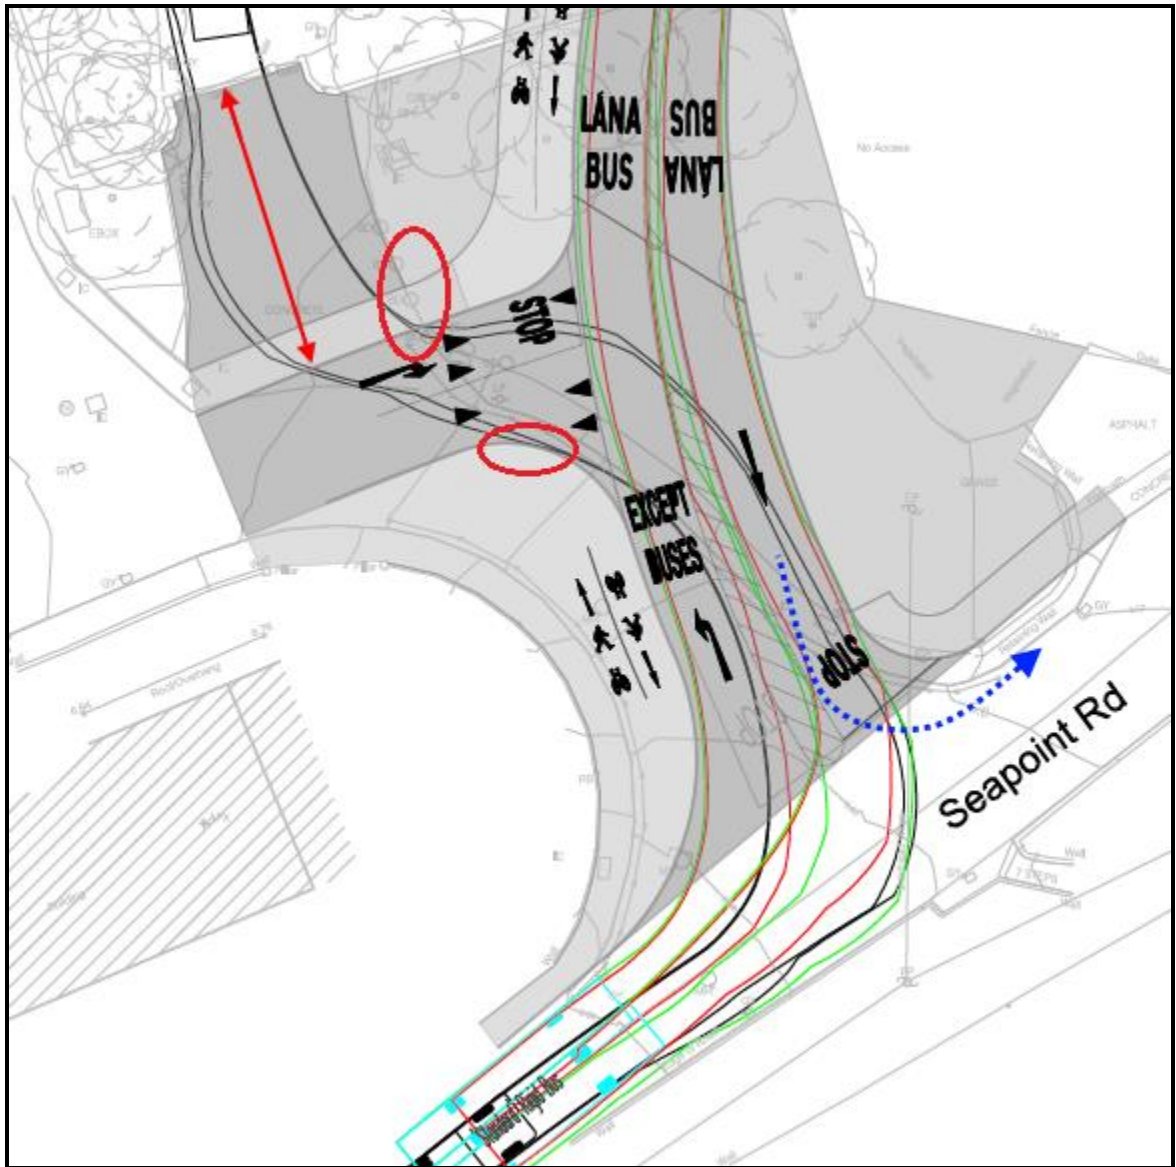
Figure 13: Restrictive geometry at Junction 2

At the Seapoint Rd Junction, there is very little margin of error for articulated vehicles to access the gated entrance to the pump house, as shown in figure 13, and the vehicle turning left from Seapoint Road must encroach almost fully onto the opposing side of the carriageway in order to make the turn. Vehicle encroachment onto the adjacent footways is considered likely, which increases risks to VRUs, including pavement damage and trip hazards. There are a number of existing bollards located immediately adjacent to the entrance, as shown in figure 14, with limited clearance to the swept path, increasing the risk that these bollards will be struck. It was noted that the gates into the pump house do not appear to be set back a sufficient distance from the carriageway to enable the entering vehicle (16.5m articulated vehicle) to wait safely off the carriageway for the gate to be opened, without obstructing pedestrians on the footway, as well as passing vehicles. This risk may arise at present, however pedestrian flows on this section of footway are likely to increase as a direct result of the new link and bridge construction, which will increase the inherent level of risk.

The proposed geometry should accommodate the swept paths and turning movements of all anticipated vehicle sizes within the proposed layout with adequate margins of safety. The location of the gate at the access to the pumping station should ensure vehicles can wait safely off the carriageway without obstructing pedestrians or motorists. The existing cross section on Seapoint Rd should be reviewed to ensure safe two way movement of buses can be accommodated as necessary, with suitable clearance to be provided to hazards adjacent to the carriageway (minimum advisable 600mm to solid continuous hazards). Gradients should also be reviewed on approaches to all junctions, particularly the approach to Seapoint Rd at junction 2, with a level dwell area to be provided for a minimum 15m back from the channel line.

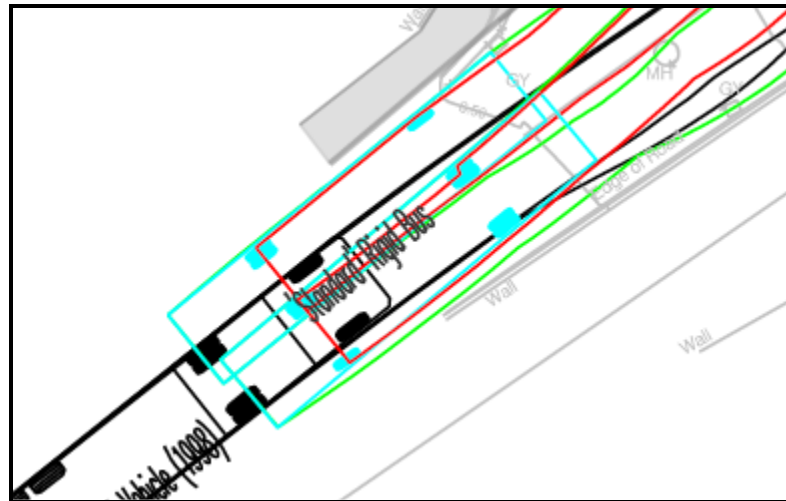
At the intersection with Seapoint Road, there is no swept path shown for the left turn movement out of the junction, which is the most restrictive movement at this junction due to the tight radius. The topographic survey terminates abruptly on the southwestern side, however it appears the existing cross section on Seapoint Road will not safely accommodate two-way movement for buses, with significant overlapping noted on the swept path analysis, as shown in figure 16, and no safe clearance to solid continuous walls which present a linear hazard along the southern

**Figure 16: Overlapping two-way movement for buses.
(Note Sudden Topo Survey termination)**

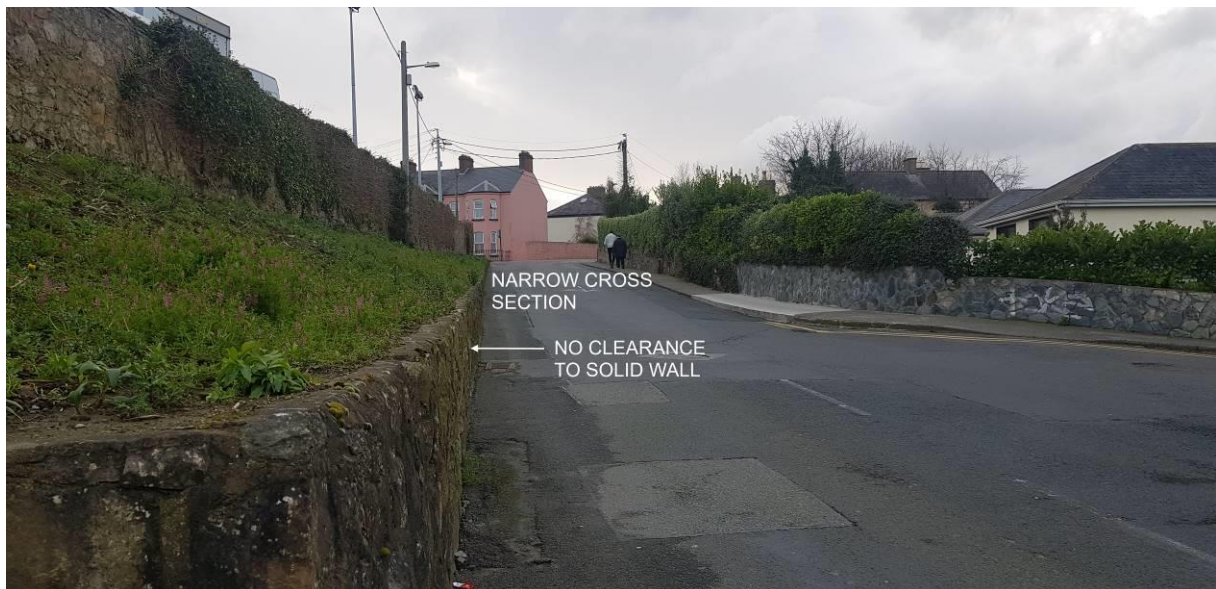
Figure 17: Narrow cross section with hazard immediately adjacent to carriageway

side of the carriageway, as shown in figure 17. Two wheeled vehicles would also be more vulnerable on this narrow cross section as a result of increased volumes of buses arising from demands to use the new public transportation bridge.

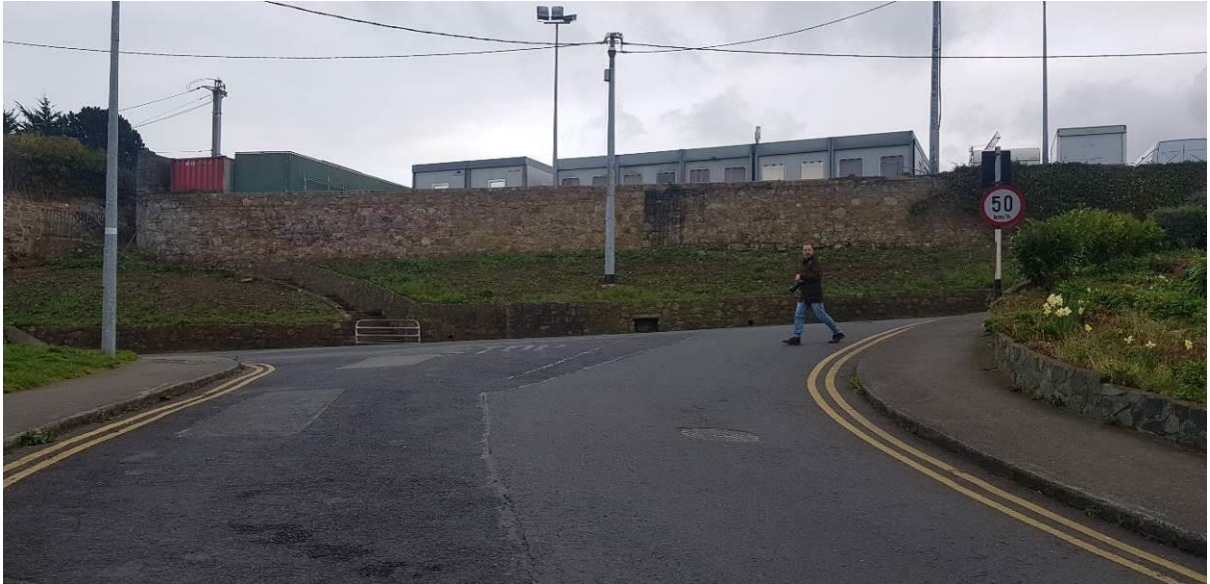
Figure 18: Rising levels and insufficient dwell area on approach to Seapoint Rd Junction

It was also noted in respect of the geometry at Junction 2 that there is insufficient dwell area provided on approach to the stop line, as shown in the photo in figure 18. Inappropriate

gradients on approaches to junctions can increase the risk of pulling out type incidents and right angled collisions, and can also increase overturning risks for larger vehicles, including double decker buses, particularly in wet and icy conditions.

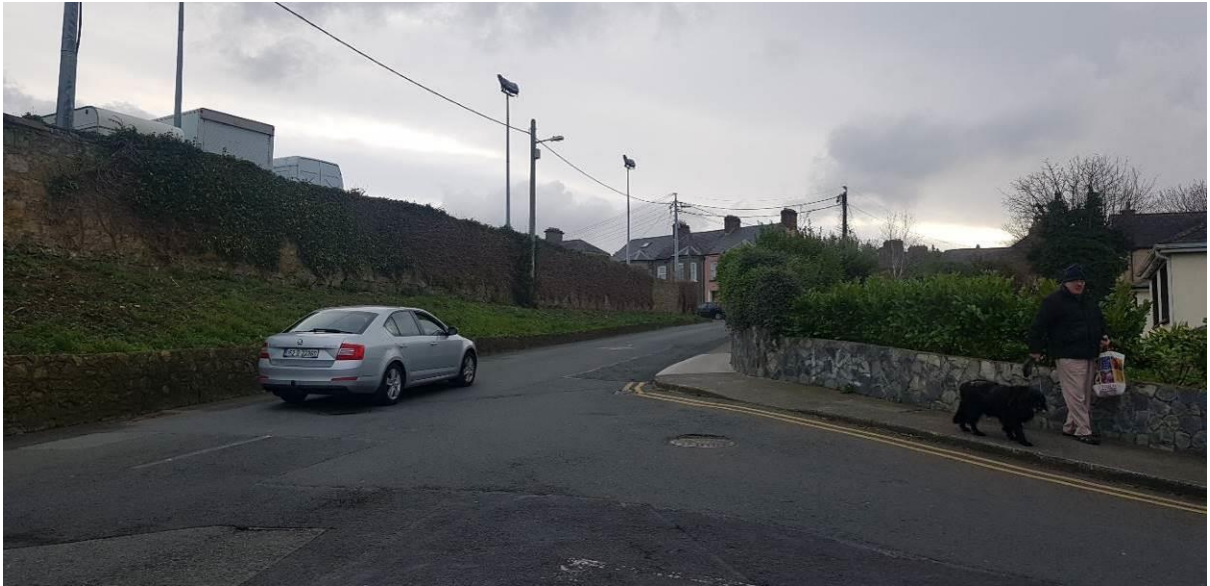
Figure 19: Poor visibility to right at Junction 2

It was noted that existing visibility to the left and right at the intersection with Seapoint Rd at Junction 1 is poor, with obstruction in visibility to and from the right arising from current boundary treatment, as shown in figures 19 - 21.

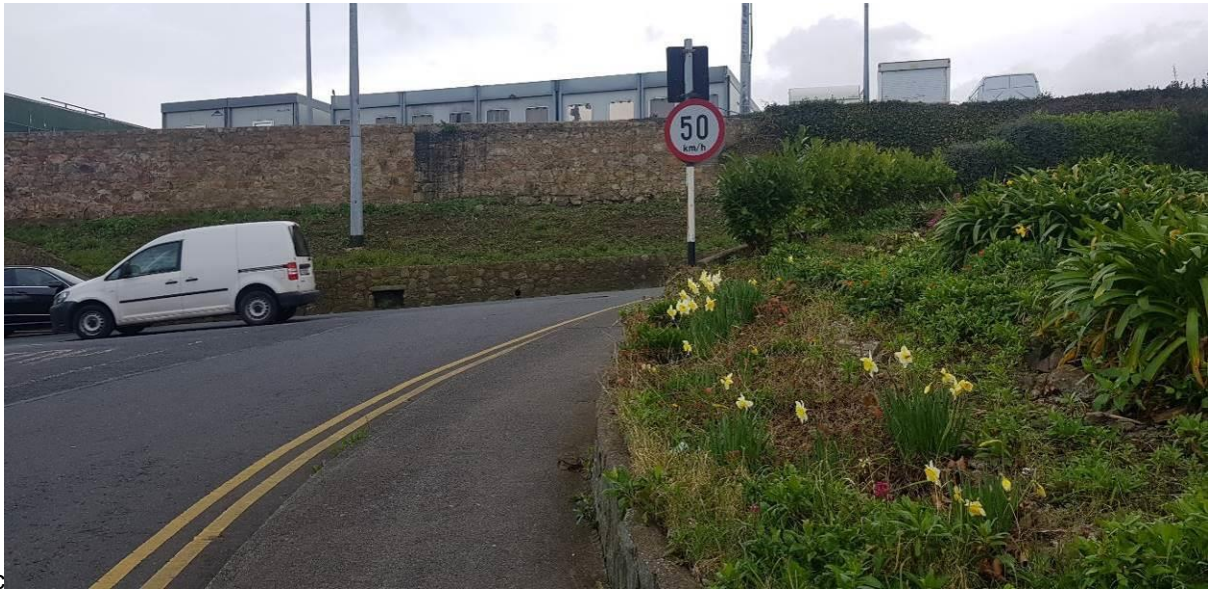
Figure 22: Intervisibility between pedestrians and Motorists constrained

The minor road access into the Seapoint Court residential area will be realigned to accommodate the new bridge and public transport link. Visibility to the right from this location is also obstructed by the existing boundary treatment at this location, as shown in figure 22, which is taken from the location of a pedestrian wishing to cross the junction mouth, which will increase the risk of pedestrian/vehicular conflict. Visibility to and from waiting vehicles will also be compromised, even taking into account the significantly reduced visibility requirements of DMURS, as indicated in figure 23. Obstructions in visibility splay increases the risk of pulling out incidents and right angled collisions, as well as potential rear shunt collision risks, which would be exacerbated by the potential for vehicles being obstructed by the restrictive geometry, as outlined in paragraph 2.2.2 (see figure 13).

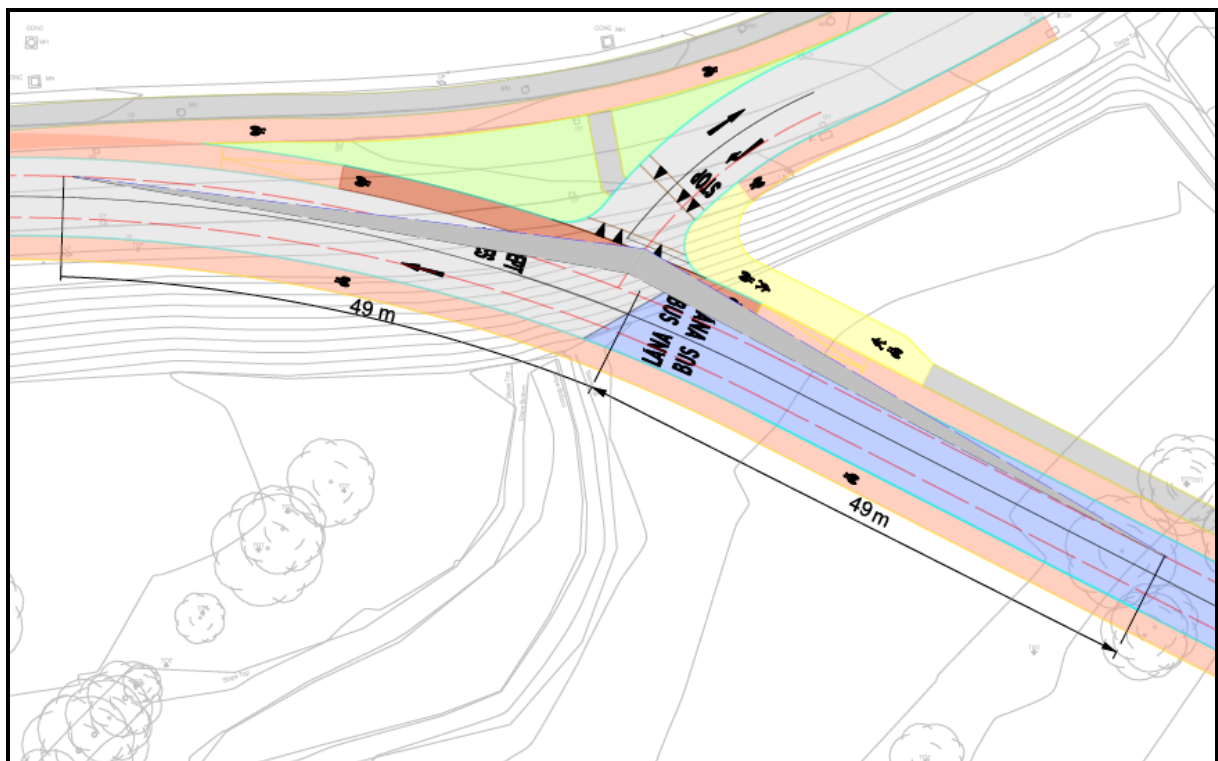
Figure 24: Visibility Splay Provided for Junction 1

It was noted in respect of the visibility splay drawings provided, that there was no visibility splay drawing provided for the minor road access into the Seapoint Court residential area. Visibility splays have been shown for Junction 1 and Junction 2 at the intersection of Seapoint Rd, however the y dimension appears to be taken to the centreline of the carriageway rather than the channel line, and the x distance has not been taken from the centreline of the minor roads, as shown in figures 23 and 24, which is the typical methodology used to demonstrate visibility. The x-dimension is also not shown.

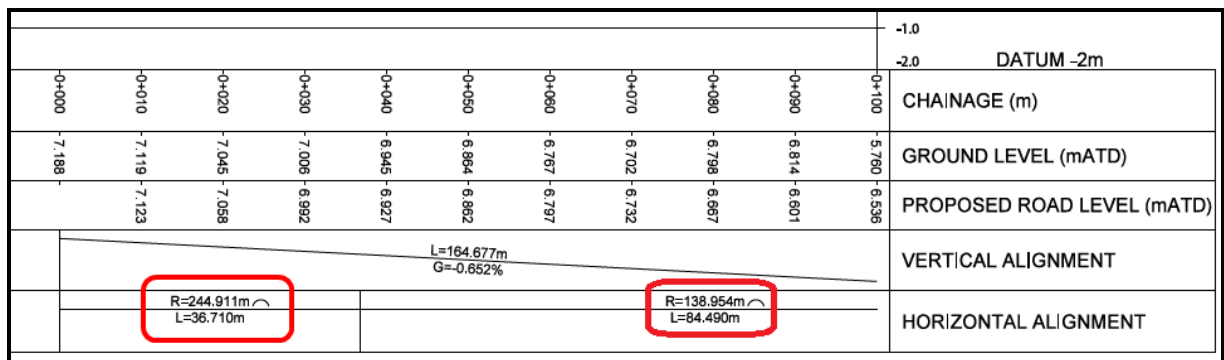
Figure 25: Successive curves with low radii and no transition length

2.2.4.1 The horizontal radii used on the proposed bridge and link alignment appear low at a number of locations, as shown in figures 25, 26 and 27. Collision rates are higher on lower radii and on consecutive curves with low radii, with collision rates increasing significantly on curves with radii lower than 250m, particularly head on or side swipe collisions on single carriageways, with collision risk increasing significantly in proportion to curve frequency. Low radii may also increase the risk of vehicular loss of control on the outside of a bend, particularly in wet and icy conditions, and may also increase passenger discomfort on buses, with an increased risk of sudden breaking when negotiating tight radii.

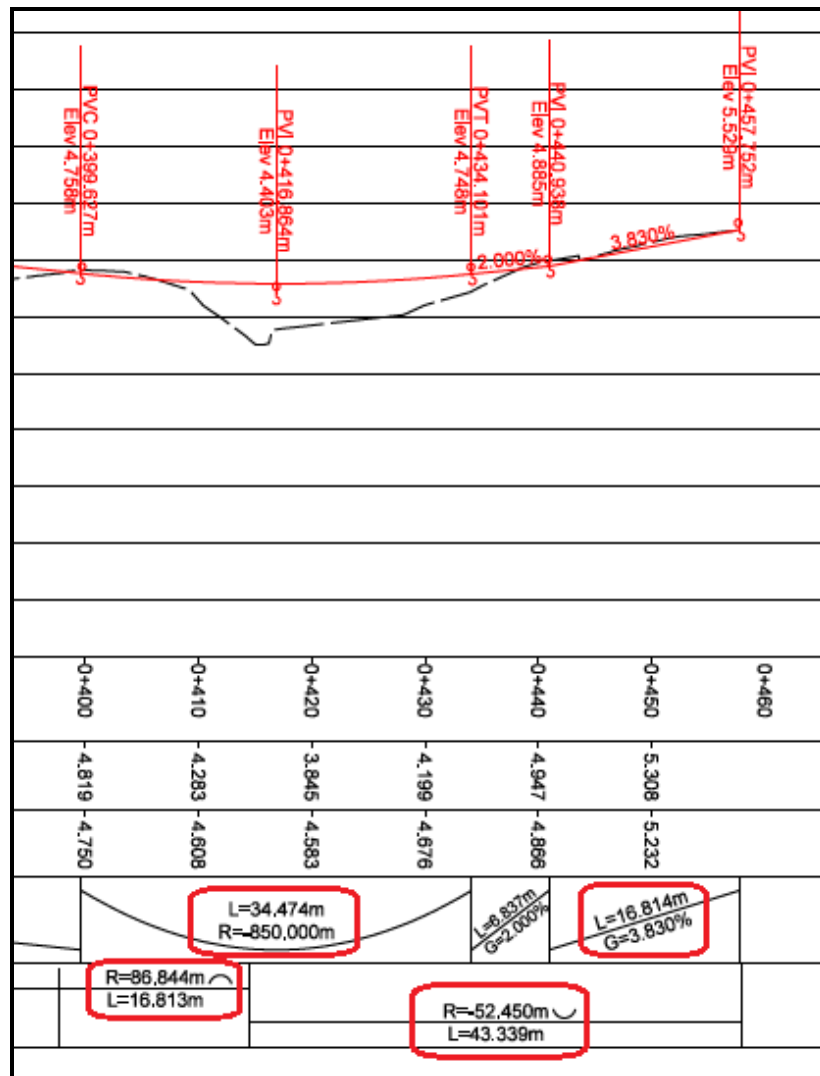
Figure 28: Coincidental sharp horizontal and vertical curvature

the available sight distance and prevent the prompt perception of the curve, leading to an increased risk of loss of control. An inefficient combination of horizontal and vertical alignment may lead to road safety problems, even when the horizontal and the vertical alignment comply separately with all relevant design standard and guidelines. Poor coordination of horizontal and vertical alignments can create locations where the available sight distance drops below the required sight distance. It is therefore unclear if there is sufficient SSD over the crest curve on the bridge on the westbound approach towards the proposed toucan crossing at approximate chainage 200m, to ensure clear intervisibility between approaching motorists and pedestrians waiting to cross, including small children. Further details on potential intervisibility obstructions at this location have been outlined in section 2.3 of this Stage 1 RSA report.

Figure 28 also highlights a steep gradient of 3.83% over a distance of almost 17m at the southern scheme tie in at junction 2. This coincides with a location where geometry is already restrictive, as outlined previously in paragraph 2.2.2. The vertical design at this location also appears to indicate a level difference of almost half a metre at the tie-in with the access road to Seapoint Court, which is at chainage 430m, as shown in figures 29 and 30. Inappropriate gradients and uneven carriageway levels on approaches to junctions can increase risks, including overturning risks for larger vehicles particularly in wet and icy conditions.

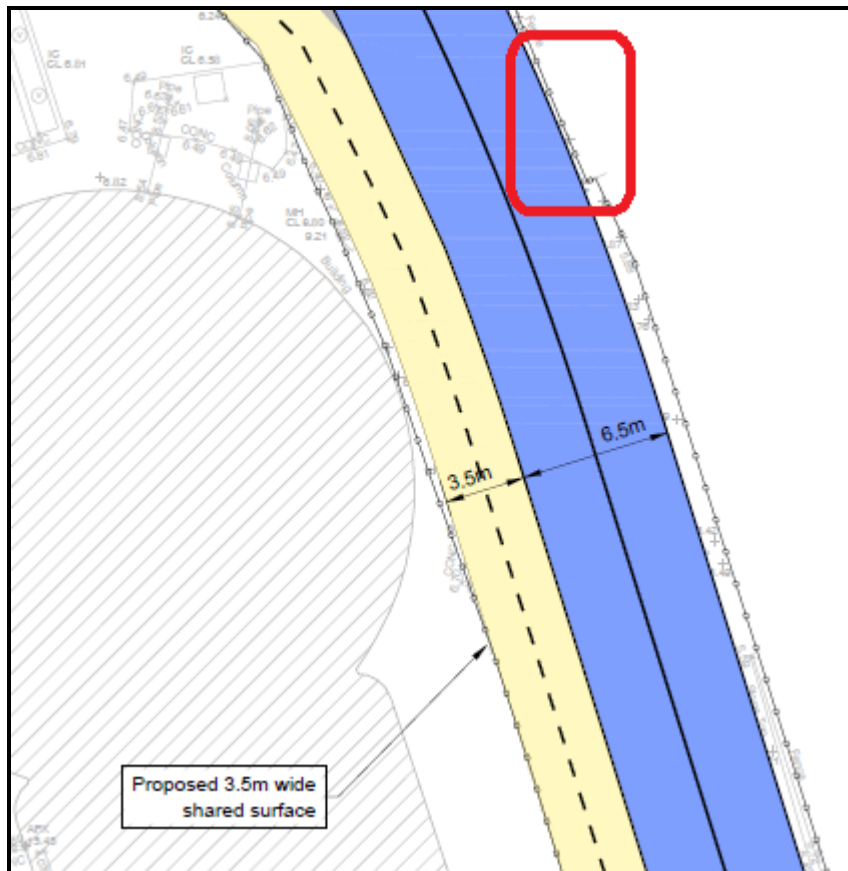
Figure 30: Minimal Clearance between boundary and carriageway

Insufficient clearance has been provided to the continuous linear hazard presented by the fence/wall at approximate chainage 300m, as shown in figures 30 and 31, where a lateral clearance of only 0.2m is indicated. The plan shows no clearance to the bridge structure, as shown in figure 32, between approximate chainage 210m-300m

Sufficient safe clearance should be provided between the carriageway edges and all street furniture and potential hazards along the length of the route. Any changes to cross section width should be implemented gradually, with sufficient advance warning regarding the narrowing ahead to ensure drivers can adjust their speed accordingly. Conservative SSD should also be applied on any locations where combinations of horizontal and vertical curvature may lead to reduced forward visibility in advance of hazards such as a reduction in carriageway width.

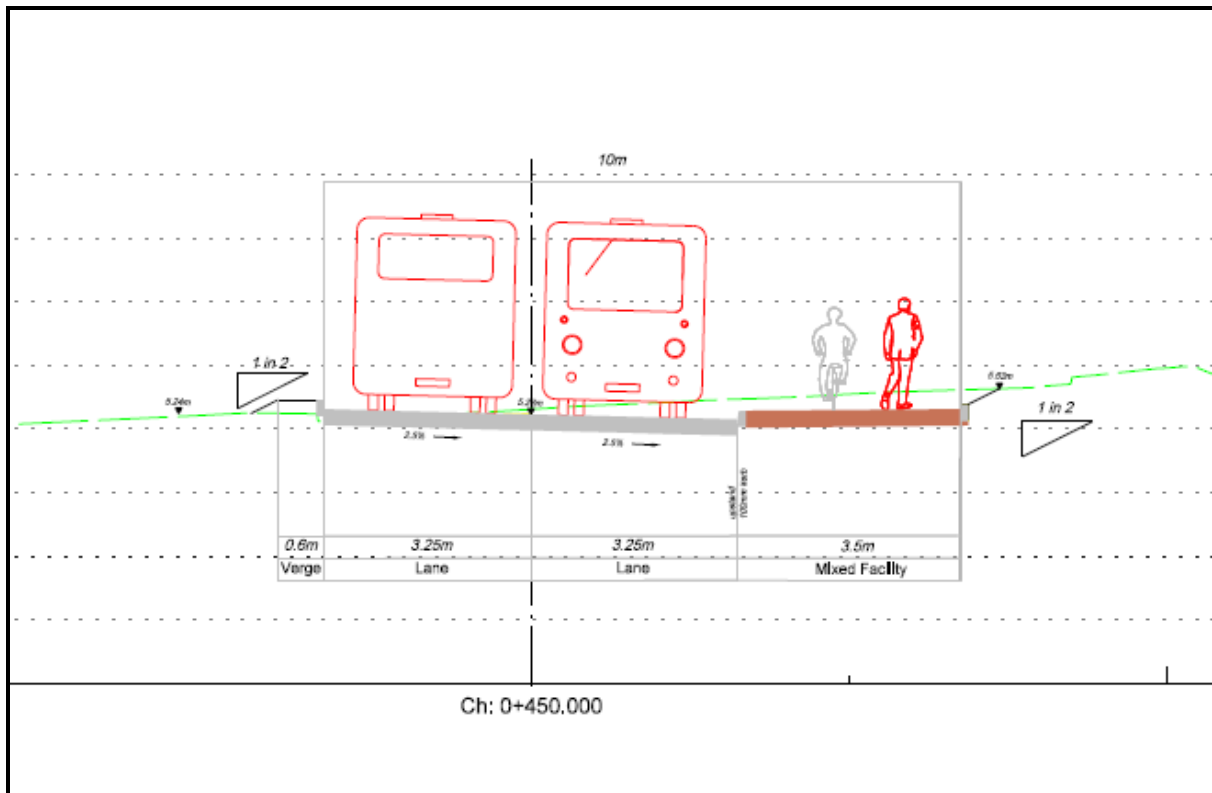
Figure 33: Cross section differing to plan proposals at ch 450m

The cross sections show that continuous crossfall or superelevation of 2.5% has been applied across the full cross section from the more northerly channel. It was noted that chainage 320-360m approximately is located on a straight section of horizontal alignment, however superelevation/crossfall has been shown across the full cross section, rather than from the centreline of the carriageway to assist with positive drainage and to minimise overturning risks for higher vehicles. The same was noted on the cross sections for the straight alignment from chainage 120-220m approx. It was also noted that the cross section at ch 450m, which is shown in figure 33, does not reflect the widened carriageway with central hatching or the wider shared surface and verge at this location.

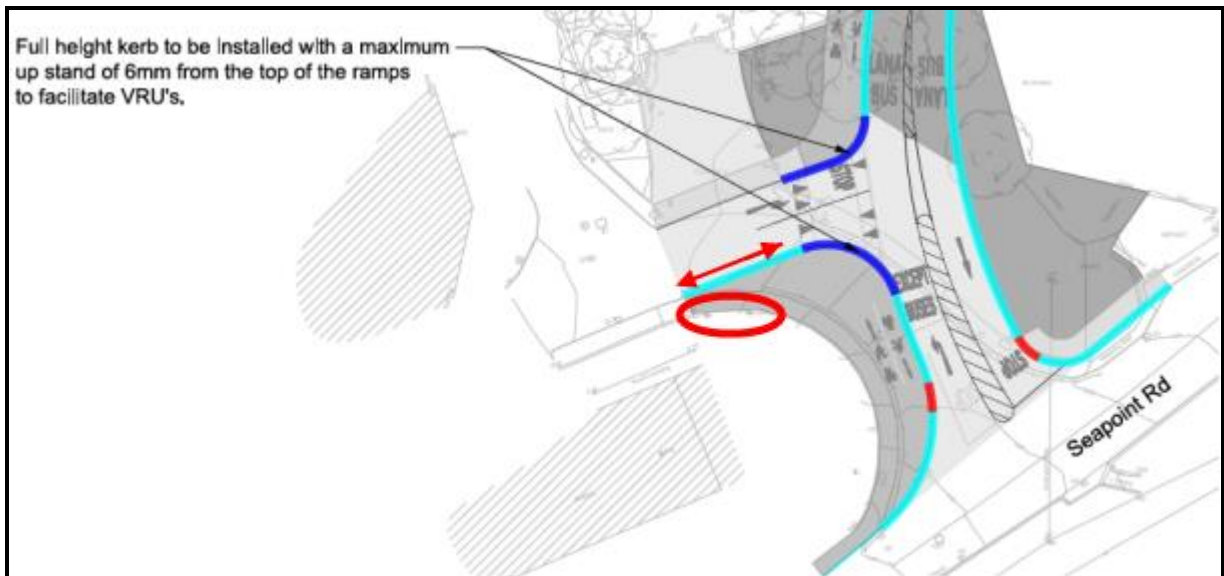
Figure 34: High Kerbs at private drive access

It was noted from the kerb drawings that a full height kerb has been provided at the private driveway access at Junction 2, which is shown in figures 34 and 35, which may present difficulties for safe access and egress at this location.

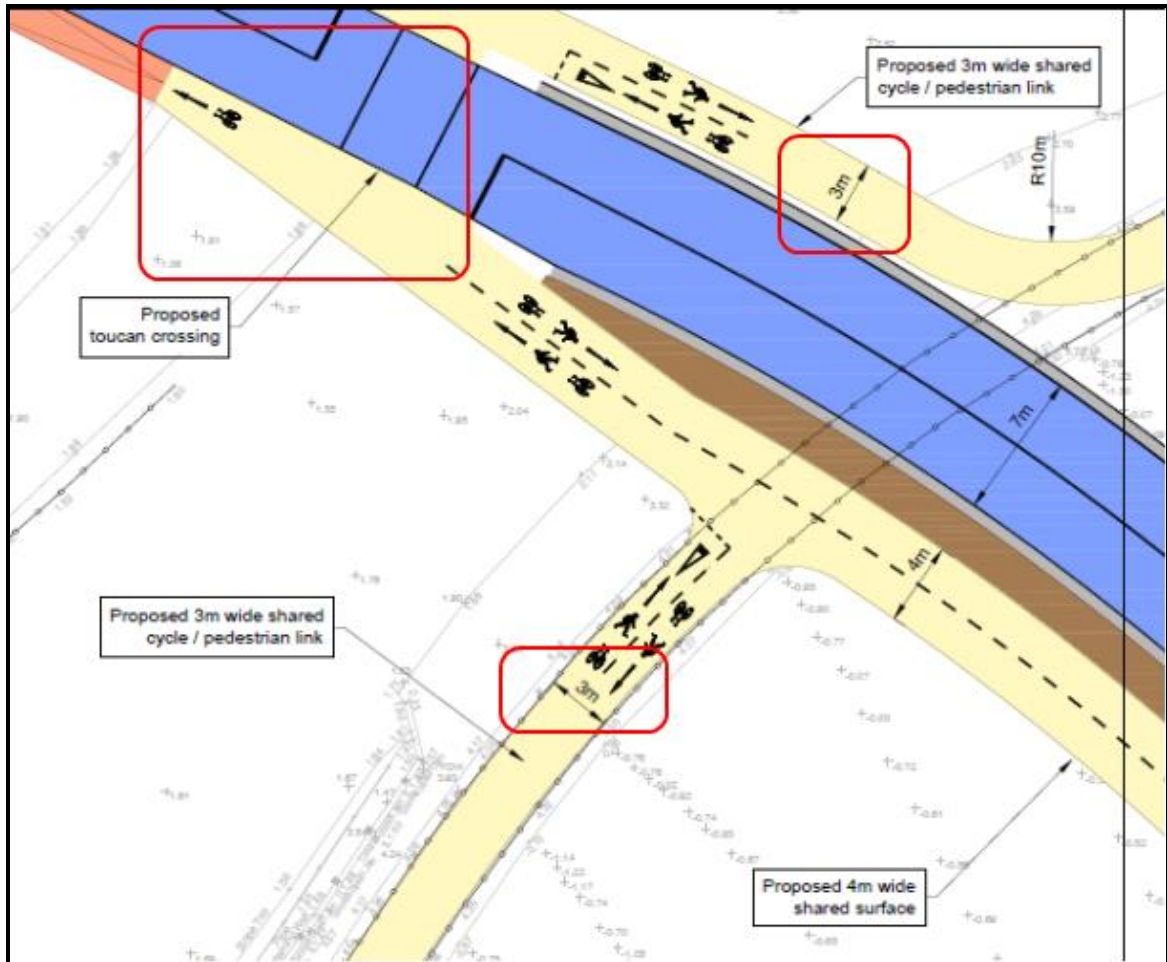
Figure 36: Narrow Shared Facilities

2.3.1.1 The proposed route will provide a segregated off-road cyclist facility, which will safely accommodate one-way cyclist movement along the link, however the facility is provided on one side of the carriageway only, and it does not appear to be sufficiently wide to accommodate two-way cycling movements along the entire length of the proposed link, particularly on the narrower sections of shared space. There is no provision on the design for a verge or separation distance between the VRU facility and the carriageway. When cycle/pedestrian facilities follow the route of a road, a separation distance should be provided between the road and the cycle track through the provision of a grassed verge. A minimum grassed verge width of 1m is usually required to improve safety for VRUs. Figure 36 shows 3m wide shared facilities, including on approaches to the proposed toucan crossing, which would only safely accommodate one-way cycling movement alongside pedestrians. Figure 37 shows a narrow shared facility with hazards immediately adjacent to the VRU facility on both sides, which would normally warrant increased widths on the VRU facility.

Likely cyclist volumes and desire lines should be considered in provision of safe continuous facilities along the route, with provision for suitable separation distance as necessary, and sufficient width to be provided to minimise the potential for conflict between cyclists and pedestrians. Where the cycling and pedestrian routes are segregated by a kerb, a minimum width of 2m is recommended for the pedestrian side, and a 2m effective width for the cycle side (one way). The effective width of the cycleway should be measured from the back of kerb and not the running edge of the carriageway. A width of 3 metres is the preferred two-way minimum width on a cycling route which is not shared with pedestrians, but only where the route is not bounded by vertical features. Where a significant amount of two-way cycling is expected, additional width should be provided, depending on anticipated user flows. Additional width should also be provided for spaces which are to be shared with pedestrians on the same level.

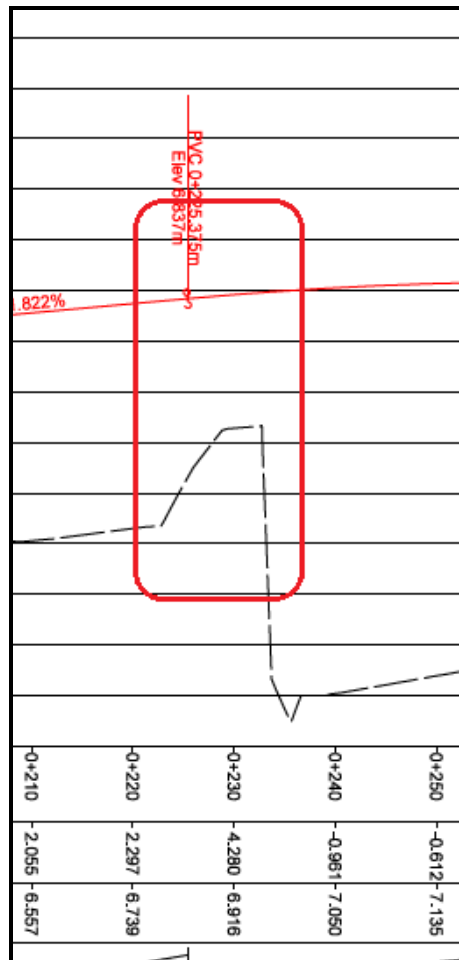
Figure 38: Level Differences at northern side of bridge

2.3.1.2 There were no details provided for the bridge deck, and no clearances shown between the bridge and the VRU route below, however significant level differences were noted on the long section. The photo in figure 40 shows current levels adjacent to the track at this location. It is unclear how the levels and gradients will work for the connection between the existing two-way cycle track parallel to the river and the new shared surface and toucan crossing adjacent to the bridge, and the scope for direct safe connectivity of the cycling route underneath the bridge is

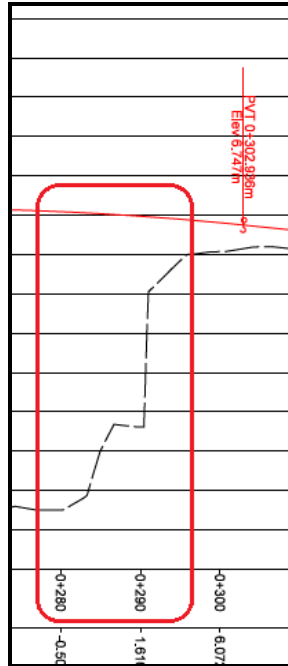
Figure 41: Level differences at proposed footway

A significant level difference was also noted on the southern side of the bridge at approximate chainage 290m, where the tie-in details and gradients for the proposed footway are unclear, as shown in figures 41 and 42.

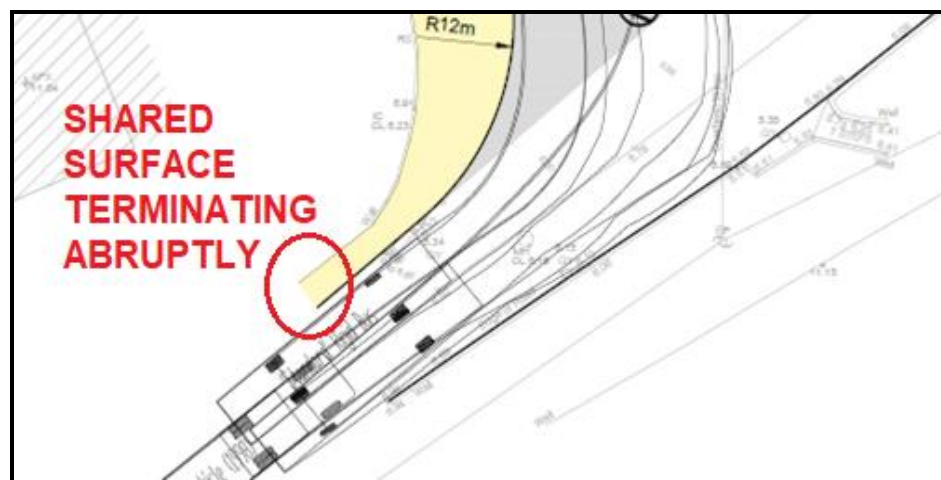
Figure 42: Cyclists vulnerable on narrow cross section

2.3.1.3 It was noted that the proposed shared footway/cycleway terminates abruptly at Junction 2, where there is no provision for dropped kerbs to facilitate transfer from on to off road facilities, and there is insufficient space on the narrow existing footway at the tie-in to facilitate safe shared use. The restrictive geometry at Junction 2, as outlined in previous sections of this report, will present risks for cyclists at this location. Two wheeled vehicles, including motorcyclists, are particularly vulnerable in narrower lanes at and on approaches to junctions, with insufficient space to queue and move alongside larger vehicles. Narrow lanes can also increase the risk of sudden braking and rear shunt collisions, as well as side swipes and kerb collisions.

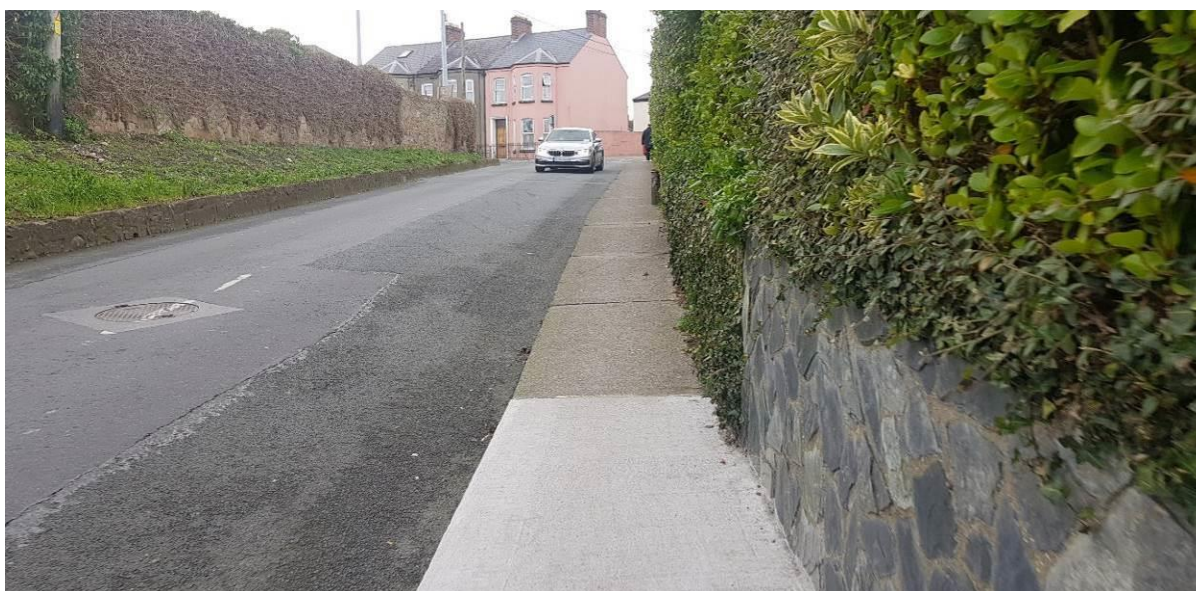
Figure 43: Existing footway narrow on cross section

There was no information provided on anticipated cyclist volumes and desire lines, and there were low levels of pedestrian activity noted on the existing network adjacent to Junction 1 and 2 at the time of the site visit however the location of the route and likely demand for high pedestrian accessibility to and from the schools should be taken into consideration with VRU movements and accessibility to be prioritised. Low vehicle speeds should also be encouraged³, with sufficient SSD to be provided in advance of all potential pedestrian desire lines to cross the carriageway, to include sufficient margins of error particularly on downhill gradients, where SSD is typically higher for heavier vehicles such as buses. Other potential safety issues which should be considered as the design progresses, have been summarised in sections 2.3.2.1 – 2.3.2.4.

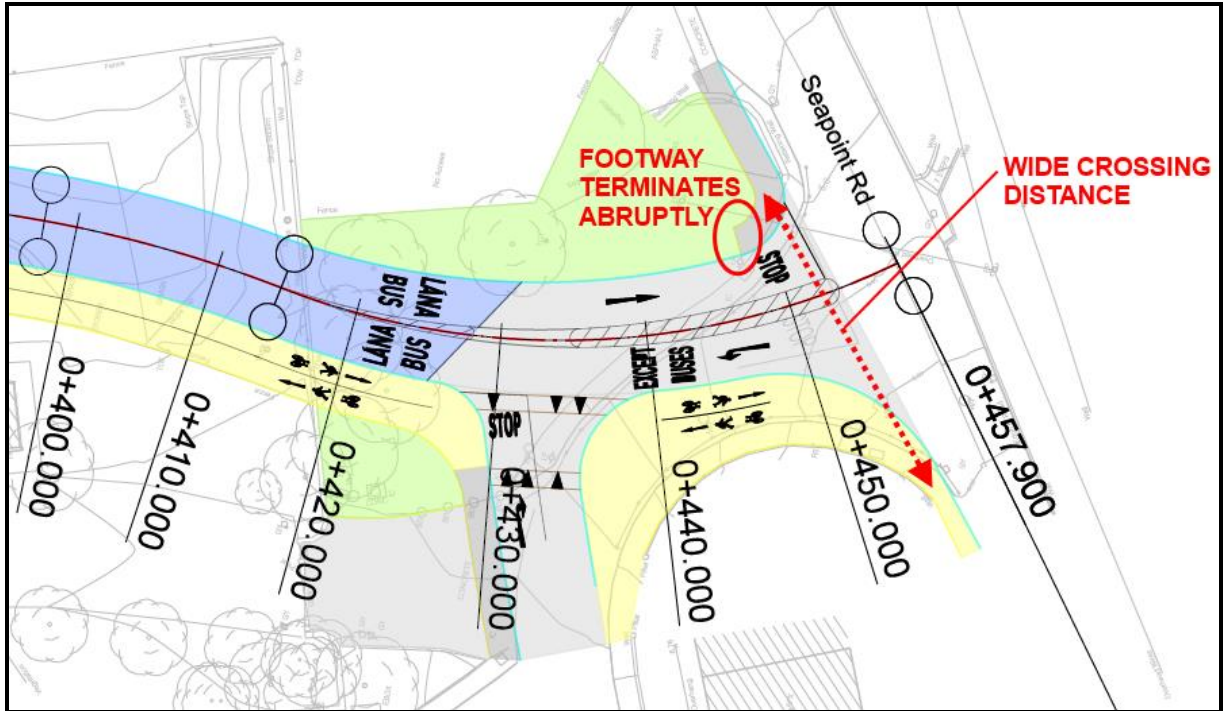
Figure 44: Wide crossing distance

2.3.2.2 A wide crossing distance was noted at the intersection with Seapoint Road, with no provision for a pedestrian refuge, to minimise the crossing distance, particularly for older and mobility impaired pedestrians. Pedestrians, particularly the mobility impaired and elderly are more vulnerable on crossing distances exceeding 10m without provision for refuge. VRUs will be particularly vulnerable at this location, where a high proportion of larger turning vehicles, i.e. buses, will be turning as a result of the proposed new bridge and link road. The footway on the eastern side of the junction also terminates abruptly, with no provision for safe crossing to the footway on the opposite side of the carriageway, and no provision for dropped kerbs and tactile paving for the benefit of visually and mobility impaired pedestrians. The crossing distance will be somewhat shortened by the proposed kerb buildout on western side, however this will impact on existing utilities, and it was noted that chamber covers will be located within pedestrian desire line, where they may present a slip hazard.

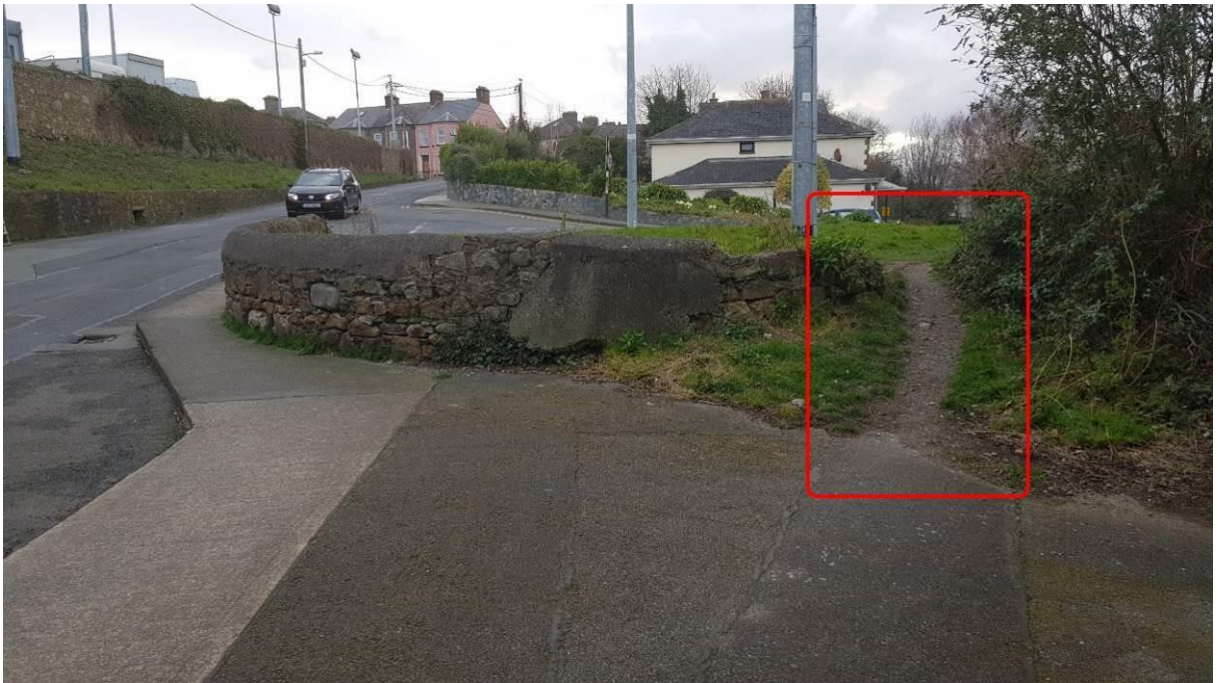
Figure 47: Pedestrian desire Line at Junction 2

2.2.3.3 A pedestrian desire was noted on site at Junction 2, as shown in figures 47, 48 and 49, which has not been catered for on the proposed layout.

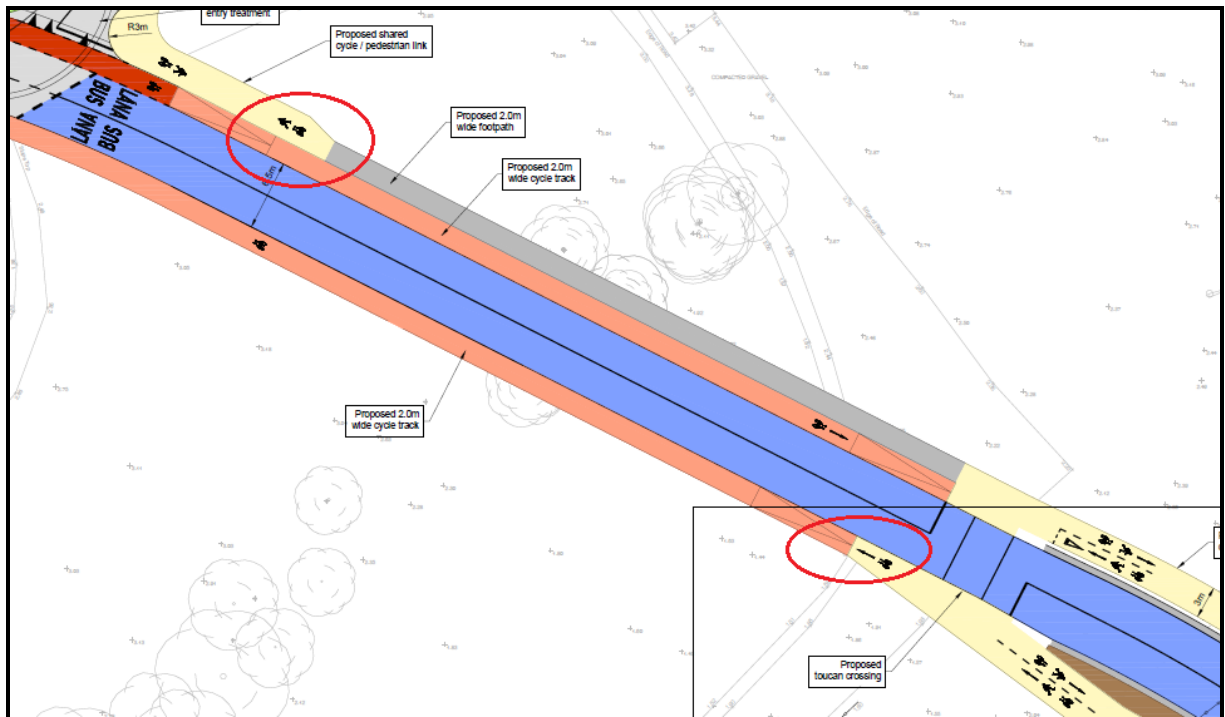
Figure 50: Shared Routes terminating suddenly

2.2.3.4 A shared VRU facility has been provided to each side of the proposed toucan crossing, however the pedestrian facility terminates abruptly on the southwestern side of the carriageway, as shown in figure 50, which may bring pedestrians into conflict with cyclists. The shared facility also terminates abruptly at Junction 1.

The continuity of the shared facilities should be considered in the context of kerb heights and potential trip hazards, and facilities should not terminate abruptly without suitable signing and lining guidance or provision for safe crossing facilities or transition kerbs. Consideration should also be given to the extension of the shared facilities and relocation of the proposed toucan crossing to a position further away from the proposed bridge.
