Road Safety Audit

Road Safety Audit
Stage 1
for
BRAY SUSTAINABLE TRANSPORT BRIDGE
BRAY, CO WICKLOW

Date: September 2020

Report produced by: Road Safety Matters Ltd

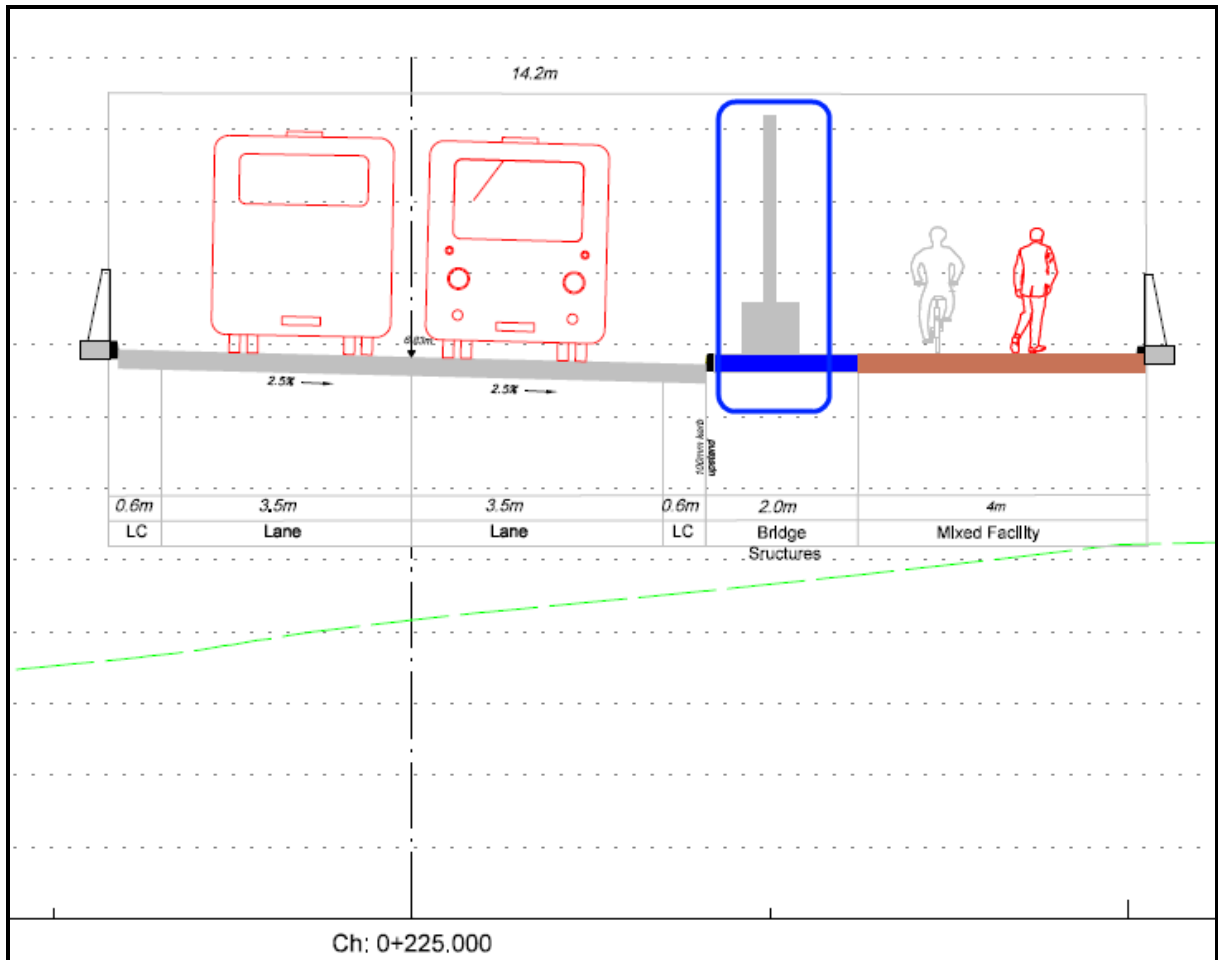
Figure 51: Bridge Structure Height and Location will compromise Intervisibility

The proposed toucan crossing is located on a downhill gradient after a crest curve which coincides with a horizontal curve, which may present reduced visibility towards the crossing in the northbound direction. A vertical visibility drawing has been provided, based on an SSD of 49m, which allows little or no margin of error for large vehicles, potentially travelling at speed and needing to break suddenly on a downhill gradient, including in wet and icy conditions, where there is no provision for the standard 50m anti-skid surfacing which is required in advance of a controlled crossing in an urban environment. There was no horizontal visibility drawing provided,

and the combination of horizontal and vertical curvature can lead to further reductions in forward visibility and SSD. It was noted that the location of the bridge abutment on the eastern side and the high bridge structure on the western side, which is highlighted in the cross section in figure 51, and on the plan in figure 52, will further restrict intervisibility at this location, and lead to an increased risk of failure to stop, and VRU/vehicular conflict at the crossing.
