PPP Social Housing Bundle 3:
Development at Blessington, Co. Wicklow
Stage 1&2 Road Safety Audit

RPS Group

August 2021

Stage 1&2 Road Safety Audit

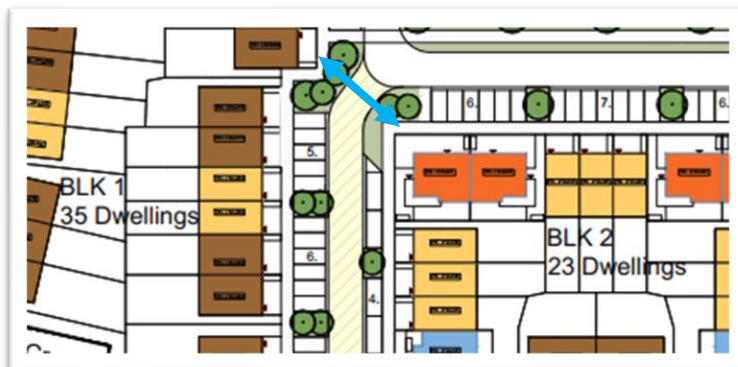
Figure 2.2 – Pedestrian Desire Line

2.2 Problem: Catering for Key Pedestrian Desire Line

Location: Homezone between BLK1 and BLK 2

An important pedestrian desire line does not appear to have been catered for. This could lead to conflicts between pedestrians and general traffic.

A formal pedestrian crossing facility should be provided at the location described.
