Social Housing PPP Programme Bundle 3
Burgage More, Blessington, Co. Wicklow
Archaeological Impact Assessment

Client: Coady Architects

Report Date: 15th January 2021

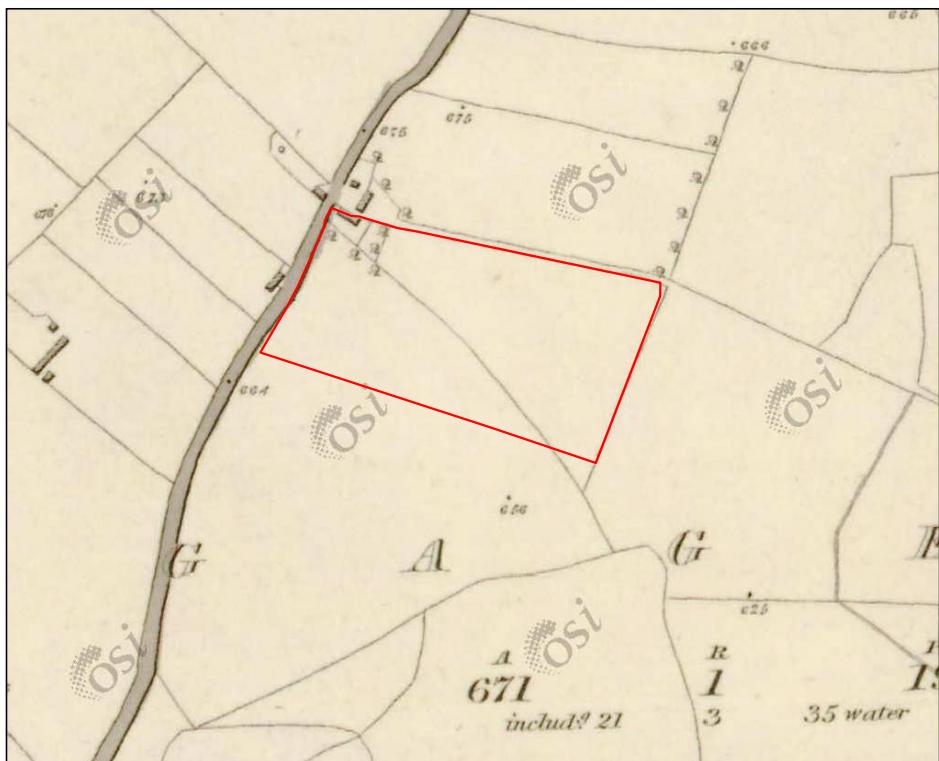
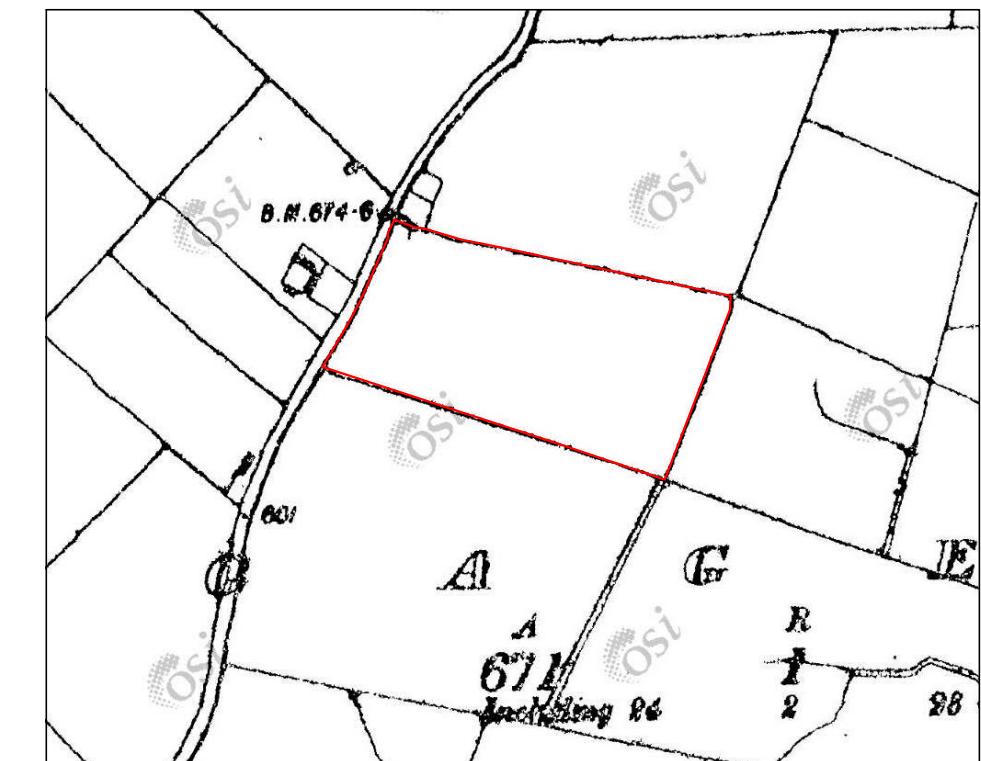
(l) 1st edition OD - 1838

(r) Cassini - 1908-9

Map	Date	Description
Historic 6inch	1838	The site occupies two fields. A field boundary runs diagonally through the middle of the site. There is one small rectangular building visible in the NW corner.
Historic 25inch	1885-87	The site is in its current shape and size.
Cassini	1908-09	No change to previous.

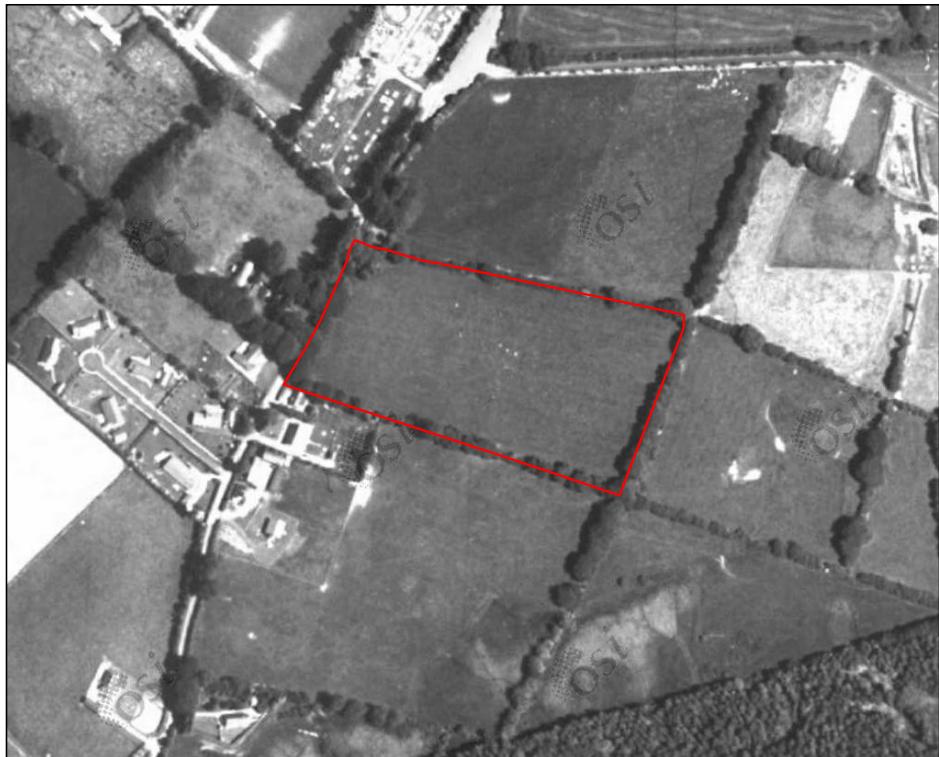
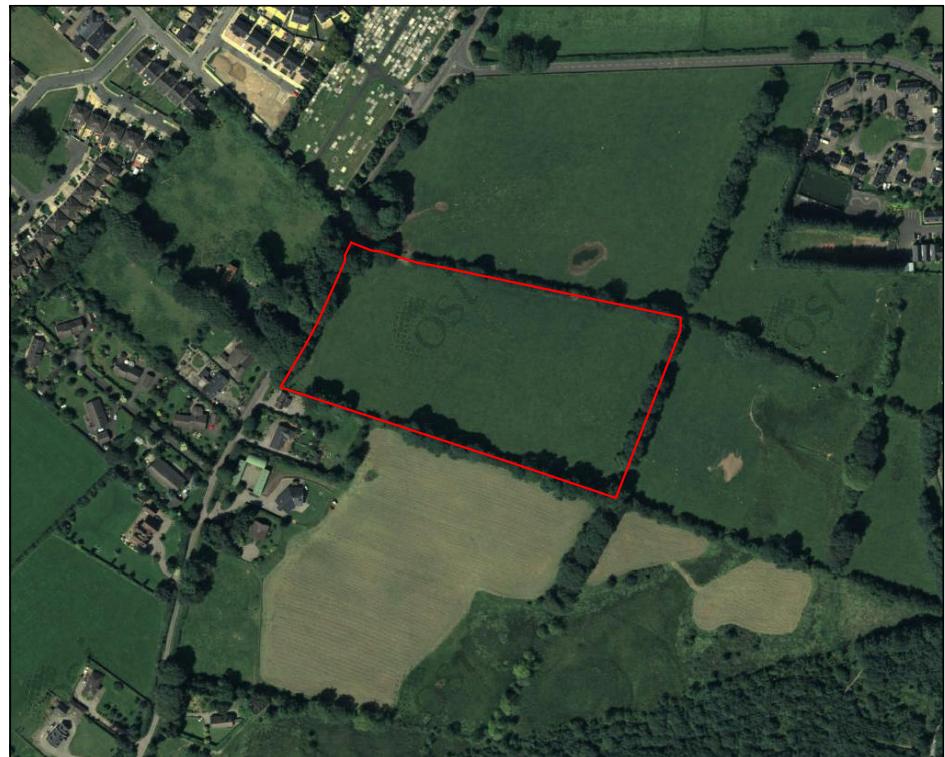
(l) 1995
(r) Premium

Aerial Photograph	Date	Description
OSi (B&W)	1995	The site appears to be a green pasture in its current shape and size. No archaeological features noted.
OSi	2005	No change
OSi Digital Globe	2013	No change
Google Earth	2018	No change

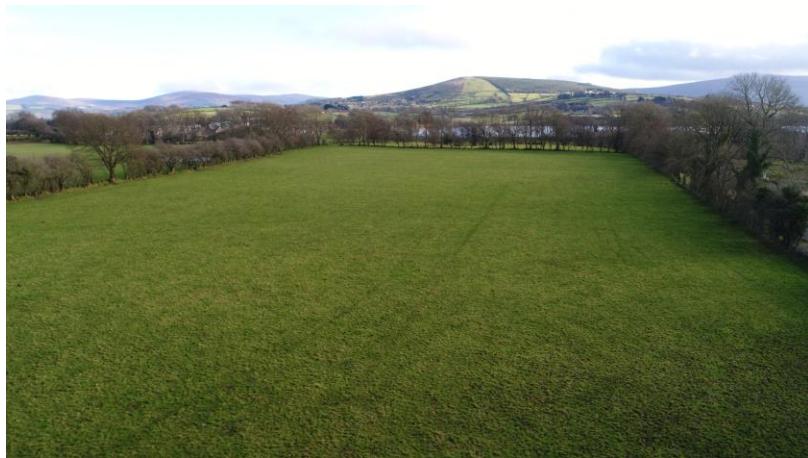
Plate 1: Aerial view of the site, looking SE

The site was visited by Bart Korfanty of Archer Heritage Planning Ltd on 15th December 2020 in dry, overcast conditions (Plates 1–4). The site is comprised of a single flat field. The field appears to be a pasture surrounded on all sides by mature hedge rows. On the ground inspection and aerial photographs obtained with the drone did not reveal any archaeological features visible on the surface.

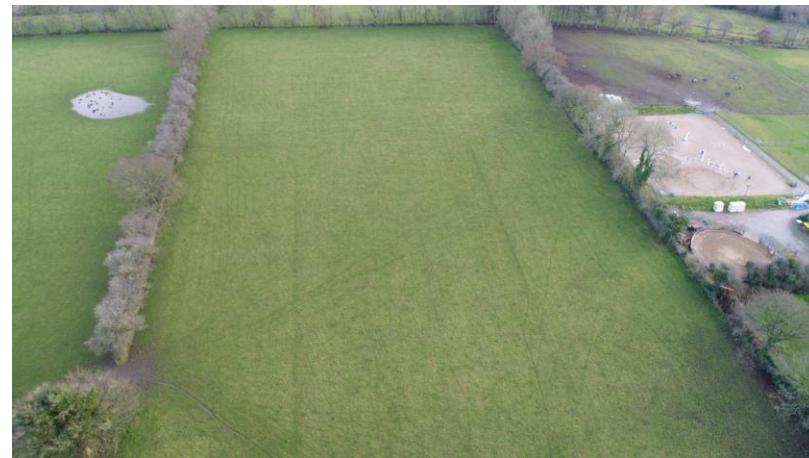
Plate 2: Aerial view of the site, looking SE

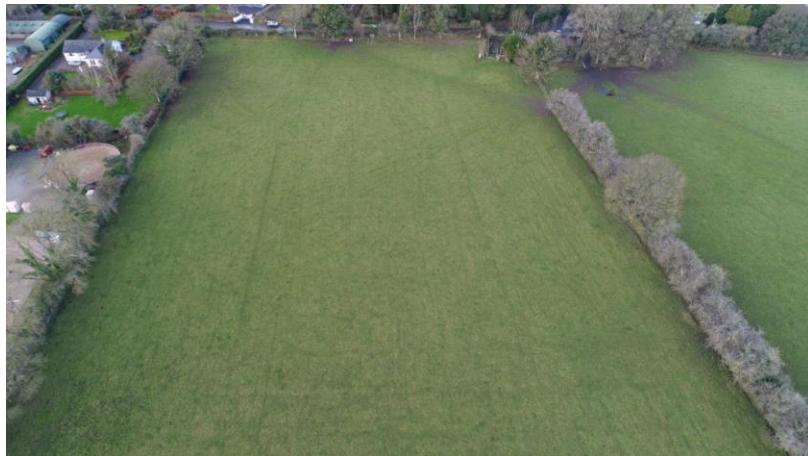
Plate 3: Aerial view of the site, looking NW

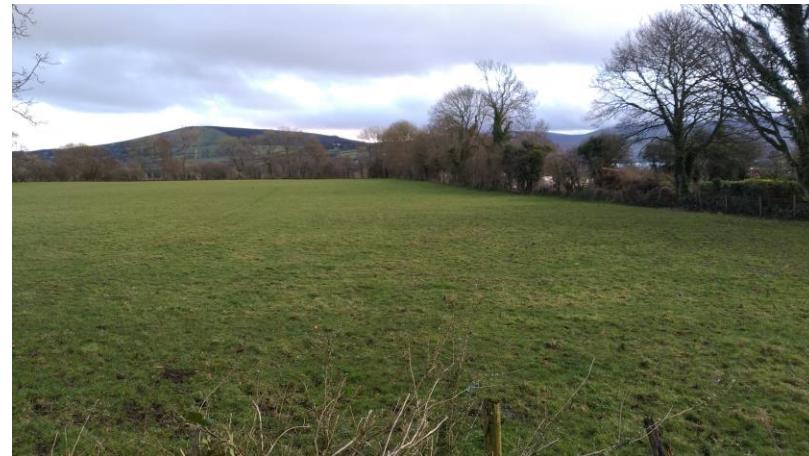
Plate 4: Ground level view of the site, looking SE
