Proposed Flood Relief

Works, Arklow, Co. Wicklow.

**PROPOSED FLOOD RELIEF WORKS
ARKLOW, CO. WICKLOW**

ARCHAEOLOGICAL TEST EXCAVATIONS

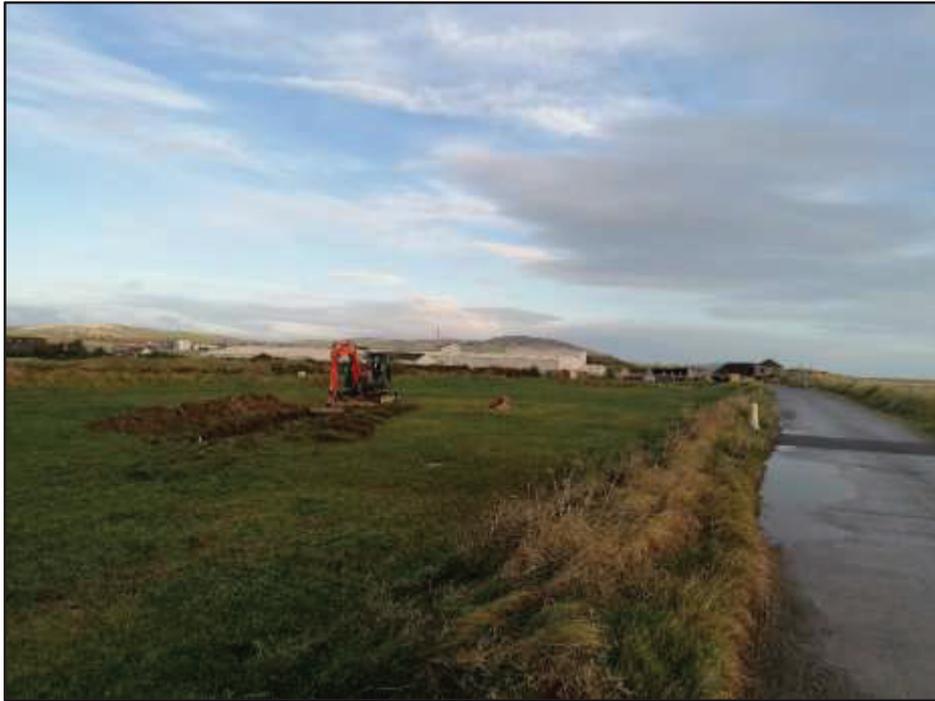
Plate 1.1: General view SC6-2 looking NNE

As with SC6-1, the SC6-2 sod and topsoil (C1) was between 0.20m and 0.30m in depth. The C1 layer overlay dense grey/orange mottled clay material with stone inclusions and intermittent pockets of modern domestic and structural waste. The depth of Trench 2 at the SSE terminus was 0.20m. The depth of the trench was graded to a depth of 0.80m without any noticeable change in the material.

Dry stone filled gullies designed to provide drainage were noted at 24.00m, 46.00 and 51.00m from the SSE terminus. These drains are modern features inserted to provide drainage to this amenity area (SC6).

A consistent spread of domestic pottery (Arklow Pottery) fragments is noticeable throughout the C1 deposit. The spread is quite random and at no time was any particular density noted.

At the NNW terminus the excavation was extended to a depth of 1.50m to confirm the original level of the beach sand prior to the reclamation. At this location the original sand level was confirmed at 2.75m OD.

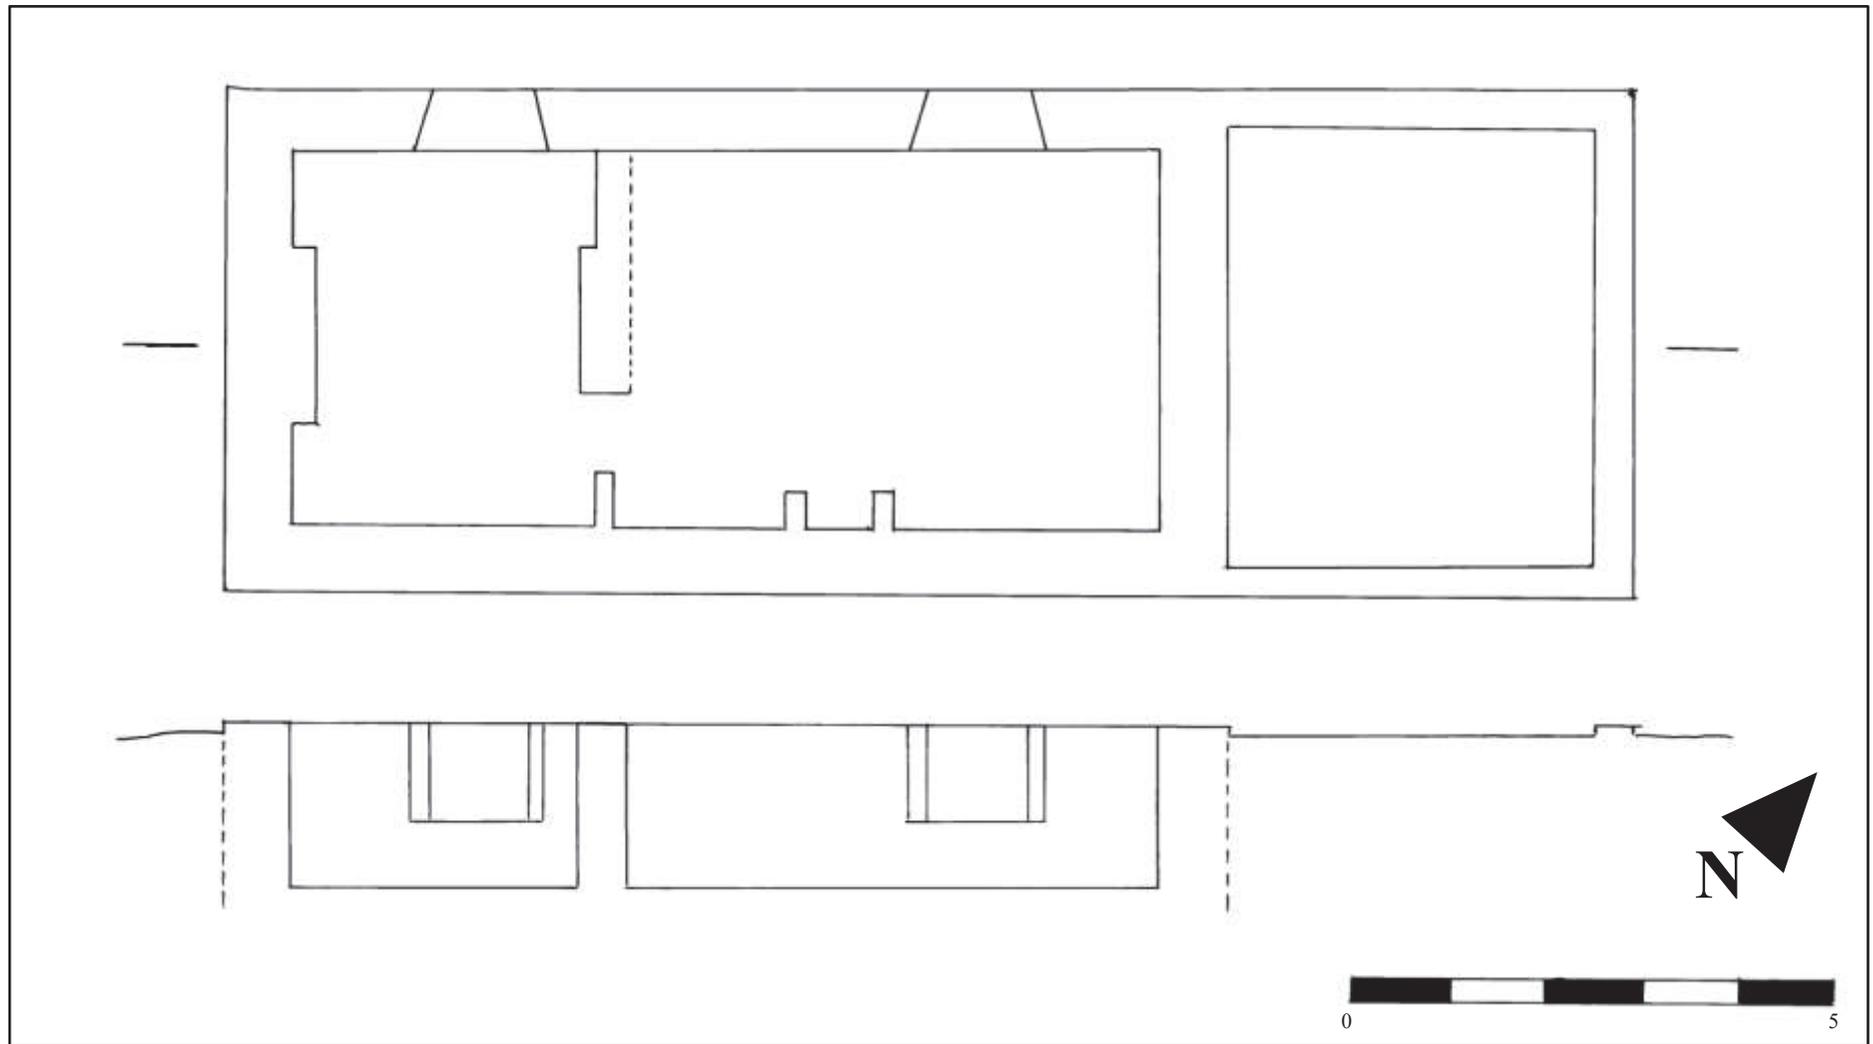
The existence of the basement and the window lights on the NW side clearly demonstrated how much the exterior ground level around the house was altered. The change in ground level is most noticeable on the N where the ground level was artificially raised to accommodate the 1865 extension. This extension consisted of a ground and first floor. The ground floor level was at 2.76m OD. Evidence for a fireplace in the form of glazed white ceramic brick was noted central to the southern wall. It was noted that the walls defining the outline of the 1865 extension were considerably thinner than those defining the basement of the 1845 structure. No evidence of the ground floor of the 1845 house was noted during testing. It is possible that the basement walls were thicker than the upper floors as they were built to form part of the foundations for the two-storey house above.

Fig 2.3: 1845 Basement and 1865 extension ground floor plan and elevation (SC3-1) 1:50

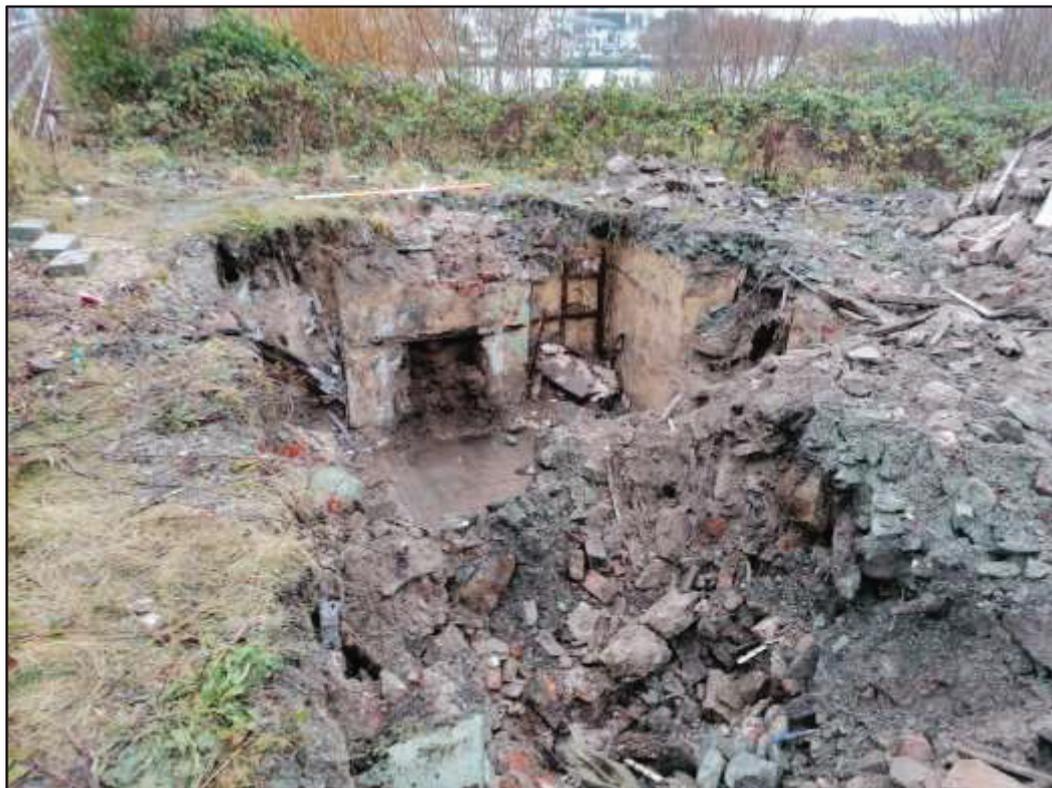
Plate 2.1: General view of basement level SC3-1 looking SW

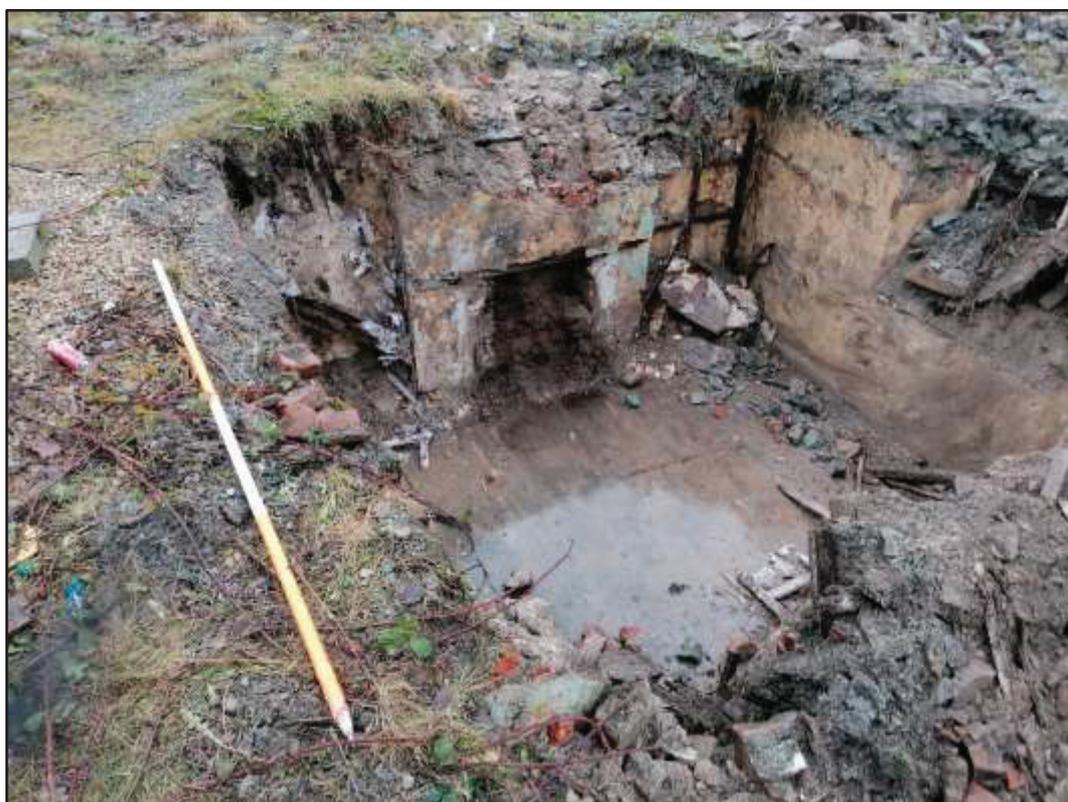
Plate 2.2: Detail of basement SW room

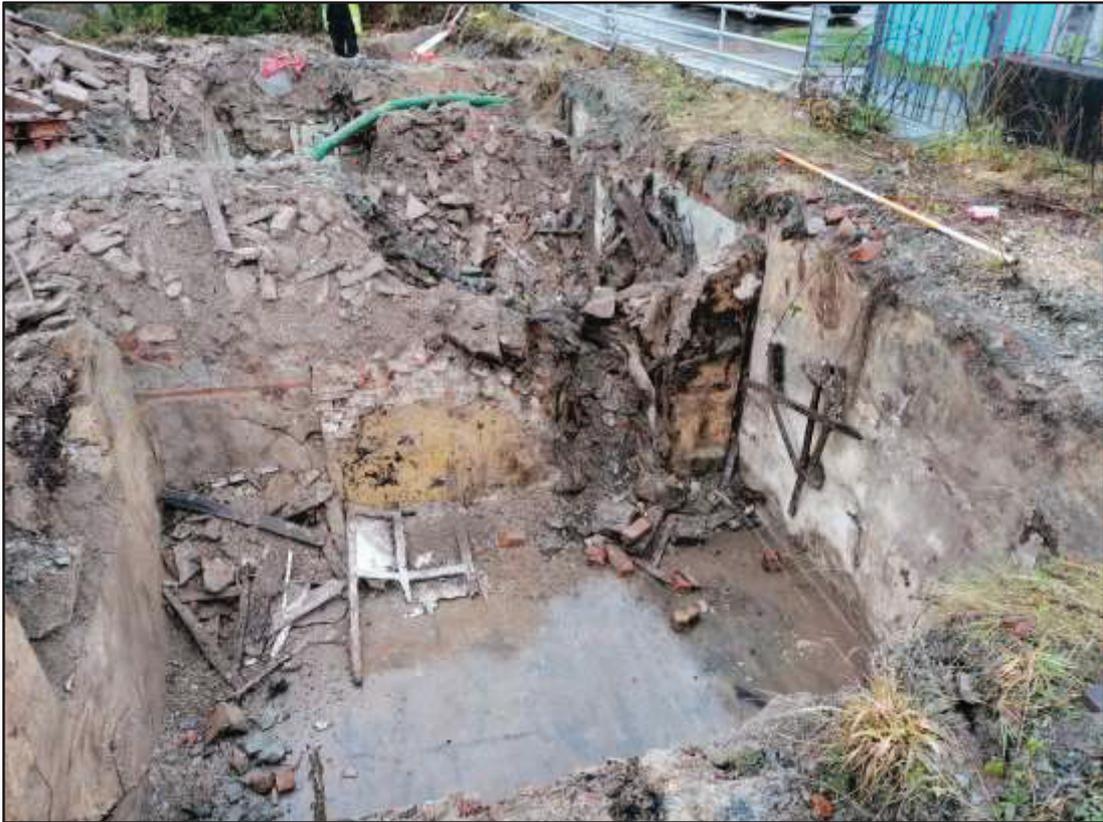
Plate 2.3: SC3-1 basement looking NE

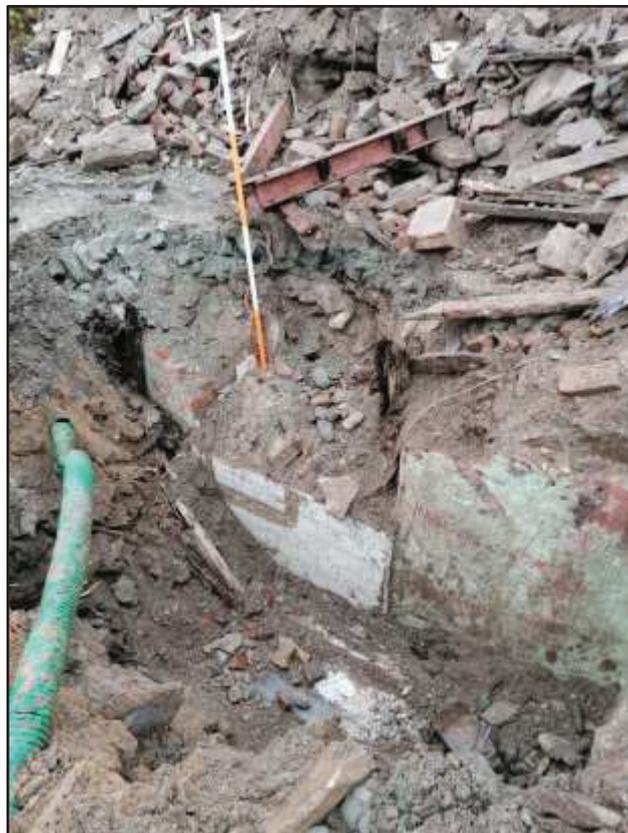
Plate 2.4: SC3-1, detail of NE room of basement – window and Belfast sink insert

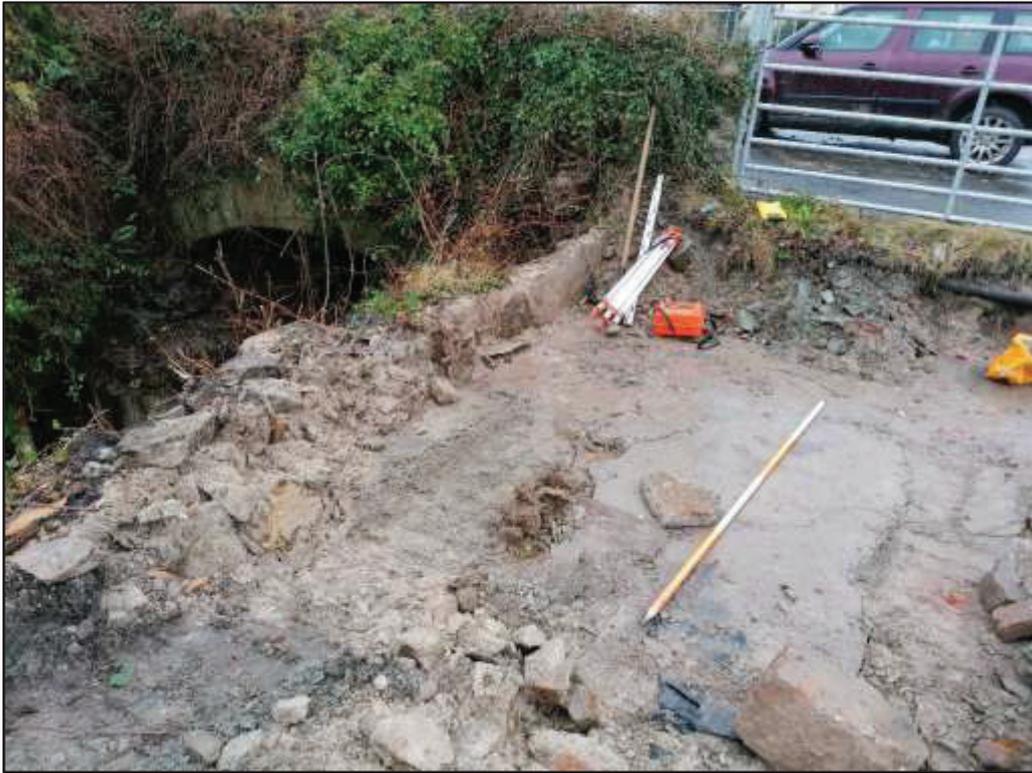
Plate 2.5: SC3-1, Ground floor of 1865 extension. Arched culvert visible to left

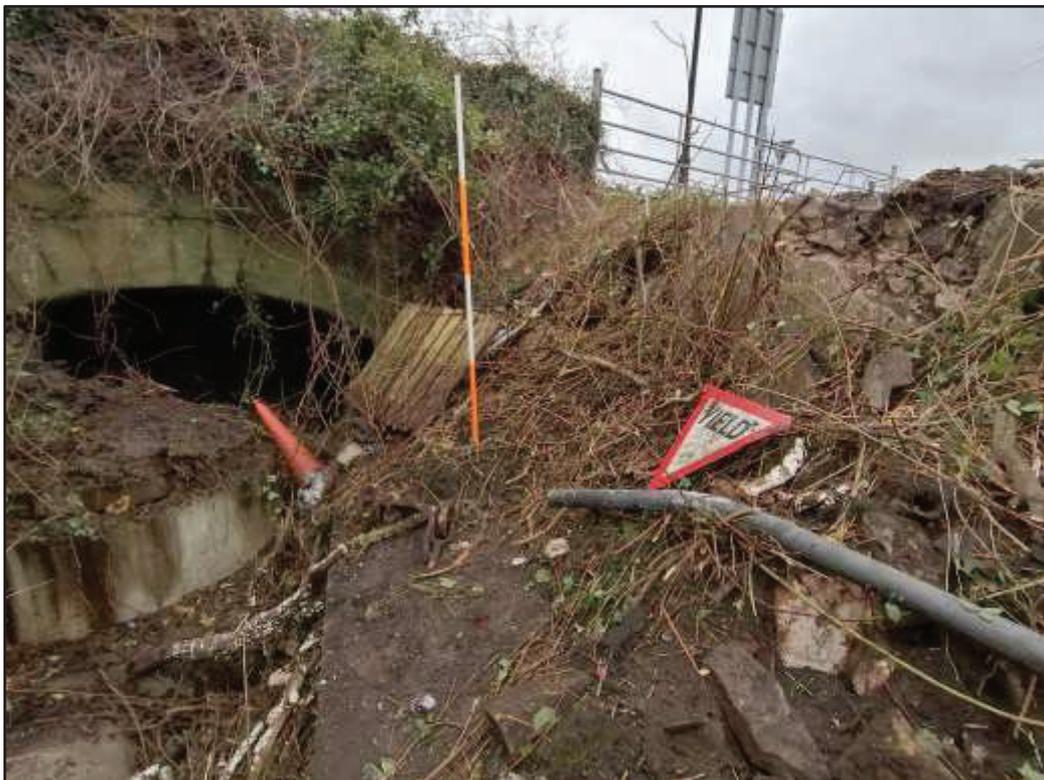
Plate 2.6: Arched culvert and watercourse with foundation level of gable of the 1865 extension to the right

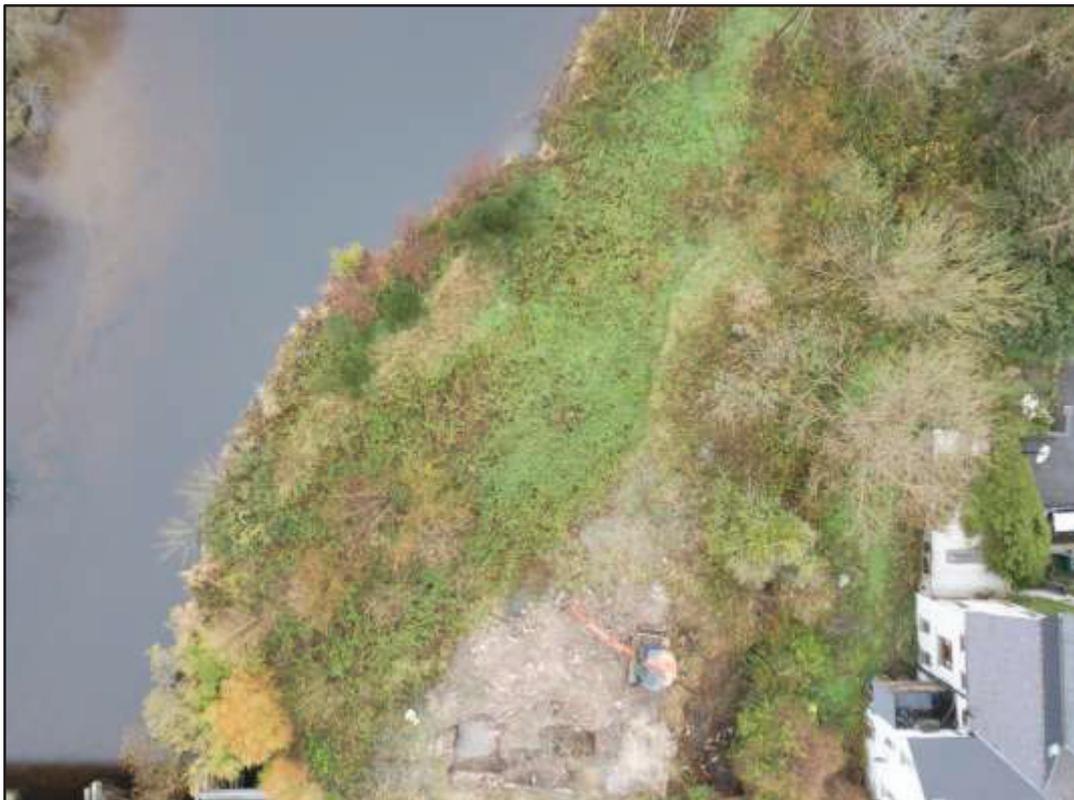
**Plate 2.8: Aerial view of SC3 from E.
Old watercourse visible to the right of excavation and extending to the NW**

It is inevitable that this location will sustain direct impacts during the construction of the FRS and the planned wastewater treatment scheme. A recent underwater archaeological assessment (ADCO, 2018) noted surviving timbers on and in the riverbed upstream of the bridge. These timbers have been suggested as being the possible remains of an earlier bridge structure that may have had its northern abutment within the precincts of the SC3 location. Any potential impacts on such a structure will require archaeological mitigation well in advance of any development work starting on the SC3 location or in the river adjacent to this site.

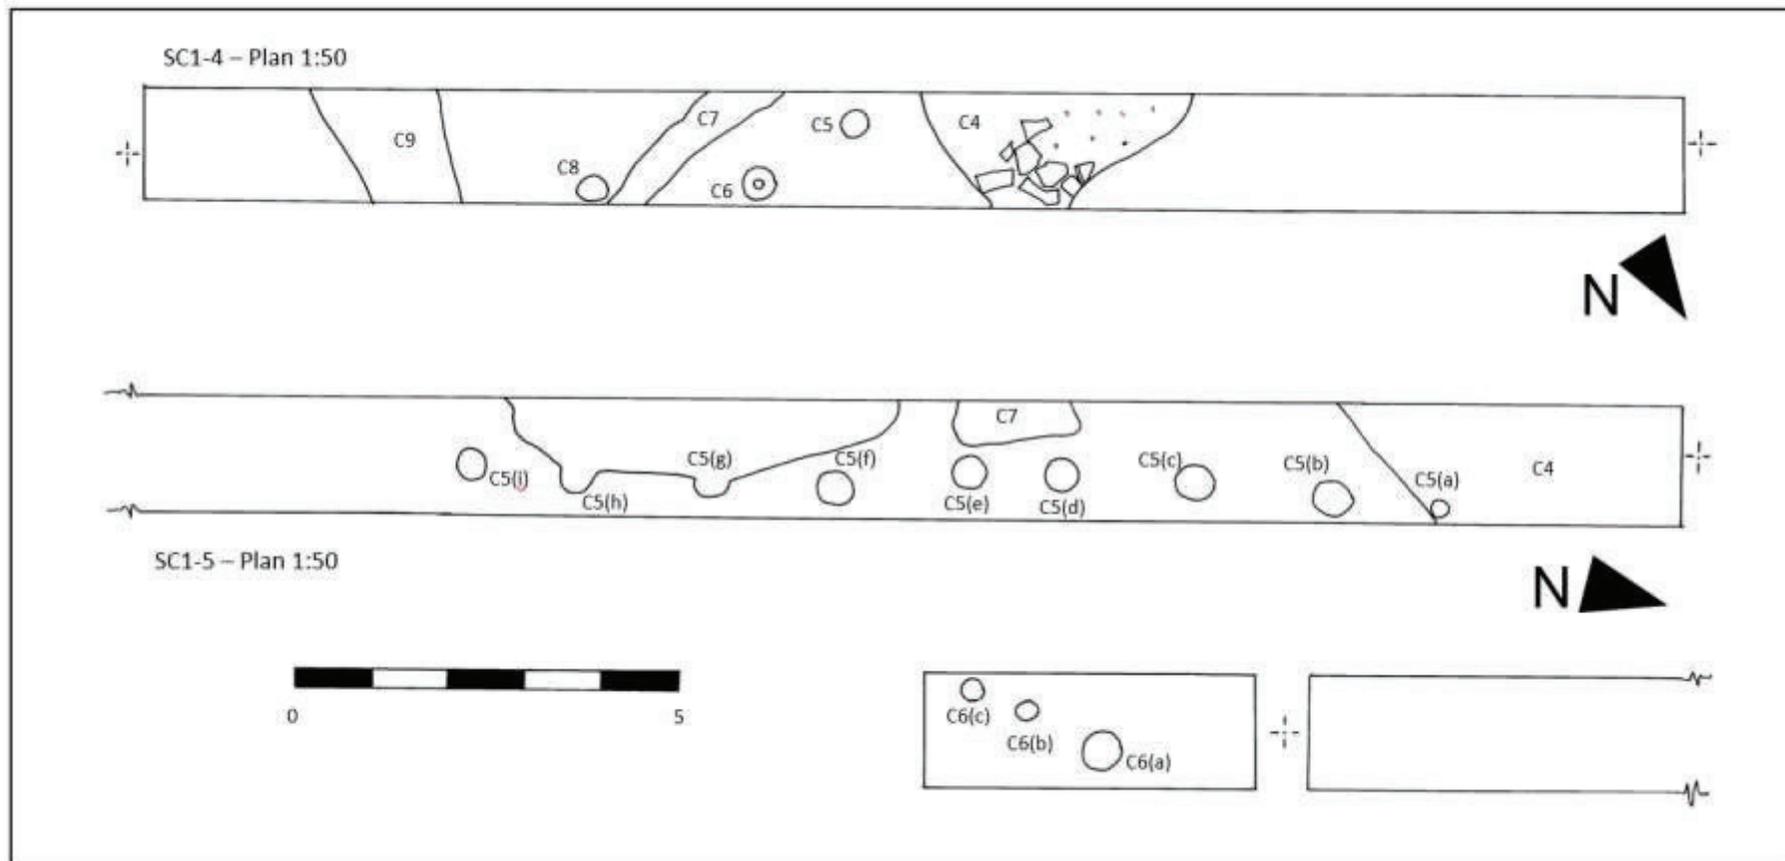
Fig 3.3: Feature plans of SC1-4 (top) and SC1-5 (bottom). Scale 1:50

C3 was a well compacted stratum which appeared to represent a good natural for this site. C3 did not produce any finds but displayed a number of cut features. The NW end of SC1-4 appeared quite sterile with the first of the features noted over 6.00m from the NW terminus. All measurements quoted are referenced from the NNW terminus and relative to the baulks of SC1-4.

C4 was an irregular area of soil discolouration, greyish brown with frequent charcoal flecking. It extended 3.50m along the SW baulk of SC1-4 and tapered inwards to 1.00m on the NE baulk. A spread of flat stones predominated in the E side of C4. This spread of stones may have been the remains of a collapsed dry-stone wall or the remnants of a stone clad yard. The stone spread was noted at 8.00m from the NW terminus at 2.48m OD.

C3 was a well compacted stratum of light brown sandy clay which appeared to represent a good natural for this site. C3 did not produce any finds but displayed a number of cut features. The NNW end of SC1-5 appeared quite sterile with the first of the features noted over 3.00m from the NNW terminus. All measurements quoted were referenced from the NNW terminus and relative to the lateral baulks of SC1-5.

No further features were noted between the location of **C5 (i)** and the SSE terminus of SC1-5 as set out. However, as features had been noted at the SE terminus of SC1-4, it was decided to extend SC1-5 to assess the area between SC1-5 and SC1-4. SC1-5 was halted at 24.80m and recommenced on the same line from 25.30m to 29.80m. A group of three (3) postholes was identified in this extension – **C6**.

An irregular shaped patch of greyish brown material was identified between 7.80m and 9.40m – **C7**. **C7** extended into SC1-5 from the WSW baulk by 0.60m. Exposed within the fill of C7 and visible on the surface was a single clamp-fired brick. It is difficult to suggest a date for this brick as similar bricks were found at the SC3 location from a 19th century context.

On completion of the test excavation at this location the archaeological horizon was marked with red and white hazard tape prior to being backfilled and reinstated.

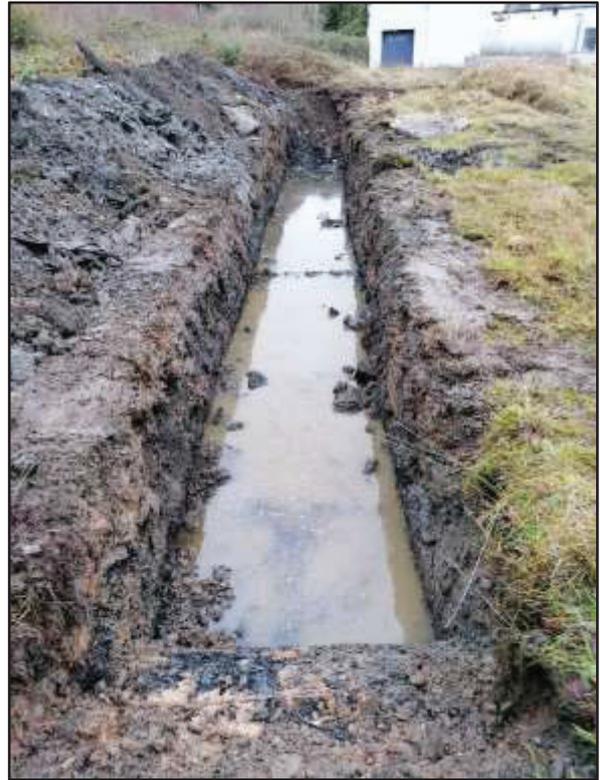
Plate 3.2: SC1-1 looking NNE

C1 in SC1-1 showed an extension of the 804 material at the SSW terminus, but this gave way to highly contaminated material consisting of construction waste, car chassis, plastic and metal waste mixed through with loose soil and hydrocarbon effluent.

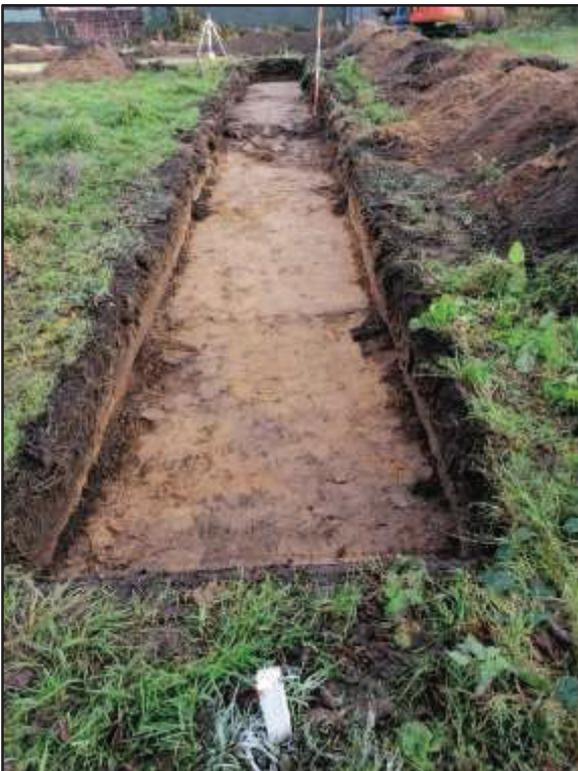
Plate 3.3: SC1-4 looking E

No further features were noted, and the excavation was halted at 20.00m. The ridge and furrow system noted in SC1-3 did not extend into SC1-4.

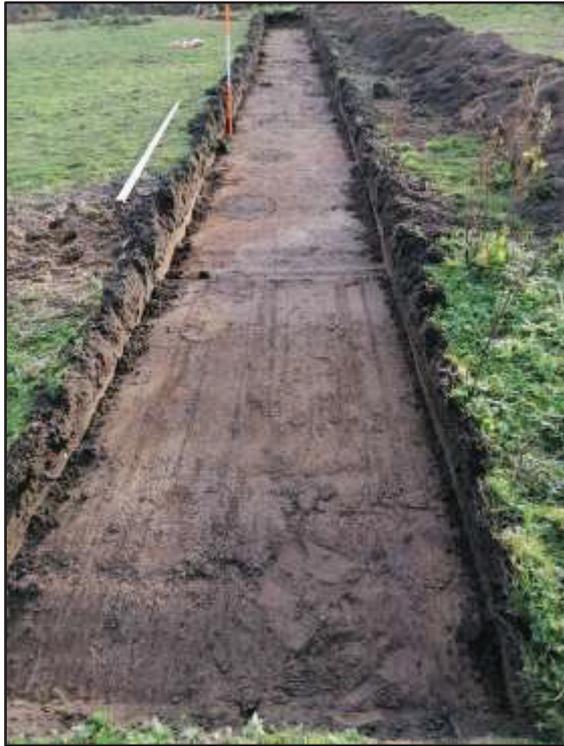
Plate 3.5: SC1-5 looking SSE

C2 was uniform in depth over the full length of SC1-5. C2 was a dark brown, almost black layer of light friable soil. Some fragments of modern pottery were noted in the C2 layer.

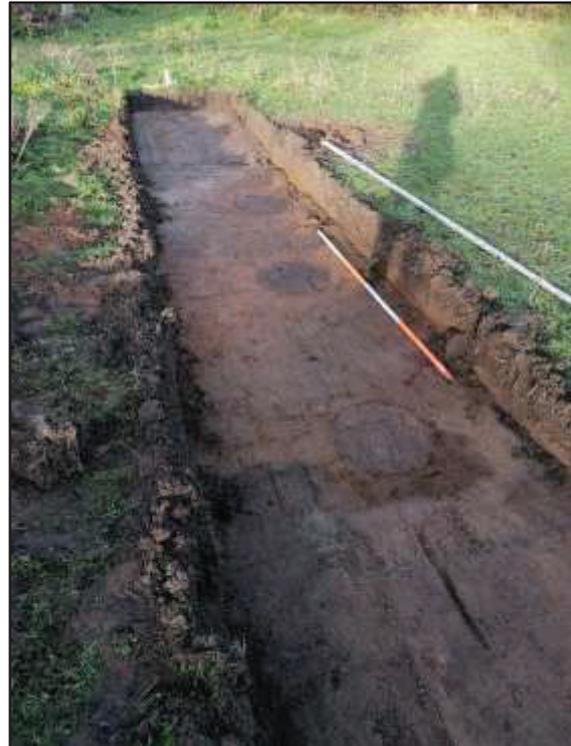
Plate 3.6: SC1-5 Detail at NNW terminus

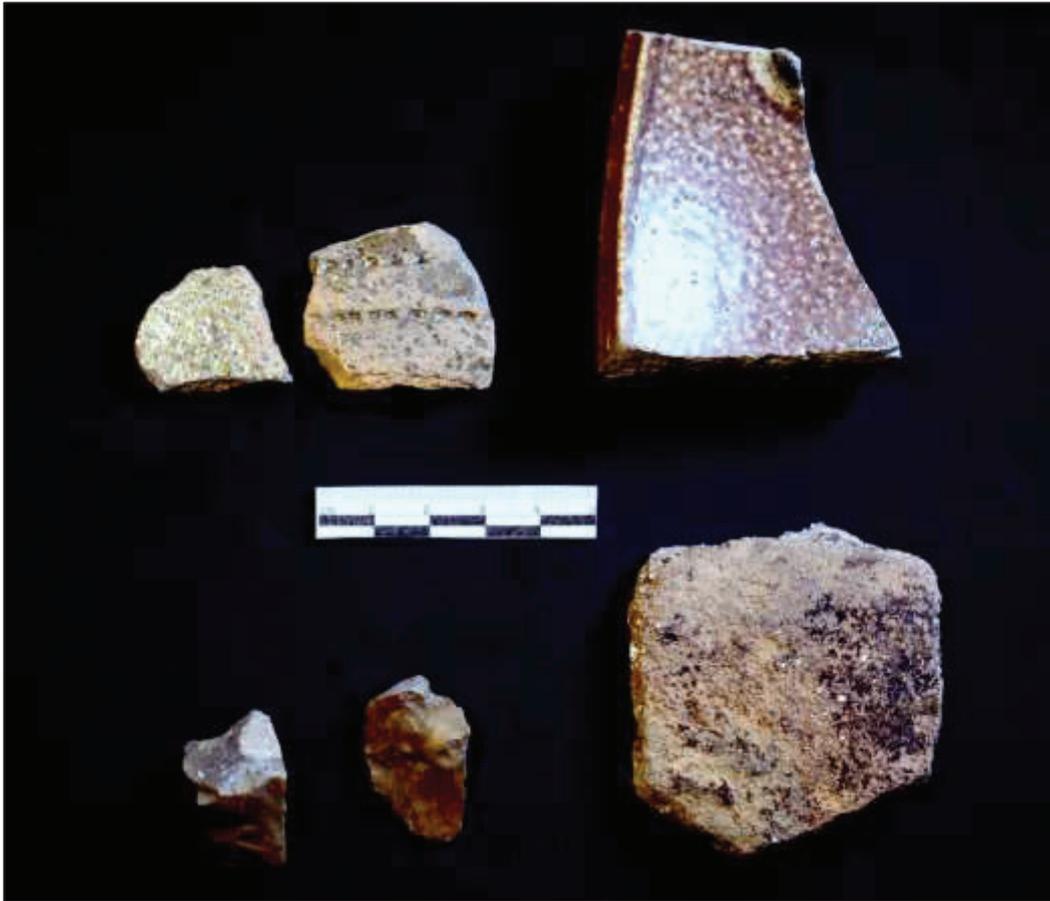
Plate 3.9: Finds from SC1.

SC1-3: Top left, two sherds of Dublin type fine ware. Top right, a single rim sherd of Bartmann / Belarmine ware

foundation. While these artefacts may also be intrusive to this area, it is important to mitigate for the possibility of both prehistoric and medieval activity.
