# Blessington Greenway

Quality Audit (including Stage 1 RSA)

Wicklow County Council

Project number: 60617025  
Doc Ref:60617025-QA1

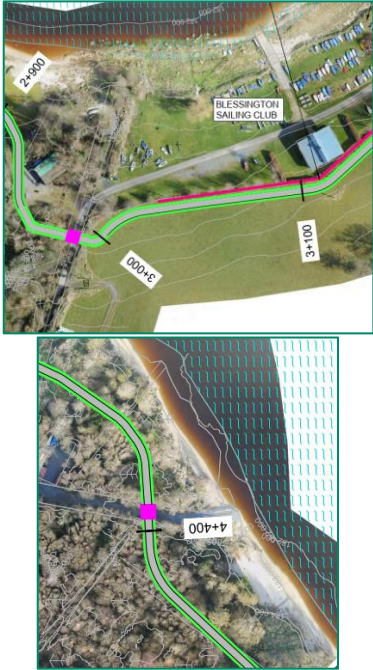
<p>Figure 5-1 – Public Road Crossings</p>
<b>Location:</b>	Road Crossing (Scheme Wide)	
<b>Drawings:</b>	60617025_SHT_DD_BLGWY_142 series	
<b>Summary:</b>	Provision of road crossings for cyclists	
<b>Description:</b>		
<p>On the scheme there are a few proposed road crossing points, where the proposed route will cross an existing road such as the R758, Access Road to Blessington Sailing Club, Valleymount Road. It is unclear to the audit team what arrangements will be provided for the road crossing at these locations. The lack of the safe crossing arrangements can lead cyclists to enter into traffic, this can cause a cyclist/vehicle collision.</p>		
<b>Recommendation:</b>		
<p>Provide appropriate crossing points on all road crossing points.</p>

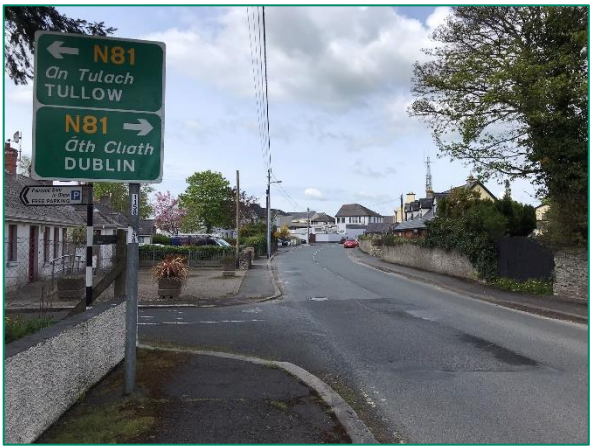
<p>Figure 5-2 – Lack of NMU Crossing Provision</p>
<b>Location:</b>	Connection onto Kilbride Road	
<b>Drawing:</b>	60617025_SHT_DD_BLGWY_142-Blessington Sheet 2 of 11	
<b>Summary:</b>	Lack of crossing provisions	
<b>Description:</b>		
<p>The existing connection between the access road and the Kilbride Road has no provisions for NMUs crossing. No road crossing provisions are proposed along the Kilbride Road for non-motorised users. The lack of appropriate crossing facilities can lead to shared footpath user crossing at undesigned location, which could result in a cyclist/vehicle collision.</p>

<b>Recommendation:</b>
Appropriate crossing facilities for cyclists should be provided at all road crossings

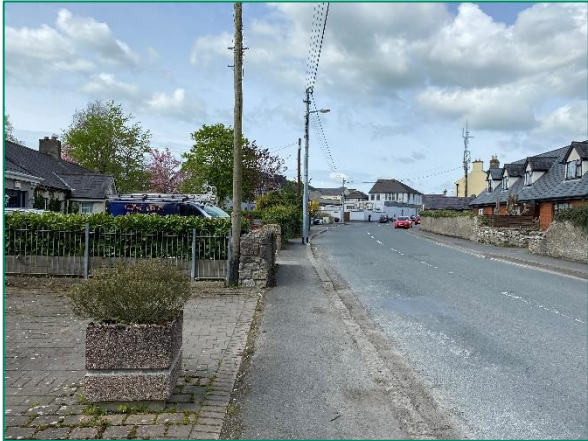
Figure 5-3 – Narrow Footpath on Shared Route

<b>Location:</b>	Kilbride Road	
<b>Drawing:</b>	60617025_SHT_DD_BLGWY_142- Blessington Sheet 2 of 11	
<b>Summary:</b>	Narrow Footpath in Kilbride Road	
<b>Description:</b>

<b>Recommendation:</b>
Appropriate footpath width should be provided to accommodate all shared footpath users.

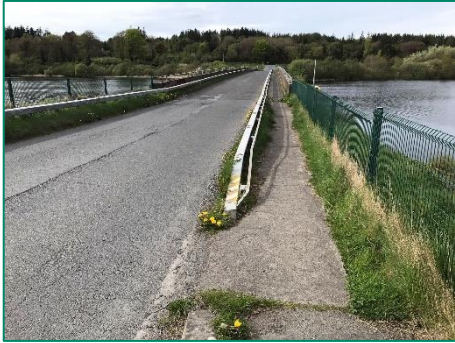
Figure 5-4 - Narrow Footpaths on Blessington Bridge

<b>Location:</b>	Blessington Bridge; Baltyboys Bridge & Valleymount Bridge	
<b>Drawings:</b>	60617025_SHT_DD_BLGWY_142 Baltyboys Sheet 8 of 8 and Lackan Sheet 9 of 9	
<b>Summary:</b>	Narrow Footpaths	
<b>Description:</b>

<b>Recommendation:</b>
Provide appropriate facilities to ensure pedestrians and cyclists can pass safely.

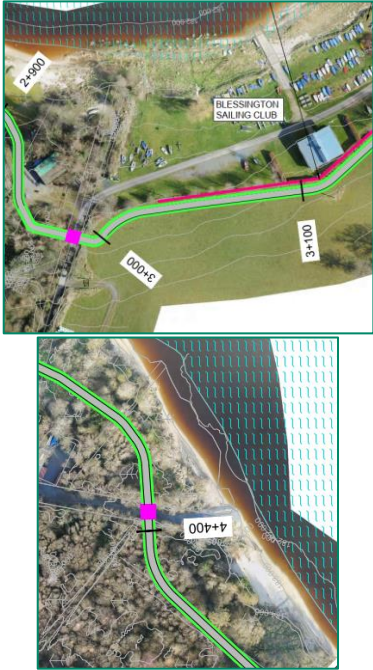
<p>Figure 6-1 – Public Road Crossings</p>
<b>Location:</b>	Road Crossing (Scheme Wide)	
<b>Drawings:</b>	60617025_SHT_DD_BLGWY_142 series	
<b>Summary:</b>	Provision of road crossings for pedestrians	
<b>Description:</b>		
<p>On the scheme there are a few proposed road crossing points, where the proposed route will cross an existing road such as the R758, Access Road to Blessington Sailing Club, Valleymount Road. It is unclear to the audit team what arrangements will be provided for the road crossing at these locations. The lack of the safe crossing arrangements can lead pedestrians to enter into traffic, this can cause a pedestrian/vehicle collision.</p>		
<b>Recommendation:</b>		
<p>Provide appropriate crossing points on all road crossing points.</p>

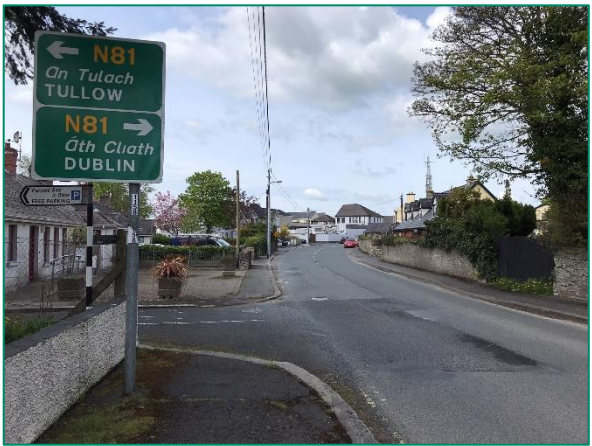
<p>Figure 6-2 – Lack of NMU Crossing Provision</p>
<b>Location:</b>	Connection onto Kilbride Road	
<b>Drawing:</b>	60617025_SHT_DD_BLGWY_142-Blessington Sheet 2 of 11	
<b>Summary:</b>	Lack of crossing provisions	
<b>Description:</b>		
<p>The existing connection between the access road and the Kilbride Road has no provisions for pedestrians crossing. No road crossing provisions are proposed along the Kilbride Road for non-motorised users. The lack of appropriate crossing facilities can lead to shared footpath user crossing at undesignated location, which could result in a pedestrian/vehicle collision.</p>

<b>Recommendation:</b>
Appropriate pedestrian crossing facilities should be provided at all road crossings

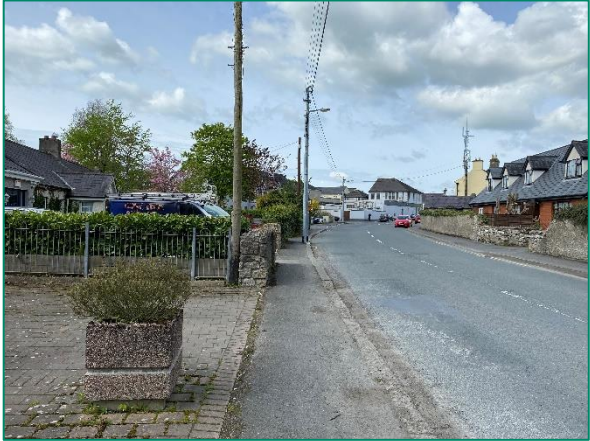
Figure 6-3 – Narrow Footpath on Shared Route

<b>Location:</b>	Kilbride Road	
<b>Drawing:</b>	60617025_SHT_DD_BLGWY_142-Blessington Sheet 2 of 11	
<b>Summary:</b>	Narrow Footpath in Kilbride Road	
<b>Description:</b>

<b>Recommendation:</b>
Appropriate footpath width should be provided to accommodate all shared footpath users.

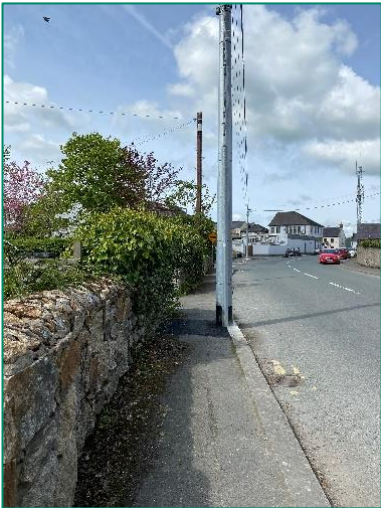
Figure 6-4 – Obstruction of the Footpath

<b>Location:</b>	Kilbride Road	
<b>Drawing:</b>	60617025_SHT_DD_BLGWY_142-Blessington Sheet 2 of 11	
<b>Summary:</b>	Street lighting pole restricts footpath width	
<b>Description:</b>

<b>Recommendation:</b>
Appropriate footpath width should be provided to accommodate all shared footpath users.

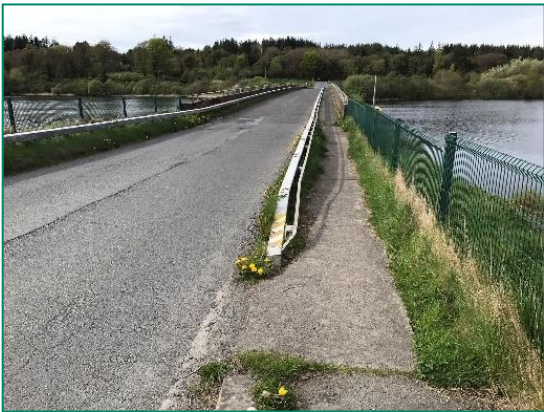
<i>Location:</i>	Blessington Bridge; Baltyboys Bridge & Valleymount Bridge	
<i>Drawings:</i>	60617025_SHT_DD_BLGWY_142 Baltyboys Sheet 8 of 8 and Lackan Sheet 9 of 9	
<i>Summary:</i>	Narrow Footpaths	
<b>Description:</b>		
<p>The Blessington, Baltyboys, and Valleymount Bridges will be a connection between proposed sections of the Greenway. As a single carriage way with a narrow footpath on the southern side of the road, it is unclear if there will be enough width for the cyclist and pedestrian to safely use these facilities to pass one another. The narrow footpath may lead to pedestrians entering onto the carriageway to pass opposing pedestrians/cyclists, which can lead to pedestrian/vehicle collision. The lack of width on the footpath to accommodate pedestrian and cyclist passing may lead to cyclist/pedestrian collisions.</p>		<p>Figure 6-5 - Narrow Footpaths on. Blessington Bridge</p>

<b>Recommendation:</b>		
<p>Provide appropriate facilities to ensure pedestrians and cyclists can pass safely.</p>

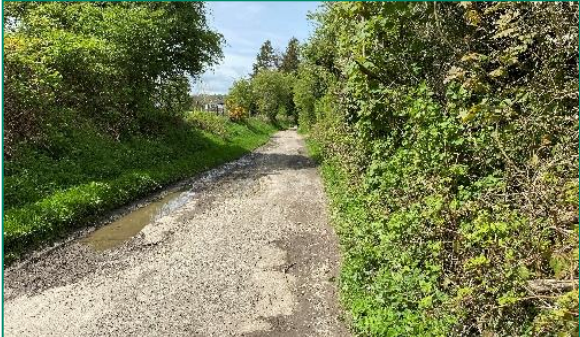
Figure 7-1 – Unsuitable Road Surface

<b>Location:</b>	Burgage Moyle Road – Chainage 5+000	
<b>Drawing:</b>	60617025_SHT_DD_BLGWY_142-Blessington Sheet 6 of 11	
<b>Summary:</b>	Unsuitable road surface	
<b>Description:</b>		
<p>During site inspection it was observed that the local road, Burgage Moyle Road, is potholed and extremely uneven which is unsuitable for many forms of cycles. As Greenway users will be directed to use this road as a connection link, the lack of proper road surface may lead to cyclists avoiding this road and bypassing this section by travelling on the section of N81, where there is no footpath provision, to link back into the Greenway. This can lead to cyclists cycling on the national secondary road where the posted speed limit is 100km/h which could result in cycle/vehicle collisions.</p>		
<b>Recommendation:</b>		
Upgrade the surface of the Burgage Moyle Road to a standard to accommodate all non-motorised users.

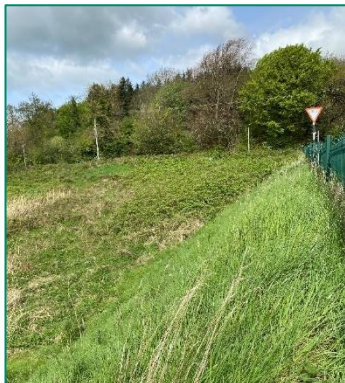
Figure 7-2 – Approach Gradient to Blessington Bridge

<b>Location:</b>	Blessington Bridge	
<b>Drawing:</b>	60617025_SHT_DD_BLGWY_142-Blessington Sheet 1 of 11	
<b>Summary:</b>	Steep slope for Greenway users on the approach to the Blessington Bridge	
<b>Description:</b>		
<p>The approach to the Blessington Bridge will connect to the footpath on the eastern side of the Blessington Bridge, During the site inspection it was observed that the slope on the approach to the abutment of the bridge would be quite steep. The Blessington Bridge Road is elevated above adjacent ground level at this location. There is no footpath or verge provision on the western side of the Blessington Bridge Road to facilitate NMUs. As the Greenway will rise to connect to the bridge, it is unclear to the auditors if there is sufficient visibility to Greenway users from vehicles travelling on the carriageway.</p>		
<b>Recommendation:</b>		
Appropriate gradient levels on the approach to the Blessington Bridge Road should be provided, as well as appropriate signage and visibility requirements at the connection location.

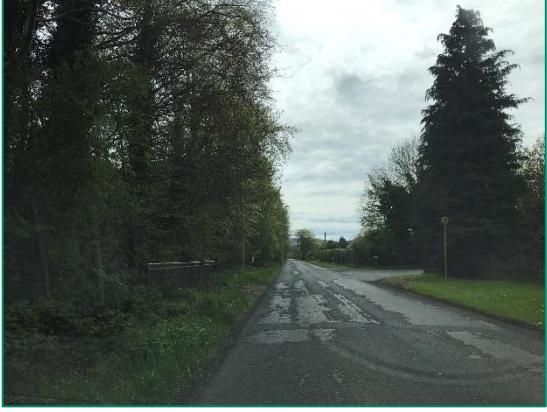
Figure 7-3 – Visibility to Greenway R758 Crossing Point

<i>Location:</i>	Baltyboys Section connection to the Tulfarris Loop	
<i>Drawing:</i>	60617025_SHT_DD_BLGWY_142 Baltyboys Sheet 8 of 8	
<i>Summary:</i>	Restricted visibility to crossing connection	
<b>Description:</b>		
<p>The connection between the Baltyboys and the Tulfarris schemes is proposed at the junction of the R758 and the local L8360 road. The R758 is posted as an 80km/h speed limit but vehicle speeds at this location. High through speeds on the R758 at this location might lead to vehicle users not observing cyclists crossing at this location which may result in the vehicle unable to stop in time and can lead to NMU/vehicular collisions.</p>		
<b>Recommendation:</b>		
<p>Ensure sufficient forward visibility and signage is provided on the R758 and L8360 road to indicate the presence of the cycle access and potential for NMUs crossing the R758.</p>

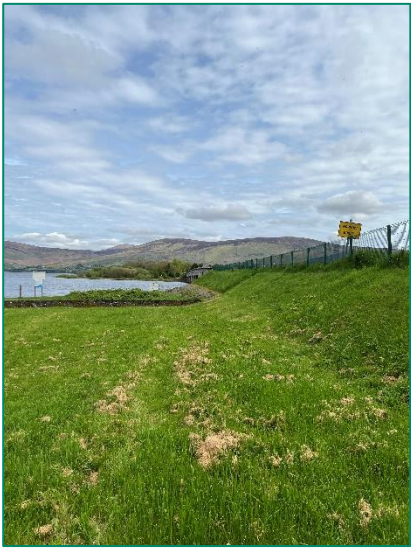
Figure 7-4 – Approach Gradient to Valleymount Bridge

<i>Location:</i>	Southern End of the Baltyboys Greenway section	
<i>Drawing:</i>	60617025_SHT_DD_BLGWY_142 Baltyboys Sheet 8 of 8	
<i>Summary:</i>	Steep slope for Greenway users on the approach to the Bridge	
<b>Description:</b>		
<p>The southern end of the Baltyboys section will connect to the western side of the Valleymount Bridge and carpark. The Greenway connects directly to the R758. The R758 is elevated above adjacent ground level at this location, and it was observed that the embankment slopes are steep. There is no footpath or verge provision on the Valleymount Bridge to facilitate NMUs. As the Greenway will rise to connect to the R758, west of the bridge, it is unclear to the auditors if there is sufficient visibility to vehicles travelling on the R758.</p>		
<b>Recommendation:</b>		
<p>Appropriate Greenway gradient on the approach to the R758 should be provided, as well as appropriate signage and visibilities requirements at the connection location.</p>

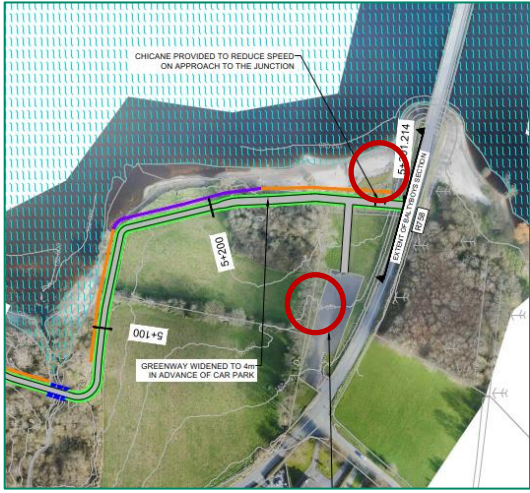
<b>7.2.5. Problem</b>	
<b>Location:</b>	Southern End of the Baltyboys Greenway section
<b>Drawing:</b>	60617025_SHT_DD_BLGWY_142 Baltyboys Sheet 8 of 8
<b>Summary:</b>	Proposed Greenway access to the carpark
<b>Description:</b>

<p>Figure 7-5 – Visibility to Greenway Egress Point</p>	
<p>At the southern end of the Baltyboys section, the Valleymount Bridge will serve as a connection link between the Baltyboys and the Valleymount sections. The Baltyboys section of the greenway terminates at the R758. as per the proposed arrangement, there will be 2 accesses to the carpark, the existing one on the western side of the carpark for vehicles, and the proposed Greenway access further east on approach to the bridge.</p> <p>After passing the carpark entrance a driver travelling eastbound may not expect a second access connection to the road ahead. If insufficient forward visibility or warning signage is not provided to R758 users approaching the Greenway, this can lead to cyclist/vehicle collisions.</p>

<b>Recommendation:</b>	
<p>Provide appropriate visibility and warning signage for vehicles on the R758 to the Greenway access or combine the access points to provide a single point of access with adequate forward visibility in both directions.</p>

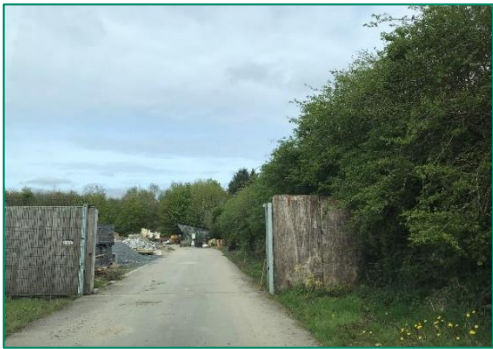
<b>7.2.6. Problem</b>	
<b>Location:</b>	Tulfarris Hotel & Golf Resort
<b>Drawing:</b>	60617025_SHT_DD_BLGWY_142.4 Tulfarris Sheet 4 of 4
<b>Summary:</b>	Crossing private lands
<b>Description:</b>

<p>Figure 7-6 - Maintenance Yard Entrance</p>	
<p>It is indicated that the proposed Greenway is to cross diagonally through the maintenance yard of the Tulfarris Hotel &amp; Golf Resort. It is unclear to the auditors how this arrangement will be formed. There is the potential for interaction with agricultural and maintenance vehicles through this yard which could lead to non-motorised user collisions.</p> <p>The connection between the offline section to the on-road section of the loop, will connect at the Tulfarris House Hotel, the offline section is proposed to cross the exciting maintenance vehicles access road, on chainage 2+400. As this road will be mainly used by maintenance vehicles the crossing at this point will be unexpected by drivers, which might cause cyclist collision.</p>

<b>Recommendation:</b>	
<p>Revise the route through this yard to minimise the crossing distance and provide defined access locations or relocate the Greenway route around the maintenance yard.</p>

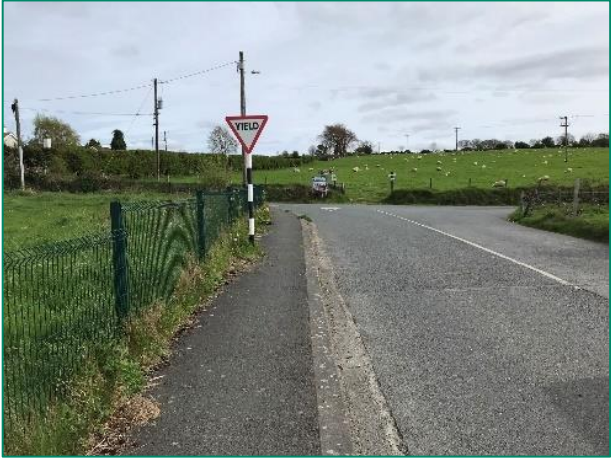
Figure 7-7 – Visibility to/from Blessington Bridge

Location:	Blessington Bridge	
Drawing:	60617025_SHT_DD_BLGWY_142 Lackan Sheet 9 of 9	
Summary:	Visibility between the proposed Greenway and Blessington Bridge	
<b>Description:</b>		
<p>The greenway travels offline close to the waters edge for most of the Lackan section, reconnecting with the public road network on the north-eastern side of Blessington Bridge via the Blessington Rowing Club Car Park. As the Greenway rises to connect to the public road, the visibility to and from the Greenway may be impaired by the existing fence line. This can result in vehicles not seeing emerging Greenway users and lead to cyclist/pedestrian collision.</p>		
<b>Recommendation:</b>		
<p>Appropriate signage and visibilities requirements should be provided at the Greenway access point to ensure safe egress onto the public road.</p>

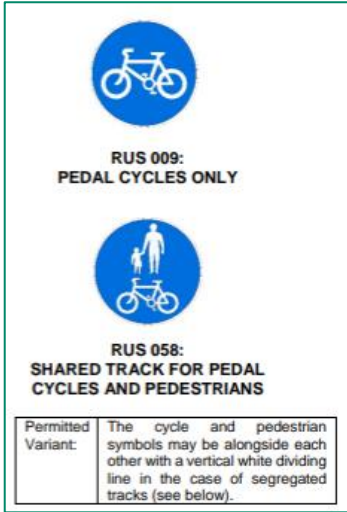
Figure 7-8 – Shared Use Signage

Location:	Scheme wide	
Drawings:	60617025_SHT_DD_BLGWY_142 series	
Summary:	Shared use Signage	
<b>Description:</b>		
<p>There is a lack of proposed signage indicated along the route and at the linkage connection points to indicate to either drivers, pedestrians, or cyclists the presence of the shared Greenway. The lack of the appropriate signage on the route will not inform the users of the shared area, which might cause confusion and lead to pedestrian and cyclist collisions.</p>		
<b>Recommendation:</b>		
<p>Provide appropriate shared use signage on all proposed linkages to existing facilities, to indicate the shared and segregated pedestrian and cycle facilities on approach to / from the Greenway.</p>

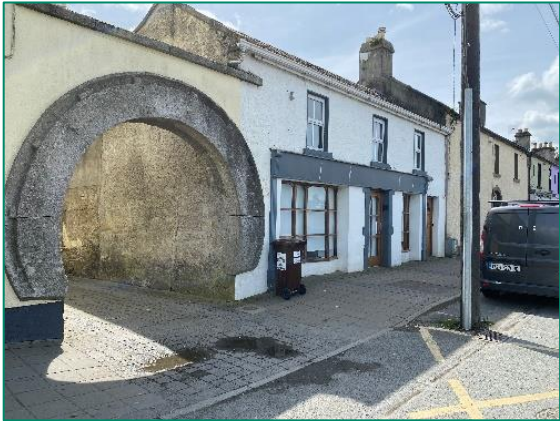
Figure 7-9 – Lack of Vehicular Access

<b>Location:</b>	Main Street	
<b>Drawing:</b>	60617025_SHT_DD_BLGWY_142-Blessington Sheet 2 of 11	
<b>Summary:</b>	Vehicular Access locations across footpath	
<b>Description:</b>		
<p>Along Main Street it is proposed to have a two-way cycle lane, on the eastern section of the road. On this section of road there is car parking provision and vehicular accesses crossing the existing footpath. The proposal does not show provisions to maintain these vehicular accesses. The lack of proper delineation of the vehicular entrance can lead to cyclists being unaware of the potential access manoeuvres into and from these access points, which can lead to cyclist/vehicle collisions.</p>		
<b>Recommendation:</b>		
<p>Ensure appropriate provision for all vehicular accesses across the cycle lane including kerbing and line markings.</p>

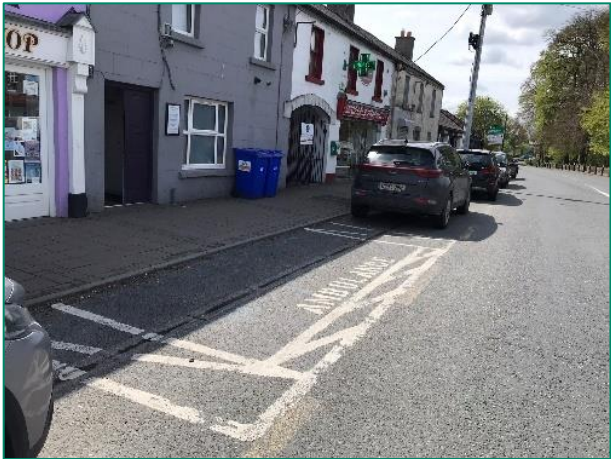
<b>Location:</b>	Main Street - Blessington Family GP Practice	
<b>Drawing:</b>	60617025_SHT_DD_BLGWY_142-Blessington Sheet 2 of 11	
<b>Summary:</b>	Removal of Ambulance Parking Space	
<b>Description:</b>		
<p>Along the Main Street it is proposed to have a two-way cycle way, on the eastern section of the road. Currently, there is a designated parking space for ambulances in front of the Family Practice GP and Doctors Clinic. The current proposal does not show any provisions to maintain this authorised parking space.</p>		
<p>The lack of proper delineation of the parking area for the ambulance will lead to an ambulance stopping in the cycle lane or on the carriageway which could cause confusion to cyclists who will be unaware of the possibility of a vehicle pulling into the cycle lane or ambulance users crossing the cycle lane at this location, which may lead to cyclist collision.</p>

<b>Recommendation:</b>		
<p>Provide appropriate parking provision for the ambulance parking bay.</p>

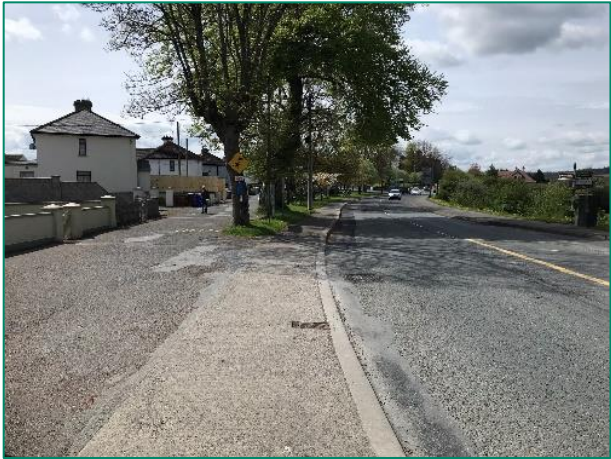
Figure 7-11 – High Vehicle Speeds into Shared Use Area

<b>Location:</b>	Rockypool Villas	
<b>Drawing:</b>	60617025_SHT_DD_BLGWY_142-Blessington Sheet 2 of 11	
<b>Summary:</b>	Shared space between vehicles and cyclist	
<b>Description:</b>		
<p>The scheme is proposed to tie the Rockypool Villas with the Troopersfield Road via a shared space between pedestrians, cyclists and vehicles. While at the connection with Troopersfield Road a raised table is proposed, at the northern end of the Rockypool Villas road there is no additional proposal for provision of any vehicle speed reduction measures. It is unclear for the auditor how the lower speeds will be maintained in this shared area.</p>		
<b>Recommendation:</b>		
Provide speed reduction measures at the accesses to Rockypool Villas.

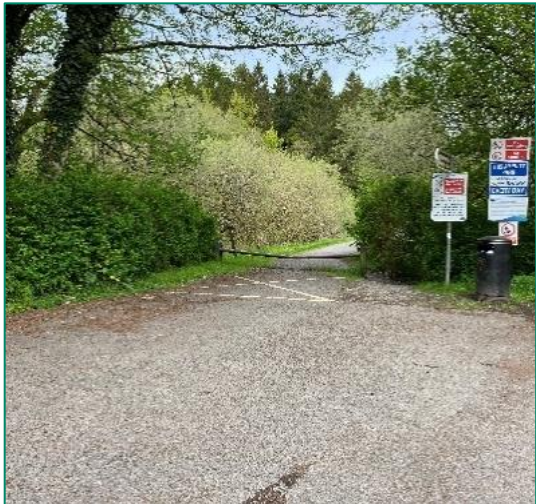
Figure 7-14 – Barrier Restricts Access

<b>Location:</b>	Russelstown Carpark	
<b>Drawing:</b>	60617025_SHT_DD_BLGWY_142-Blessington Sheet 10 of 11	
<b>Summary:</b>	Vehicular Barriers restrict cyclists	
<b>Description:</b>

The existing barrier should be replaced with an alternate access control which will enable access for cyclist and pedestrians and restrict the vehicular access.

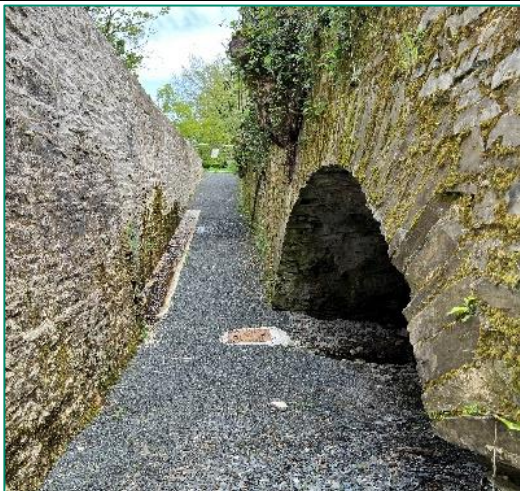
<b>Location:</b>	N81 – Connection with Russborough House & Park	
<b>Drawing:</b>	60617025_SHT_DD_BLGWY_142-Blessington Sheet 11 of 11	
<b>Summary:</b>	Restricted Headroom at tunnel	
<b>Description:</b>

<p>The proposed greenway is to link into the Russborough House estate via a tunnel below the N81. This tunnel has a restricted headroom, which will restrict the cyclist using this crossing. This may lead to cyclists attempting to cross the N81 at unsafe locations where vehicles do not expect NMUs crossing the road, which could lead to cycle/vehicle collisions.</p>
<p><b>Recommendation:</b></p>
<p>Appropriate provision of the clear headroom space should be provided, or appropriate signage provided to direct Greenway users to alternate crossing locations or restrictions.</p>

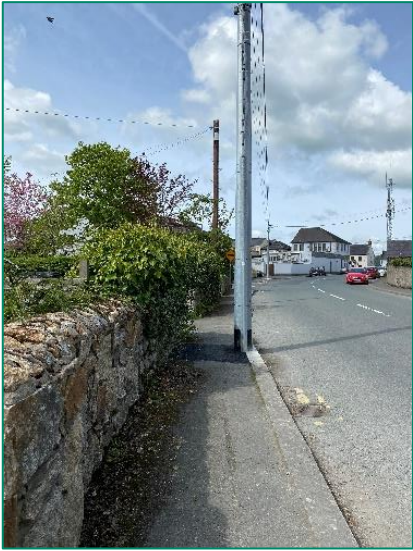
<p><b>7.6.1. Problem</b></p>	
<p><b>Location:</b> Kilbride Road</p>

<p><b>Drawing:</b> 60617025_SHT_DD_BLGWY_142-Blessington Sheet 2 of 11</p>	
<p><b>Summary:</b> Street lighting pole restricts footpath width</p>	
<p><b>Description:</b></p> <p>On the existing footpath on the Kilbride Road, a street lighting/electricity pole is located on the footpath at the edge of the carriageway. This pole further restricts the usable width of the narrow footpath. The obstruction of the footpath will present a difficulty for some users. This may lead to Greenway user entering onto the carriageway, which can lead to pedestrian/vehicle collisions.</p>	
<p><b>Recommendation:</b></p> <p>Appropriate footpath width should be provided to accommodate all shared footpath users.</p>
