Bat Derogation

Licence Application

Licence No.: DER/BAT 2021 – 07

**An Assessment of the Proposed Flood Relief Scheme
At Ferrybank, Arklow, County Wicklow
And Potential Impacts of The Proposal on the Bat Fauna**

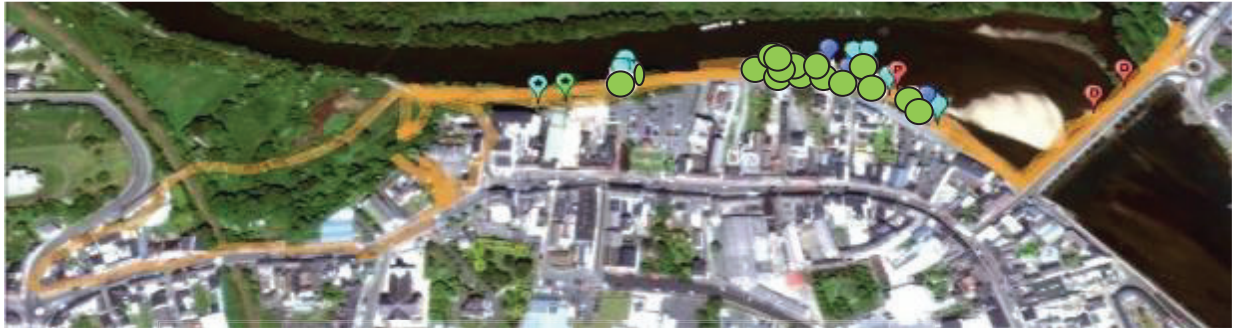
Bat activity along the River on October 17th, 2016

Green circles = common pipistrelles Blue paddle = soprano pipistrelle
Purple paddle = pipistrelles and Daubenton's
"D" = Daubenton's P = 2 pipistrelle species * indicates pre-dawn bat signals

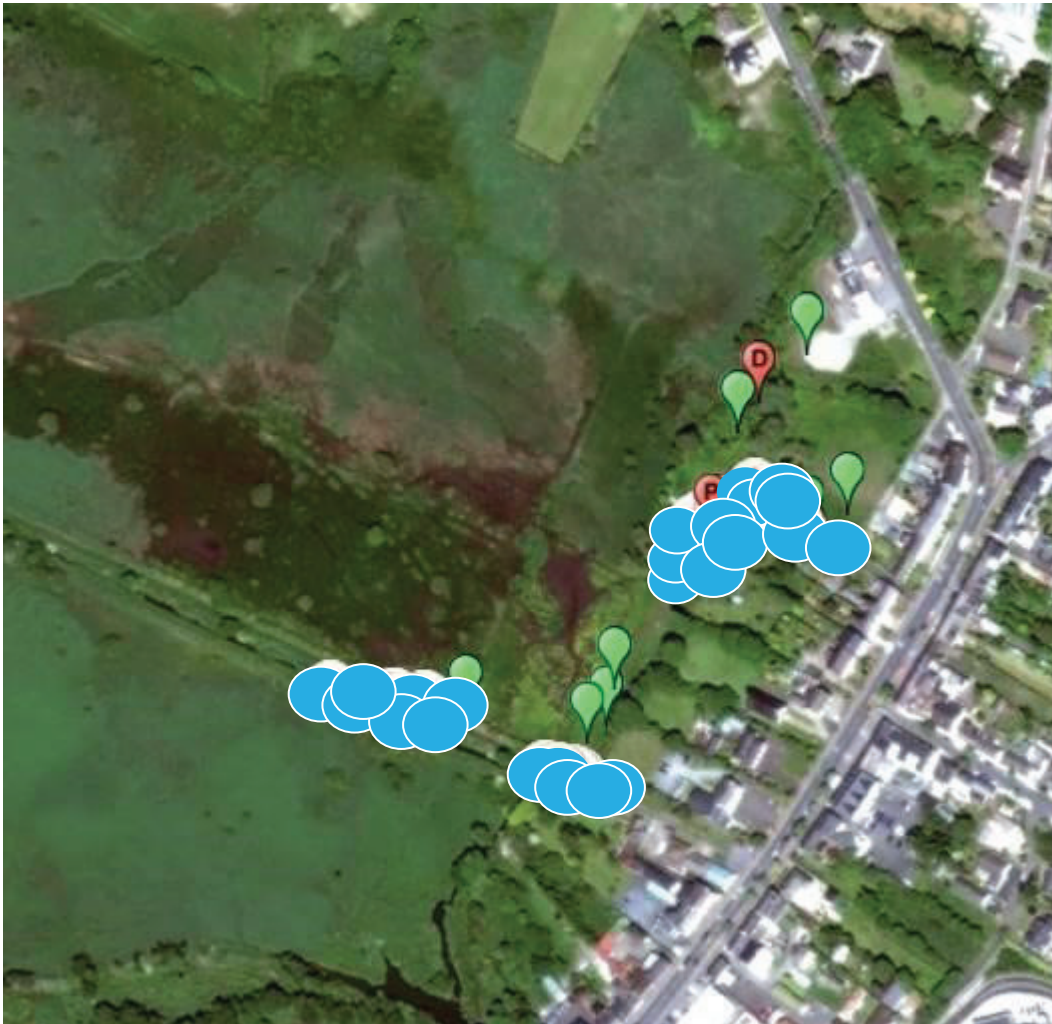
Bat activity around the proposed FRS site October 19th, 2016

The majority of signals are shown as blue circles and represent soprano pipistrelles
Green paddle = Common pipistrelle "D" = Daubenton's P = 2 pipistrelle species at the same time

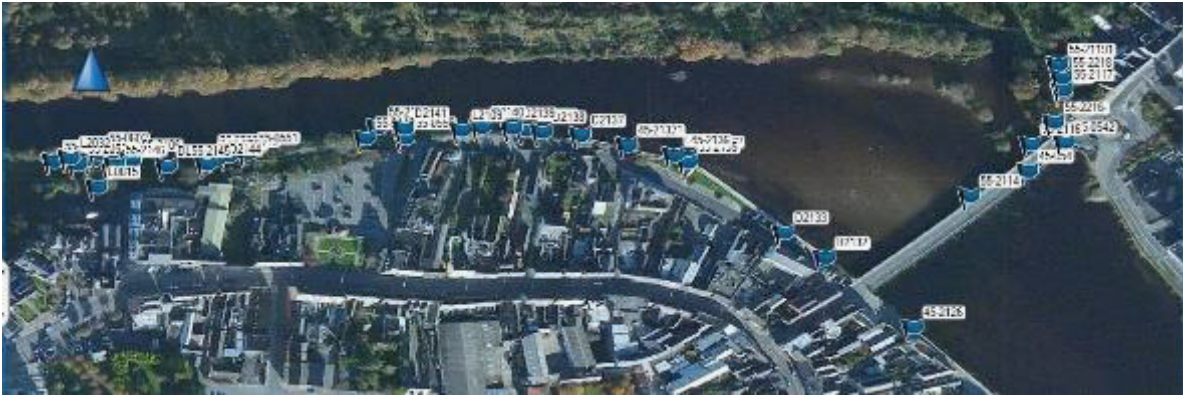
Bat activity along the River on October 17th, 2016

Each flag denotes a recording for an individual bat at the time indicated by the last four-digit number

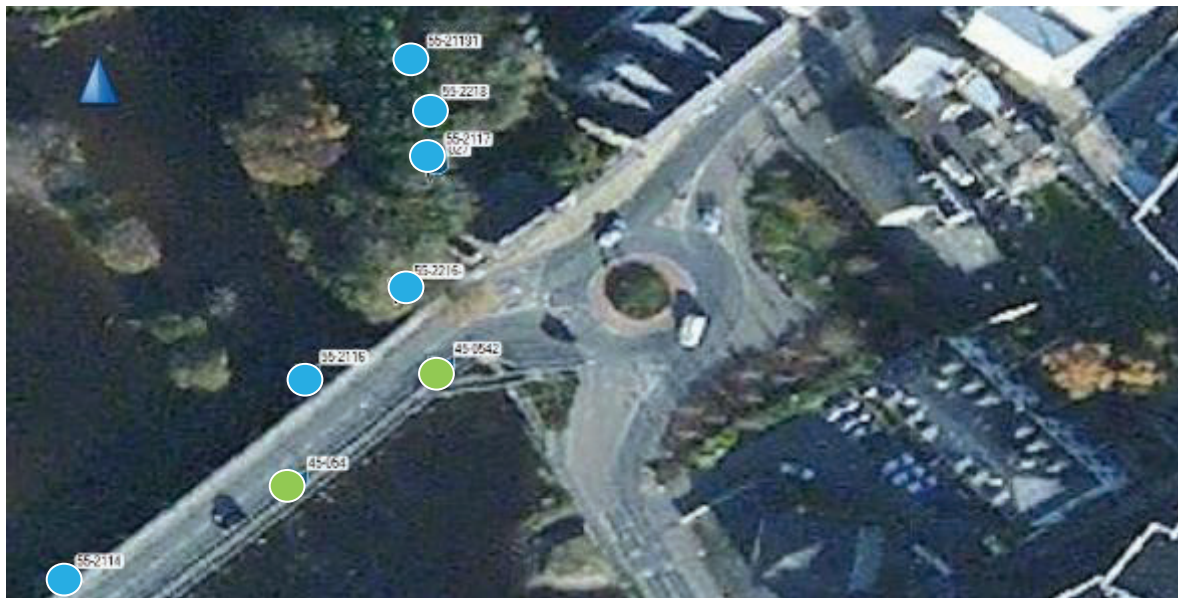
Bat activity in August 2017 at Ferrybank

Blue circle = Soprano pipistrelle Green circle=Common pipistrelle

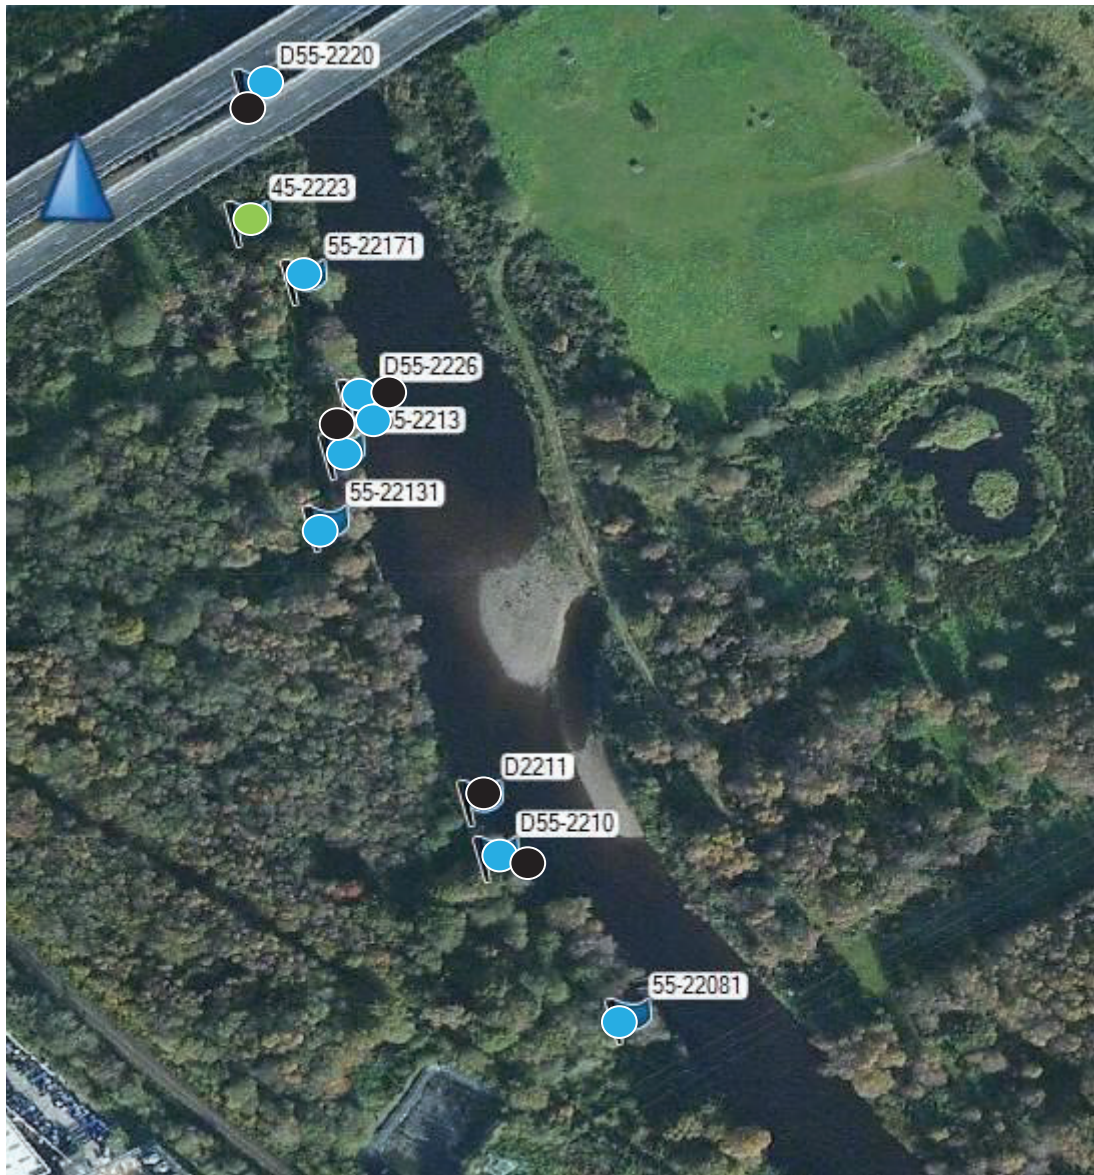
Bat activity close to the M11 bridge in August 2017

Blue circle = Soprano pipistrelle Green circle=Common pipistrelle

Black circle = Daubenton's bat

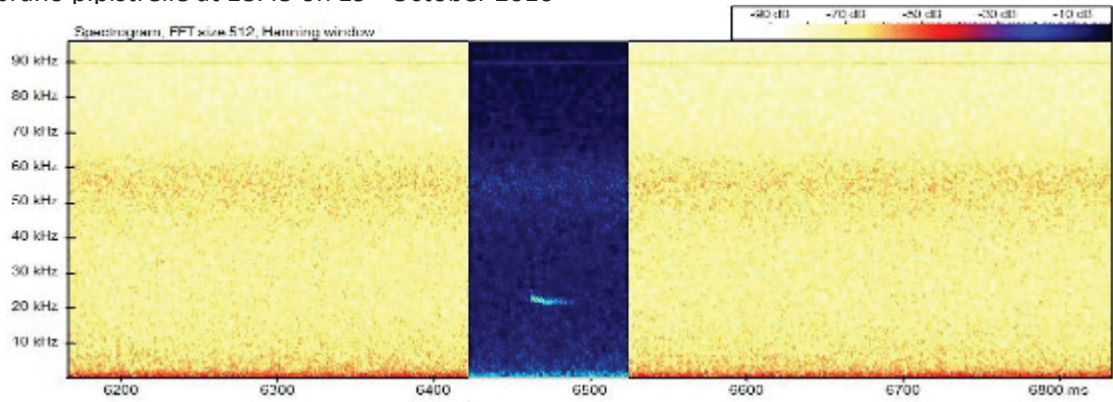
Leisler's bat signal

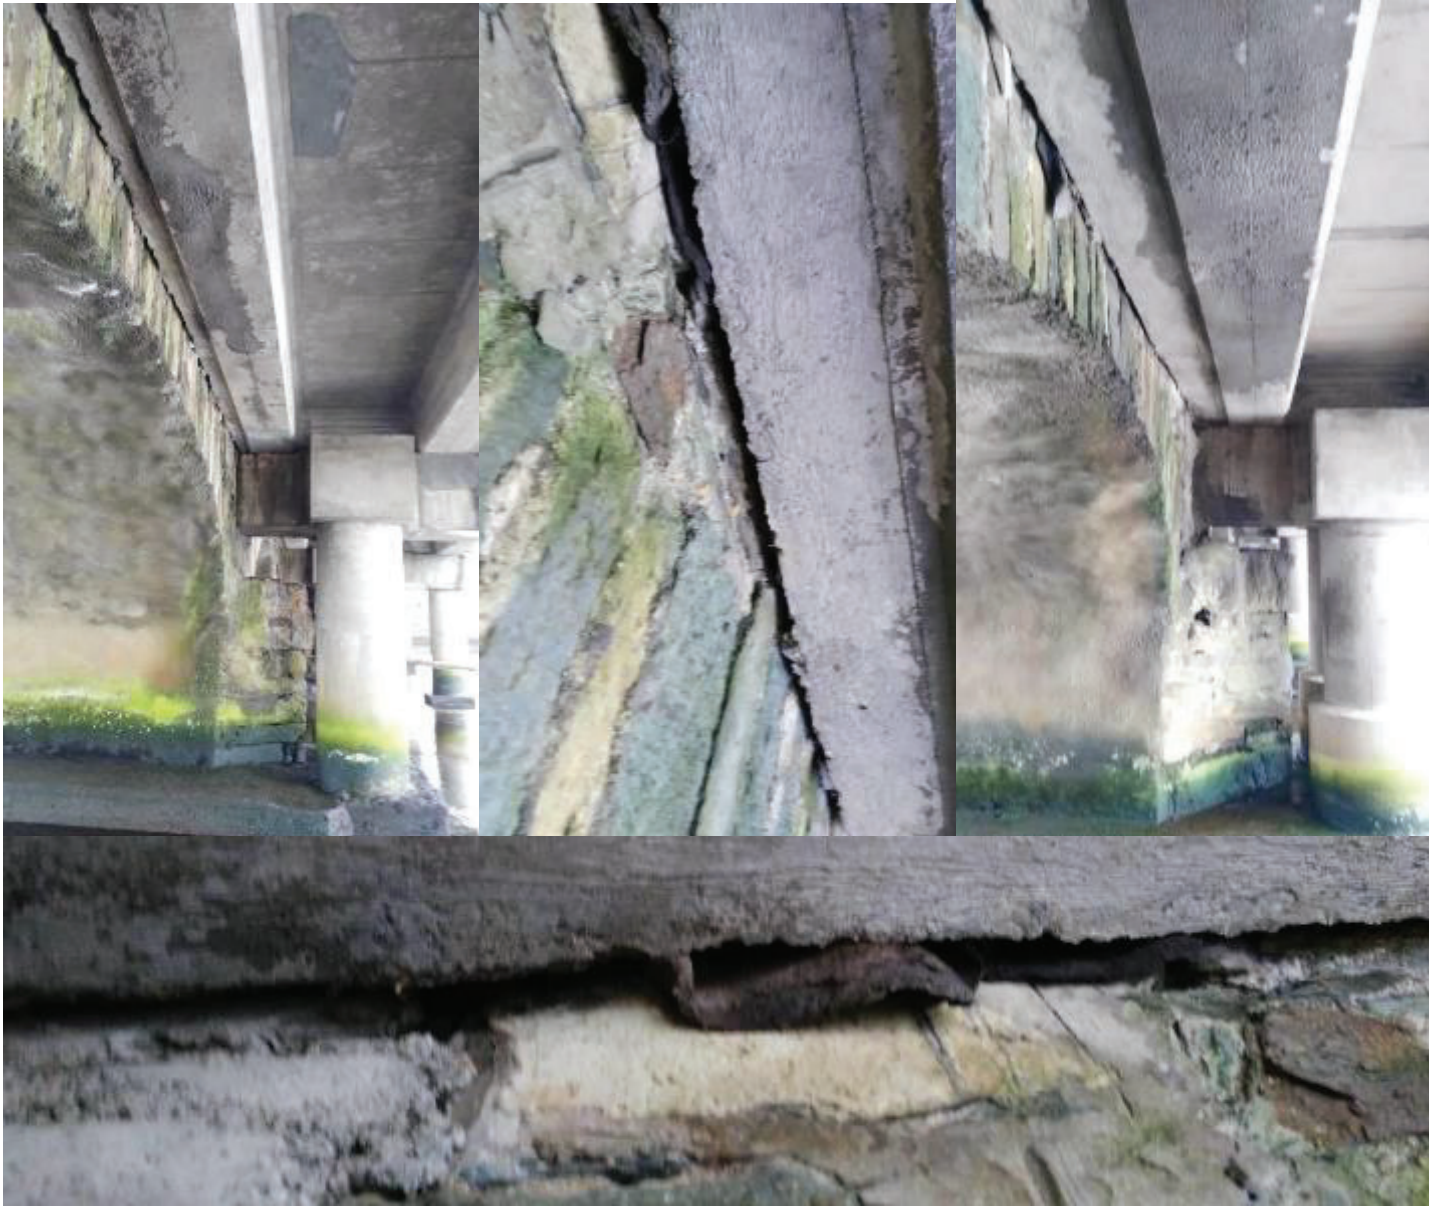
Bridge crevices under which bat droppings indicate use of the bridge by roosting bats T2530673188

Bat droppings under the upriver concrete expansion joints of the bridge are considered to be Daubenton's bats. No bats were seen to exit or emerge from the bridge on 21st August 2017. Bat activity around the bridge included Daubenton's bat feeding and commuting, soprano pipistrelle, common pipistrelle, and Leisler's bat while there was also Leisler's bat activity over the river.

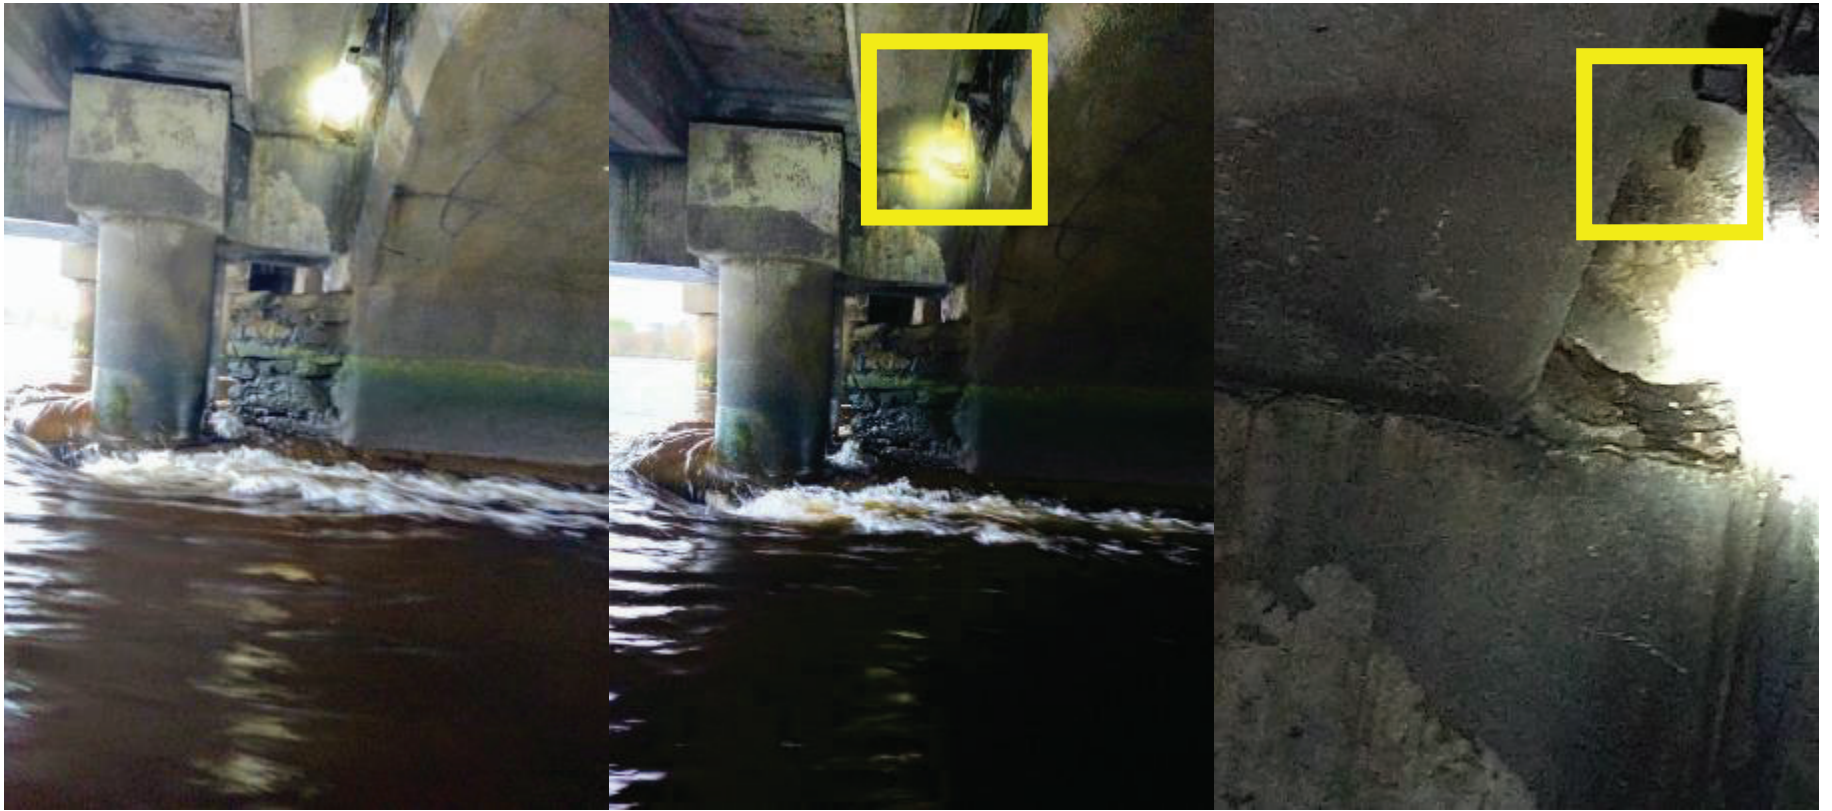
Daubenton's bat on the southernmost arch of Arklow Bridge November 17th, 2020

One Daubenton's bat was noted resting on the wing wall of the older bridge section at the most southern arch of the bridge (closest to the town centre) close to the bridge expansion (western side of bridge) on November 17th, 2020. This bat was not seen to become active as it was not visible from the riverbank but signals on both detectors indicate that a Daubenton's bat flew past at approximately 10.20 hours. There was evidence gathered in August 2017 that bats were availing of crevices in the upriver side of the bridge (west) to roost at the southern end of the bridge. This was in the form of clusters and individual droppings below the crevices. The northern end offers very suitable roosting conditions, but no bat signs or bats were present within this section either in 2017 or 2020.

Bats are using Arklow bridge as a roost site (western side of the southern end of the bridge). This is likely to be most often individuals roosting rather than a maternity roost and it is a transitional roost. On 17th November 2020, a single Daubenton's bat was noted roosting on the bridge.

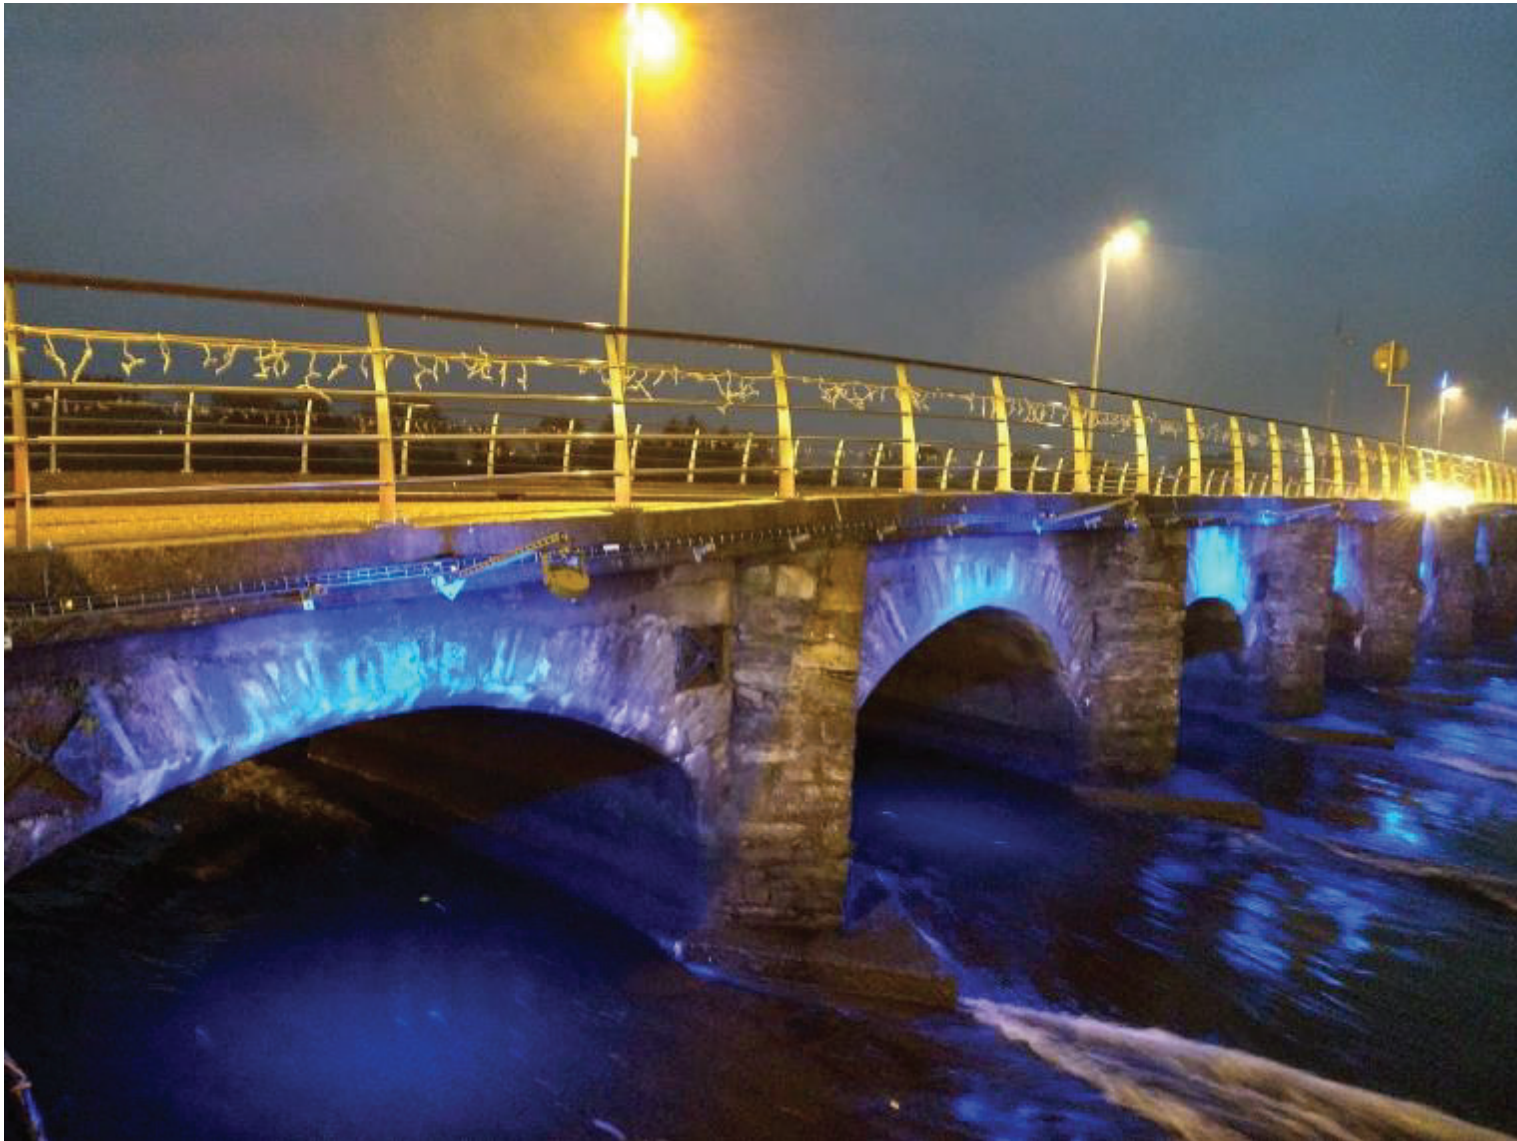
Existing lighting of the bridge. Most illumination is to the east while bats roost to the west. Nonetheless, lighting has increased considerably since 2017

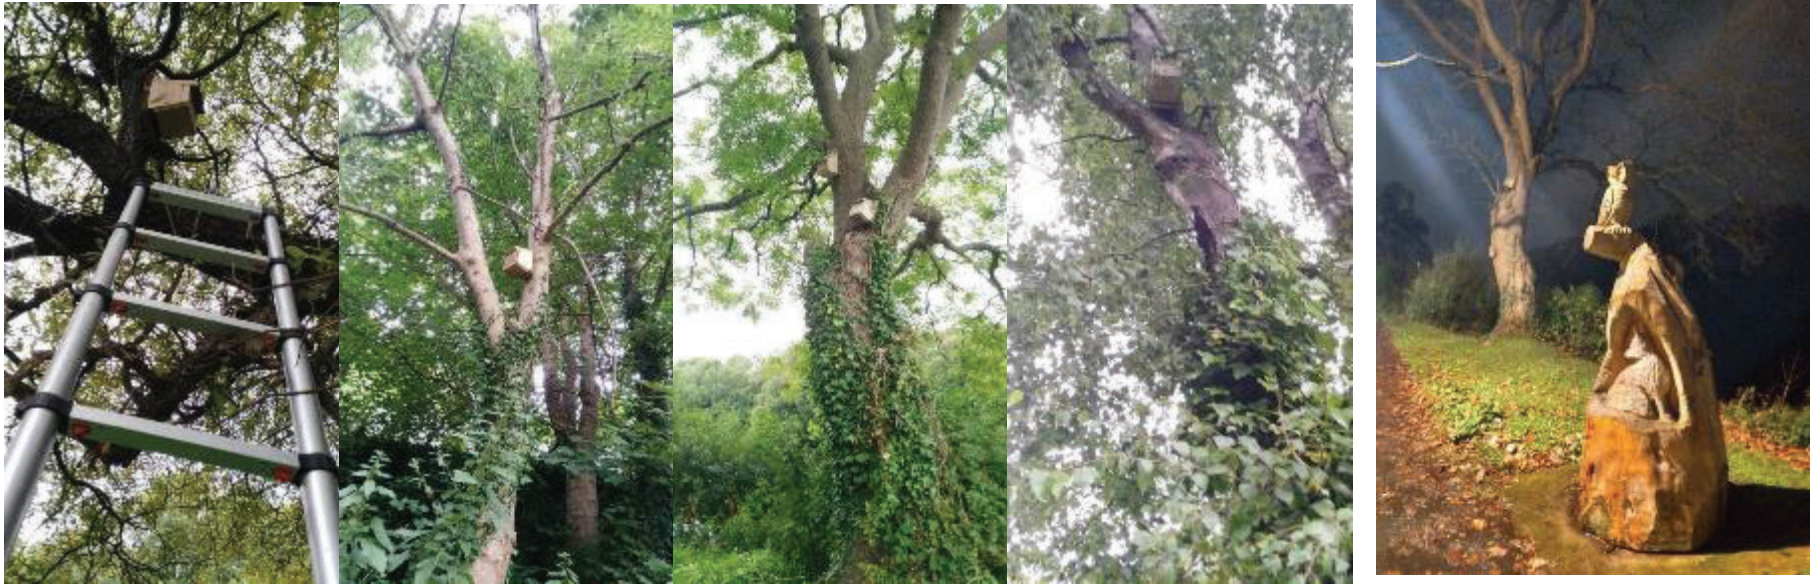
Bat boxes examined along the Avoca River in 2017

None of these bat boxes were used by bats. The tree on the right was photographed in 2020 with a greater level of lighting evident.

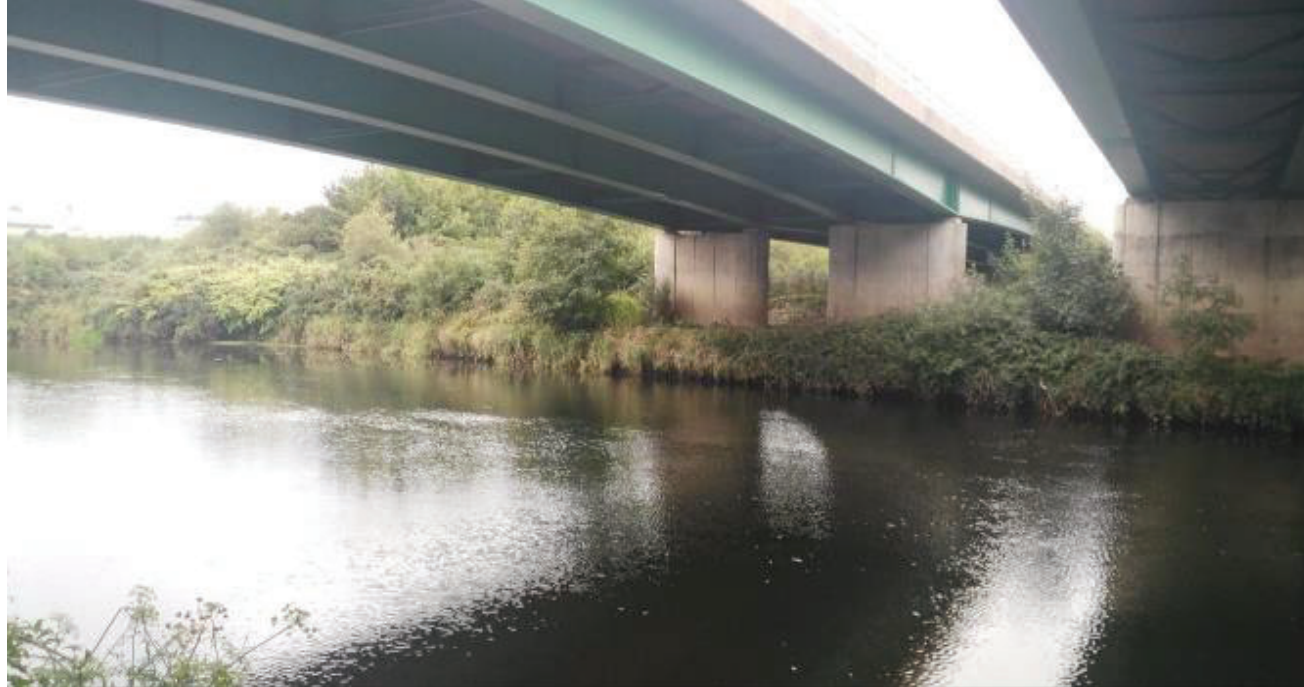
Habitat towards the M11 Bridge.

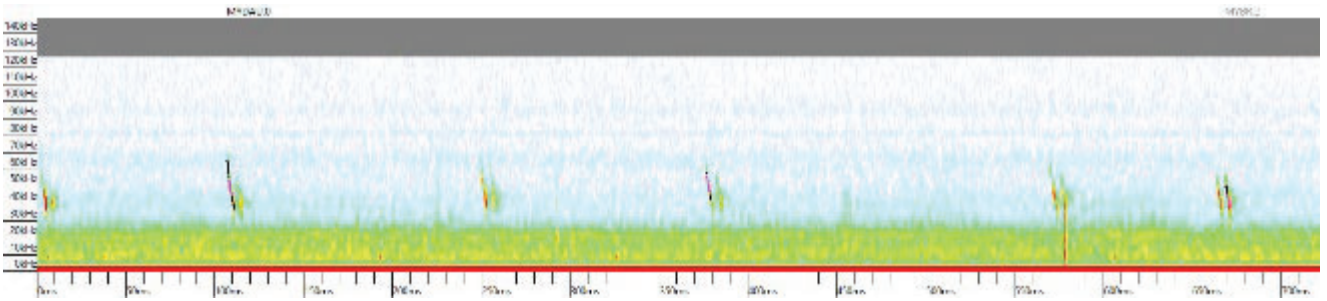
Daubenton's bat at 18.20 hours at the bridge recording on Songmeter Mini (downriver of roost site) 17th November 2020

There was only a single sequence of signals from 16.25 to 18.30 hours
