Redford Park Protected Signalised Junction  
Stage 1 Road Safety Audit

Wicklow County Council

January 2022

## Stage 1 Road Safety Audit

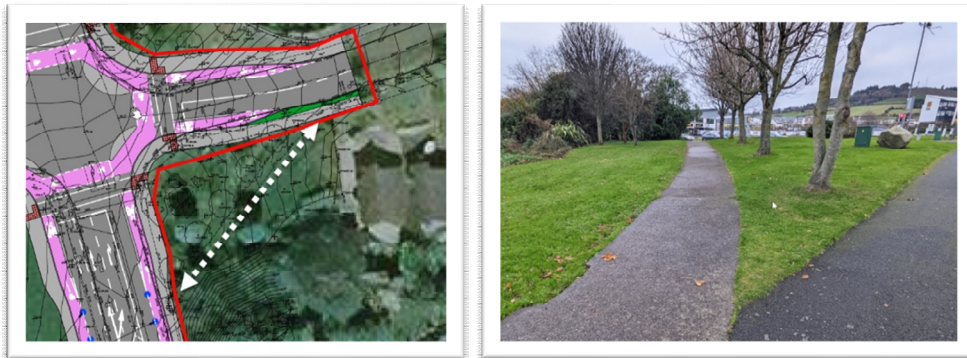
Figure 2.1 – Existing Section of Footpath in Southeast Section of Junction

**Location:** South-East Section of Junction

Failing to incorporate the existing section of footpath could result in slips and trips for pedestrians who will (habitually) continue to walk along the established pedestrian desire line.

The existing section of footpath should be incorporated into the junction improvement proposals.

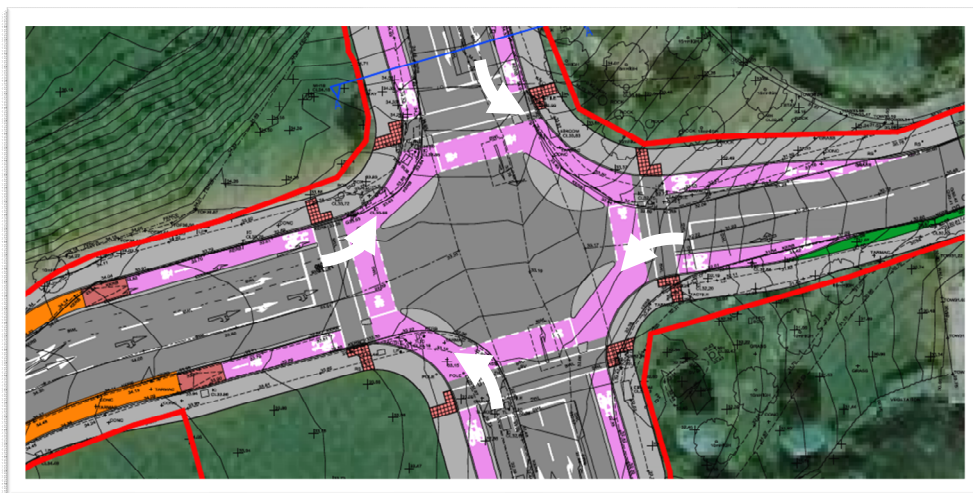
Figure 2.2 – Possible Vehicle Trajectory through 'Cycle Only' Areas

**Location:** Behind Protective Islands

Errant drivers may enter 'cycle only' areas, placing cyclists at risk of conflict with general traffic.

The potential for vehicle entry to these locations should be physically restricted.

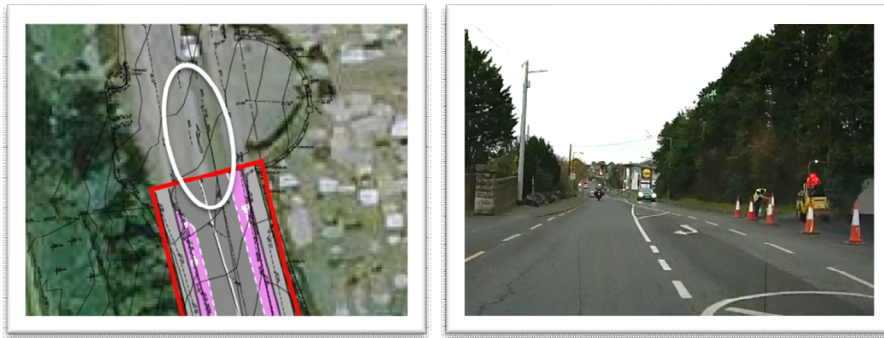
Figure 2.3 – Existing Right Turn Lane Serving Cemetery

**Location:** Existing Right Turn Lane Serving Redford Cemetery

The proximity of the northern scheme tie-in could result in there being insufficient cross section to incorporate the existing lane configuration which includes a northbound lane, right turning lane and southbound lane. This could result in side swipe and opposition type conflicts.

The following options are proposed to mitigate the risk described:

1. Remove the right turn lane and utilise the space it occupied to maintain two opposing traffic lanes, improved footpath widths and continuous cycle lanes on approach to the junction.
2. Maintain the right turn lane and move the northern scheme tie-in south to the commencement of the central hatched area serving the existing cemetery right turn lane.

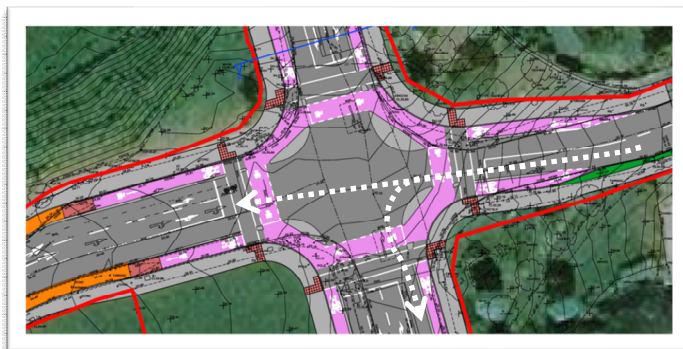
Figure 2.4 – Alignment of Westbound Approach for Straight Ahead & Left Turn Movements

**Location:** Redford Park – Westbound Approach

The right hand horizontal curve on the immediate westbound approach to the junction:

1. Directs drivers into the opposing traffic lane on the eastbound approach arm.
2. Makes the left turn onto the R761 more challenging for drivers to negotiate.

A swept path analysis should be undertaken on the movements described, with a view to improving the approach alignment of the Redford Park westbound approach if required.
