# Road Safety Audit, Stage 1/2

53No Unit Residential Development, Rockbrae House, Bray, Co Wicklow

Project No: P3852

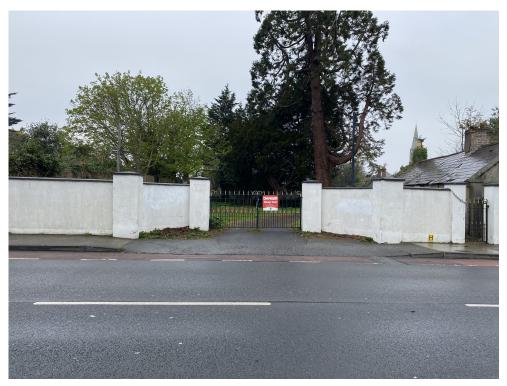
There is a risk of vehicles using the existing dropped kerb arrangement (Photo 1) at the proposed pedestrian access location and coming into conflict with cyclist or pedestrians.

It is recommended that the dropped kerb provision at the existing entrance is reduced so to prevent vehicle access. Consideration should also be giving to providing a staggered pedestrian guardrail to prevent vehicles using the pedestrian access route.

| Paragraph<br>No. In Safety<br>Audit Report | Problem accepted (yes/no) | Recommended<br>measure<br>accepted<br>(yes/no) | Alternative measures (describe) | Alternative<br>measure<br>accepted by<br>Safety Auditor<br>(yes/no) |
|--|---|--|---|---|
| 2.2 | Yes | No | Existing dropped kerb to be removed completely and replaced with upstand kerb as the existing entrance will only be used by pedestrians. Landscape and hardscape to be reviewed at detailed design stage for visibility of entrance, to ensure vehicles don't attempt to use the wide pedestrian access. | |

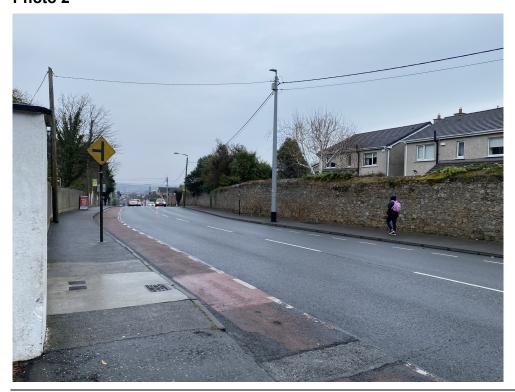
Photo 2

Existing advanced warning clashes with proposed access junction (Photo 2) and not shown on the drawings as being relocated. There is a risk of the advanced warning sign being moved to an inappropriate location during the construction phase.

It is recommended that the advanced warning sign is relocated and the appropriate location shown on the tender drawings.

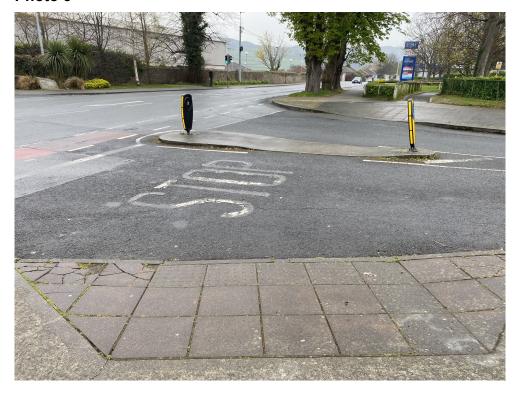
- At the crossroads of Charnwood and Sans Souci Wood with Vevay Road, the pedestrian crossing provisions are substandard, with insufficient tactile provision in some locations (Photos 3 and 4), no tactile paving in other locations (Photos 5 and 6) and uneven surfacing (Photo 7).
- Surface of existing cycleway in poor condition (Photo 8)
