Arklow Bridge (NIAH

16322046) Site

Investigations 2019

Licence No. 17E0482

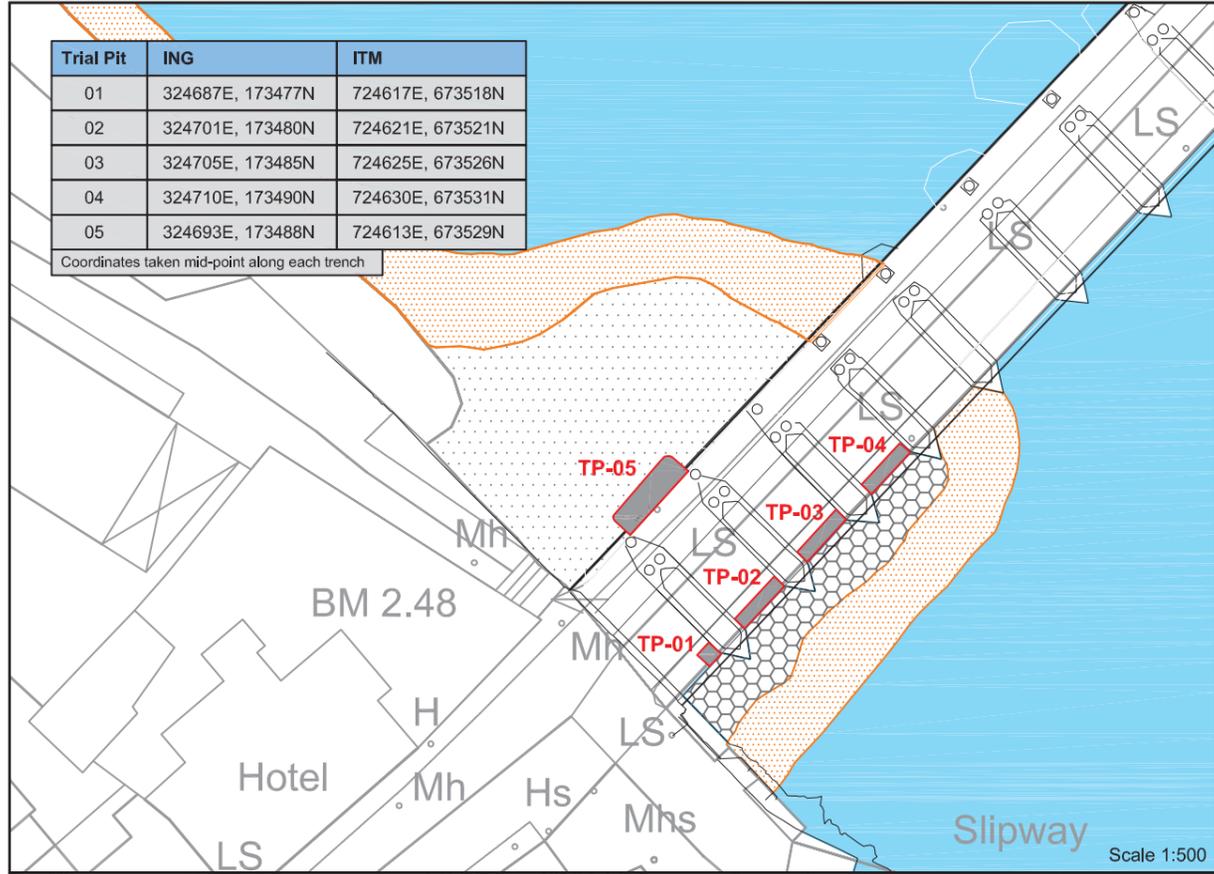
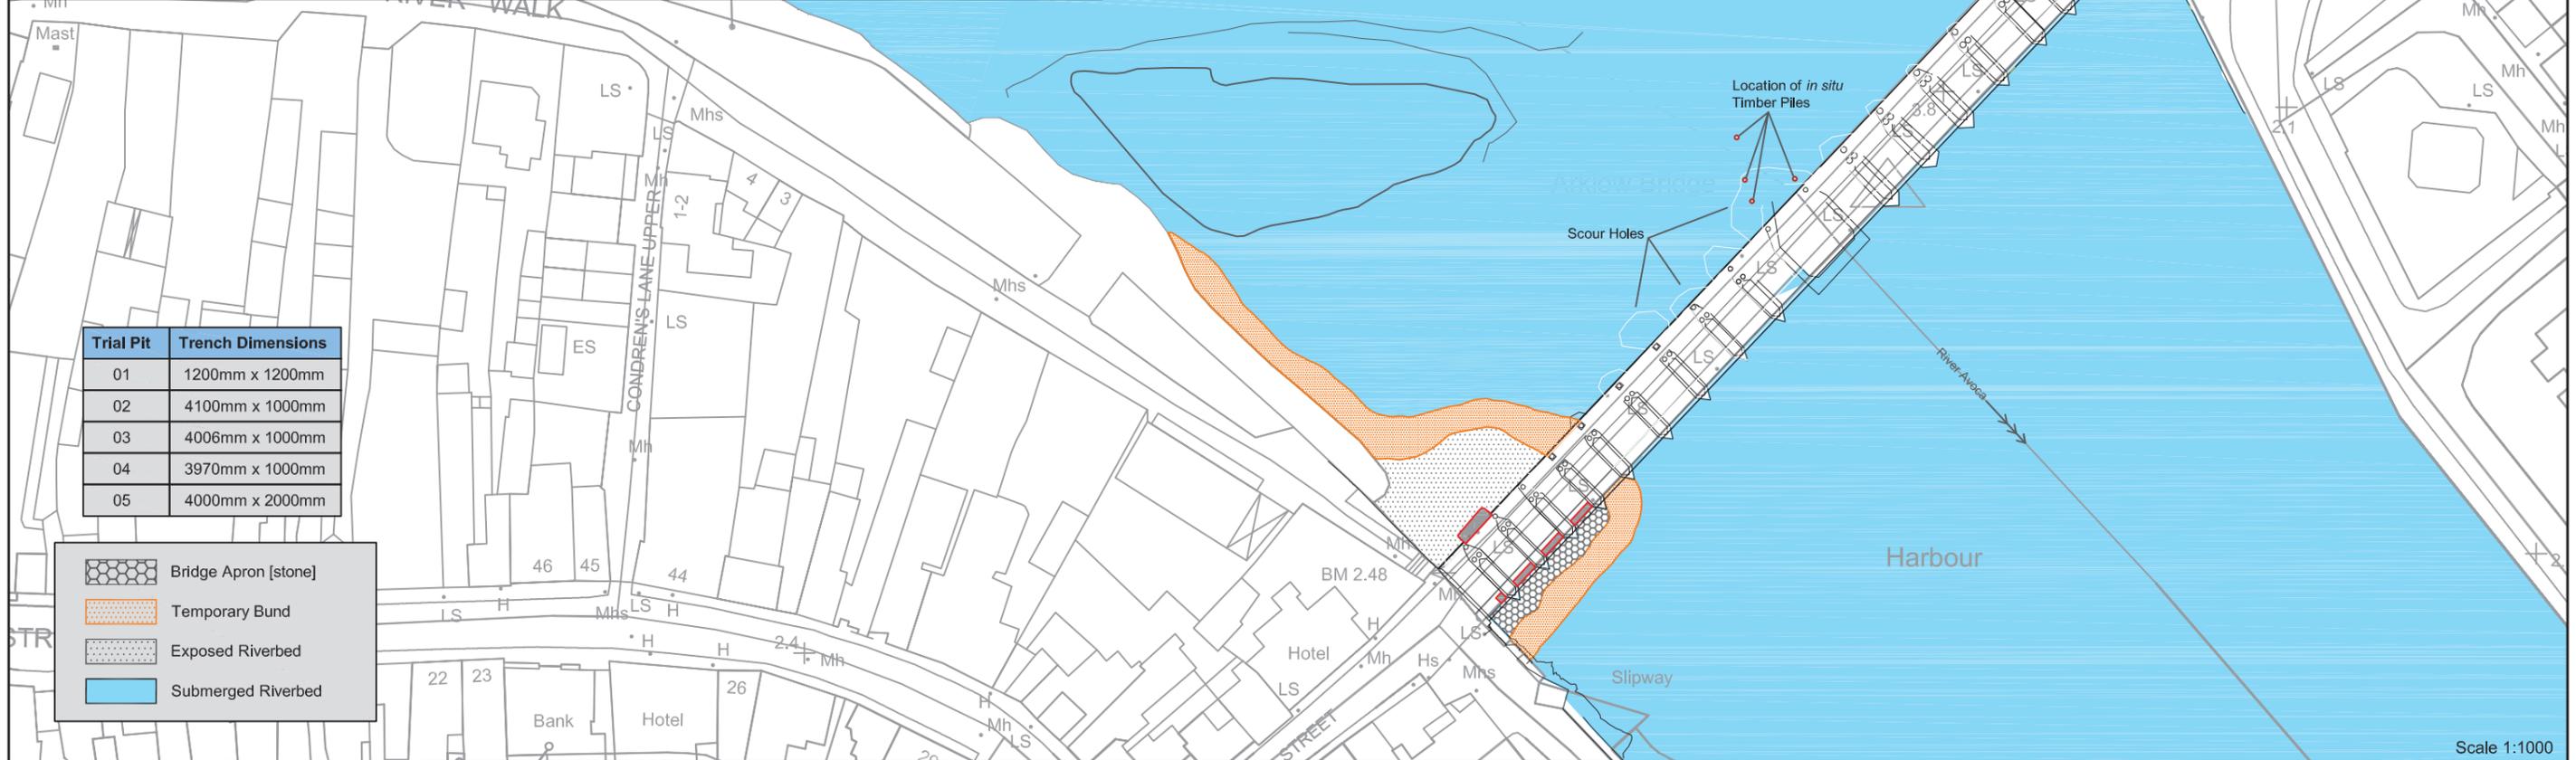
Title
Figure 4- Location of Geotechnical Trial Pits along footings/ foundations of Arklow Bridge.

Trial Pit	ING	ITM
01	324687E, 173477N	724617E, 673518N
02	324701E, 173480N	724621E, 673521N
03	324705E, 173485N	724625E, 673526N
04	324710E, 173490N	724630E, 673531N
05	324693E, 173488N	724613E, 673529N

Trial Pit	Trench Dimensions
01	1200mm x 1200mm
02	4100mm x 1000mm
03	4006mm x 1000mm
04	3970mm x 1000mm
05	4000mm x 2000mm

The SI works required the construction of a river bund, extending upstream and downstream of the bridge at its western end (Figure 4). The bund was created using the river shingle that accumulates naturally upstream of the bridge and forms a shingle bar (Plates 4–7). The shingle was machine-excavated at Low Water and transported to the west bank from where it was spread along the edge of the active channel to form an access road. The shingle was then stock-piled upstream of the bridge before being spread out to create the bund. Bridge Arch 2 is somewhat higher than its neighbouring arches, and this permitted a smaller wheeled excavator to transport the shingle across the bridge apron between the piers and to place it along the toe of the bridge apron that is on the downstream side of the bridge, forming the bund on that side. The bund created a working environment at Low Water. This proved suitable except at Neap Tides, when Low Water tended to be too high.

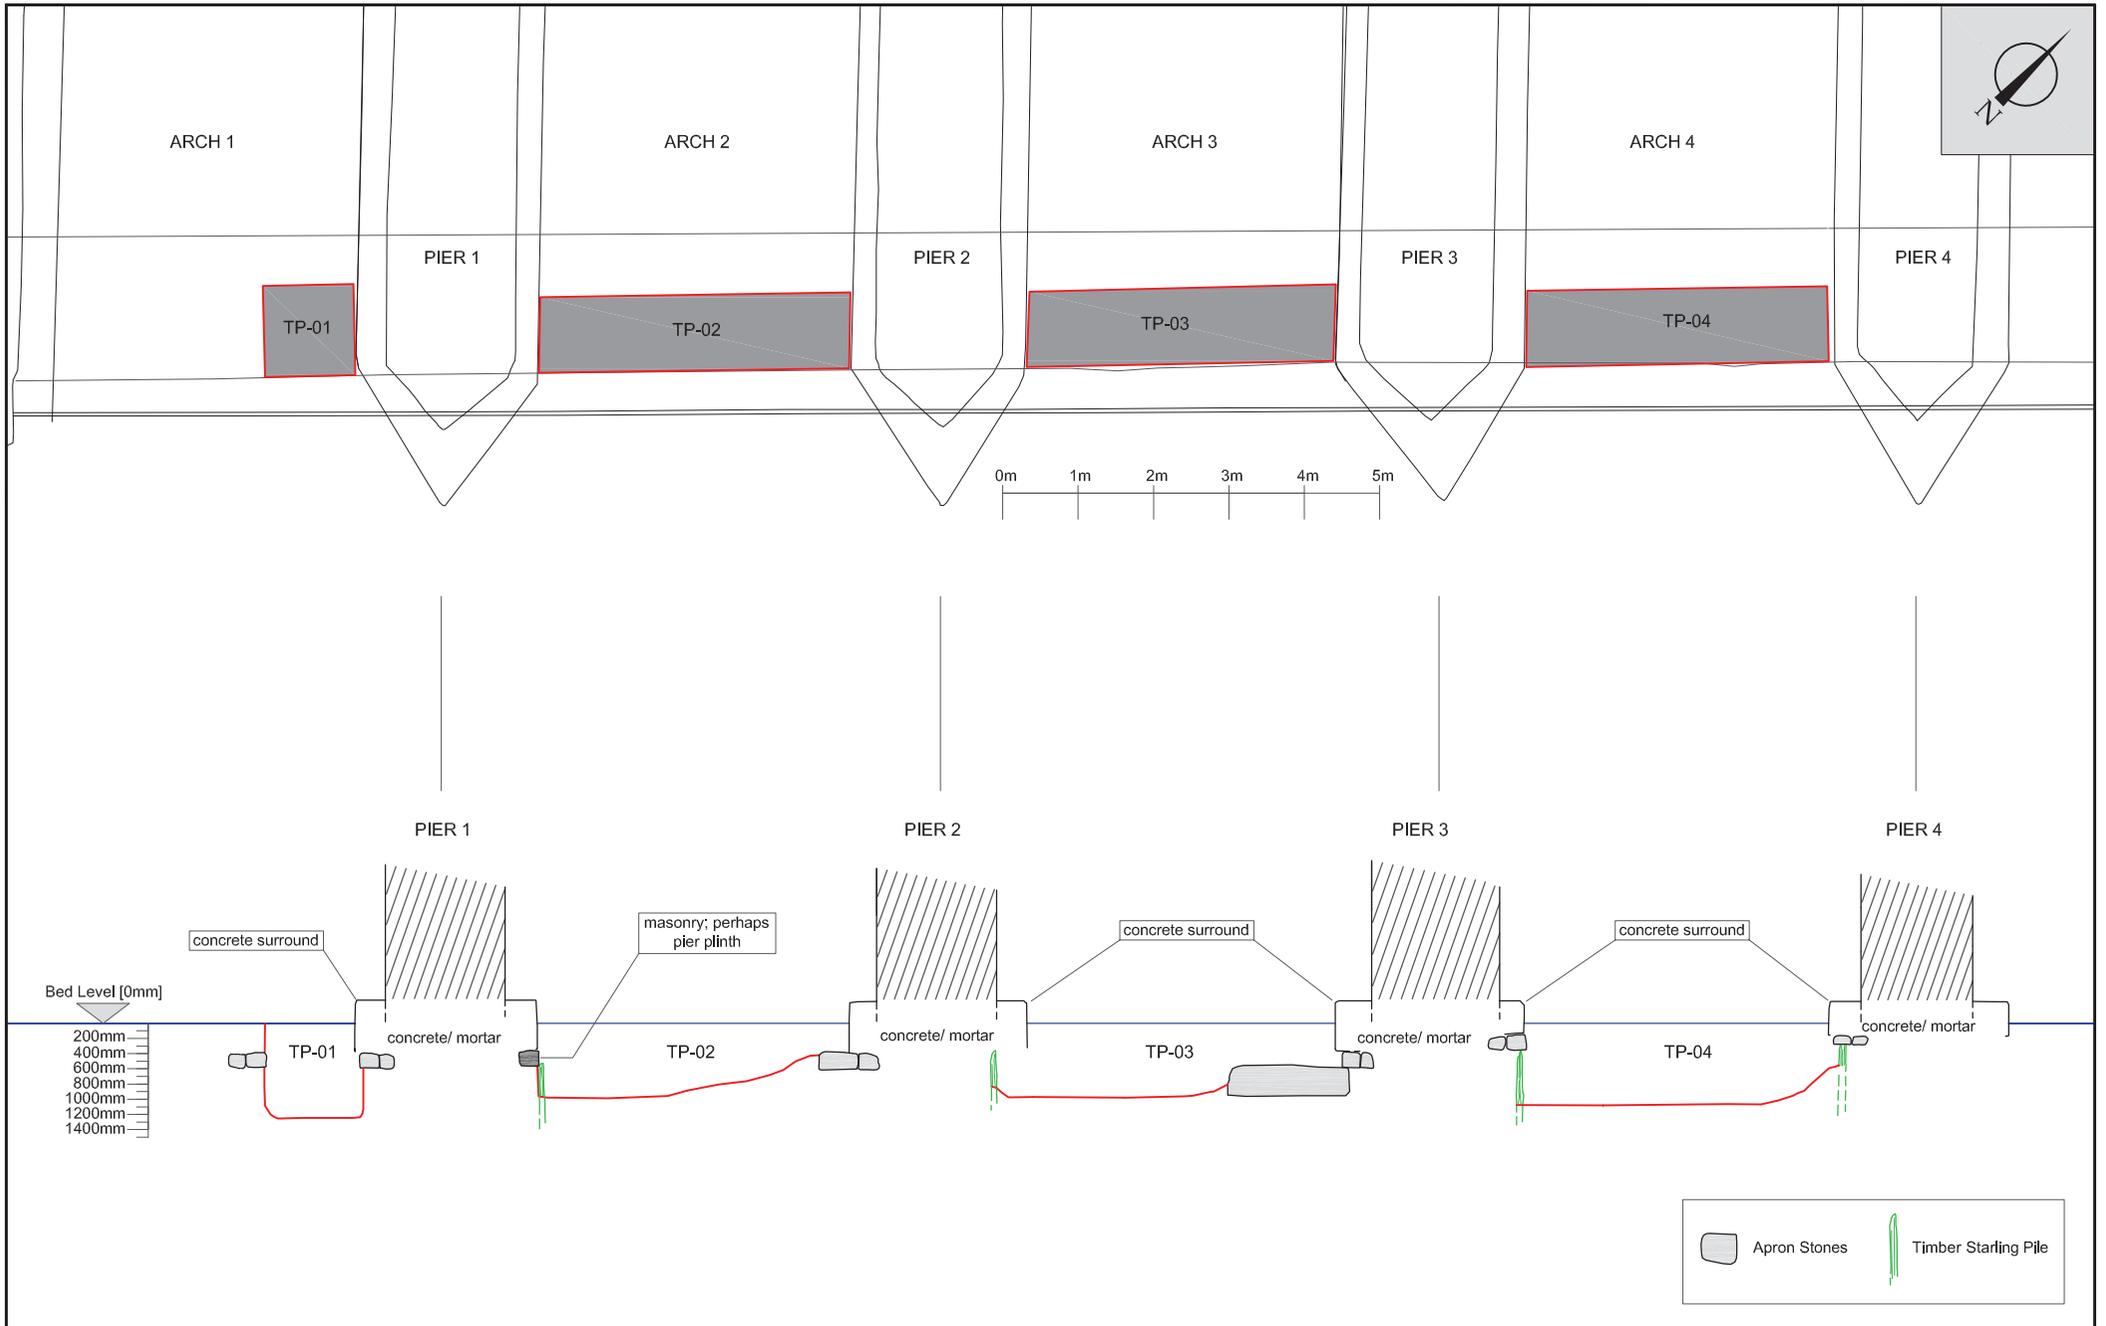
Title
 Figure 2- Schematic drawing showing Trial Pits TP1-TP4 in Plan and Elevation.

Notes
 Source: ADCO onsite survey
 Note: levels shown are relative to Bed Level

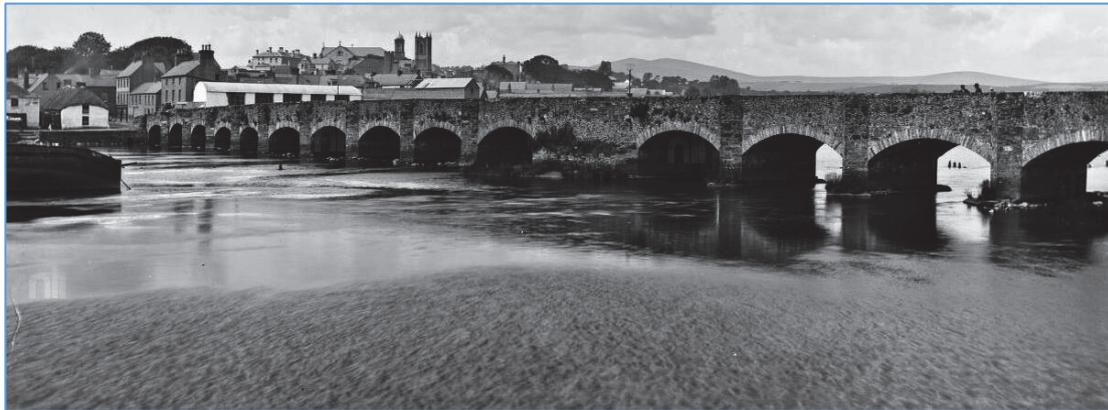
Plate 1: Arklow Bridge, photographed by Robert French (1841-1917), part of the Lawrence Photograph Collection, NLI, accessed www.catalogue.nli.ie

An historic photograph of the bridge attributed to Robert French (1841–1917) and taken from the east bank downstream of the bridge shows a series of four wooden upright features through one arch upstream of the bridge and a further series of two uprights through another arch (Plates

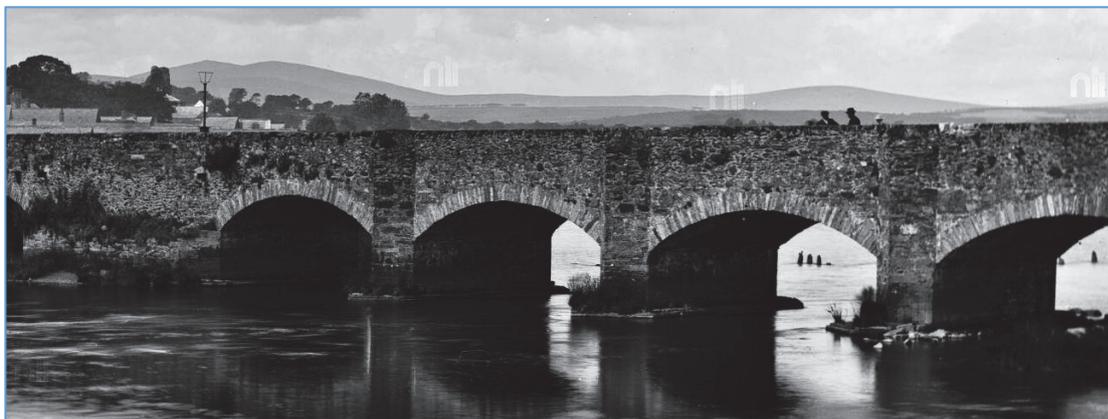
Plate 2: Arklow Bridge, photographed by Robert French (1841-1917), detail of showing timber posts lying upstream of the bridge on its east side.

1–2). It is reasonable to deduce that these are the same timbers visible below the waterline today.

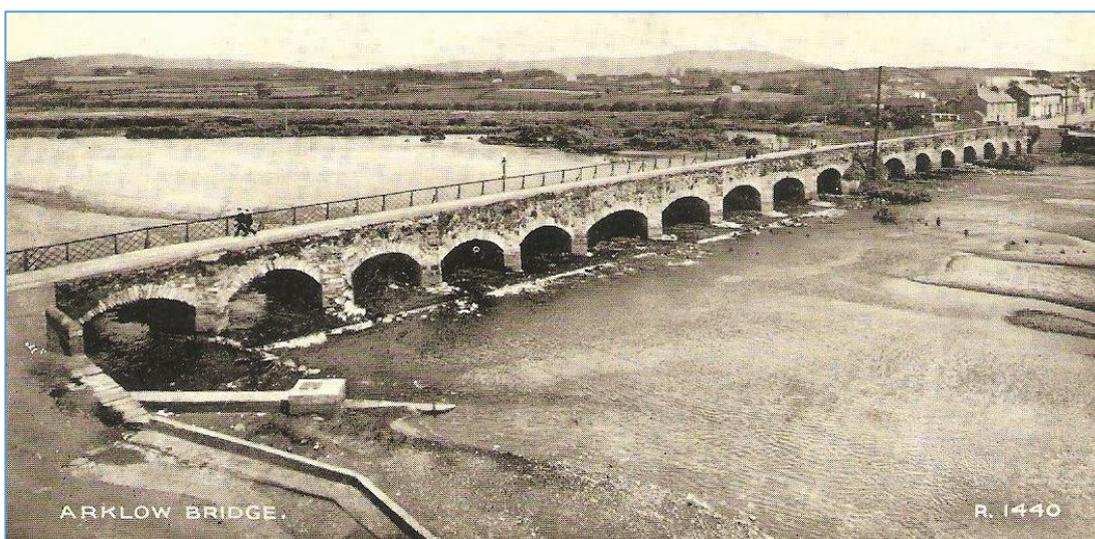
Plate 3: Historic photograph of Arklow Bridge taken from the west bank. Date unknown, Collection unknown. Source: ARUP.

The photograph taken by French appears to have been taken at High Water, insofar as the waterline is almost level with the tops of the bridge piers. Another historic photograph that appears to be of more recent date is taken from the west bank downstream of the bridge (Plate 3). Exposure of the stone apron that extends downstream of the bridge piers suggests that the image was taken at Low Water. It also indicates that the apron has been in place for some time.

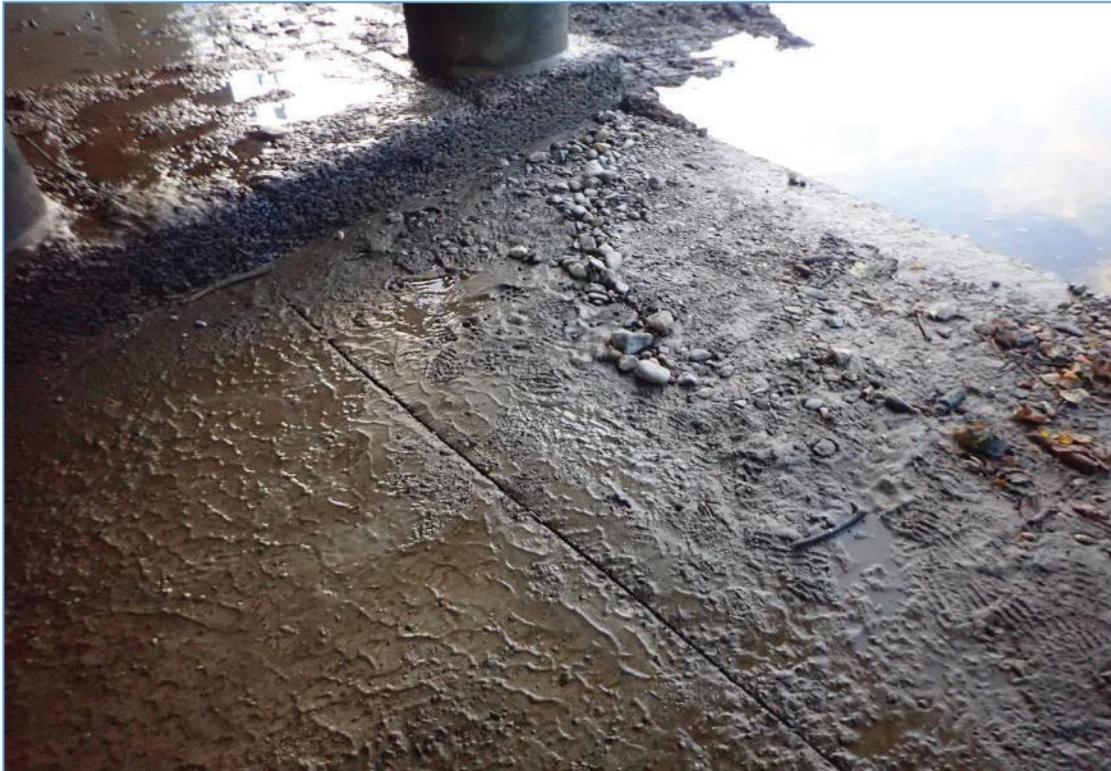
Plate 8: Record shot of cut through the apron between the piers in preparation for excavation of the trial pits.

In preparation for the trial-pits on the downstream side of the bridge, the stone and concrete apron was cut by road saw and broken-up using a pneumatic hammer-driven rock-breaker (Plates 8–9). While excavation focussed on the bridge corners, the full width of the apron was removed under Arches 2, 3 and 4 because the large stone used in the apron made the process

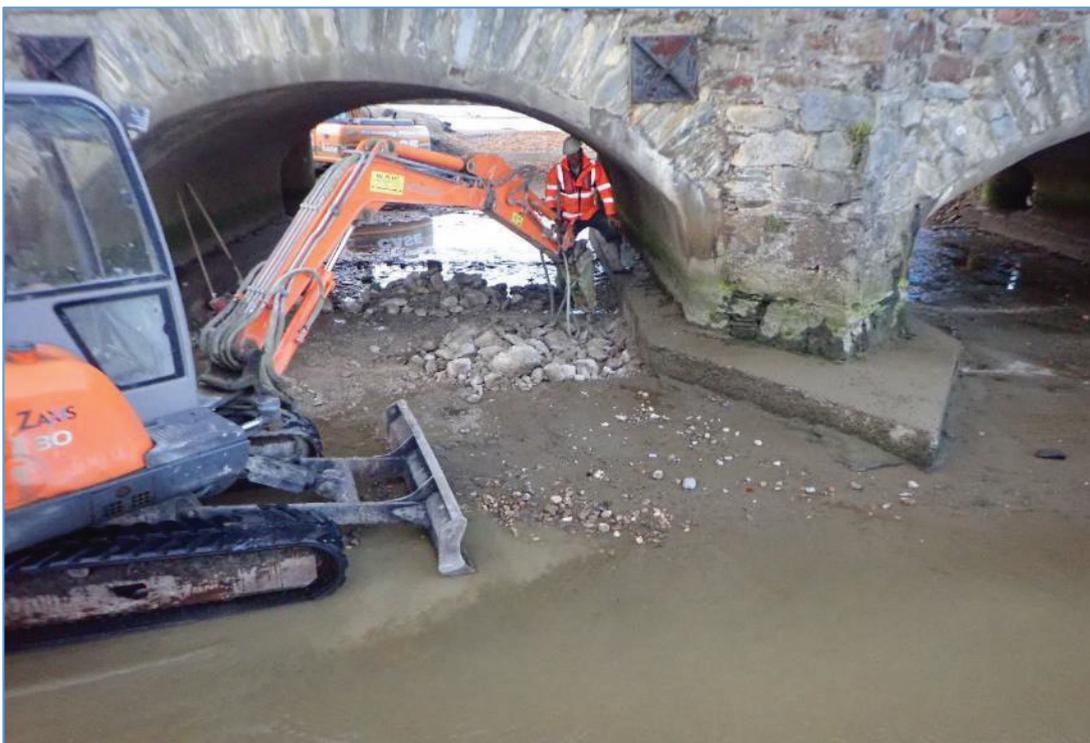
Plate 9: Record shot of the rock-breaking employed to break through the apron at the trail pit locations.

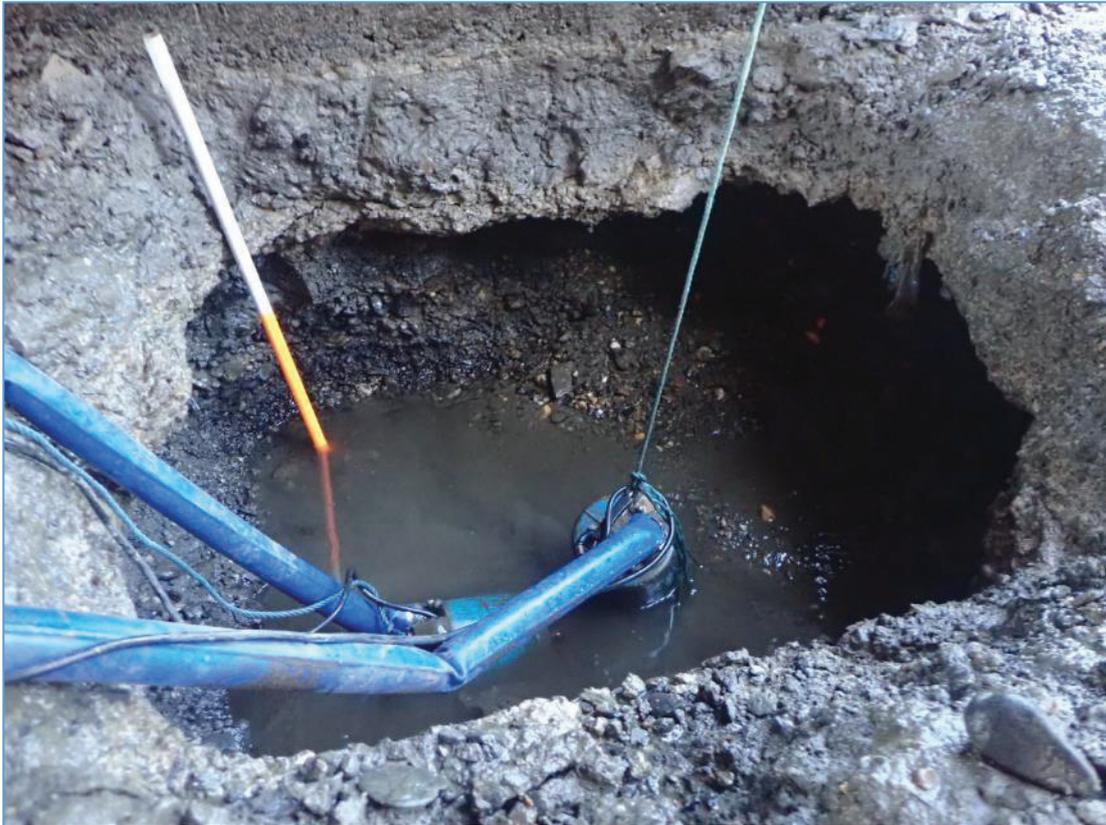
Plate 12: TP-01, close-up view showing large stone associated with the apron underlying the more recent concrete surface and overlying river shingle.

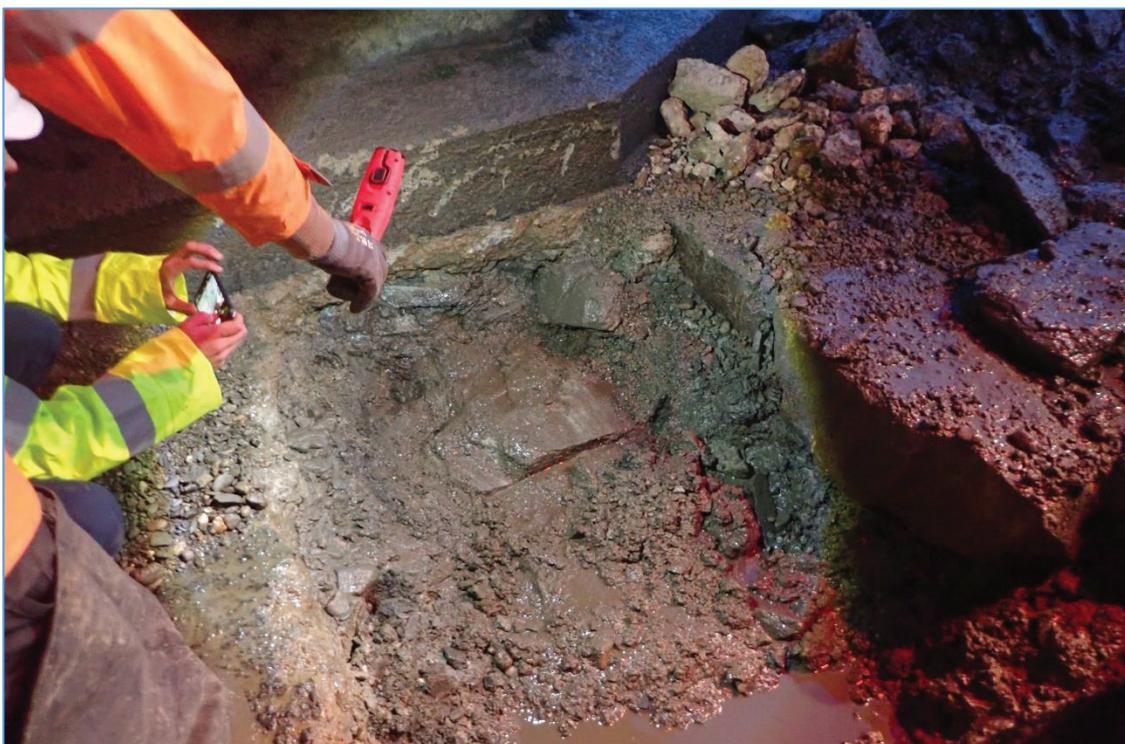
Plate 23: TP-02, view showing the stone of the bridge apron exposed below the more recent concrete layer above.

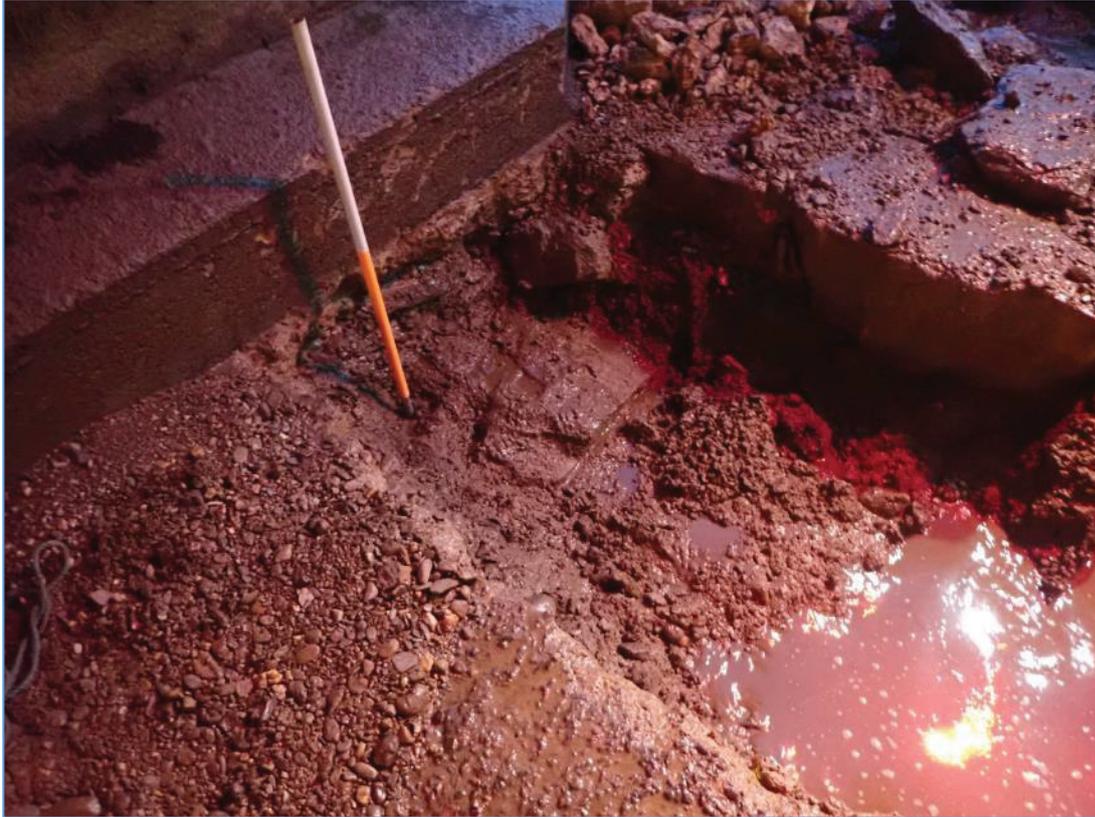
Plate 14: TP-02, view showing the full excavated depth at Pier 2.

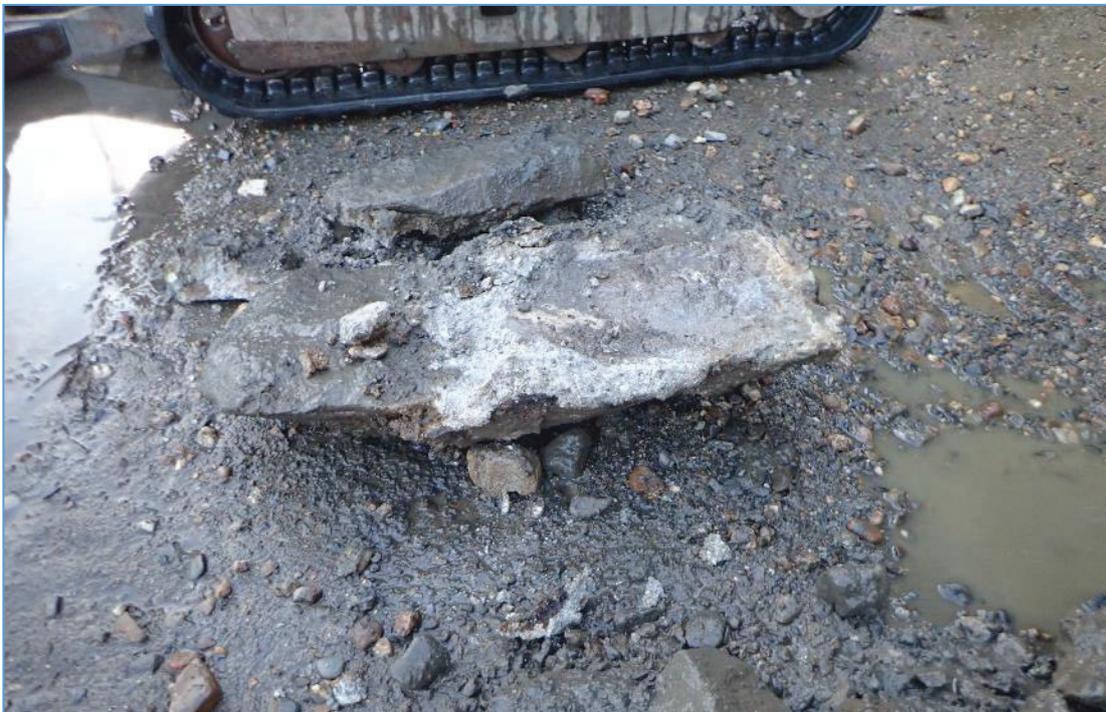
Plate 15: TP-02 showing a large stone removed from the apron. The stone measured 700mm long, 400mm wide, 100mm thick.

Across the width of the trench, excavation reached 700mm, exposing the stone apron under the concrete cover, and river silt under the stone apron. A large stone of the apron was recovered from the trial pit and its underside had mortar/loose cement attached (Plate 15). The stone measured 700 x 400 x 100mm. A series of objects was recovered from the mortared matrix of the apron and underneath the large stones (Plate 16). They included an L-shaped metal strap, a piece of wire sheathed in plastic and a piece of decaying rubber. The objects provide a dating context for the stone apron, indicating that it is not of ancient date but is comparatively modern.⁵ As indicated on Plate 2, the apron is recorded on an historic photograph. Robert French's earlier photograph of the bridge (Plate 1) indicates gas lights as the public lighting employed on the bridge. The lighting recorded on Plate 2 is not the same, and the globe-shaped light bowls might represent early electrification. This would place the photograph in the second quarter of the twentieth century, which is in keeping with the objects recovered from the apron's matrix.

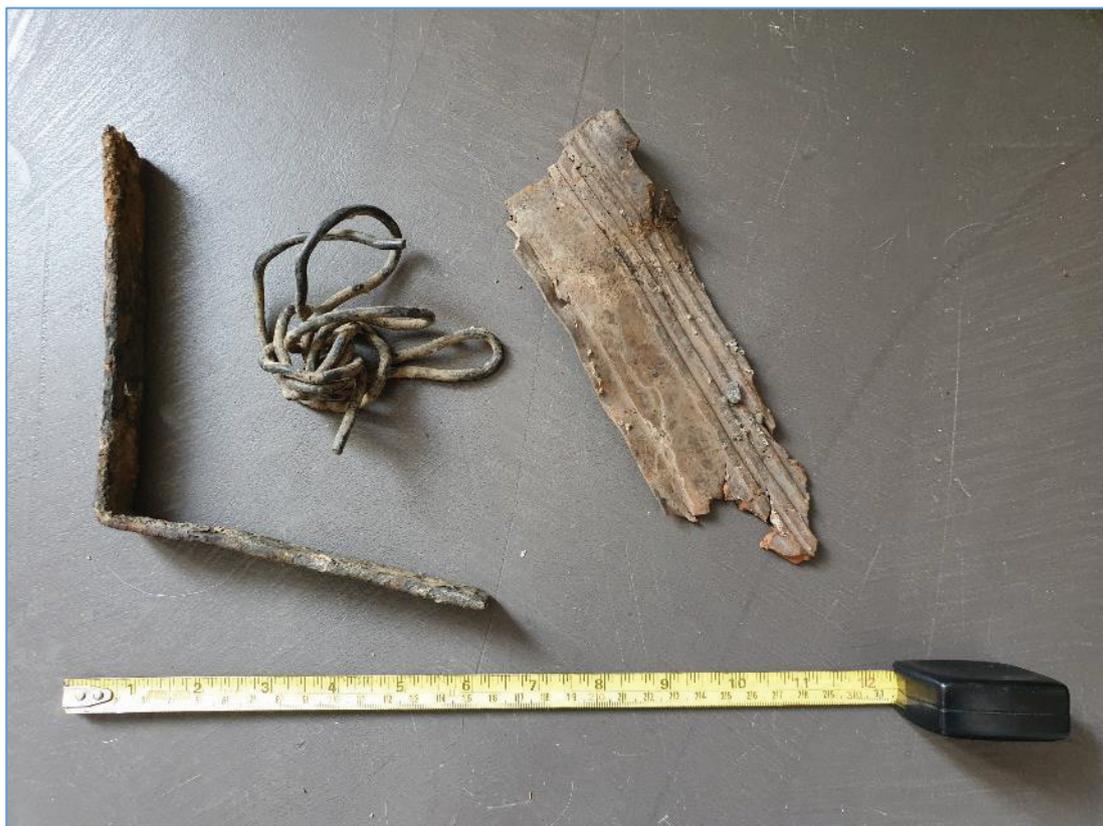
Plate 16: TP-02, selection of objects recovered from the mortar matrix of the stone apron, indicating a dating context for the apron. A metal strap, with each arm measuring 150mm (6") long, 26mm (1") wide and 3mm thick, and with two perforations for screw fittings. The ball of wire has a plastic sheath and a single strand metal core, 4mm in diameter. The rubber fragment on the right is originally orange in colour and is 200mm long, 60mm wide and 4mm thick.

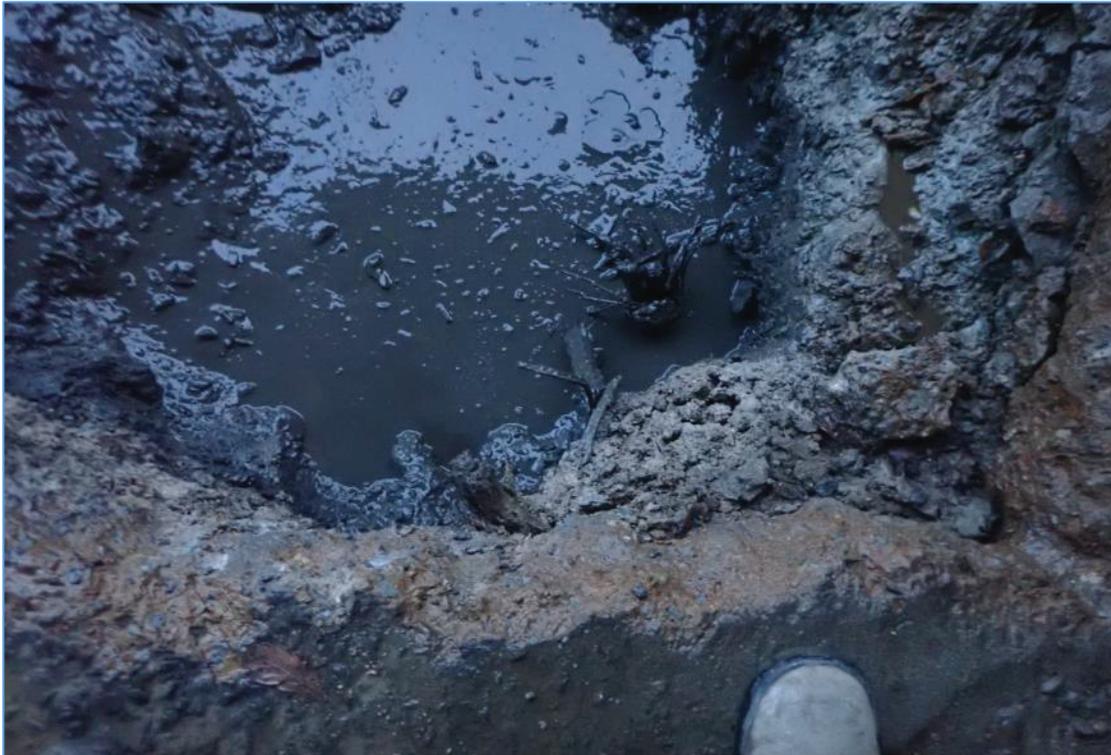
Plate 37: TP-02 at Pier 1. Excavation of the covering concrete layer revealed the tops of large stone and timber fragments.

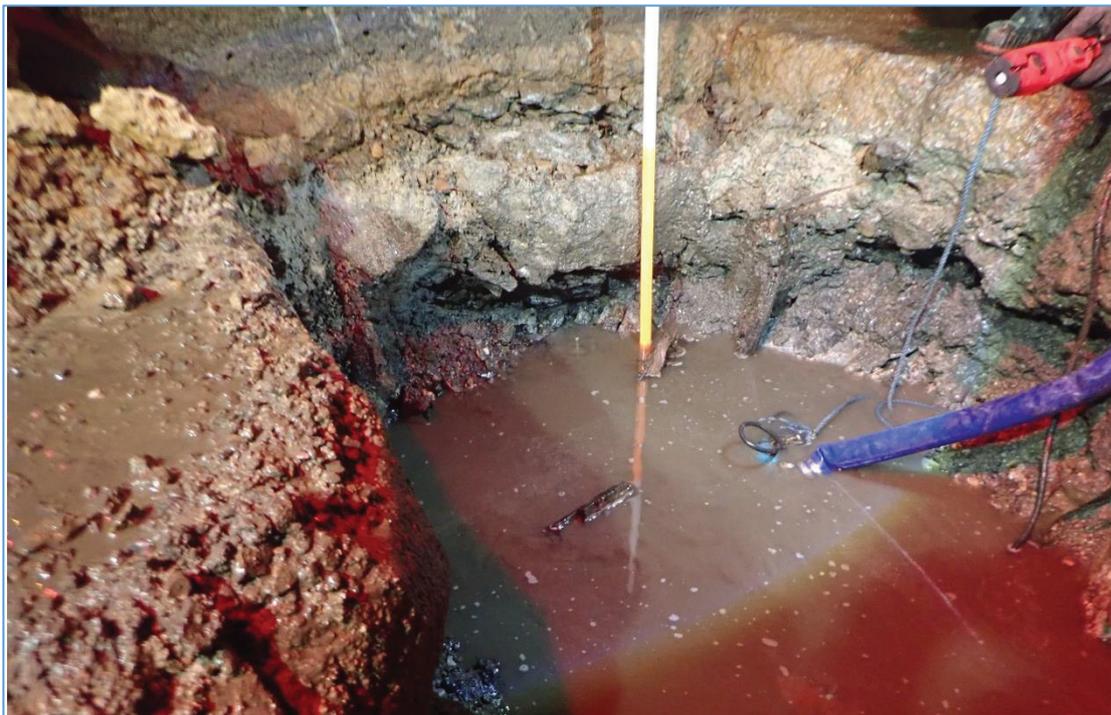
Plate 18: TP-02 at Pier 1. Excavation beneath the concrete revealed the base of stone considered to be associated with the originally plinth of the stone pier, as well as a series of starling piles that lie outside the plinth stones and continue in depth below the excavated levels.

rectangular-sectioned pieces were also observed. The timbers represent starling piles. Such timbers were used as a protective measure against scour and were set around the base of bridge piers. In one instance (Pier 1, Trial Pit TP-02) it was possible to observe the stone that is inside the line of starlings, and this is interpreted as evidence for the plinth of the bridge pier.

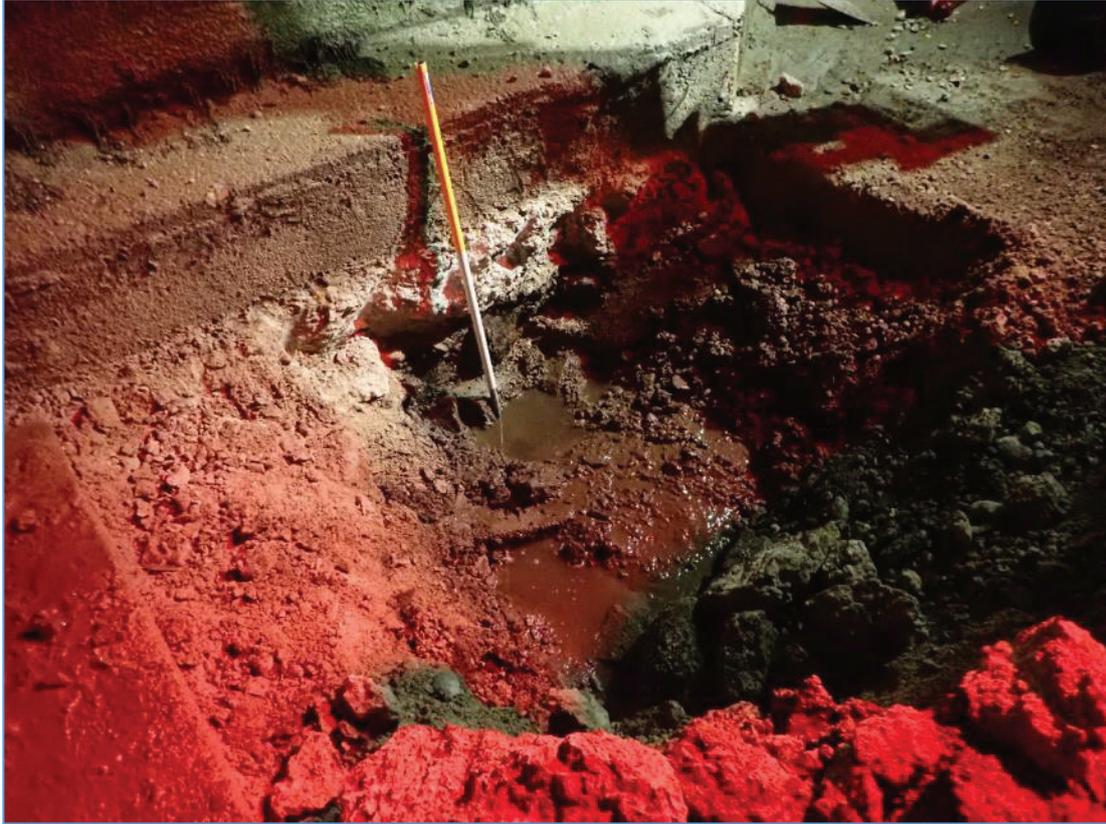
Plate 19: TP-03. Excavation of the concrete above the bridge apron at Pier 3 reveals the apron's stone.

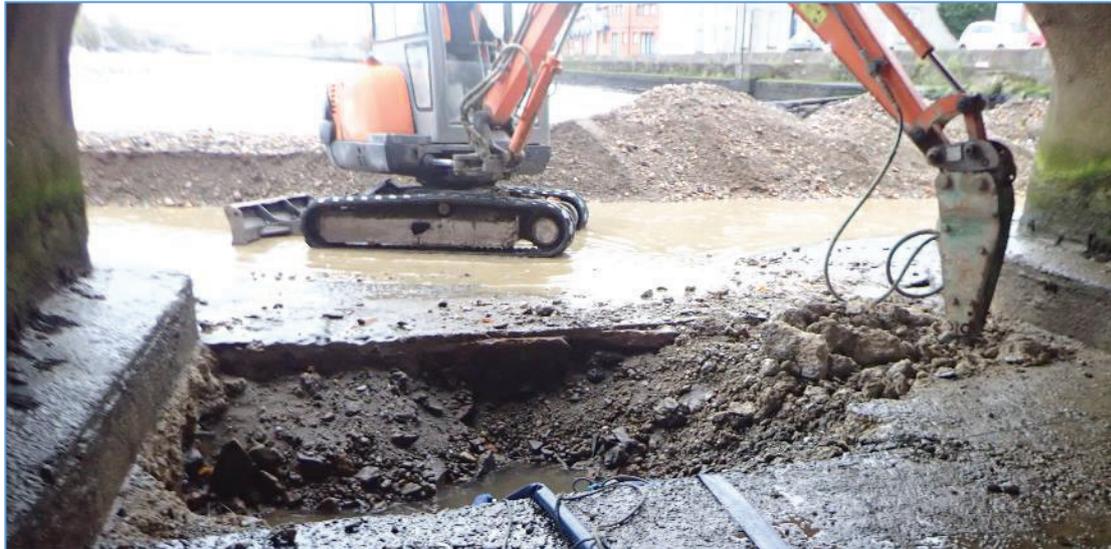
Plate 24: TP-03 as it was being excavated across the space between the bridge piers, reveals the shallow nature of the concrete added above the stone apron.

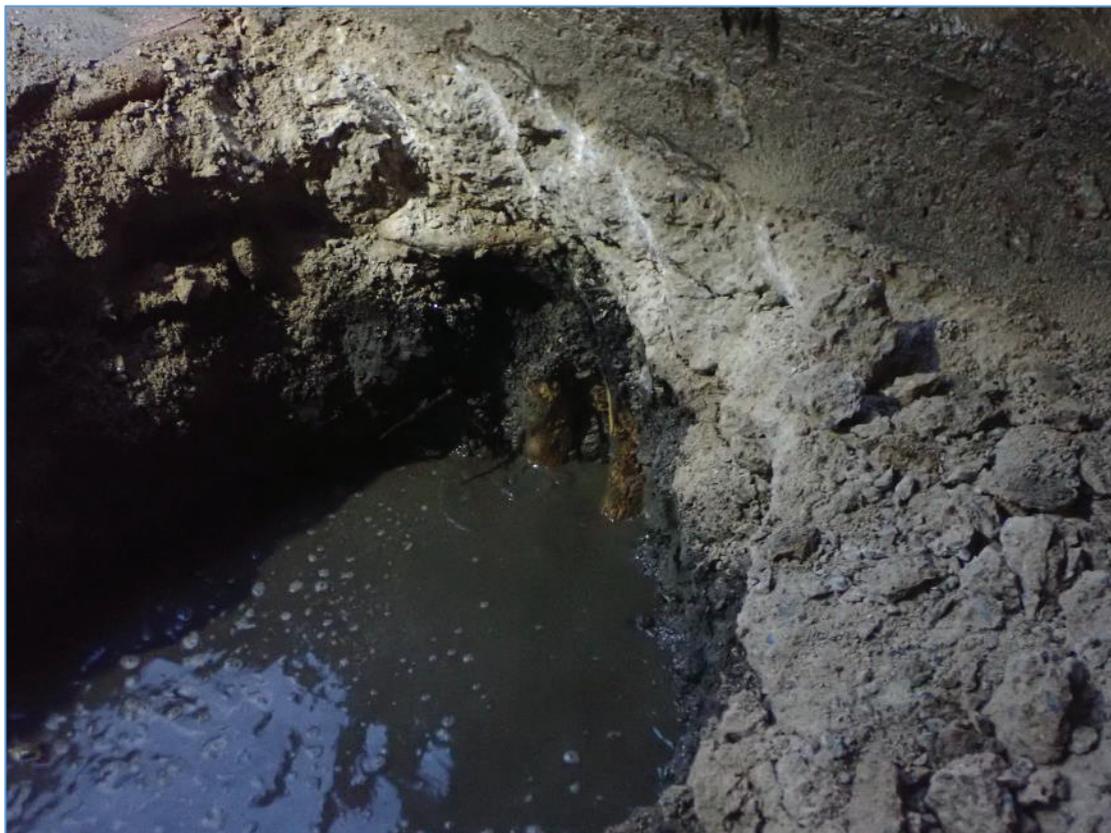
Plate 22: TP-03 at Pier 2. Removal of the covering concrete reveals river clay and starling piles.

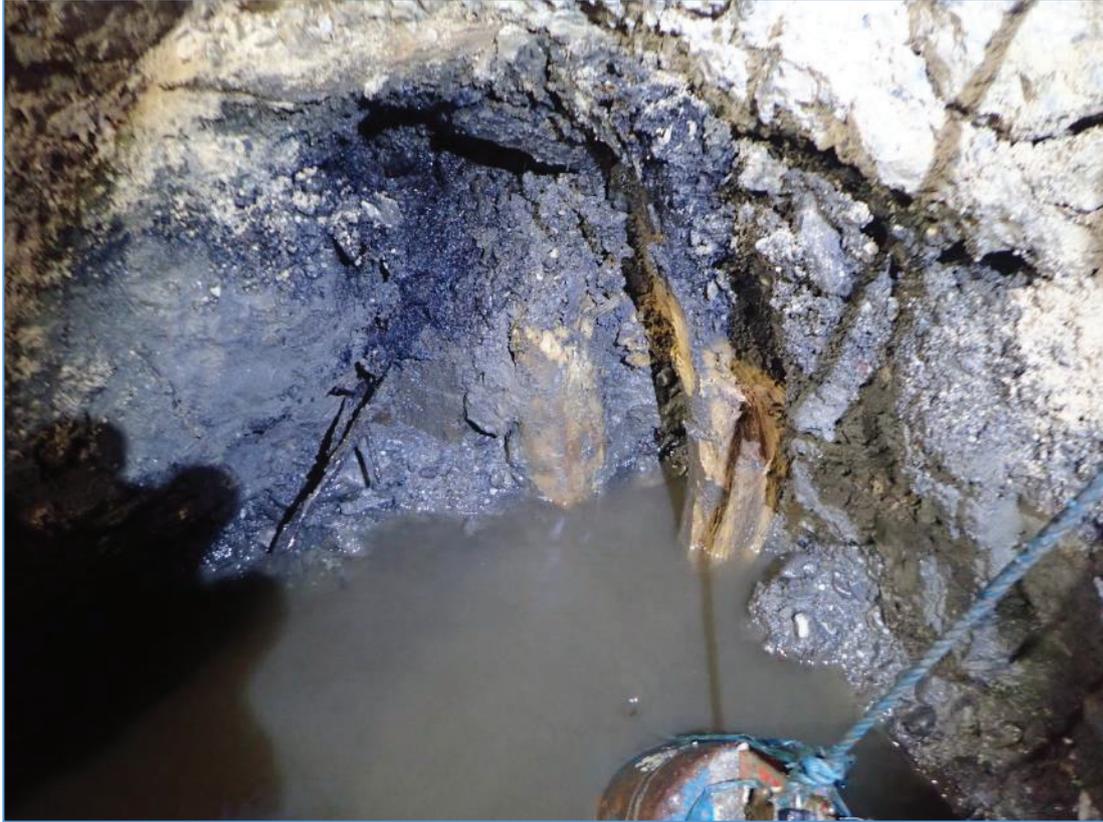
Plate 23: TP-03 at Pier 2, close-up view of the starling piles to their excavated depth.

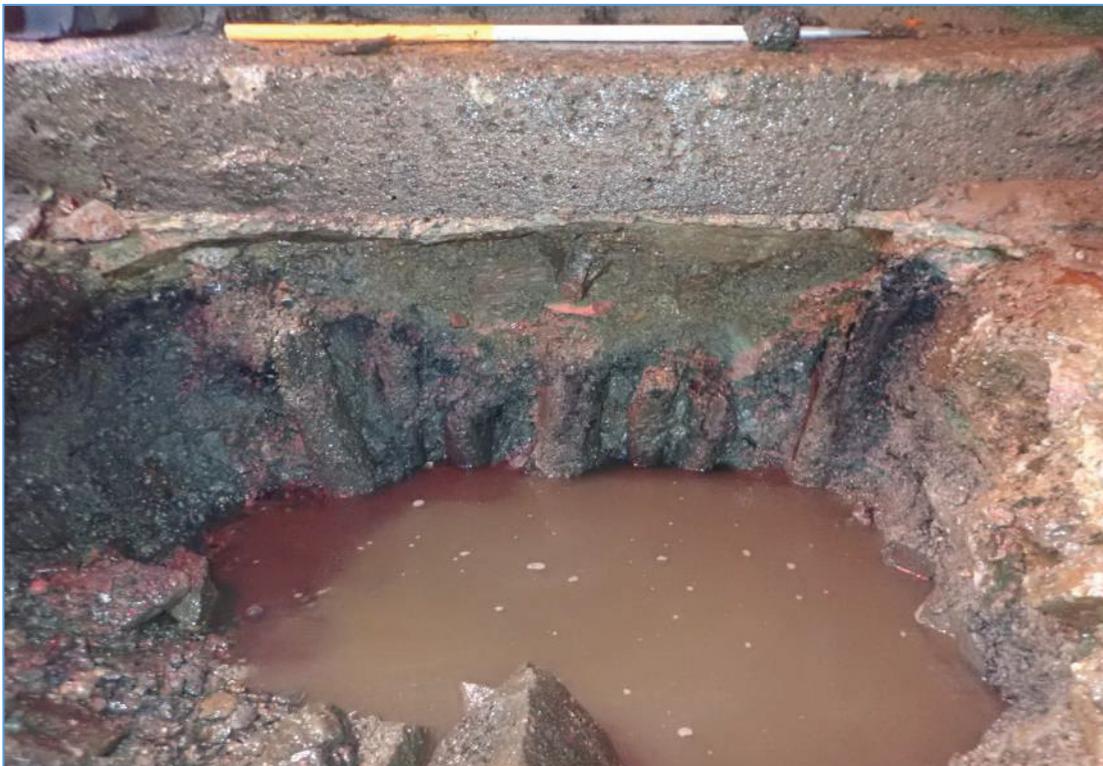
Plate 24: TP-04 at Pier 4. Excavation reveals a line of starling piles under the stone apron.

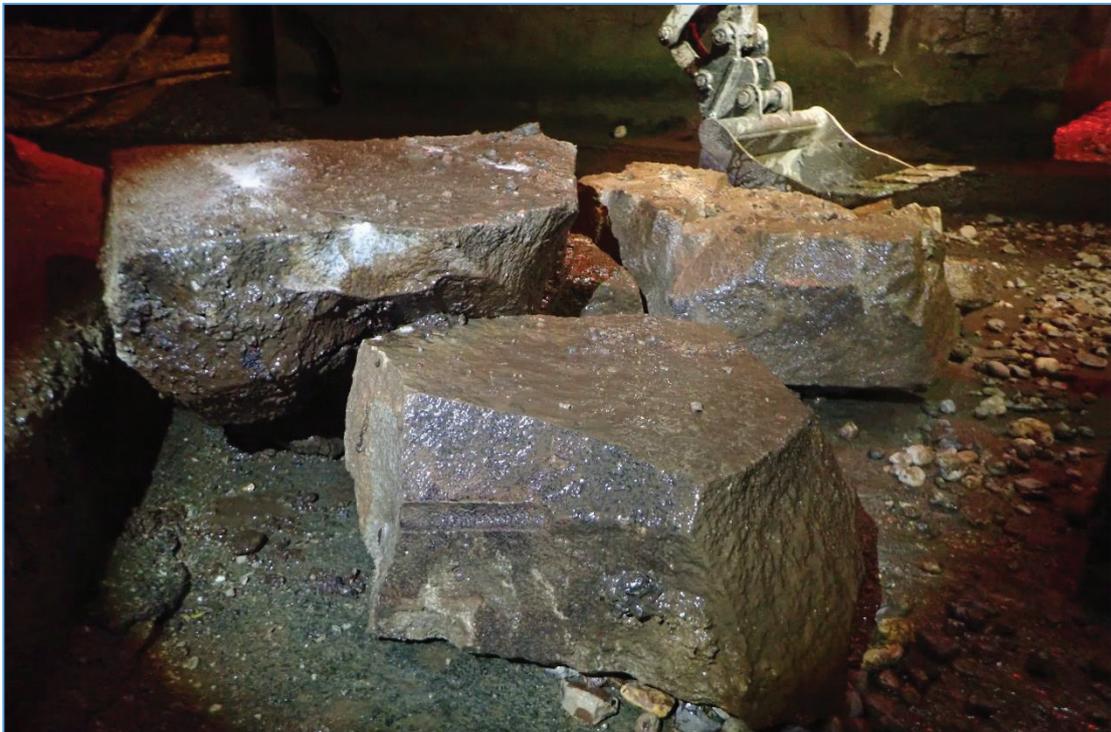
Plate 26: TP-04. Stone apron stone recovered. Note the shot hole on the stone in the foreground, a tell-tale indication of the quarrying process to extract the stone.

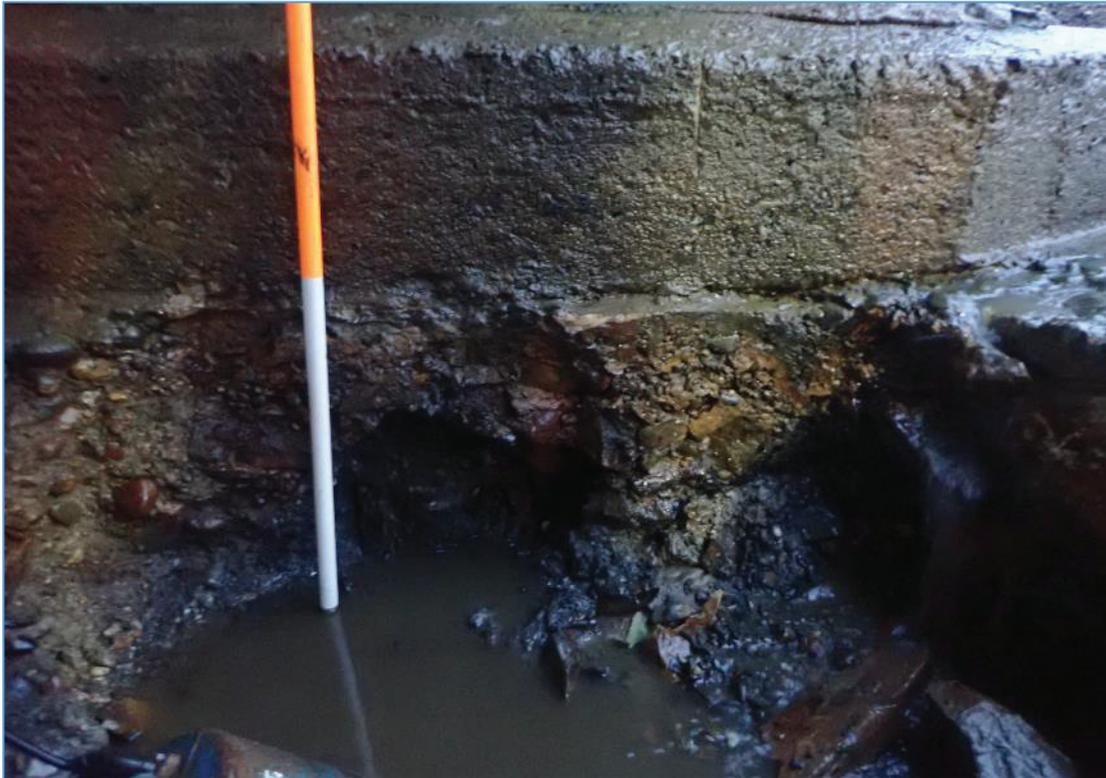
Plate 27: TP-04 at Pier 4. Excavation revealed starting piles under the stone apron that in turn lies under the more recent concrete that forms the current bed level.

Excavation at Pier 4 revealed a similar stratigraphic sequence to that observed at Pier 3 within TP-04. The concrete surround added to the base of the stone pier is 300mm wide and high above bed level. The stone apron and its mortared/cement matrix is shallower at 200mm thick, and it lies directly on top of a line of softwood starling posts that were exposed to a depth of 930mm below bed level (Plates 27).
