Arklow Bridge (NIAH

16322046) Site

Investigations 2019

Licence No. 17E0482

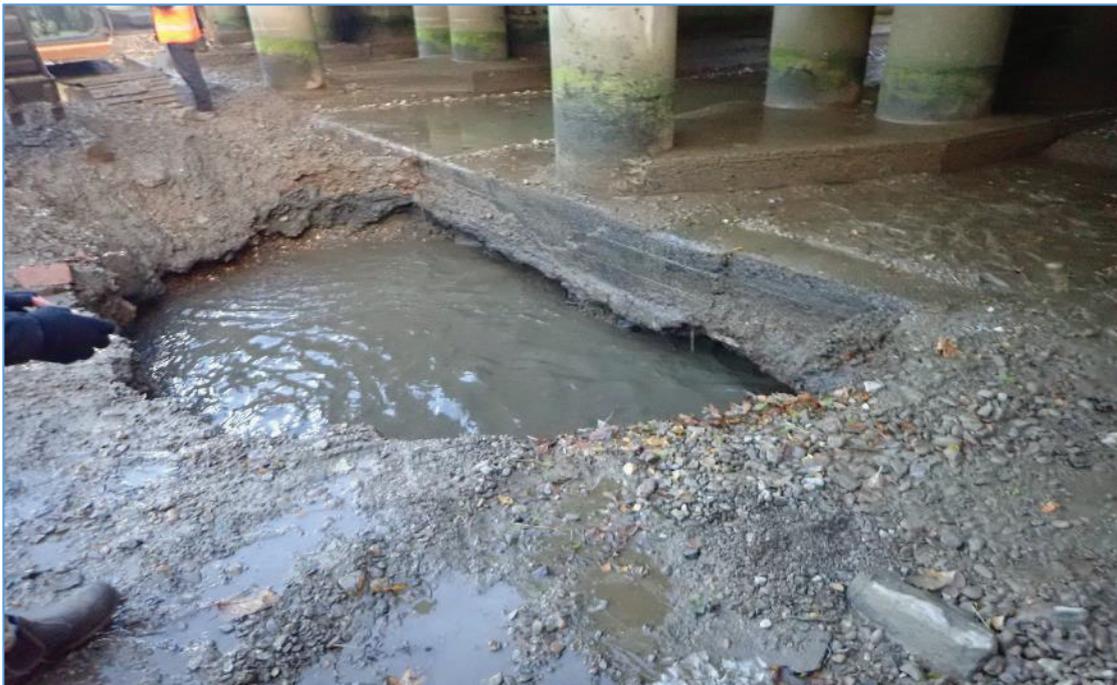
Plate 28: TP-05, view from the west, showing the extent of the area opened upstream of the bridge, exposing the concrete plinth added as part of the bridge-widening works in the 1970s.

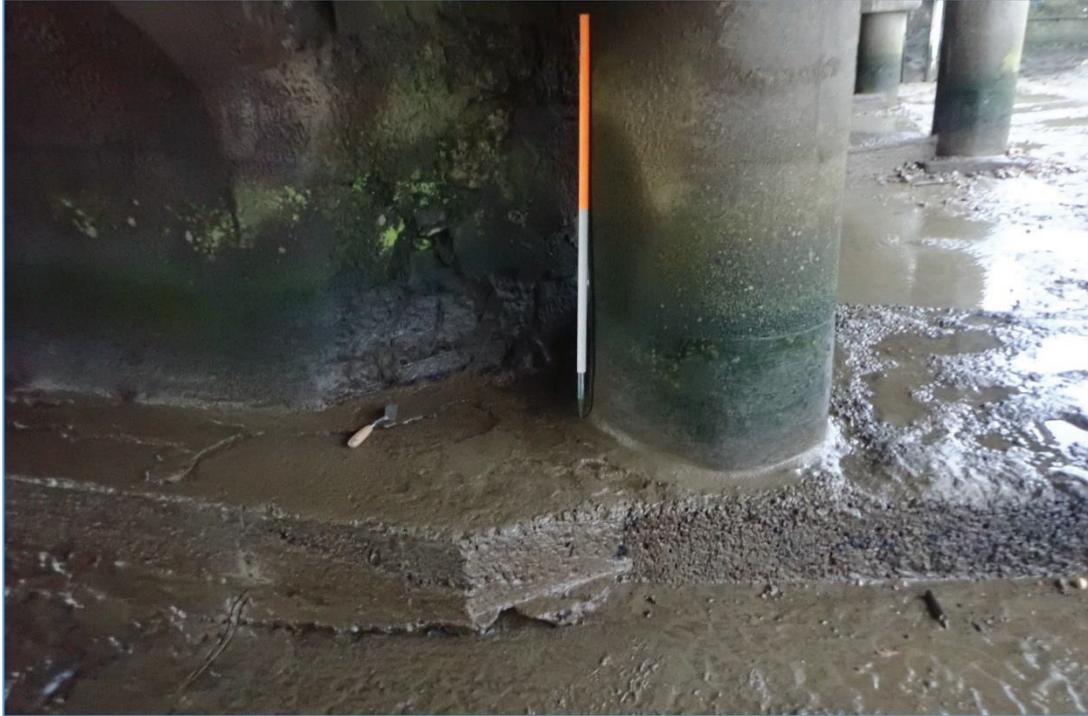
Plate 29: Pier 3, east-facing side, showing the join where the bridge-widening works of the 1970s is added to the concrete surround to the earlier stone pier. This presents a stratigraphic sequence of the bridge works in the modern period.

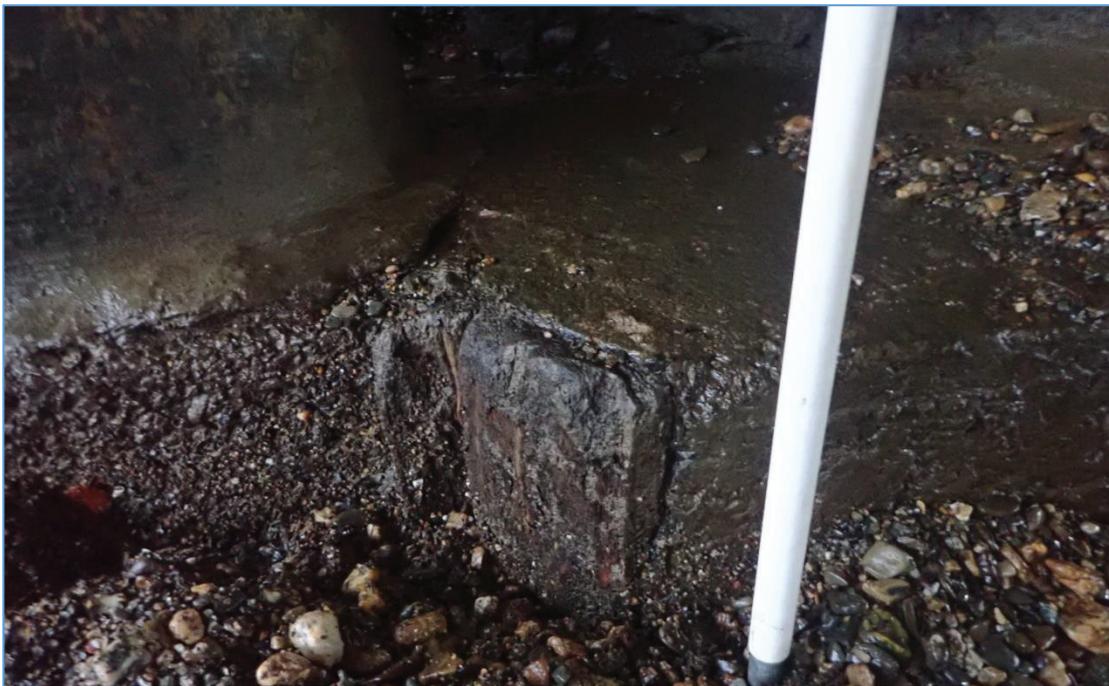
Plate 30: Pier 4, east facing side, showing a timber plank that survives as part of the form-work associated with the addition of the concrete surround to the stone piers, and which in turn is impacted on by the insertion of the concrete pile as part of the 1970s bridge-widening works.
