Arklow Flood Relief Scheme

# Screening Statement for Appropriate Assessment and Natura Impact Statement

**Arklow Flood Relief Scheme**  
**Screening Statement for Appropriate Assessment**  
**and Natura Impact Statement**

**May 2021**

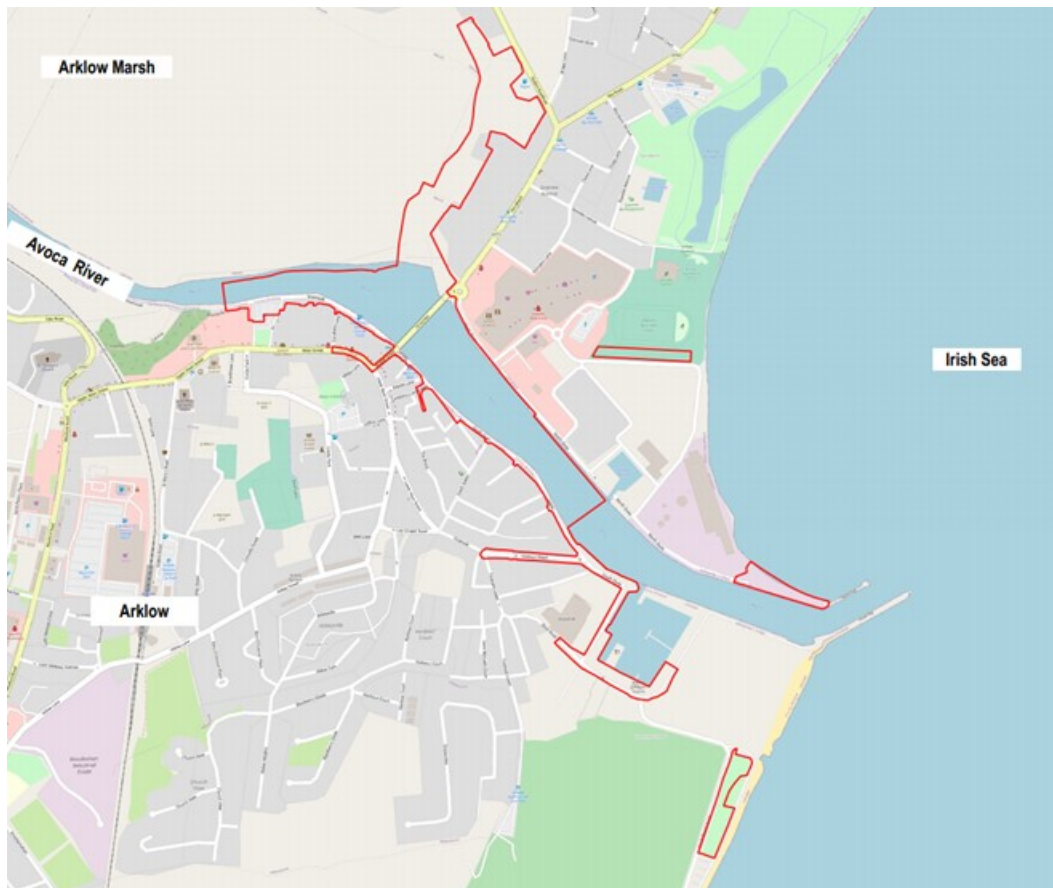
**Figure 2-1: Overview of planning boundary (including working areas) required for the proposed development. Not to scale. Extracted from Figure 5.2 in Appendix 5.2 of the EIAR.**

Construction of the proposed development will require land take to accommodate construction activities (including site compounds) and the permanent elements of the proposed development. The planning boundary for the proposed development is shown in (see **Figure 2-1**).

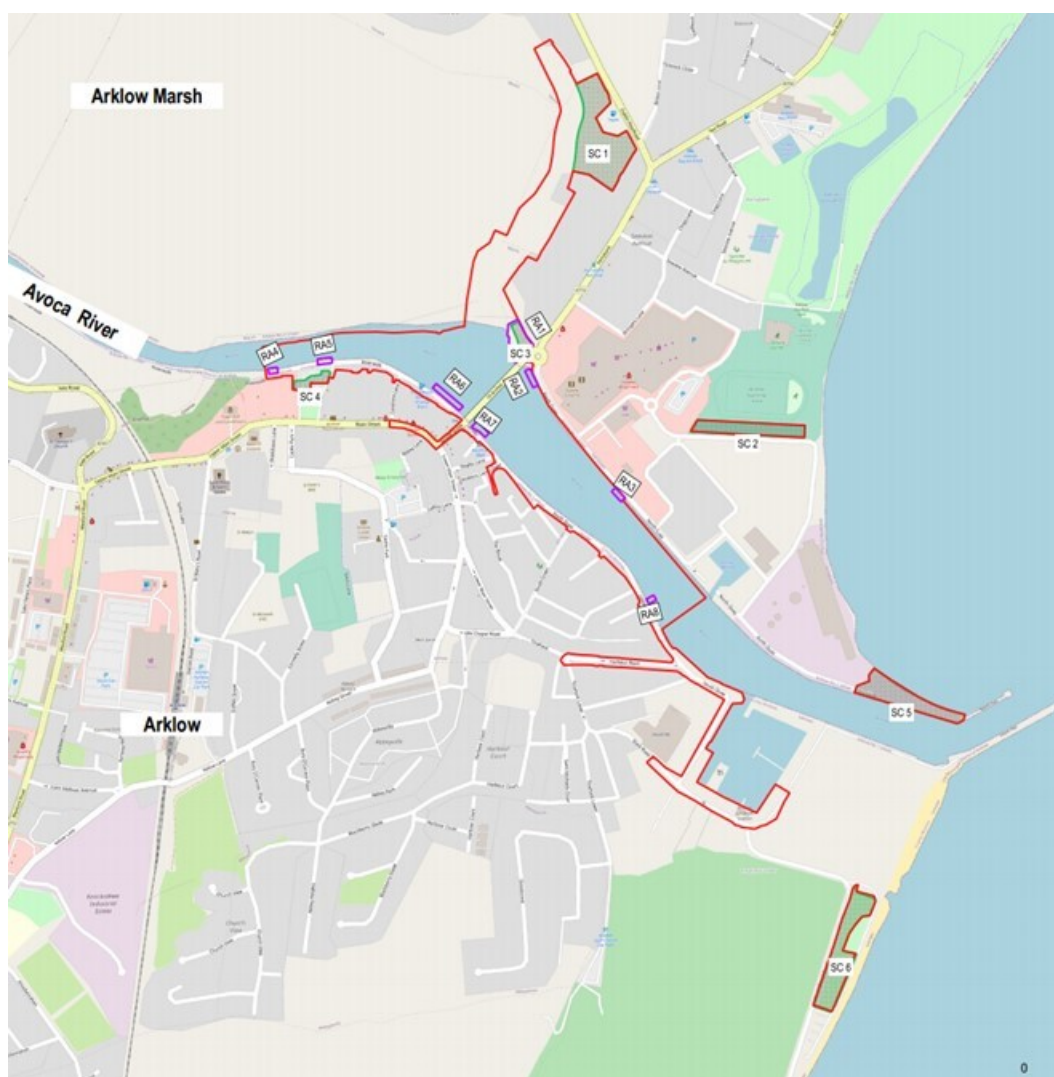
**Figure 2-2: Site Compounds (SC) and River Access (RA) Locations. Not to scale. Extracted from Figure 5.2 in Appendix 5.2 of the EIAR.**

Site preparatory works are required prior to undertaking activities for the WPs. These preparatory works included the establishment of construction compounds (SC1 - SC6) (see **Figure 2-2**) and establishment of river access points. The location of SC1 to SC6 and river access (RA) point are presented in **Figure 2-2**.

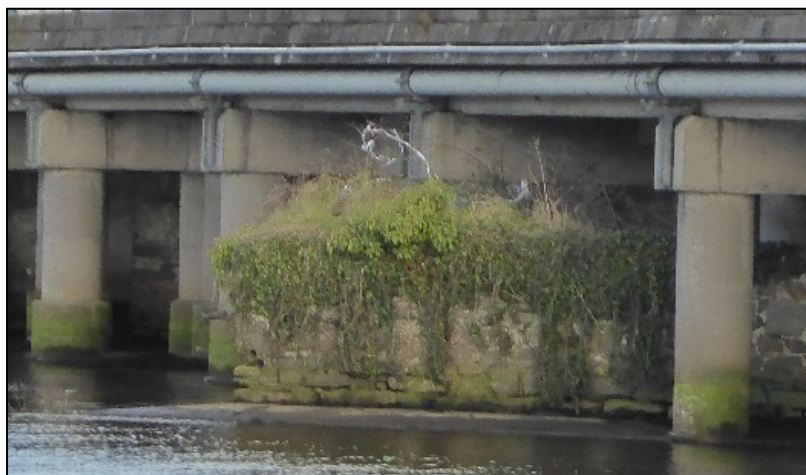
**Photograph 1** - Vegetation Growing on Arklow Bridge

levels upstream of the bridge. The lowering of the floor of the bridge will require underpinning of the bridge abutments and piers and the reconstruction of the scour protection slab at the new riverbed level. Minor defects have been identified on the older bridge as described below. Vegetation is growing on the bridge. This may lead to deterioration of the masonry joints in the bridge over time. Refer to **Photograph 1** below.

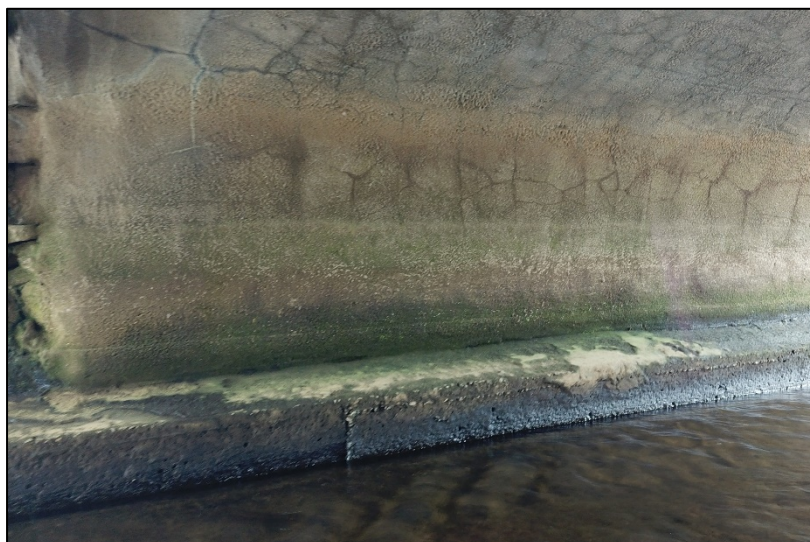
**Photograph 2** – Cracking of Bridge Soffit Repairs

The arches of the masonry bridge were previously coated with a cementitious material – probably through guniting or shotcreting. This coating has hairline cracks and more serious cracks in places. Refer to **Photograph 2**.

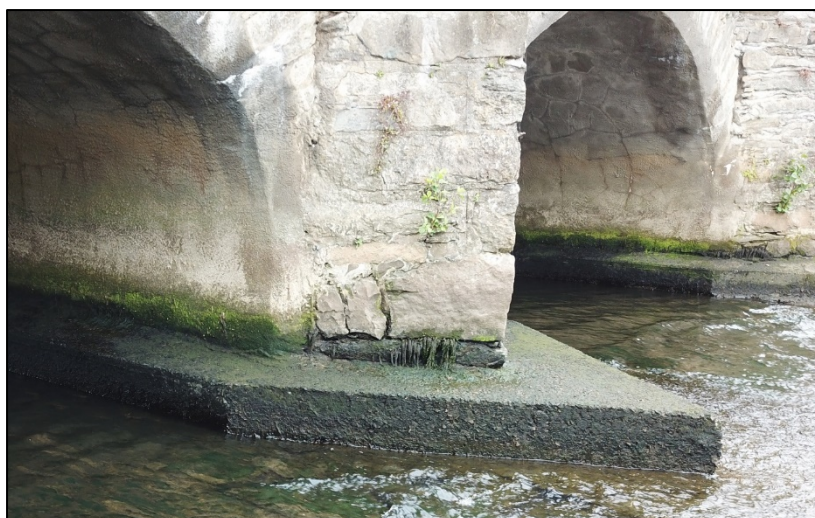
**Photograph 3 – Masonry Joint Defects**

The mortar joints of the old masonry work have deteriorated significantly in places with loss of mortar. This could lead to further deterioration if not addressed. Examples can be seen in **Photograph 3**.

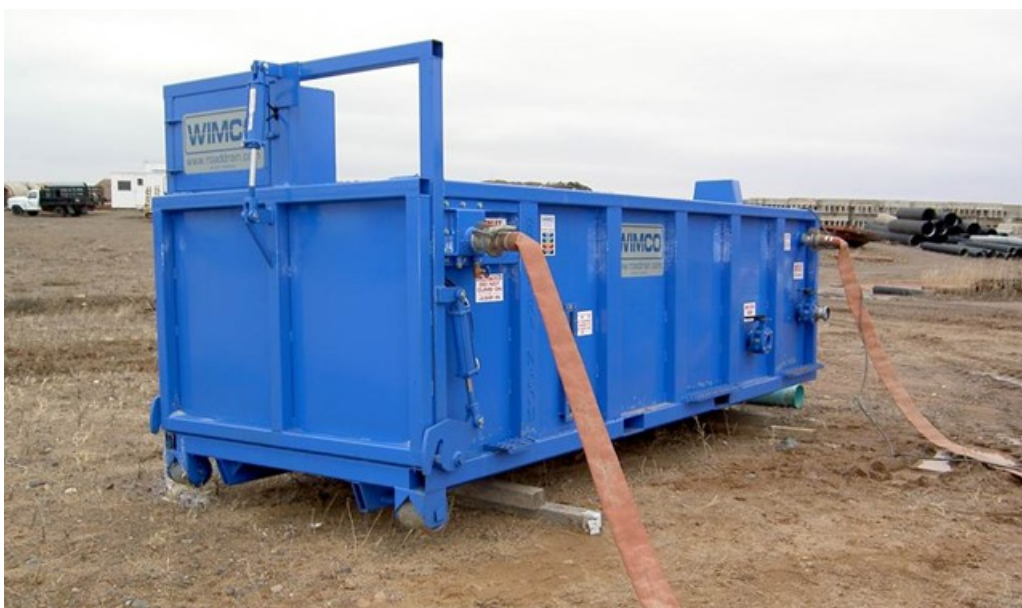
**Photograph 4** Typical sediment control system

Bunds will be installed on a suitable formation. The water within the bund will be electro-fished to ensure all fish are removed and released into the Avoca River in advance of dewatering. Dewatering will typically be achieved by using a series of sumps and submersible pumps. Discharge from the dewatering process will be passed to a suitably sized proprietary sediment removal system located within the bund before discharge to the Avoca River. The diesel pumps and settlement tanks will be located within bunded areas as and when required. Refer to **Photograph 4** for a typical sediment removal system.

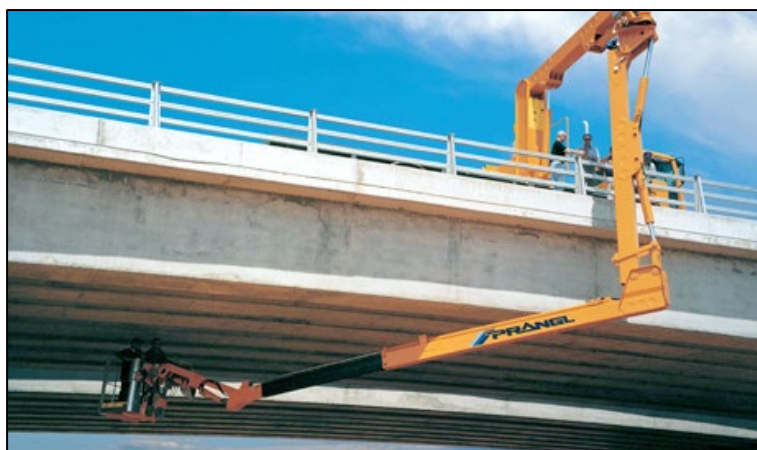
**Photograph 5 - Aerial Mobile Platform**

Works to the masonry of the historic part of Arklow Bridge will include repairs to the previously applied gunite on the soffits of the arches, repairs to the masonry of the older sections of Arklow Bridge and removal of the vegetation growing on the bridge. Defective joints will be raked out and repointed. Deeply embedded roots will be drilled and injected with a suitable herbicide, where to remove them would prove destructive to the integrity of the masonry. All loose stones will be re-seated and eroded will be mortar raked out and repointed with appropriate mortars. The render to the underside of the arches will be checked for integrity and where defective, removed and the masonry underneath repaired. Areas of render requiring repair / reinstatement will be carried out in materials more appropriate to the original stonework. Scaffolding and/or aerial work platforms (AWP) will be required to gain access to the bridge superstructure and the soffits of the bridge arches. The scaffolding will be erected from the riverbed or suspended from the bridge superstructure. The AWP will operate from the bridge deck as per the example in Photograph 5.

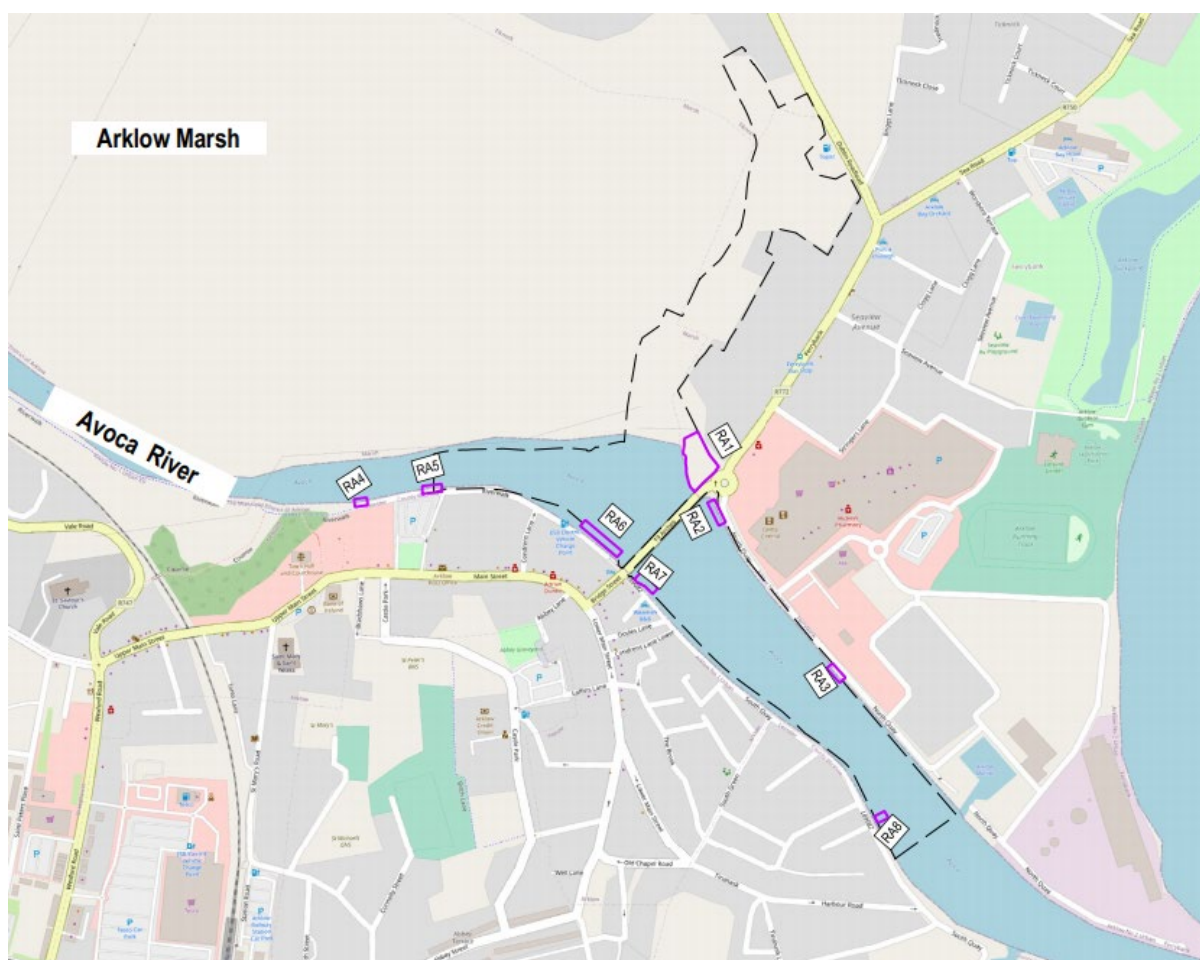
**Figure 2-10: Working Area (WA2) and River Access (RA) Areas. Not to scale. Extracted from Figure 5.22 in Appendix 5.2 of the EIAR.**

River access for upstream dredge works will be restricted to RA1. Downstream dredge works will be accessed via RA8, RA3 and RA2.

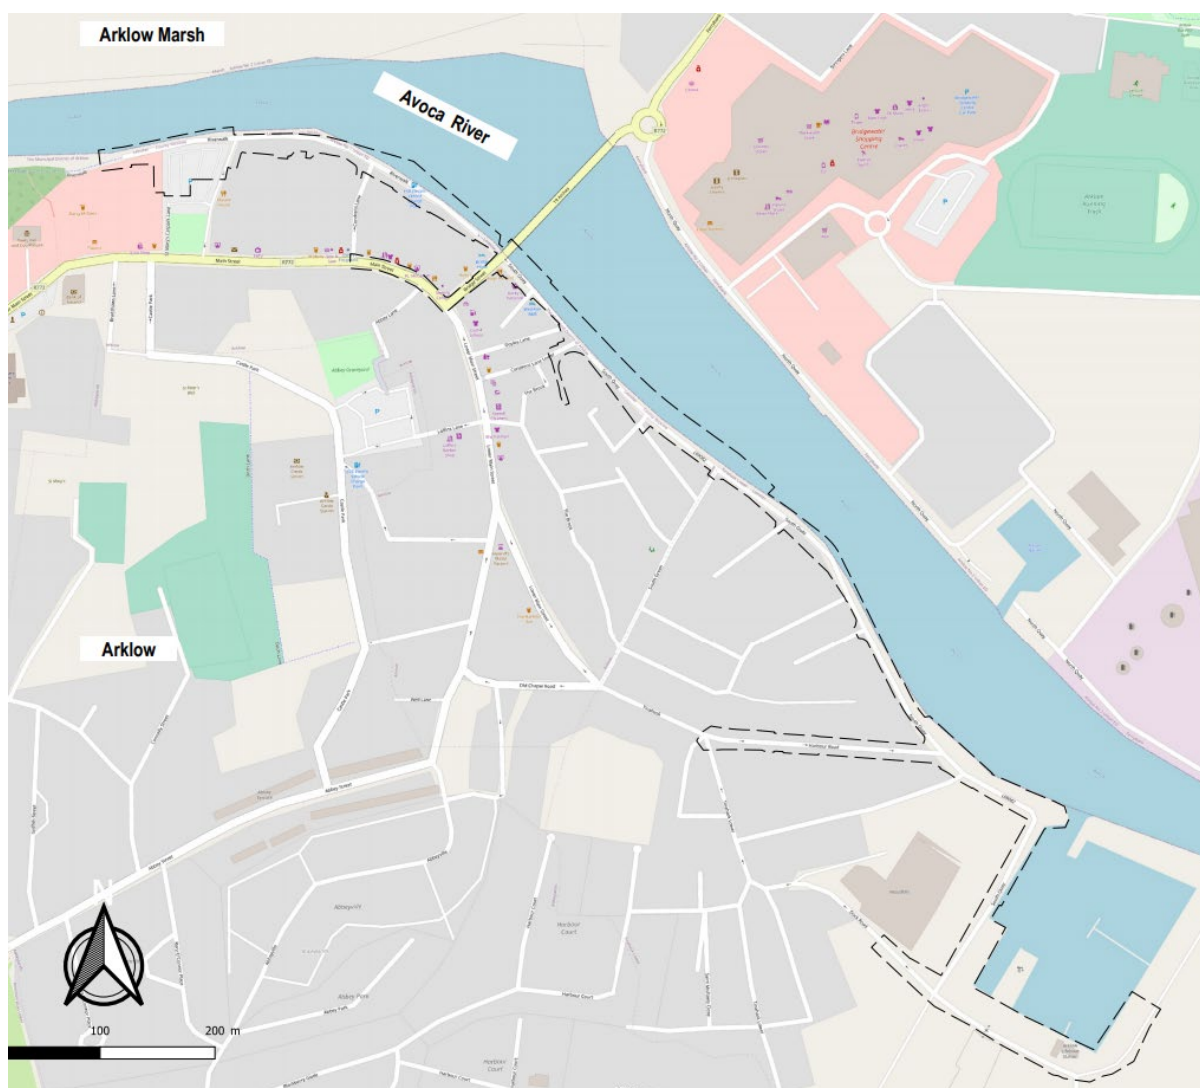
**Figure 2-14: Working Area WP4 (Not to scale. Extracted from Figure 5.29 in Appendix 5.2 of the EIAR)**

The working area (WA4) are shown on **Figure 2-14**. Working Area 4 is located on along River Walk and will support the construction of the flood defence walls and drainage work from Riverwalk to Arklow Docks.

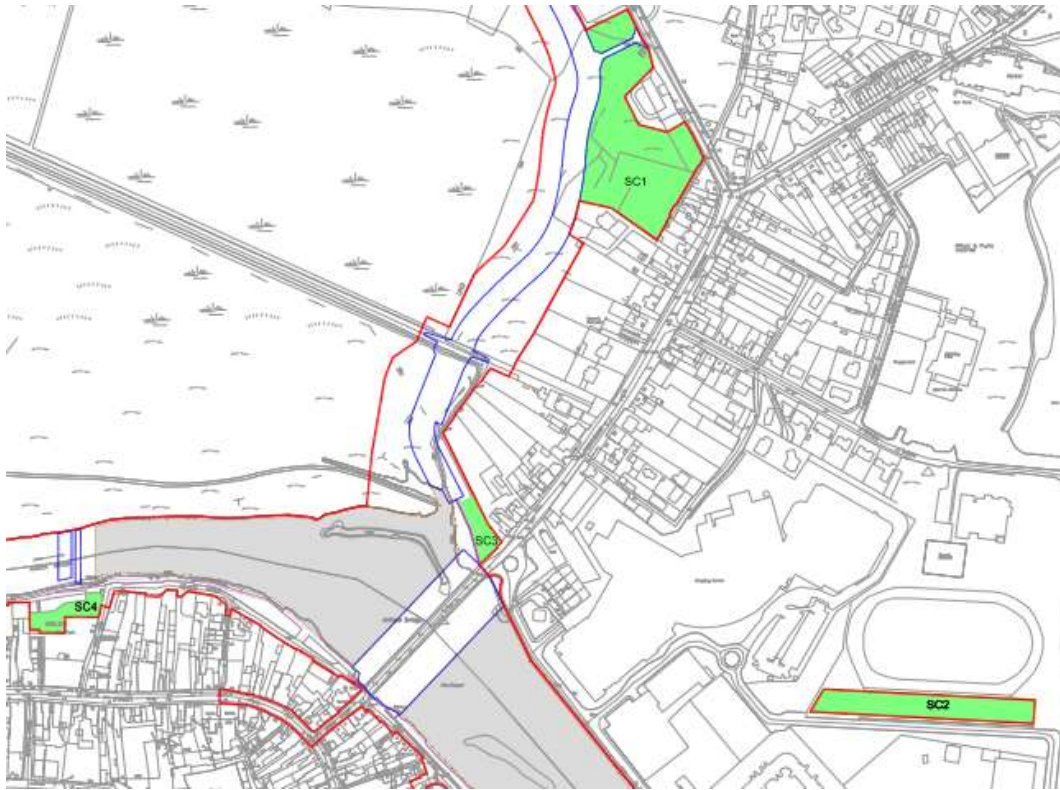
**Figure 10.2: Site Compounds** (extracted from Drawing No 1065 as described in Chapter 5). Site Compound 1 (SC1) located in Arklow Marsh, SC3 located on north bank (Ferrybank), SC2 located to the east near running track, SC4 located at Main St carpark on south bank near Riverwalk. Do not scale

Walkover surveys have also been carried out at the locations proposed for construction compounds (SC1-SC6), shown on **Figures 10.2** and **10.3**. The habitat types are listed in **Table 10.6** and shown in **Drawing No 001** below.

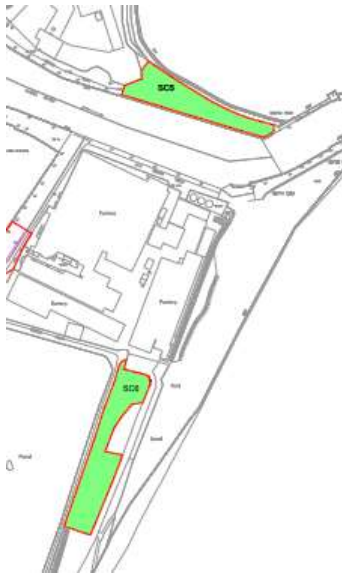
**Figure 10.3: Site Compounds** (extracted from Drawing No 1065 and in Chapter 5). Site Compound 5 (SC5) located at North Pier, SC6 located at South Beach. Do not scale

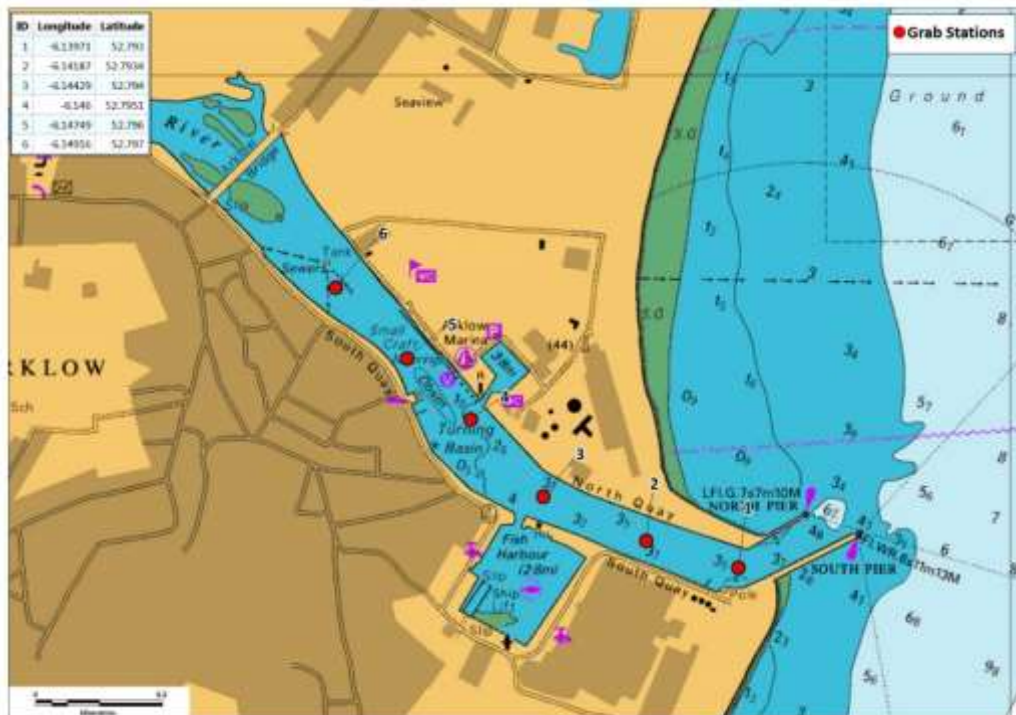
**Figure 10.18: Location of 6 sampling sites in the Avoca Estuary, 13 August 2020.**

Duplicate faunal samples were taken at each location and positions were recorded using a hand held GPS device. A 0.025m<sup>2</sup> grab was deployed from an inflatable and on recovery, the sediment type, colour and smell was recorded, and the sample was placed for later washing through a 1mm mesh sieve and preserving in 5% formalin on land. The samples were returned to the laboratory for sorting, identification and enumeration of macrofauna under a microscope. Faunal returns for each sample at each site are presented in **Table 10.11** below. The examination of the sediments showed them all to be black, muddy sands with small amounts of shell and gravel and strongly smelling of hydrogen sulphide.

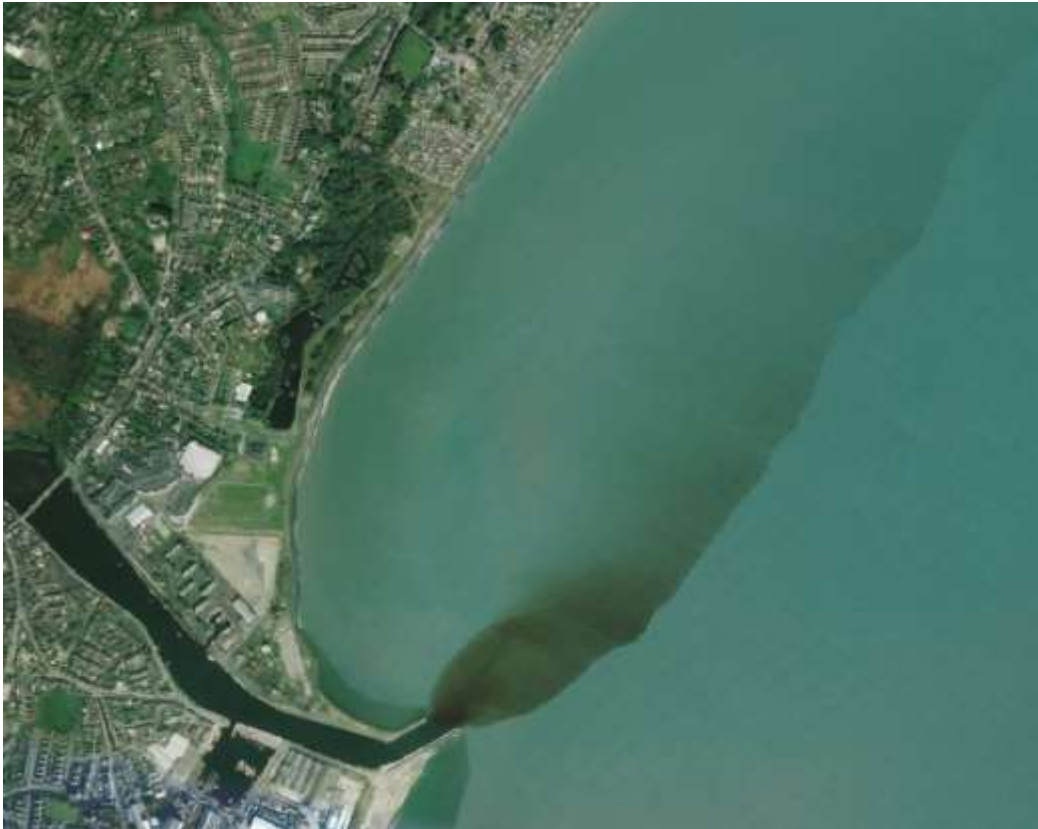
**Figure 10.19: Sediment plume from the Avoca River dispersing into the Irish Sea.**

**Figure 10.19** below shows the sediment plume from the Avoca River dispersing northwards into the Irish Sea. This image suggests that the Avoca River is naturally quite turbid.

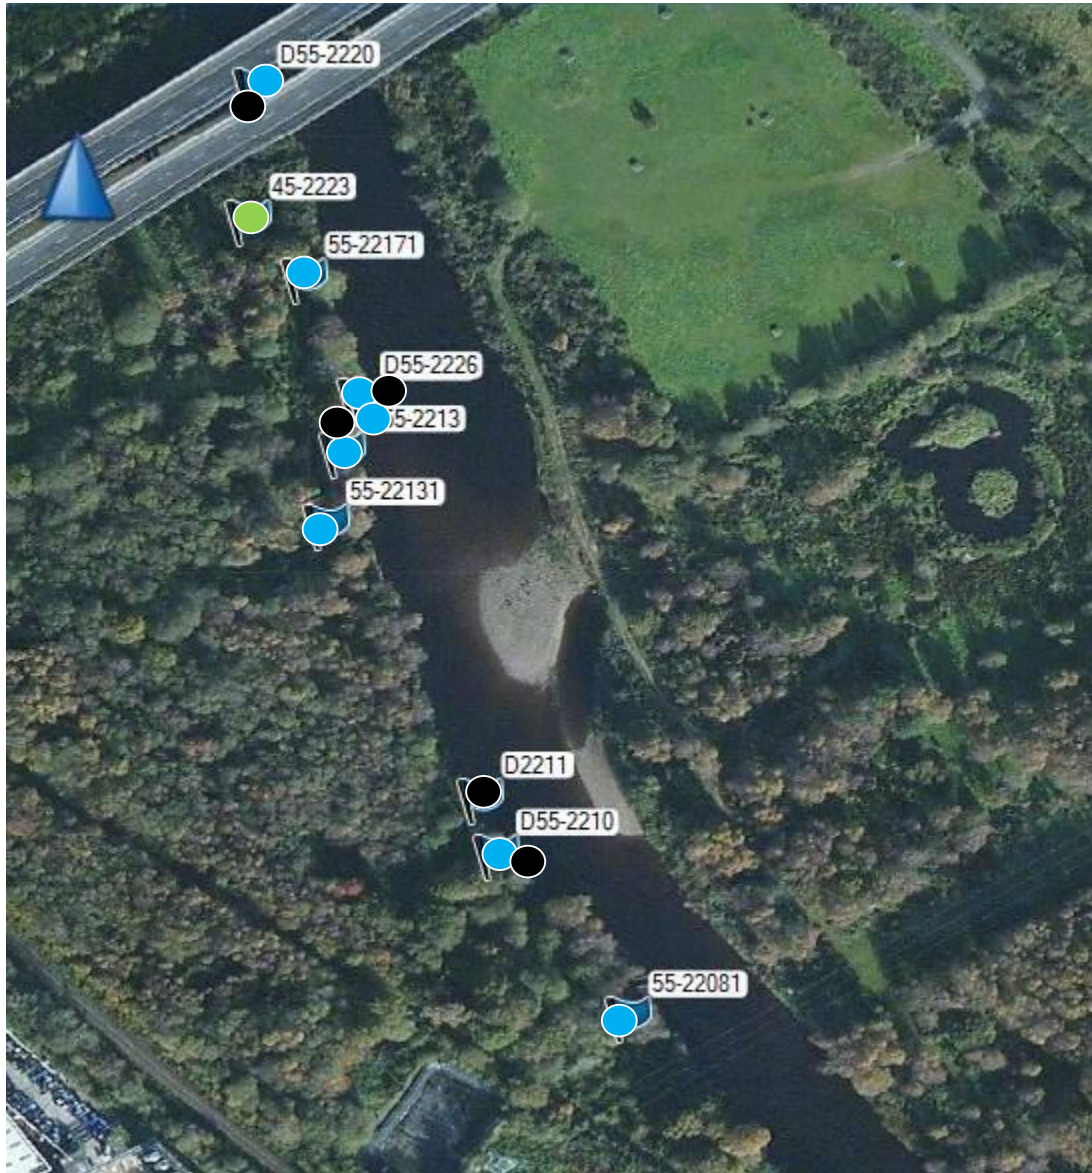
**Figure 1. Bat activity along the Avoca River close to the M11 Bridge in August 2017**

Blue circle = Soprano pipistrelle      Green circle=Common pipistrelle

Black circle = Daubenton's bat

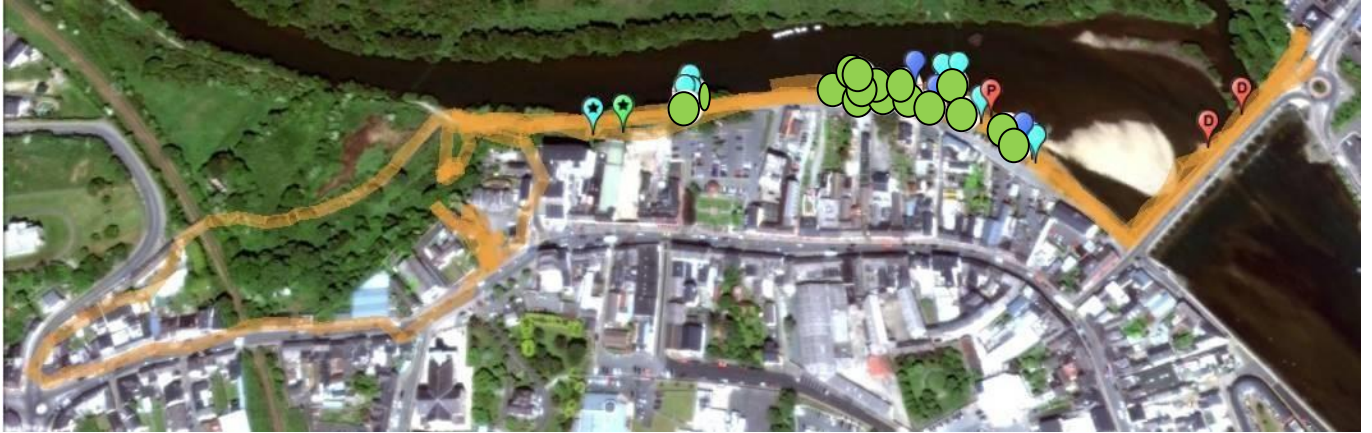
**Figure 2. Bat activity along the south bank of the Avoca River October 17<sup>th</sup> 2016.**

The orange track shows the survey route.

Green circles = common pipistrelles, Blue paddle = soprano pipistrelle, Purple paddle = pipistrelles and Daubenton's, "D" = Daubenton's, P = 2 pipistrelle species \* indicates pre-dawn bat signals

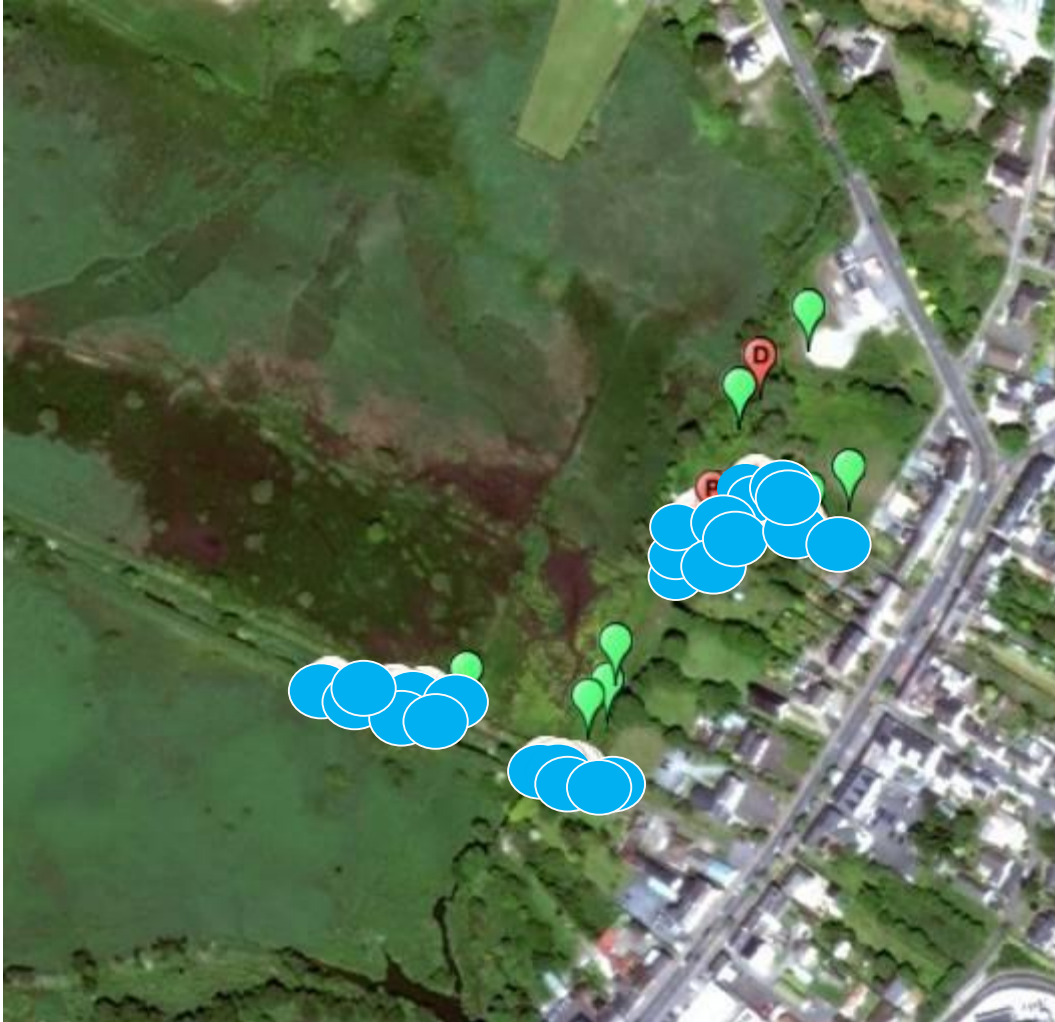
**Figure 3. Bat activity to the north of the Avoca River October 19<sup>th</sup> 2016**

The majority of signals are shown as blue circles and represent soprano pipistrelles

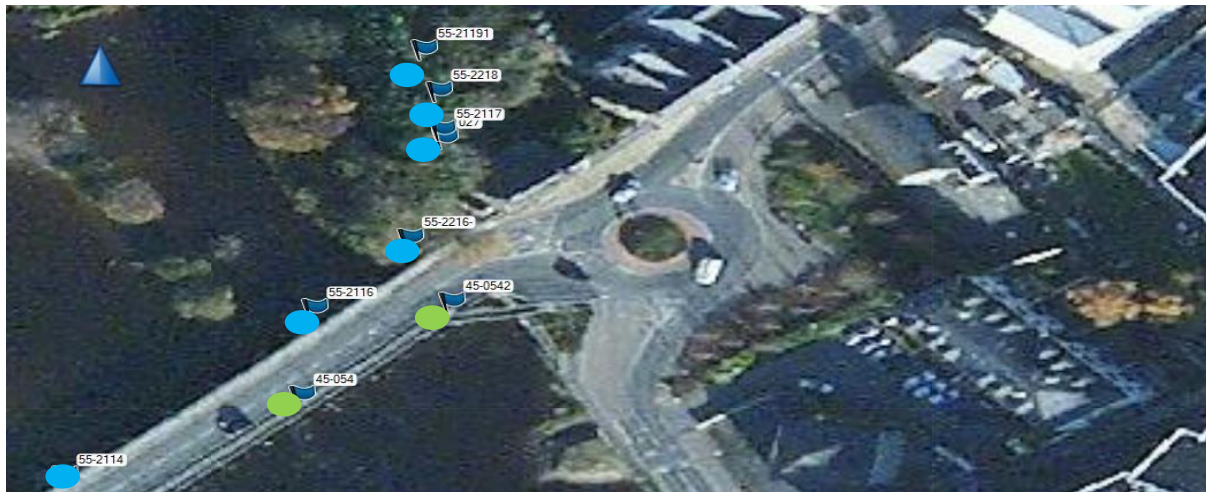
3. Northern end of Arklow Bridge; Blue circle = Soprano pipistrelle, Green circle = Common pipistrelle

**Figure 4. Bat activity from the Alps to Arklow Bridge in August 2017**

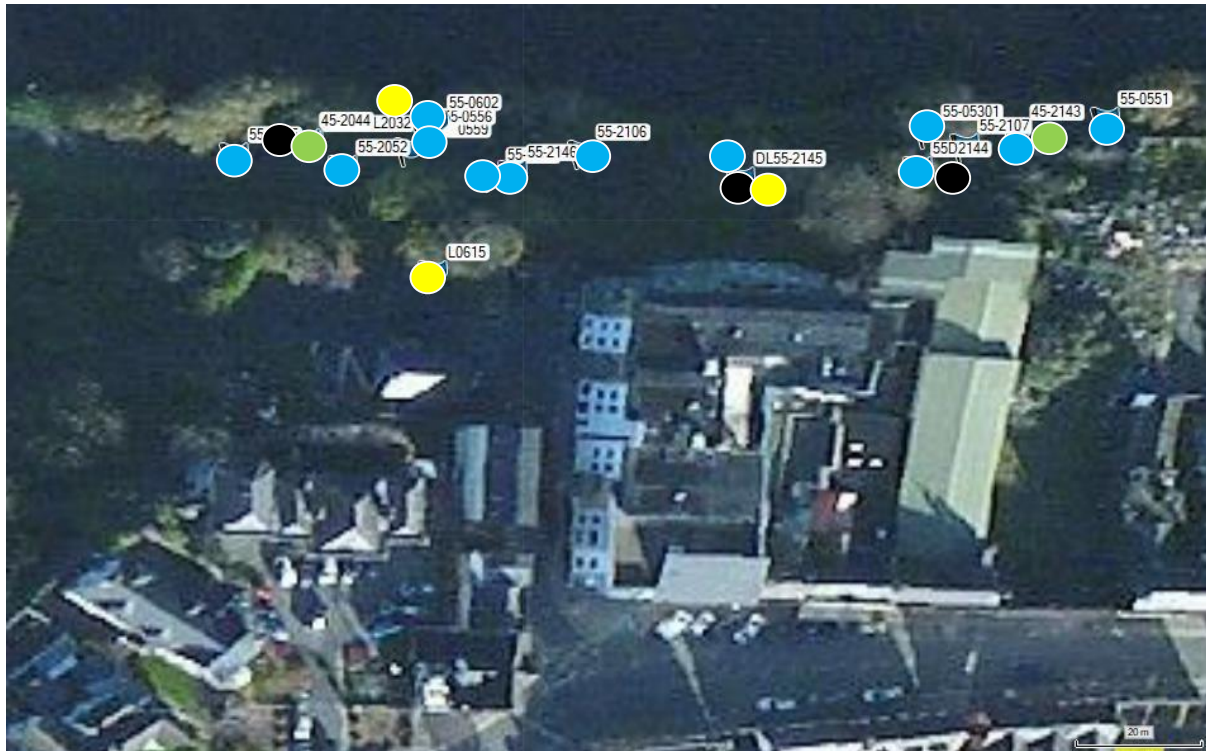
**Figure 5. Bat activity around the Alps and Arklow Castle in August 2017**

Blue circle = Soprano pipistrelle, Green circle = Common pipistrelle,

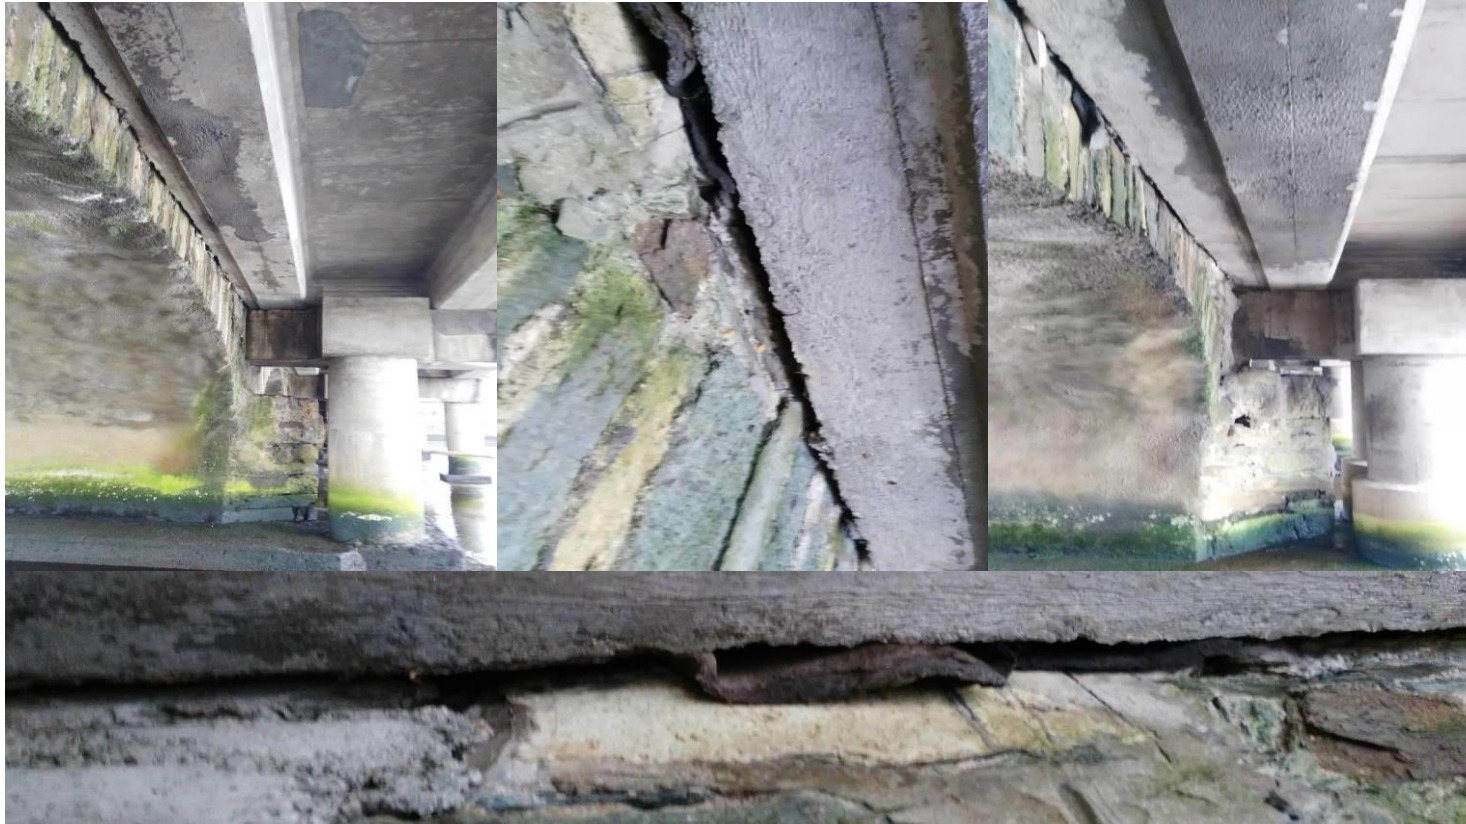
**Figure 8. Crevices under which bat droppings indicate use of Arklow Bridge by roosting bats T2530673188**

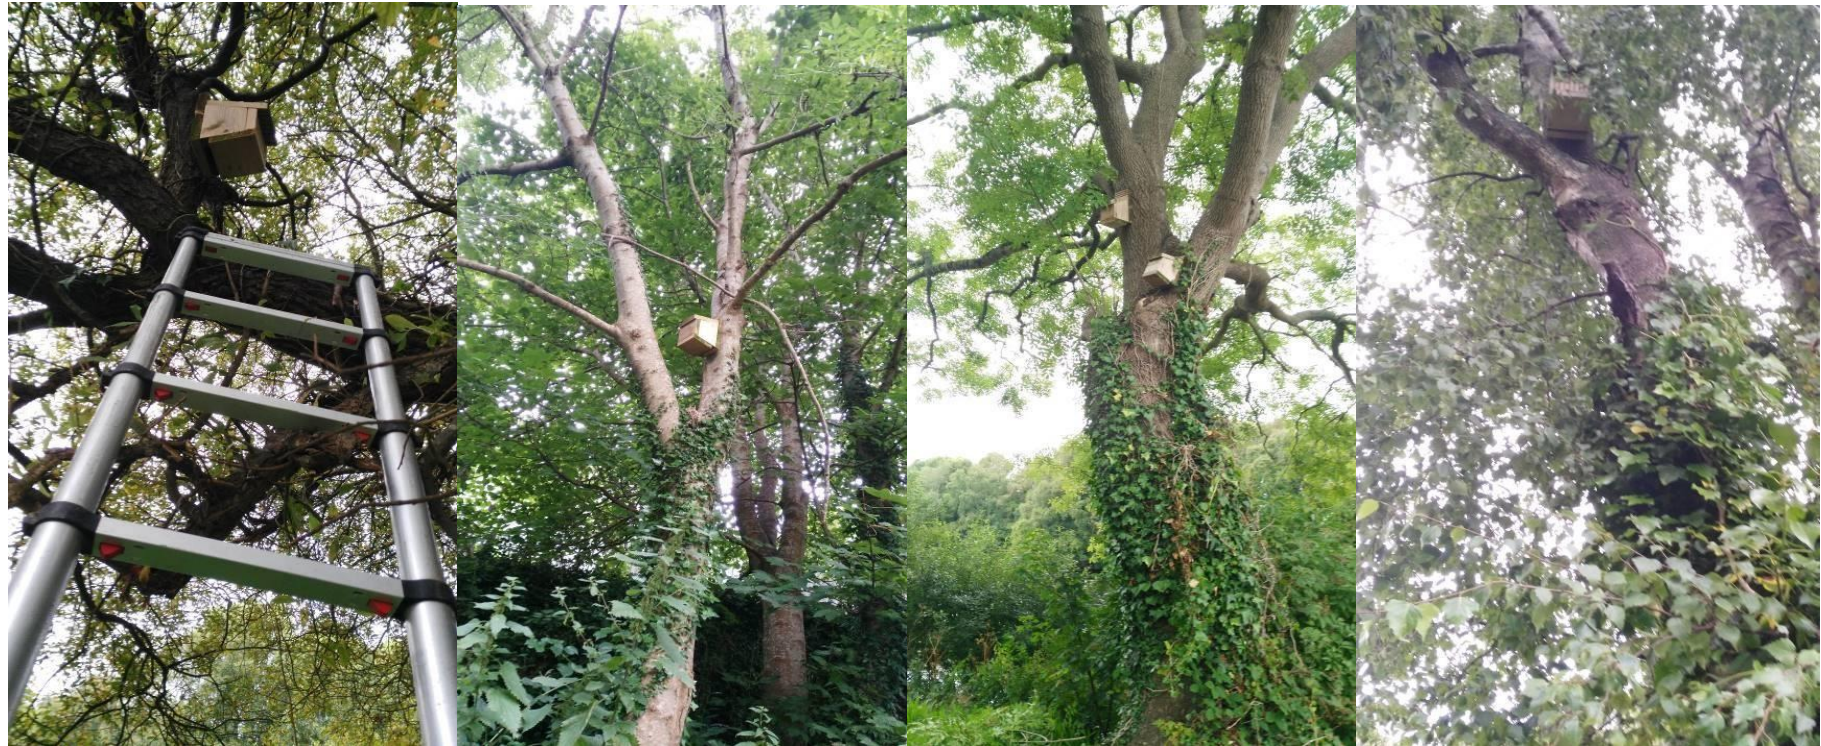
**Figure 9. Bat boxes examined at River Walk along the Avoca River in 2017**

None of these bat boxes were used by bats in 2017

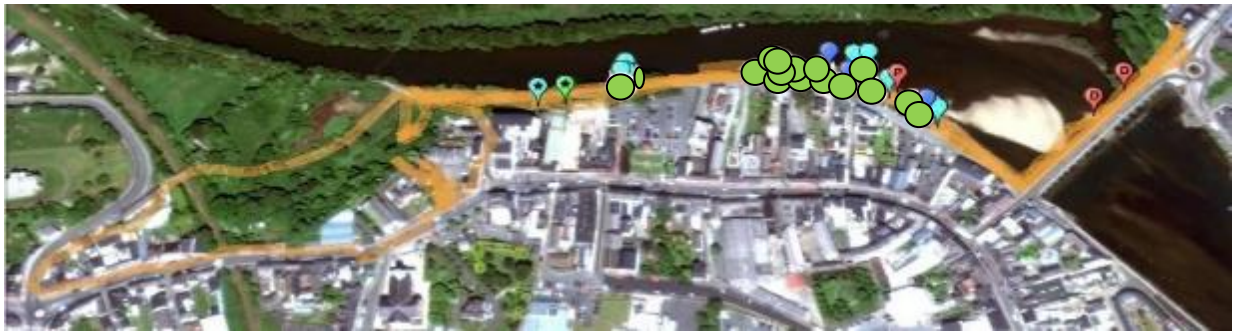
**Bat activity along the River on October 17<sup>th</sup>, 2016**

Green circles = common pipistrelles      Blue paddle = soprano pipistrelle  
Purple paddle = pipistrelles and Daubenton's  
"D" = Daubenton's      P = 2 pipistrelle species \* indicates pre-dawn bat signals

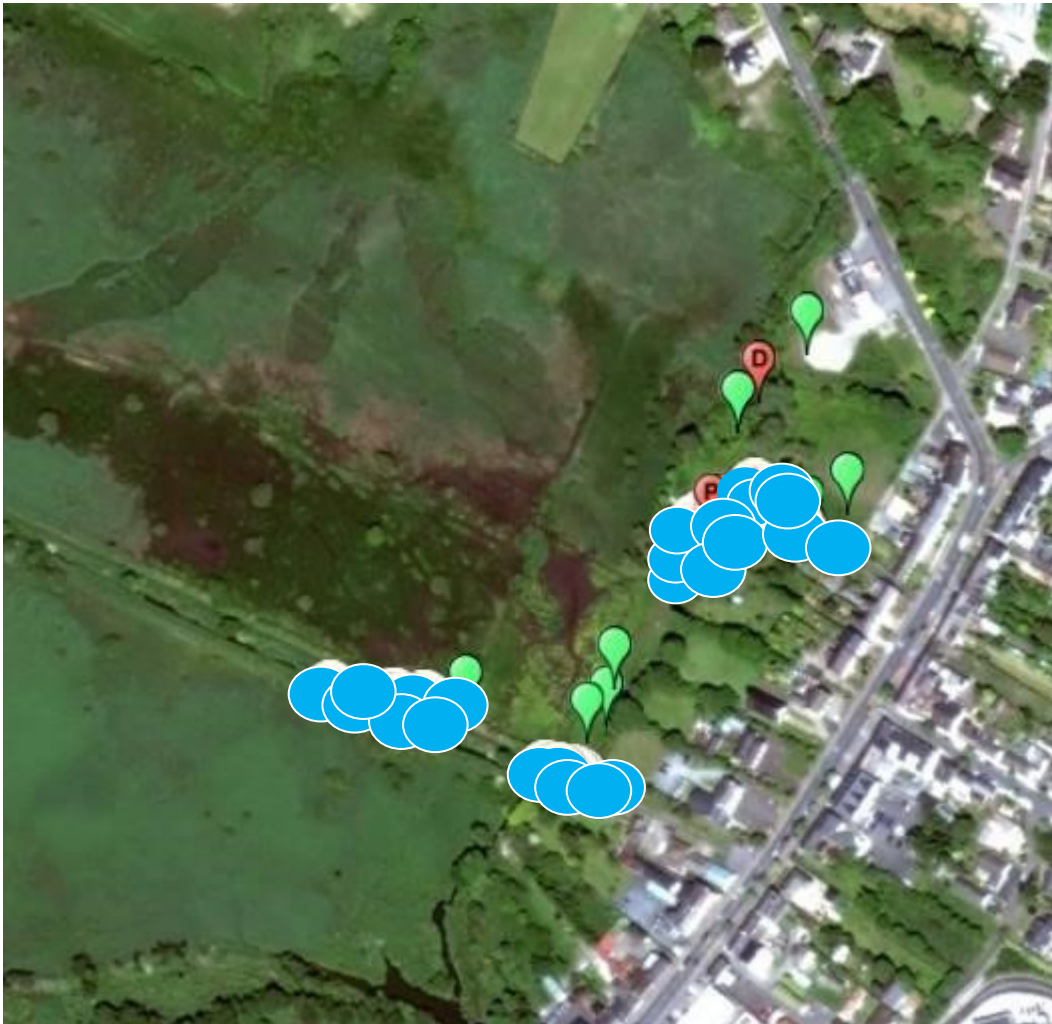
**Bat activity around the proposed FRS site October 19<sup>th</sup>, 2016**

The majority of signals are shown as blue circles and represent soprano pipistrelles  
Green paddle = Common pipistrelle      "D" = Daubenton's      P = 2 pipistrelle species at the same time

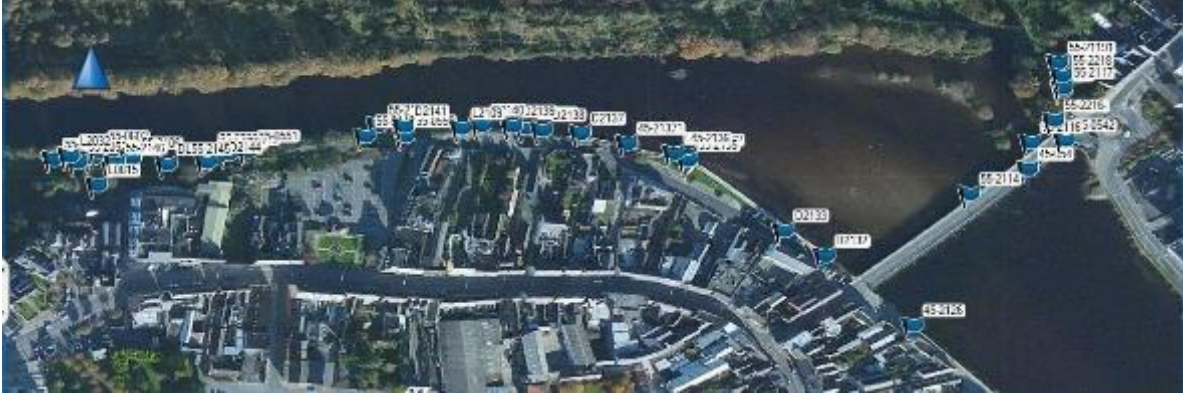
**Bat activity along the River on October 17<sup>th</sup>, 2016**

Each flag denotes a recording for an individual bat at the time indicated by the last four-digit number

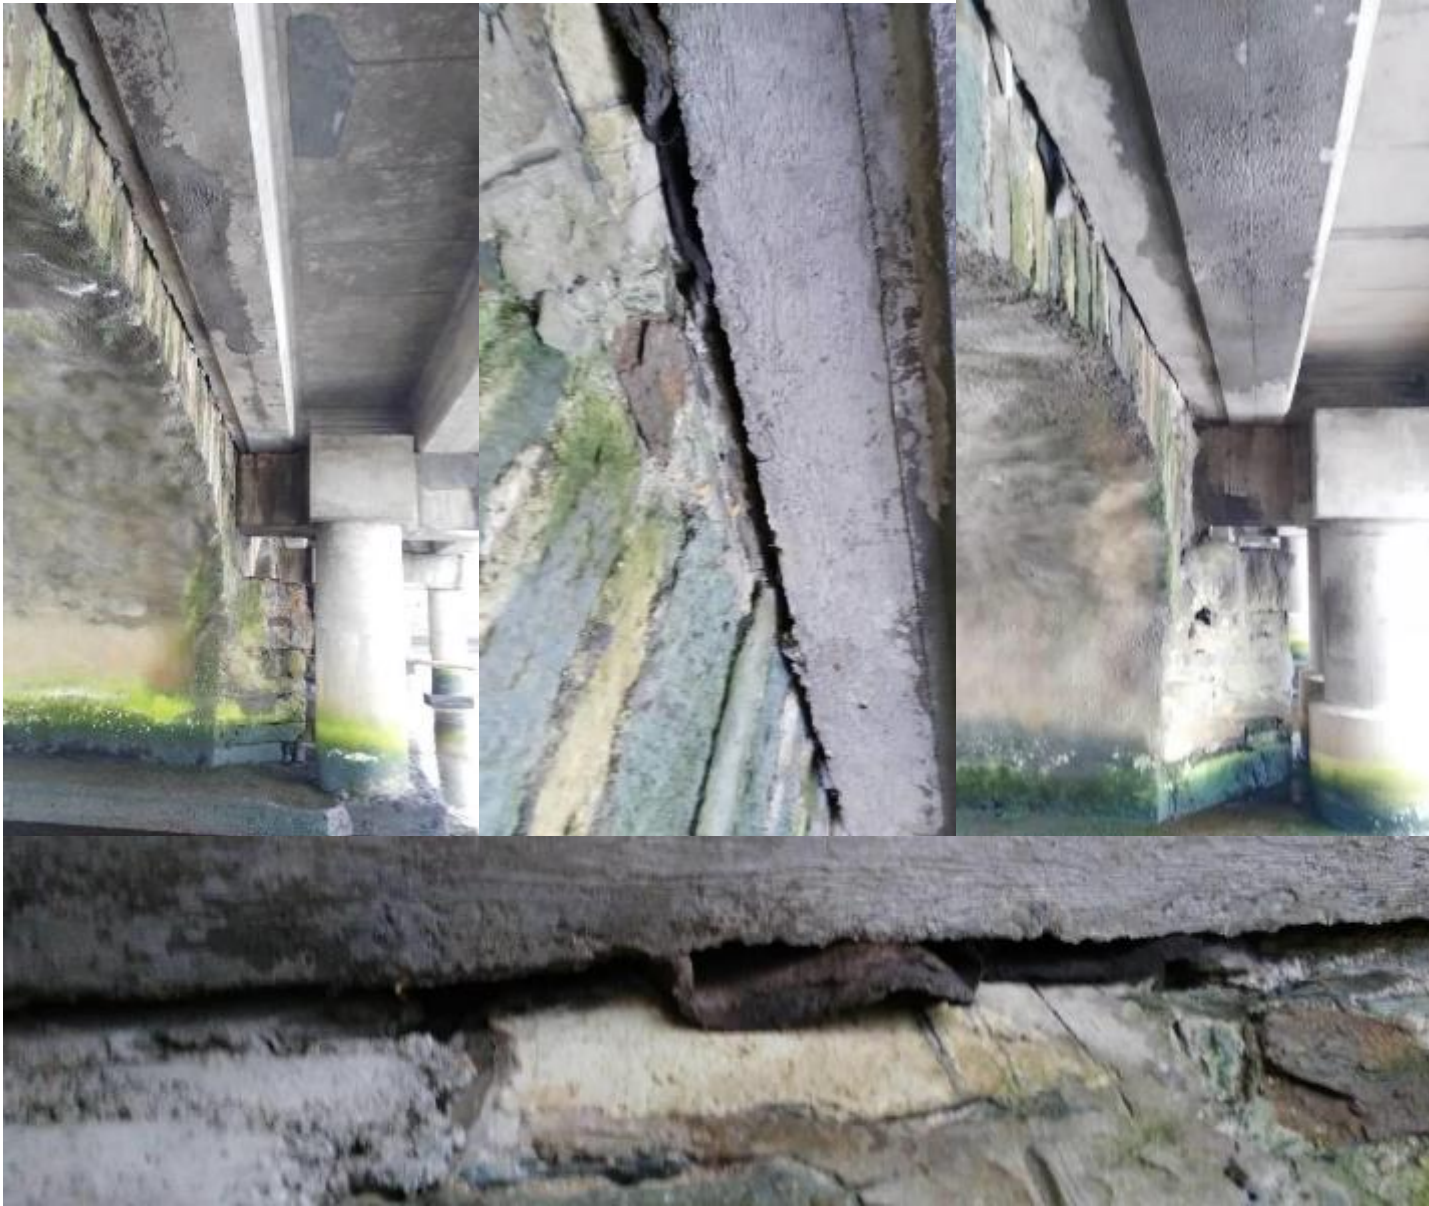
**Bridge crevices under which bat droppings indicate use of the bridge by roosting bats T2530673188**
