Arklow Flood Relief Scheme

# Screening Statement for Appropriate Assessment and Natura Impact Statement

**Arklow Flood Relief Scheme**  
**Screening Statement for Appropriate Assessment**  
**and Natura Impact Statement**

**May 2021**

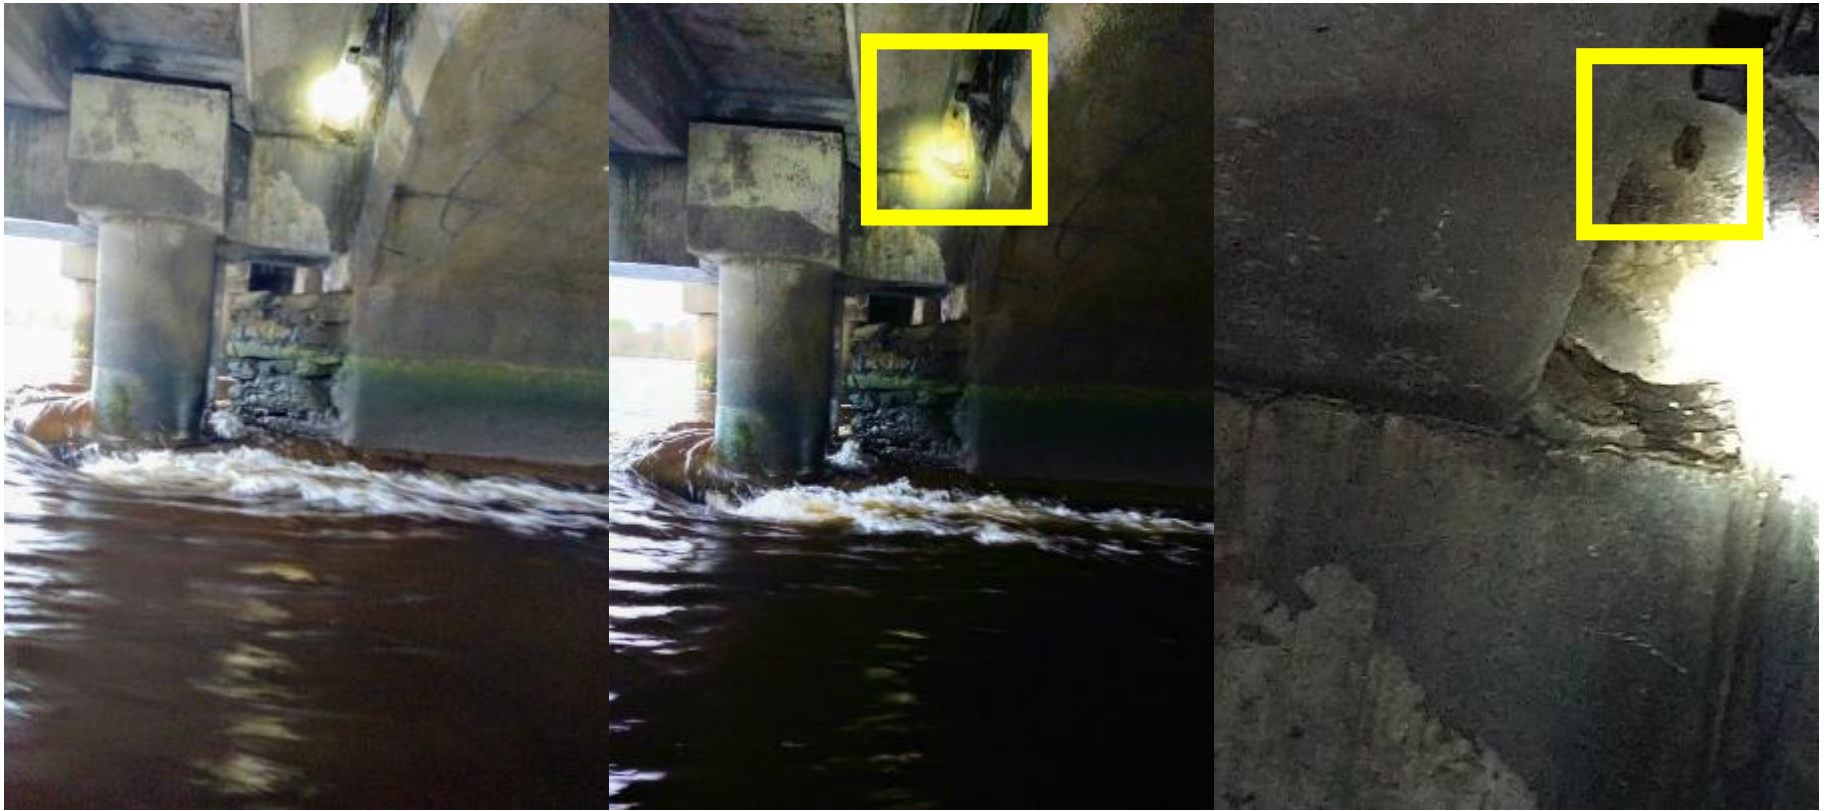
**Daubenton's bat on the southernmost arch of Arklow Bridge November 17<sup>th</sup>, 2020**

A Daubenton's bat was noted on the wing wall at the first arch from the town centre direction (southern end of the bridge) on 17<sup>th</sup> November 2020. This bat was inactive and did not move during the period of observation. However, a Daubenton's bat was noted at the bridge two hours after sunset by two separate monitors and is almost certain to have been this bat departing the site possibly to feed or re-locate roost following disturbance. The water flow was too strong to allow examination of all arches and in all 5 of the 19 arches were examined.

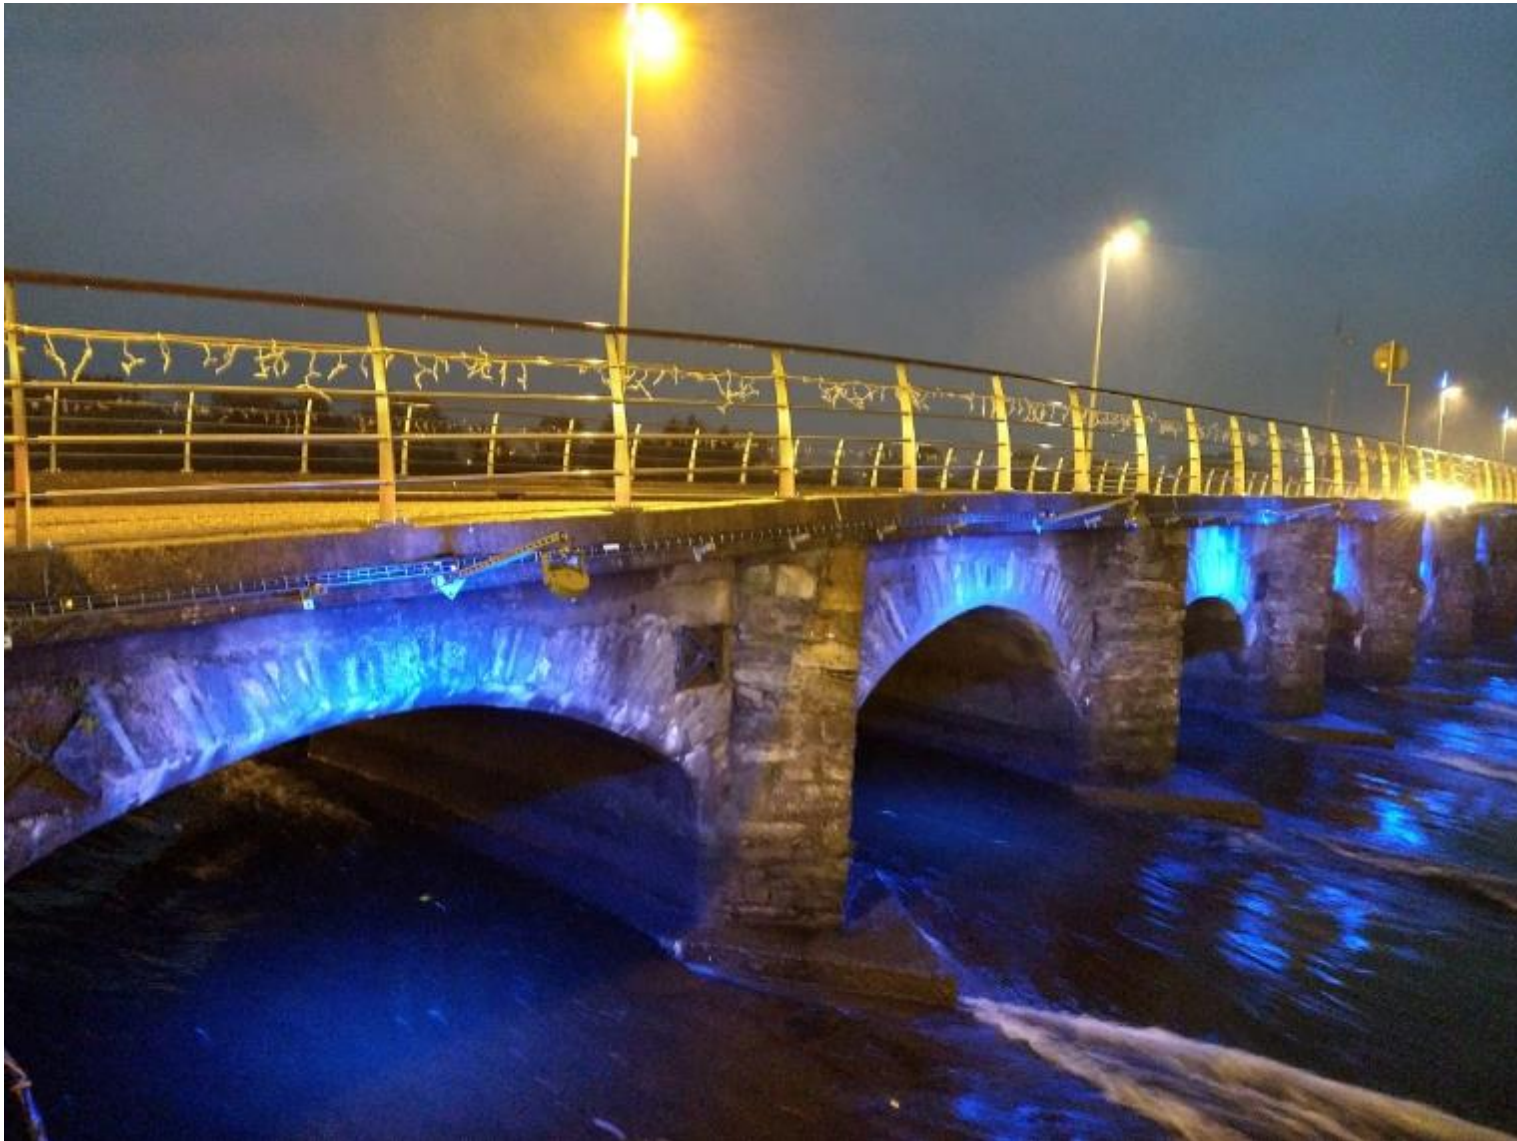
**Existing lighting of the bridge. Most illumination is to the east while bats roost to the west. Nonetheless, lighting has increased considerably since 2017**

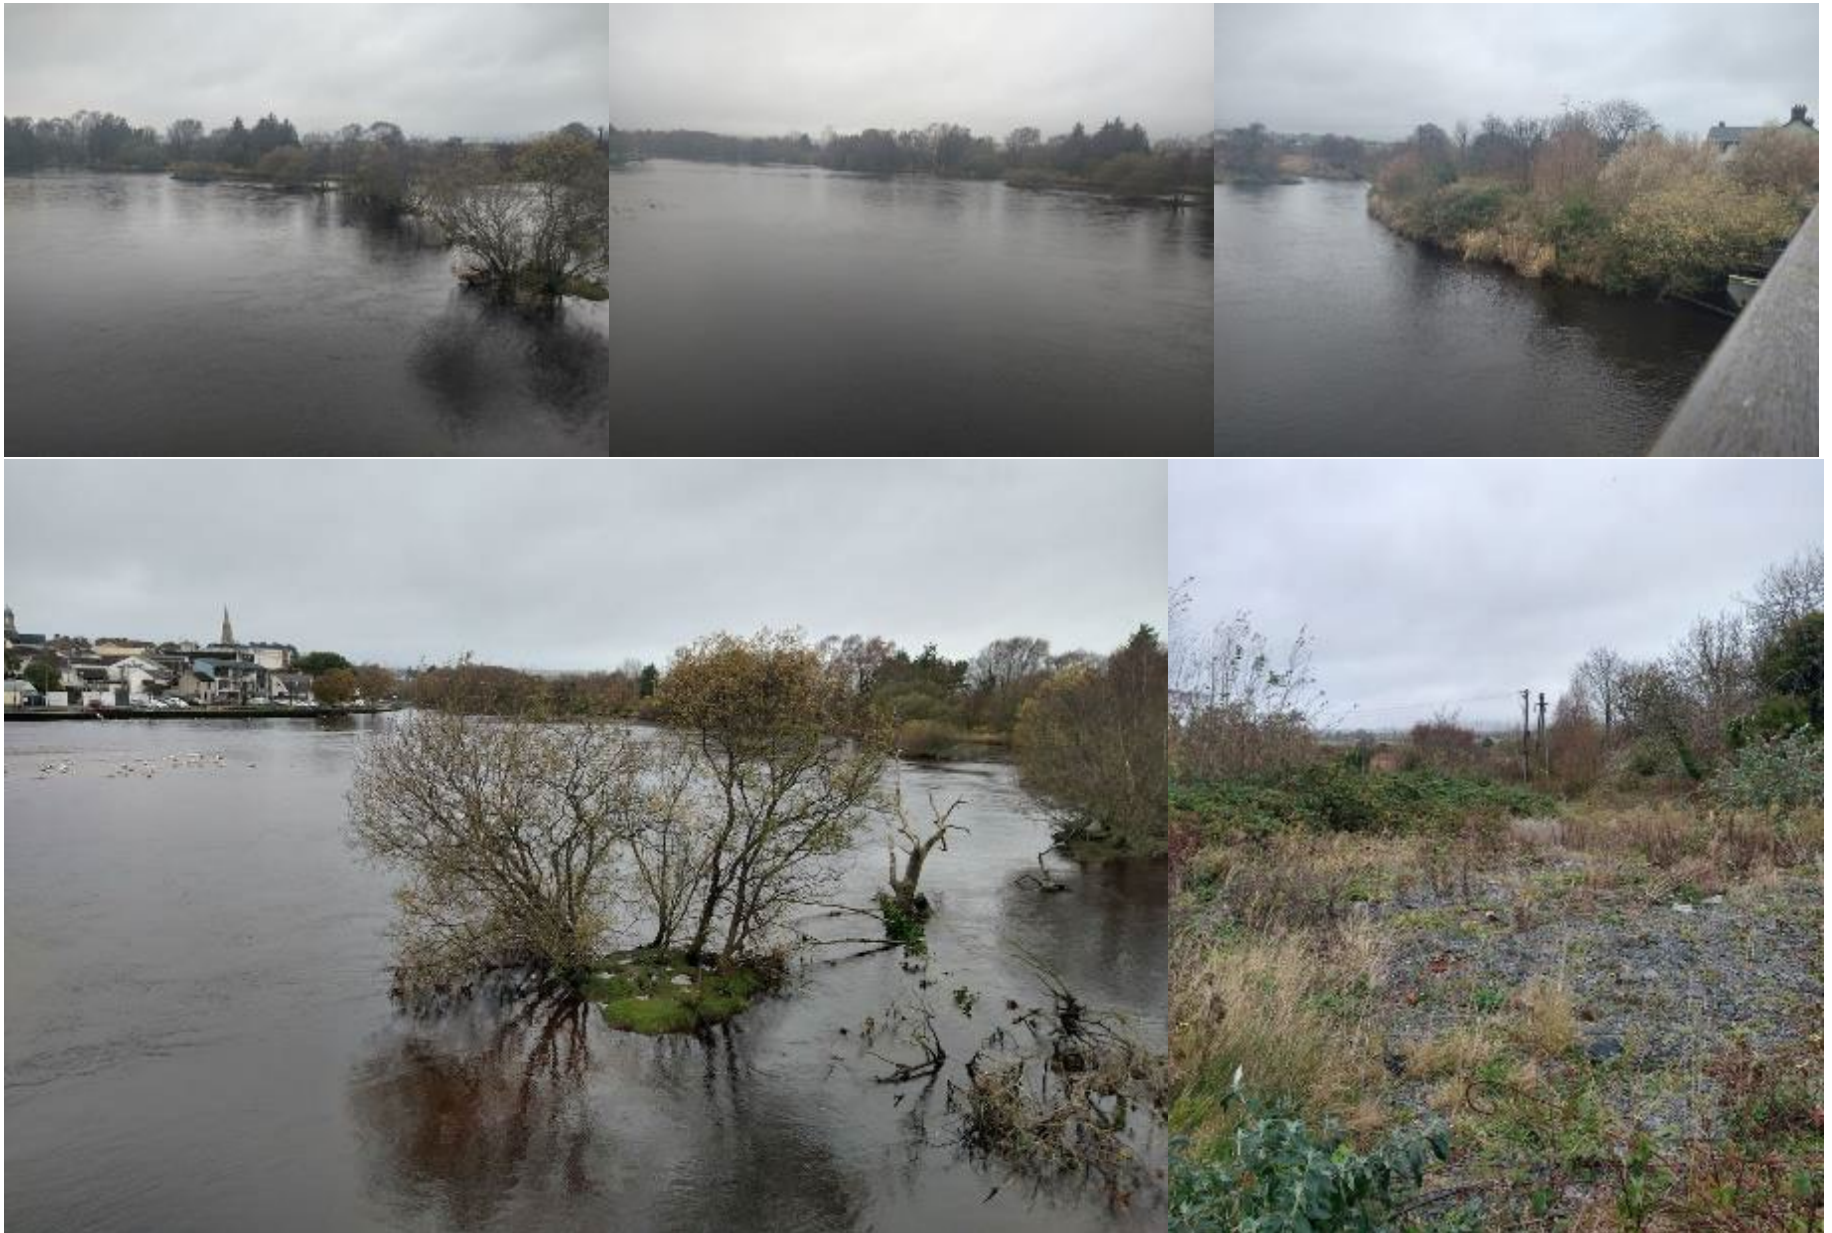
**Trees and islets that will be removed by the scheme**

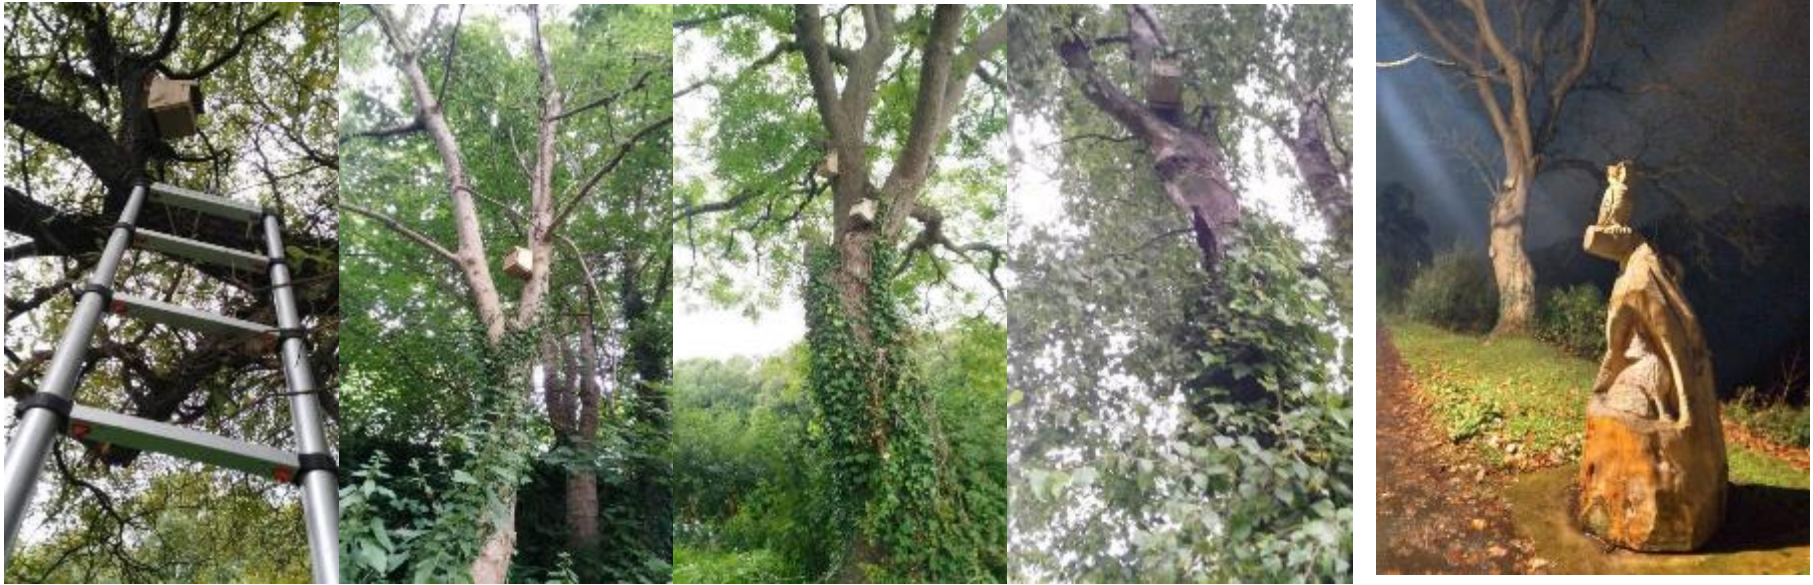
**Bat boxes examined along the Avoca River in 2017**

None of these bat boxes were used by bats. The tree on the right was photographed in 2020 with a greater level of lighting evident.

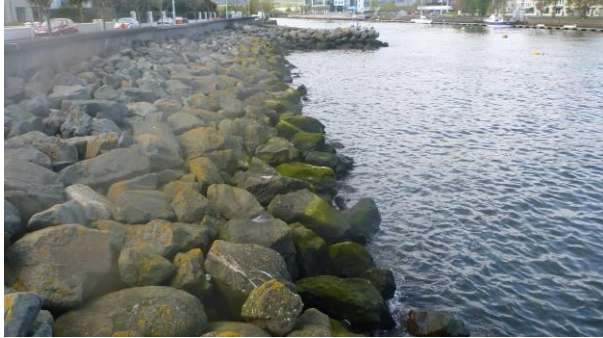
**Plate 11:** Rock armour showing algae and lichens

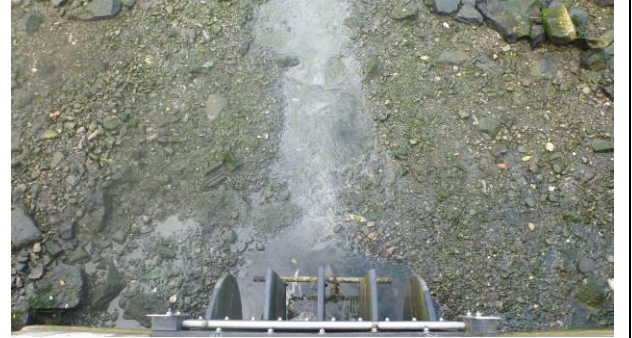
**Plate 12:** Sewage fungus at flap valve on the South Quay

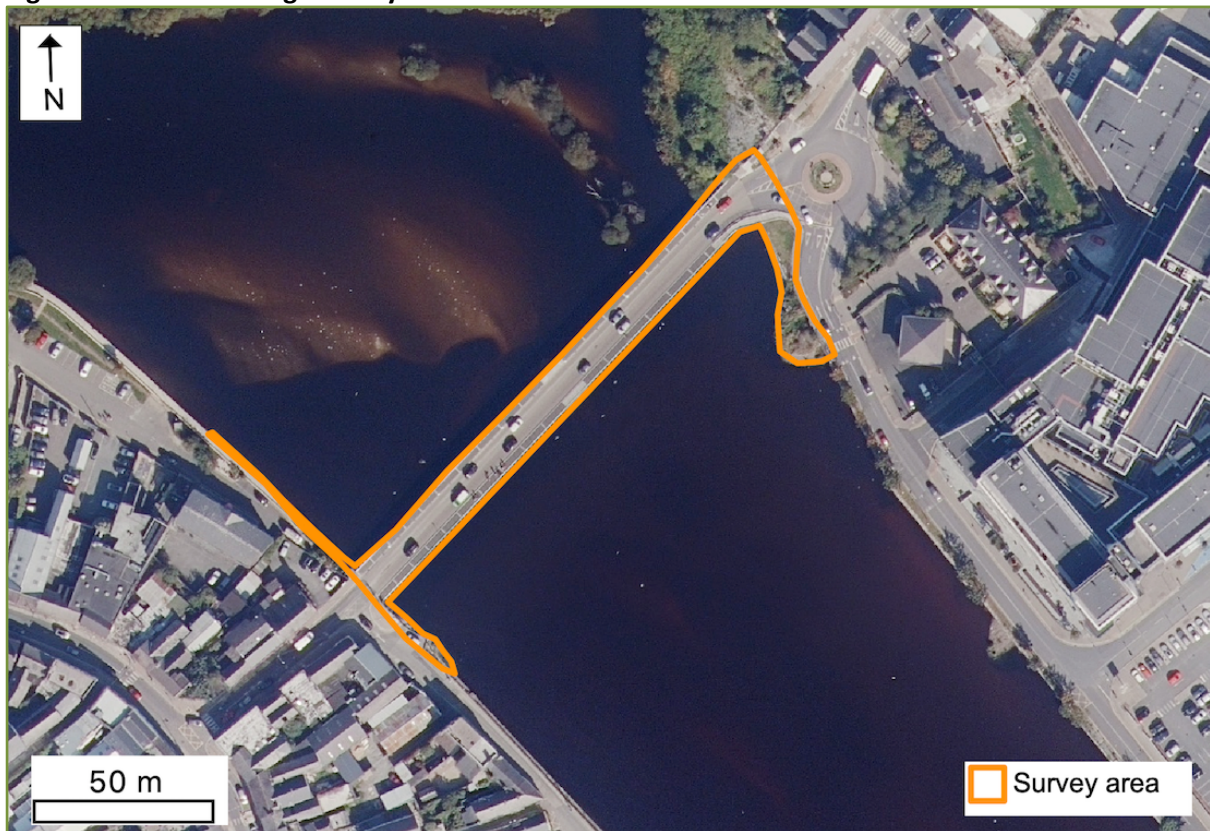
Figure 1.1. Arklow Bridge survey area

The site location is shown in Figure 1.1. The project area includes accessible areas of the bridge and adjacent watercourse edge. The bryophyte habitats surveyed include aquatic species on stonework and stones below high tide level, saxicolous species on the bridge above high tide level and terrestrial species on disturbed soil adjacent to the watercourse at the high tide level.

The site was walked over by an experienced bryologist in November 2020. The site survey area is shown on Figure 1.1. All accessible areas of the site that were considered of potential interest for bryophytes were surveyed (see also Section 2.6 'Limitations' below). All bryophytes encountered in the field were recorded on a recording card.

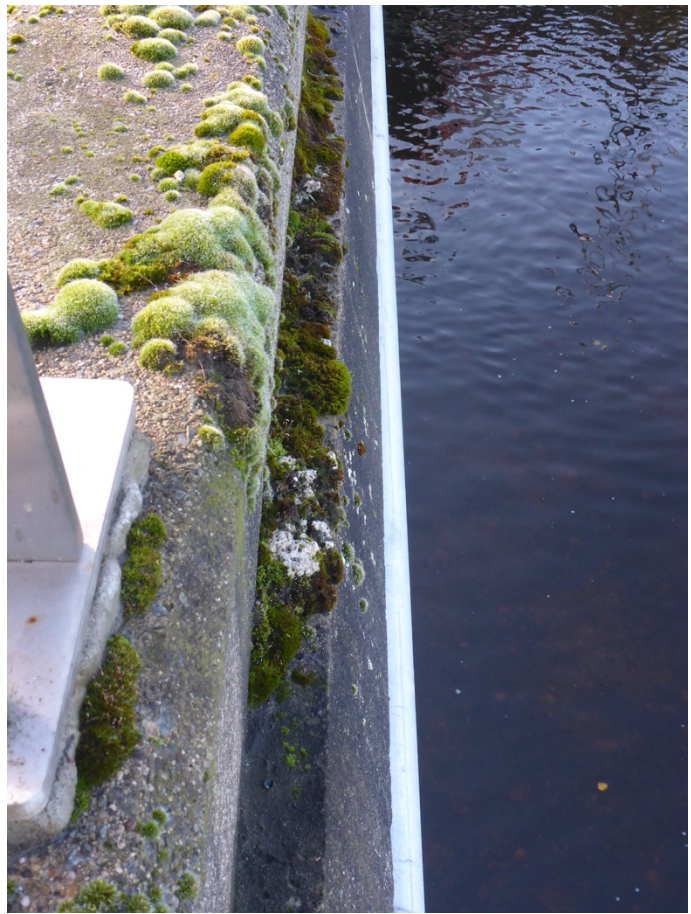
Photograph 3.2. *Grimmia pulvinata* on top surface of concrete on bridge. W side of bridge.

- concrete at the top of the bridge on either side (above high tide level) (Photographs 3.1 to 3.4);
- bridge stonework (below high tide level) Photographs 3.5 to 3.6);
- walls and stonework at the edge of the river upstream and downstream of the bridge (between low and high tide levels) (Photographs 3.7 to 3.8);
- disturbed soil at the edges of the riverbank below the bridge (at high tide level) (Photographs 3.9 and 3.10).

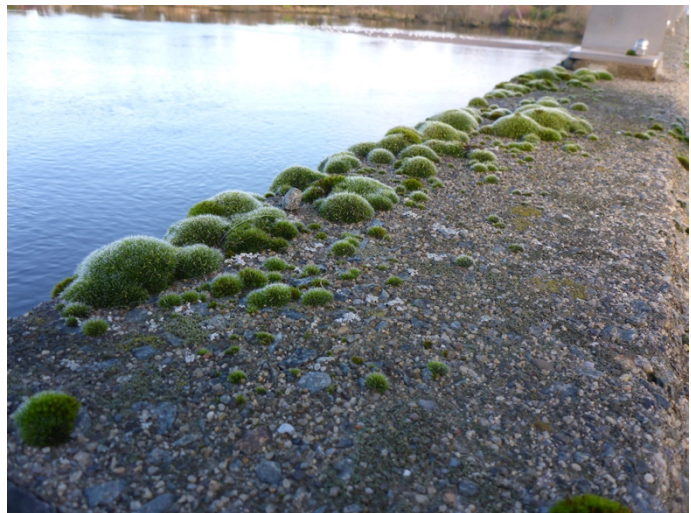
Photograph 3.3. *Schistidium crassipilum* and *Orthotrichum anomalum* on the side of the concrete surface at top of bridge. W side of bridge.

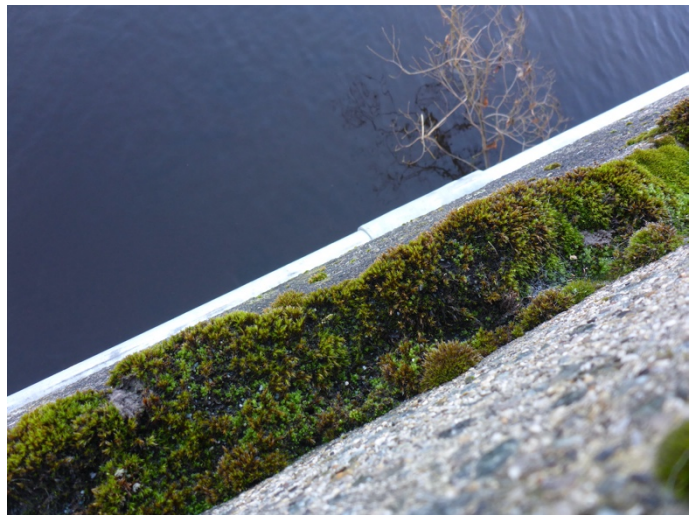
Photograph 3.4. *Syntrichia latifolia* and *Syntrichia ruralis* on concrete at the N end of W side of the bridge.

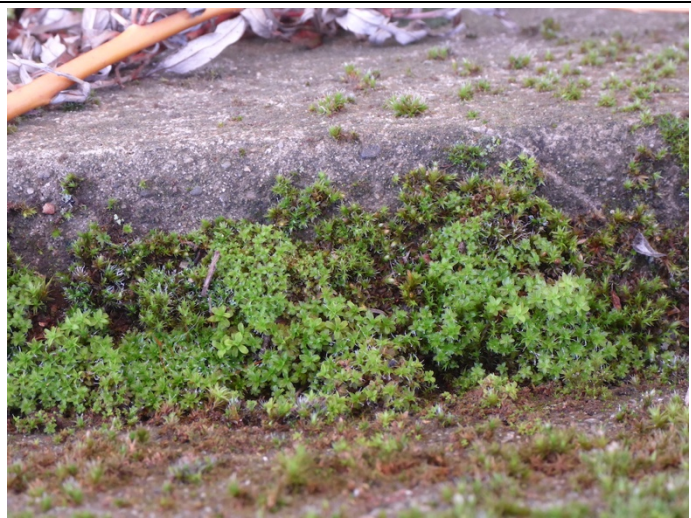
Photograph 3.5. Stonework on bridge arches (above high tide) has little/ no bryophyte cover. E side of bridge.

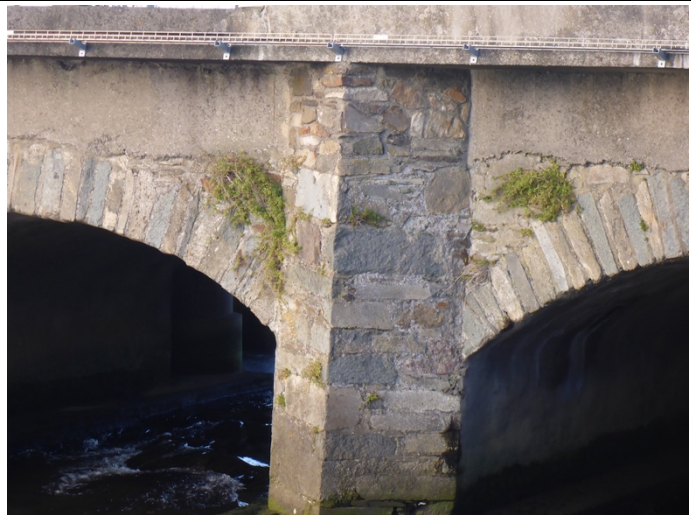
Photograph 3.6. Stonework on bridge arches (below high tide) has little/ no bryophyte cover. Red arrows show the small amount of aquatic moss *Fontinalis antipyretica*. E side of bridge.

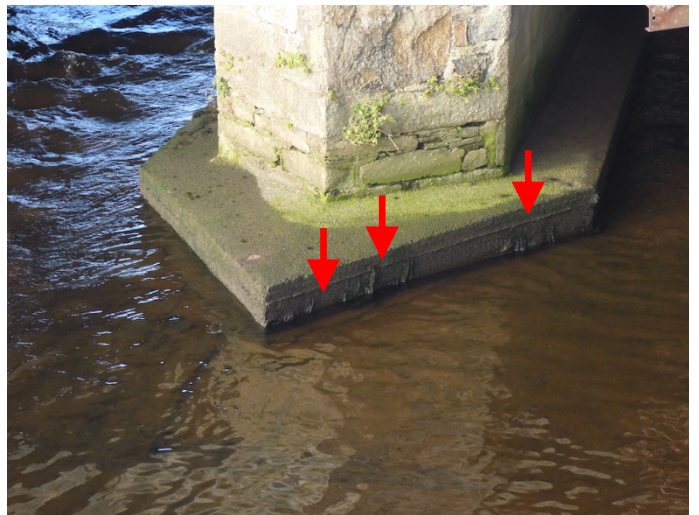
Photograph 3.7. Absence of aquatic bryophytes on stonewall and gravel downstream of bridge. Red arrow indicates high tide level. N bank of the river.

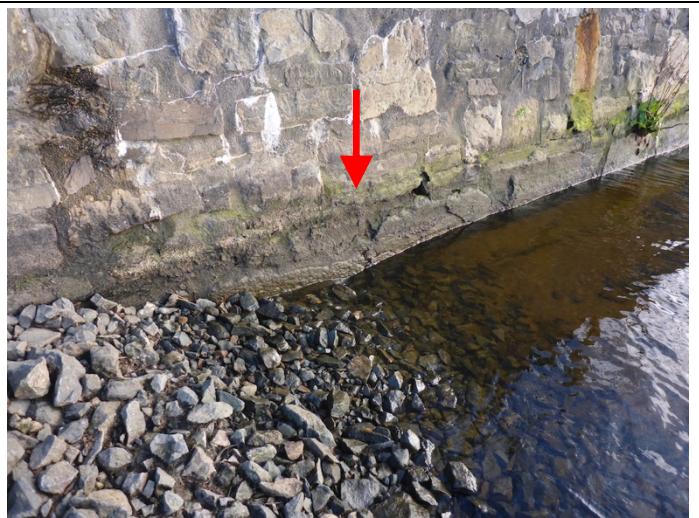
Photograph 3.8. Concrete wall and stonework at the edge of the river, downstream of the bridge. Bryophytes locally frequent and dominated by urban species of walls and disturbed ground. S bank of the river.

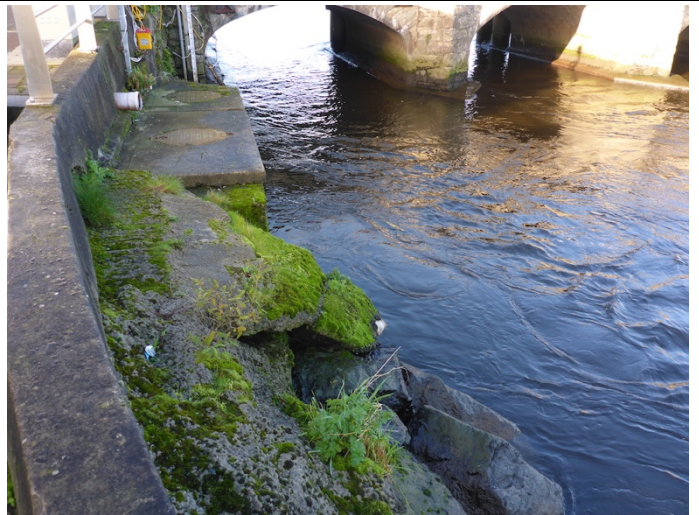
Photograph 3.9. The aquatic moss *Fontinalis squamosa* (red arrow) on gravel downstream of the bridge, between the high and low tide levels. N bank of the river.

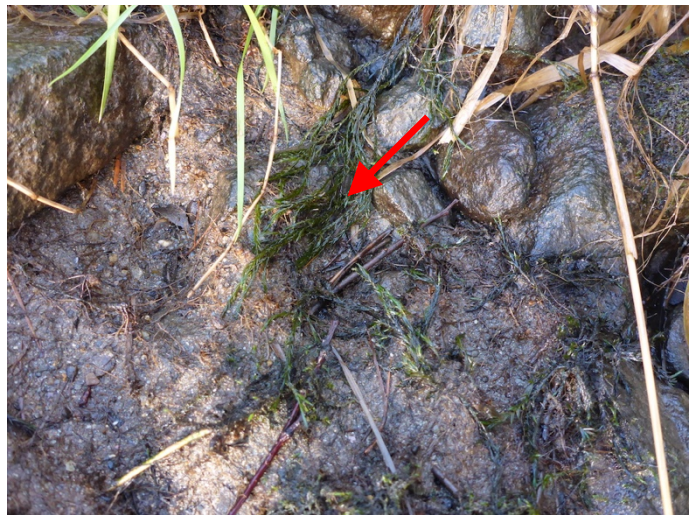
Photograph 3.10. The aquatic moss *Leptodictyum riparium* growing below high tide level on soil between boulders downstream of the bridge. S bank of river.

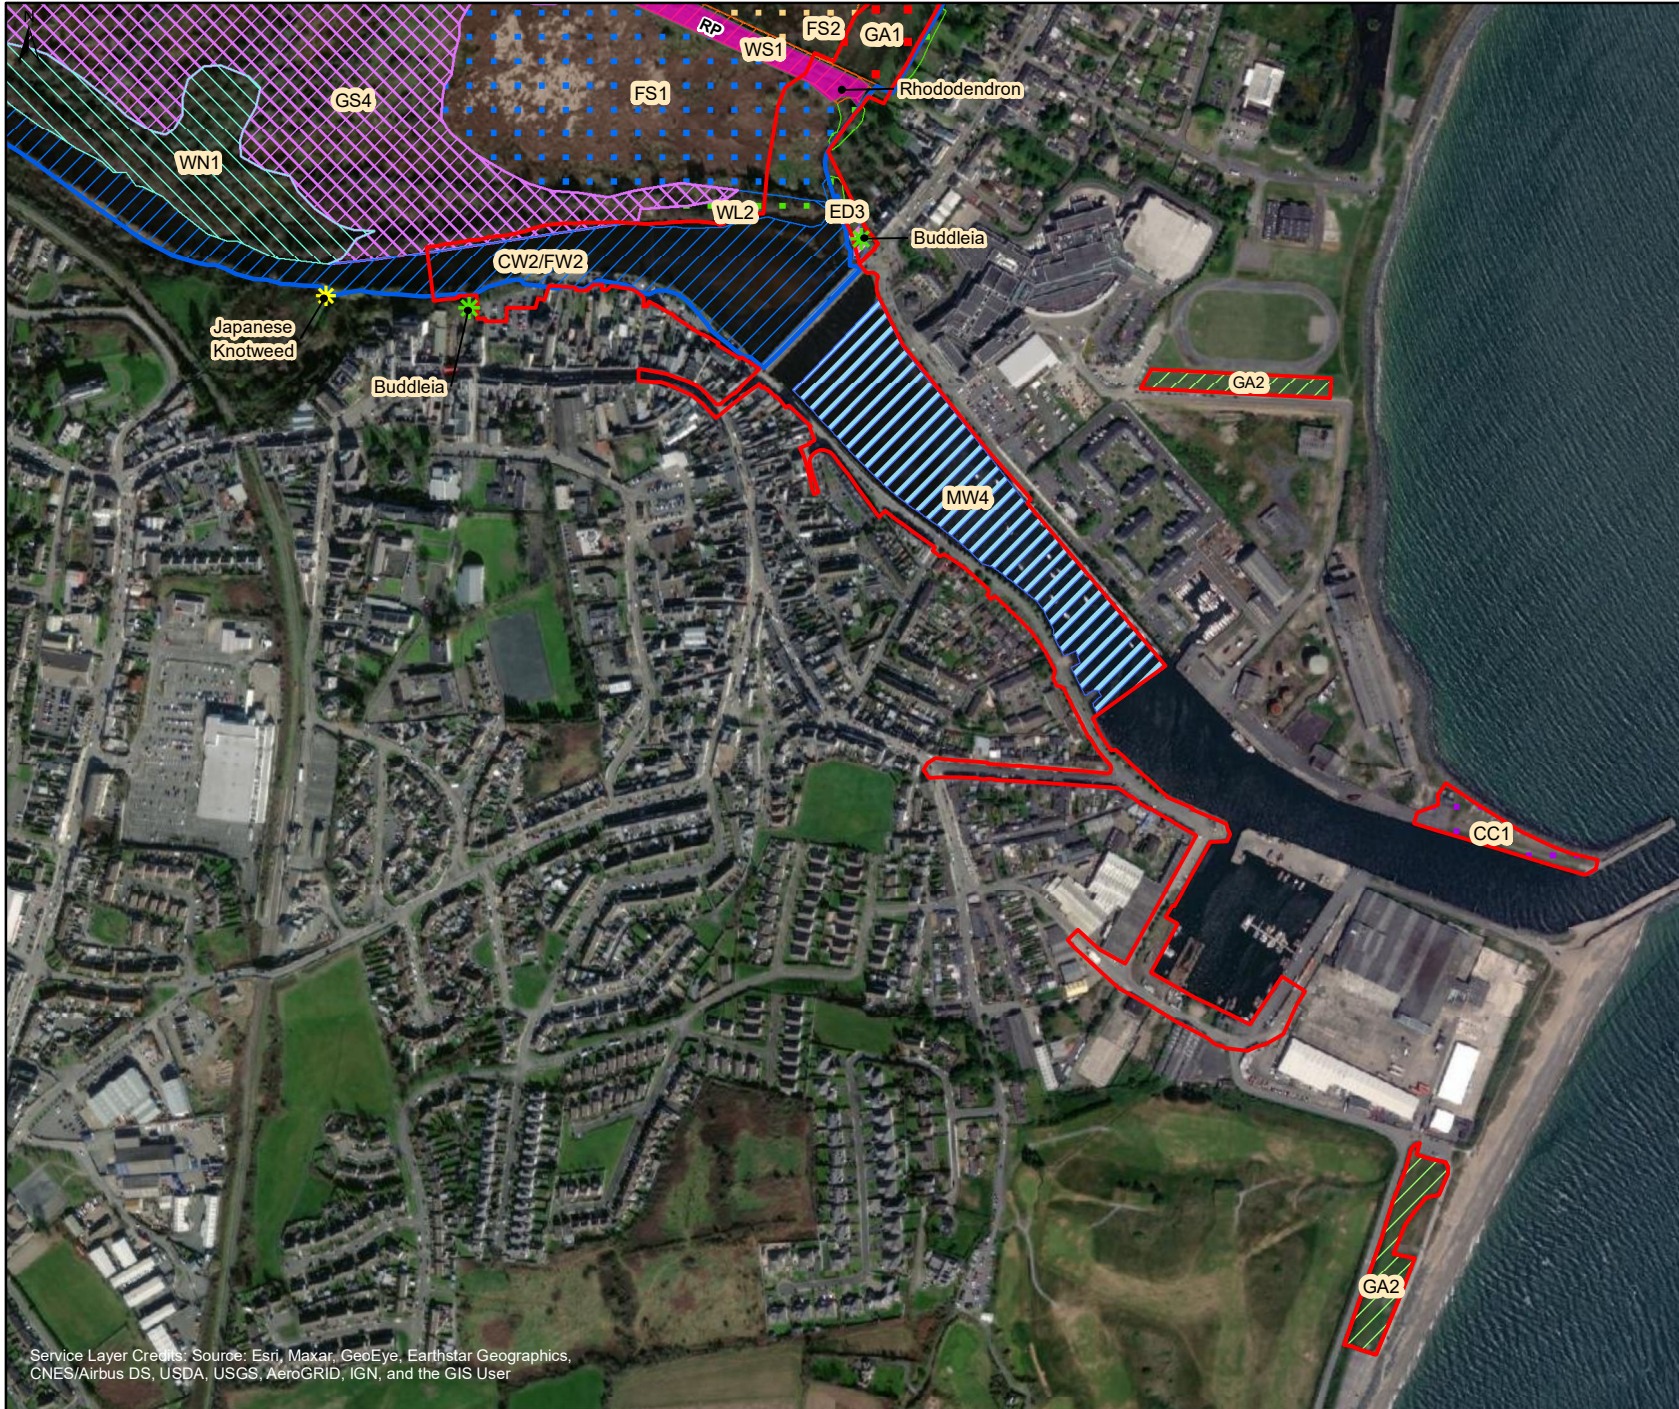
Drawing No <b>001</b>	Issue <b>I1</b>
--------------------------	--------------------

- Arklow FRS Boundary
- pNHA Boundary
- Invasive Species (Approximate location, do not rescale)**
- HB Himalayan Balsam
- RP Rhododendron ponticum
- ✱ Buddleia
- ✱ Japanese Knotweed
- Habitat**
- CC1 Sea walls, piers and jetties
- CW2 Tidal rivers/FW2 Depositing lowland rivers
- ED3 Recolonising bare ground
- FS1 Reed and tall sedge swamps
- FS2 Tall-herb swamps
- GA1 Improved agricultural grassland / GS4 Wet land
- GA2 Amenity grassland
- GS4 Wet grassland
- MW4
- WL2 Treelines
- WN1 Oak-birch-holly woodland
- WS1 Scrub
- WS1 Scrub / GS4 Wet Grassland
