**Street Route Accessibility Audit
For
Blessington & District Forum**

Accessibility Audit

BLESSINGTON MAIN STREET, CO WICKLOW

For Blessington & District Forum

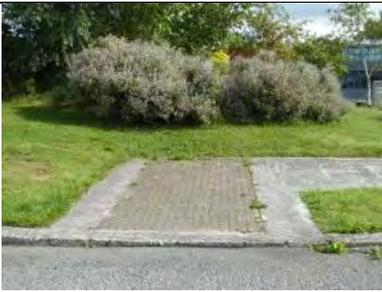
1.4	Dished pavements on pedestrian route to playground	All of the crossing points leading to the playground within the housing estate had dropped kerbs and blister paving but the dropped kerbs are not always flush or with a small lip.

Refer: Good practice guidelines on accessibility of streetscapes and BS8300-1. Lip should be a maximum of 6mm high and blister paving should extend across full width path where level with the road junction.	3

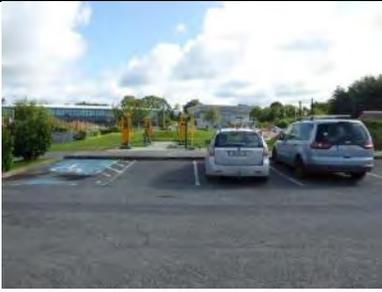
1.5	Designated parking at the playground	There is one designated accessible parking bay at the playground but no designated family parking. The designated accessible bay does not accord with current standards. See 1.2

BS 8300-1: 2018Section 7.4.1 <i>.... If there is an evidenced need, parent and child parking spaces should be provided in addition to any other designated/assigned parking spaces..... These are to be designated with a suitable parent and child sign. Such spaces are to be provided with extra room around the vehicle. This space provides additional room that is required to load the small child, associated baggage, and pushchair or stroller into the vehicle.</i>	2

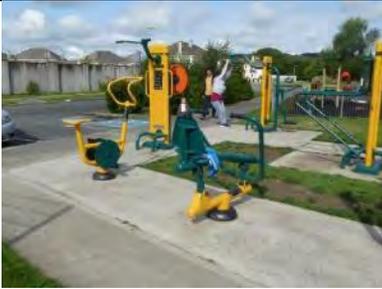
1.6	Outdoor gym	The outdoor gym and exercise equipment is an excellent addition to the playground area and much of the equipment is suitable for people of varying abilities. Despite signage indicating that certain items are usable by wheelchair users it was not clear that they were.

See 1.7 below	2

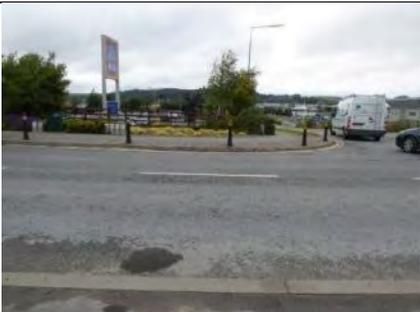
1.8	Corner of Oak Drive & N81	For pedestrians approaching from the north on the N81 there are no dropped kerbs /dished crossings on the east side of the N81 to permit level crossing to Oak Drive or from the Maxol Station to the footpath at Aldi.

Traffic Management Guidelines 2003 10.7 Dished crossings should be provided at locations where pedestrians will cross regardless of the provision of a pedestrian phase. ...(see Diagram 13.1)	1

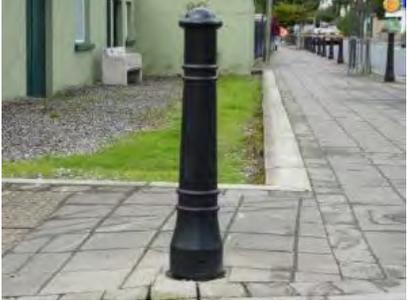
1.10	Bollards	Several black bollards through the town have no reflective bands at the top and are located where they restrict clear access and circulation.

<p>TGD-M:2010 1.1.3.1 General (e) low level posts e.g. bollards should not be located within an access route. Wherever bollards are provided they should contrast visually with their background (refer to 1.6.4)..... See also 1.13</p>

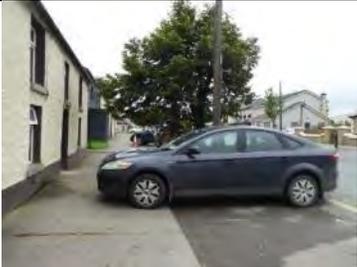
1.12	In front of Vincent's	In front of Vincent's there is a parallel parking bay with no kerb and a telegraph pole in the middle of the parking area. Cars were seen parking across the path.

Ensure measures are put in place to prevent cars parking across footpaths and initiate awareness raising	1
1.13	Junction of Access Road to St Kevin's Community Centre	Bollards are located on both radius corners on the direct line of travel with dished kerbs around the corner. On the southern side the corner leading to the dished kerb is only 1300mm wide making it difficult for people with buggies or mobility aids to turn the corner.

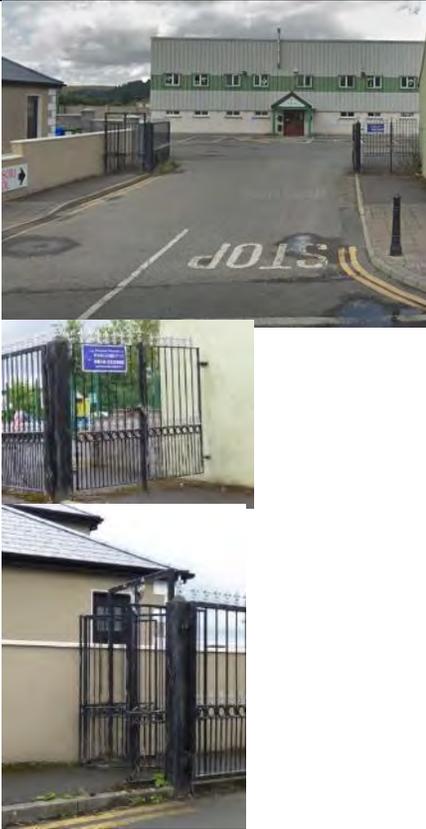
<p>1.14</p>	<p>Pedestrian gates to St Kevin's</p>	<p>Neither the pedestrian gates on the footpath leading to St Kevin's Community Centre are accessible. One is kept locked and the other is a turnstile. Thus pedestrians are forced on to the carriageway.</p>

<p>BS8300-1:2018 8.5.1 Gates Any side-hung gate on an accessible route should be capable of opening in both directions and of being opened easily with either hand, and should be self-closing. <i>NOTE 1 A gate that is self-closing under its own weight is preferable to one with a sprung hinge. NOTE 2 If the catch can be operated with a clenched fist it is likely that the design is acceptable.</i> Gates should be a minimum of 1 000 mm wide, and should have a 300 mm clear space to both the pull and push sides of the leading edge.</p>	<p>2</p>
<p>1.15</p>	<p>Murphy's Auctioneers to Printshop</p>	<p>There are no kerbs between the footpath and the parallel parking bays over a distance of approx. 120m on the east side of the road from Murphy's to "Punctual Print & Signs". The bays are approx. 3m deep without markings and are broken into sections by trees surrounded by raised kerbs. All cars were parked head on and oversailed the path causing significant obstructions. On the building side of the path there were also obstruction with shop displays and sandwich boards.</p>

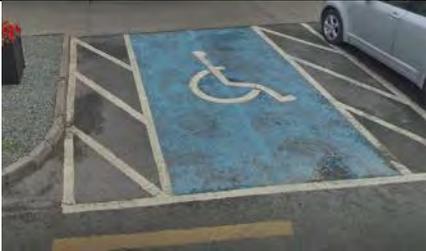
<p>1.16</p>	<p>Designated accessible parking bay opposite the flower shop</p>	<p>A designated bay diagonally opposite the flower shop has no rear access zone and substandard access zones both sides.</p>

<p>TGDM 2010:1.1.5 On Site Car Parking (d) the minimum dimensions of the designated parking bays should be in accordance with Diagrams 8 and 9; (e) A 1200 mm wide access zones should be provided on both sides and at the rear of each designated parking bay. The access zone at the rear of the parking bay should be clear of vehicular circulation routes. The access zone should contrast visually with the adjoining surfaces to ensure it is kept clear (refer to 1.6.4).</p>	<p>1</p>
-------------	---	--	--	---	----------

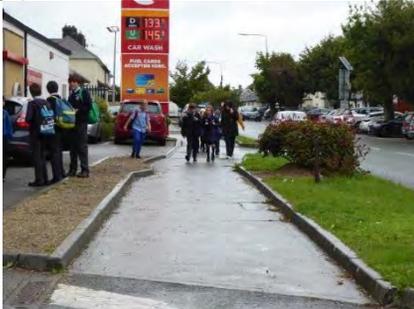
2.3	Route between St Mary's schools	Concern was expressed by a number of people about school children moving between the senior and junior schools at St Mary's. The route also passes by the entrance and exit to the Circle K filling station where children also use the shop.

Perhaps Circle K could be asked to erect signage alerting motorists to the presence of school children in this area as well as clearly visible road and footpath markings	1

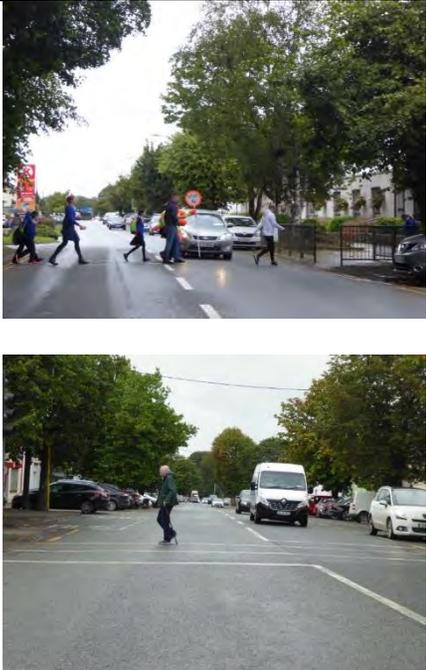
2.4	Road crossing at St Mary's School	At St Mary's junior school there is a school warden to assist with traffic at school hours but there is neither a controlled or uncontrolled crossing for use at other times.

Provide a correctly designed crossing at this point complete with necessary dished kerbs, road markings and tactile paving	1
2.5	Tactile Paving at St. Mary's	An uncontrolled and an unmarked road crossing is located at the school gate. There is no tactile blister paving on either side.

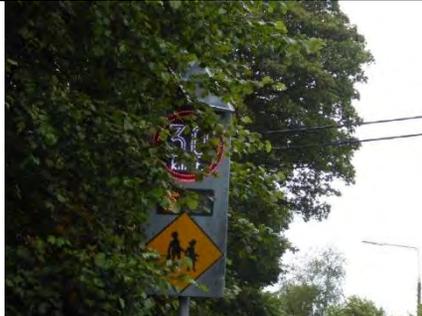
2.6	Concealed Speed limit sign	The speed limit sign at St. Mary's was completely obliterated by overhanging branches

Cut back branches and maintain clear	1

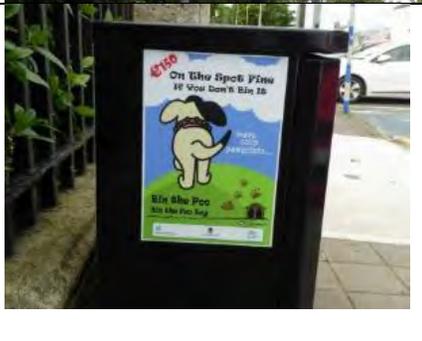
2.7	Litter bin at school gate	A black litter bin is located at the inside of the pavement at the school gate, where it creates an obstacle though Bin the Poo Signs are a helpful reminder to dog owners

TGDM 2010: 1.1.3.1 General (d) street furniture, such as lighting columns, signposts, litter bins, seats, etc., should be located at or beyond the boundaries of the access route;	2

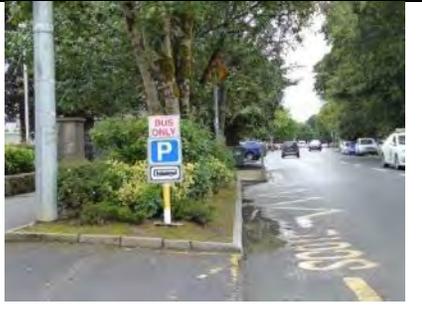
2.8	Bus Set down parking at St Mary's school	A designated bus set down is located at the Coimín Centre, partially on the carriageway and partially set in between two buildouts. The set down area is on an incline and is too small for some vehicles.

BS 8300-1 : 2018 6.1 Setting down & picking up points Setting-down points should have dimensions of not less than 9 m x 3.6 m as shown in figure 1. Dependent on bus size and door locations enlarge set down area to suit	2

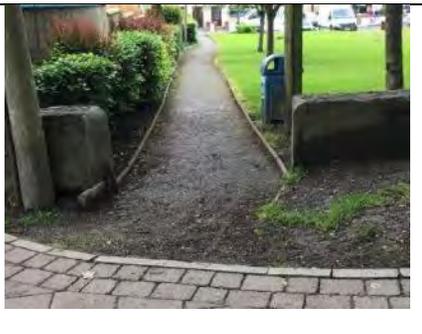
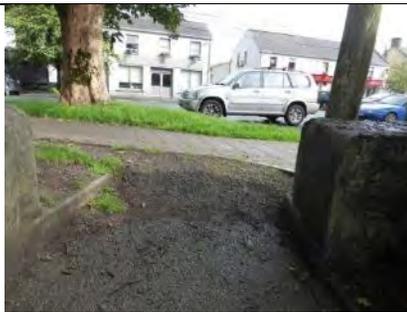
2.9	St Joseph's Road	The main pedestrian route from the residential estate at St Joseph's Road to the centre of town is via a path to the south of the green. The 1400mm wide path is too narrow for people to pass comfortably and is difficult to negotiate for people with mobility impairments, particularly at its junction with the main footpath due to the gradient of 1:5, the surface and the lip at its junction with the paved footpath.

TGDM 2010 1.1.3.4 Ramped access routes A gradient of 1:20 or steeper is considered to be a ramp. Ramped access routes should be designed to have the shallowest gradient practical. The preferred maximum gradient is 1:20 but where site specific constraints require it, ramps not steeper than 1:12 may be provided if	2

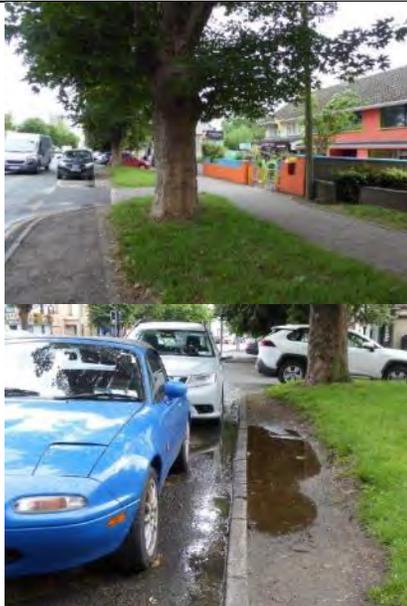
individual flights are not longer than 2000 mm.	
2.10	Sakura Crèche	There is no safe accessible set down or parent/guardian and child parking area close to the Sakura crèche. There is sufficient space to create both in the indented parking bays to the south of the hair studio.

BS 8300-1:2018 Clause 7. If there is an evidenced need, designated parent/guardian and child parking should be provided in addition to other designated accessible parking spaces Where setting down areas & parking are provided, they should be designed and constructed in accordance with the guidance given in TGD M 1.1.6 and BS 8300	1

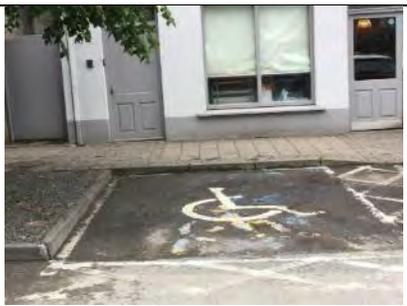
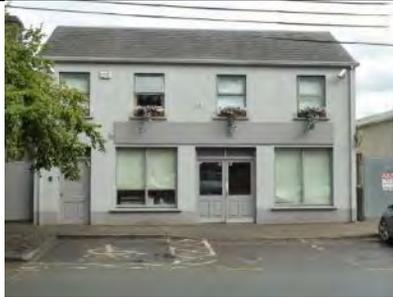
2.11	Opposite the crèche	A designated accessible parking bay opposite the crèche is well below minimum standard with a 900mm marked transfer zone on one side only and no safe zone to the rear.

TGDM 2010:1.1.5 On Site Car Parking (d) the minimum dimensions of the designated parking bays should be in accordance with Diagrams 8 and 9; (e) A 1200 mm wide access zones should be provided on both sides and at the rear of each designated parking bay. The access zone at the rear of the parking bay should be clear of vehicular circulation routes. The	1

<p>access zone should contrast visually with the adjoining surfaces to ensure it is kept clear (refer to 1.6.4).</p> <p>(g) all designated parking bays should be clearly marked on the ground with the symbol of access and, if necessary further signage should be provided (refer to 1.6.3);</p>

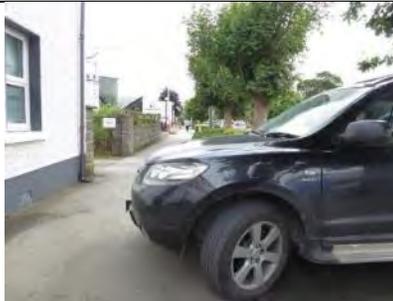
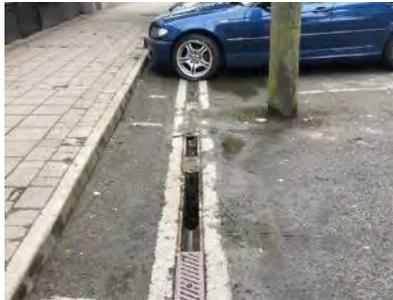
2.12	SuperValu to Murphy's Pub	The absence of a kerb and sub-standard head-on / perpendicular parking on the east of Main Street between SuperValu and Murphy's results in vehicles over-sailing the footpath. In other areas there are open drainage channels in the parking bays. Oversailing of footpaths occurs in numerous locations.

<p>Where the bays are of sufficient depth kerbs and wheel stops should be provided to prevent over sailing of the paths. If the bays are too short then parallel parking should be considered.</p> <p>TGDM 2010: 1.1.3.1 General</p> <p>(h) drainage gratings should be positioned beyond the boundaries of the access route. Where this is not feasible they should be flush with the surrounding surface.</p> <p>(i) dished channels should not be incorporated within an access route</p> <p>Rationale: They increase the risk of tripping; This would apply to where drainage channels cross the transfer space to the side of a designated bay</p>	1

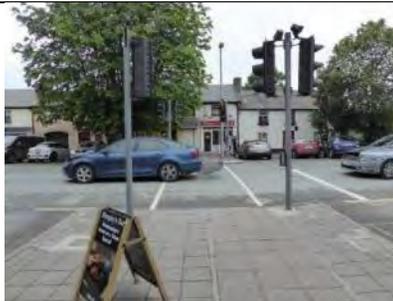
2.13	Controlled Crossing at Murphy's Pub & Dry cleaners	The crossing is identified by red concrete paving laid correctly. However the colour of the paving, as with the buff blister paving throughout the town, has faded and is no longer distinguishable. On the west side of the crossing poor drainage results in ponding at the junction of the road and footpath in the middle of the crossing point.

<p>TGDM 2010</p> <p>1.1.4 Pedestrian crossings</p> <p>Where pedestrian crossings are provided, tactile paving and dropped kerbs should be provided at controlled and uncontrolled pedestrian crossings in accordance with 'Good Practice Guidelines on Accessibility of Streetscapes'.</p>	3

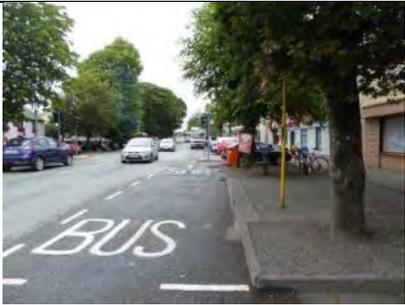
2.14	Footpath surfaces	Footpath surfaces in the vicinity of Hair Creations and Reid's pub are very uneven		Make good uneven surfaces	1
2.15	Bus Stop at Boyle Sports	The bus stop on the east of Main Street near Boyle Sport is not clearly visible due to overhanging trees, it has no shelter or seat, and lighting at night-time may be poor. Information about routes and timetables is not fully accessible. Whilst one stop on the west side of the street has a shelter there are none on the east side.

BS8300 2018:1 6.2.1 All Transport Modes Real-time information about routes and departures should be provided in both visible and audible formats (including assistive listening systems), both at stops and on the vehicle 6.2.4 Bus shelters	1

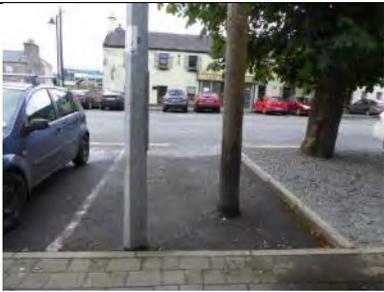
2.16	Obstructions in parking bays	Throughout the town there are numerous examples of obstructions in parking bays

These should be highlighted by reflective and contrast markings and relocated if necessary as part of an overall infrastructure upgrade	3

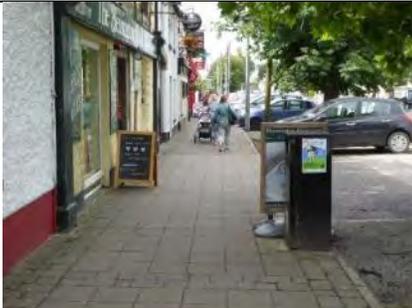
2.17	Sandwich boards	Sandwich Boards, litter bins, private bins and street furniture are inconsistently located throughout the town on both sides of the footpath, restricting access and making the footpaths difficult for people to negotiate, particularly people with mobility or vision impairments

BS 8300-1: 2018 A.1.7 "A" board signs are a particular problem, as being movable low-level signs they can be hazardous obstacles for people who are blind or partially sighted and restrict the width of routes for wheel chair users and parents with prams, etc. Many could be replaced by signs on buildings. Where they are used they need to be restricted to the street furniture zone, highlighted by visual and ground surface contrast, and robustly positioned in place so they do not fall or get knocked over.	1

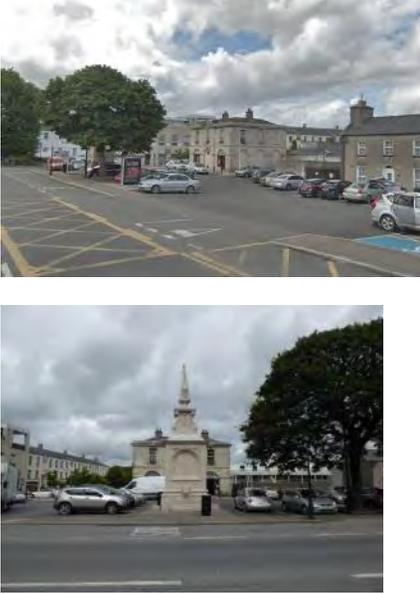
Ref.	Location	Observation	Photo	Relevant Guidance	Priority
3.1	Town Square	At the MarketSquare to the west of Main Street, there is no clear safe accessible route for pedestrians either from the east side of the street or in a north / south direction or leading to / from the square to the new shopping precinct and Dunnes Stores. There is confusion as to where there is pedestrian priority, whether part of the square is a shared space and where footpaths begin and end. The absence of dished kerbs in some areas and the proliferation of cars and other obstacles makes this area very difficult to negotiate for families, people with sensory or cognitive impairments and wheelchair users.

<p>Recommendations for this area need to be made in the context of a complete redesign.</p> <p>In the short term works are necessary to ensure that a) the accessible parking bays are large enough and with transfer zones in accordance with good practice b)there is at least one designated bay large enough to accommodate a mini-bus c) footpaths are continuous, wide enough and with dished crossings in sequence</p>	1

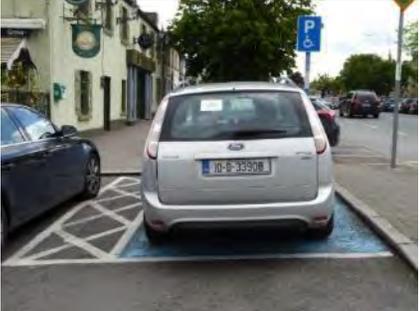
3.2	Designated Accessible Parking	There are six designated accessible car parking bays in the Market Square area, one at the West Wicklow House, one beside the public WC, one at the Ulster Bank, one on the opposite side of the road beside St Mary’s Church and two at McGreal’s Pharmacy. All bays are sub-standard either due to their size, their limited transfer space or absence of road markings. All are well signed on vertical poles.

<p>TGDM 2010:1.1.5 on Site Car Parking</p> <p>(d) the minimum dimensions of the designated parking bays should be in accordance with Diagrams 8 and 9;</p> <p>(e) A 1200 mm wide access zone should be provided on both sides and at the rear of each designated parking bay. The access zone at the rear of the parking bay should be clear of vehicular circulation routes. The access zone should contrast visually with the adjoining surfaces to ensure it is kept clear (refer to1.6.4).</p> <p>(g) all designated parking bays should be clearly marked on the ground with the symbol of access and, if necessary further signage should be provided</p>	1

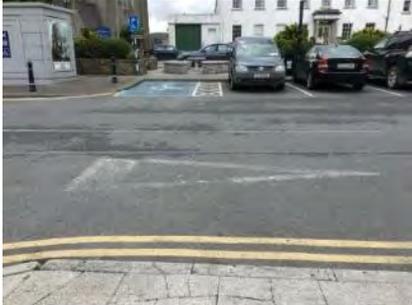
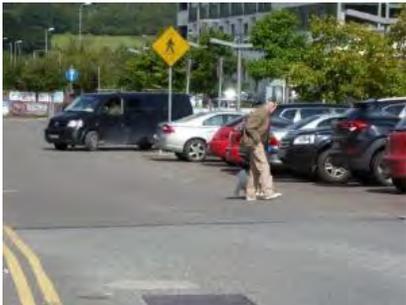
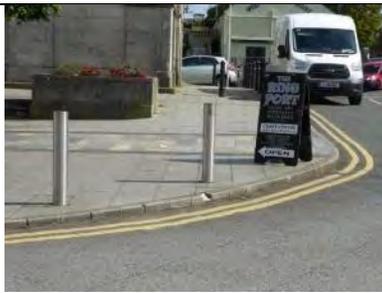
3.4	Dropped kerbs / footpath dishings	For buggies or wheelchair users the path dishings are inconsistent. In some areas eg. at the WC there is a dishing on one side of the road but not on the other. For example the footpath is dropped beside the accessible bay adjacent to the Public WC but is not dropped on the opposite beside the Lemon Tree or on the Credit Union side

`See 3.1 above	1

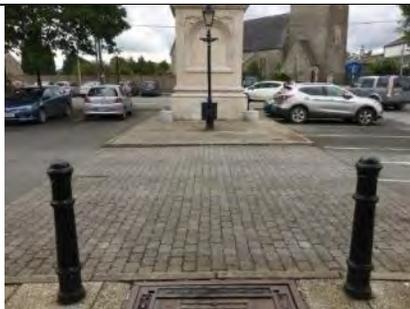
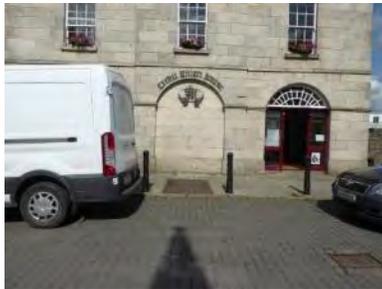
3.5	Raised table	There is a raised table (crossing) at the Credit Union (former Market House) leading to the monument but insufficient space either side of the monument to get past. If one remains on the path at the Credit Union there is then no access to the west side of Market Square in front of the old forge building.

See 3.1 above	1

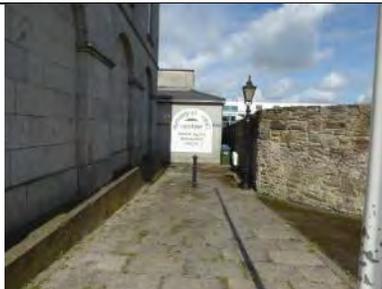
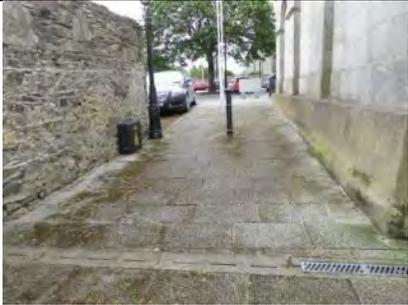
3.6	Ramped Route	To the north side of the Credit Union / Market House there is an unsigned access route to the lower level where the former tourist office and current craft centre is located. This route is at a gradient of between 1:13 and 1:15, equivalent to a ramp, but without any support or handrails. People arriving at the top of the steps on the southern side of the Credit Union Building are

<p>not necessarily aware that there is a ramped access route on the other side and this should perhaps be signposted</p>

TGDM 2010 1.1.3.4 Ramped access routes (g) the ramped access route may form part of a wider ramped area. The intended ramped access route(s) should be clearly identified and signposted where necessary (refer to 1.6.3). Additional handrails should be used to divide any intended ramped access route in to channels of	3

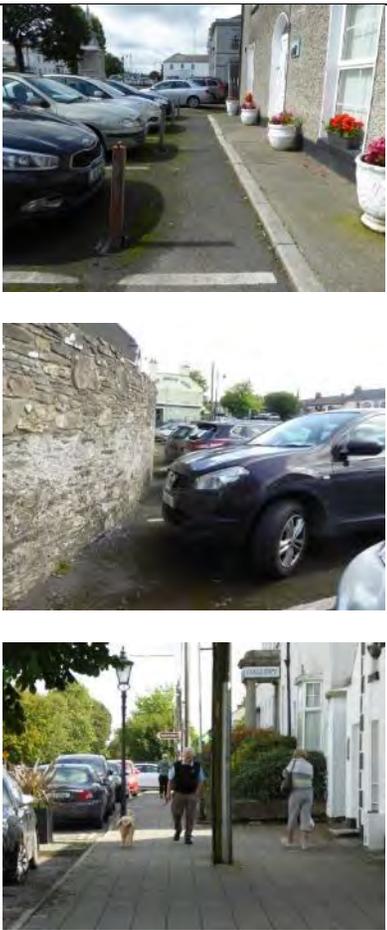
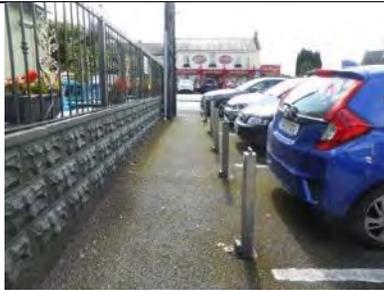
<p>unobstructed width not less than 1200 mm and not greater than 2500 mm. Rationale: This permits a person with less strength on one side to be within easy reach of support;</p>	
<p>3.7</p>	<p>West of Market Square</p>	<p>A narrow footpath runs along part of the West side of the Square which is too narrow for pedestrians and wheelchair users can't get on or off it in front of the Lemon Tree. A clear space has been created on the roadway by the introduction of bollards in front of the West Wicklow House and the Old Forge but it does not lead to another footpath.</p>

<p>Where shared surfaces are envisaged in any redesign great care should be taken to ensure that stringent guidelines are followed as the use of shared surfaces is controversial and not liked by many people with vision and hearing impairments, older people and people with children</p> <p>See 3.1 above</p>

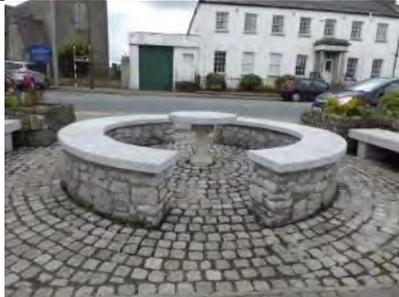
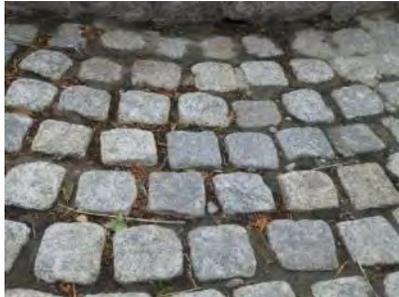
3.8	Seating	A pleasant circular seating area has been created in natural granite to the South of the WC. There is no area with backs or armrests for people who need support and the rough cobbled surface makes it inaccessible to wheelchair users and people with limited mobility.

<p>BS 8300 2018:1</p> <p>8.4.1 General An access route should have a firm, slip resistant and reasonably smooth surface. Cobbles, bare earth, sand and un-bonded gravel should not be used.</p> <p>10.7 Seating ...b) For some seats, back support and arm rests should be provided as some people requiring support need both.</p>	3

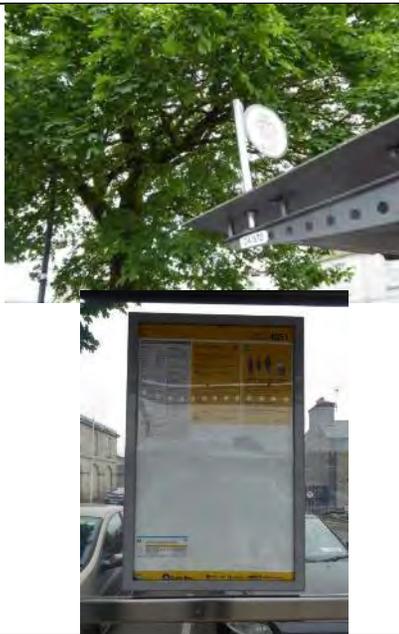
3.10	Bus Stop	<p>The bus stop on the western side of the Main Street in the Square is the only stop with a shelter and a perch seat. The stop sign was camouflaged by tree branches and the signage within the shelter was located too high and not legible to either small people, wheelchair users or vision impaired people.</p> <p>The Kasselkerb (raised kerb used to access buses) is located before the stop instead of at the stop making it difficult for wheelchair users or buggies to enter or disembark.</p>

<p>BS 8300-1:2018 Sxn 6.2.4</p> <p>....Where seating is provided to bus shelters it should be usable for a variety of people and should therefore incorporate arm rests and back supports.</p> <p>Bus shelters should be well lit with sufficient illumination to enable reading. Route information should be provided for passengers which includes route number, pictogram, direction of travel, contact details for assistance. Information displays should be made of non-reflective materials, and should be designed to take account of: viewing distance in relation to text sizes; display heights suitable for seating and standing</p>	2

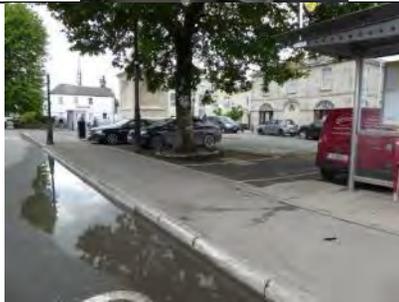
3.11	Drainage	<p>A blocked gully, which was silted up with leaves, near the bus stop impeded access to the buses and the stop</p>

<p>BS 8300-1:2019 A 2.2A.2.2</p> <p>External surfaces</p> <p>Pedestrian routes (footpaths, ramps and steps, parking areas and public open spaces) need to be kept clean, unobstructed and free of contamination from surface water, snow, ice, leaves, lichen, debris, etc., at all times.</p>	1

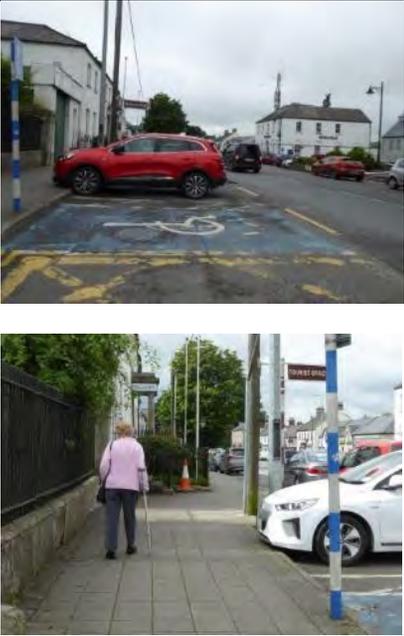
<p>3.12</p>	<p>Parking at St Mary's Church</p>	<p>The designated parking bay at St Mary's has no safe zone to the rear and for people needing to remove a wheelchair from a car or to exit a multi-purpose vehicle at the rear the transfer has to be made in the carriageway.</p>

<p>TGDM 2010 1.1.5 On-site car parking (e) A 1200 mm wide access zone should be provided on both sides and at the rear of each designated parking bay. The access zone at the rear of the parking bay should be clear of vehicular circulation routes. The access zone should contrast visually with the adjoining surfaces to ensure it is kept clear (refer to 1.6.4). Rationale: This provides sufficient space to enter and leave the vehicle and move to the rear of the vehicle and should safely lead to an access route;</p>	<p>1</p>
<p>3.13</p>	<p>Directional Signage</p>	<p>Generally directional signage is quite poor, particularly for visitors and people unfamiliar with the area. For example at St Mary's Church there is a sign pointing west for the tourist office but no place to cross and no sign on the opposite side to show how to continue. On the same post a sign for Avon Rí is not followed by another one at the junction with the Kilbride Road.</p>

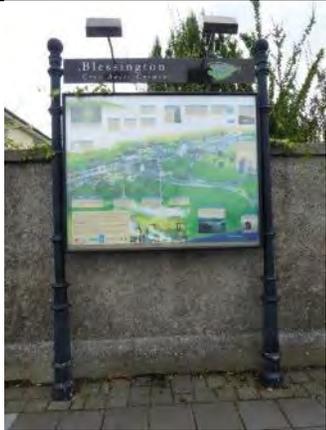
3.14	Signage for local amenities	<p>Attractive signs have been mounted in cast iron stands in a number of location around the town. They provide much information about the heritage of the town and items of interest to both locals and visitors. Often information is located too high on the sign to be legible, it is provided in one format only eg. no provision for people who may be blind or partially sighted, and the Perspex protective layer can be reflective.</p>

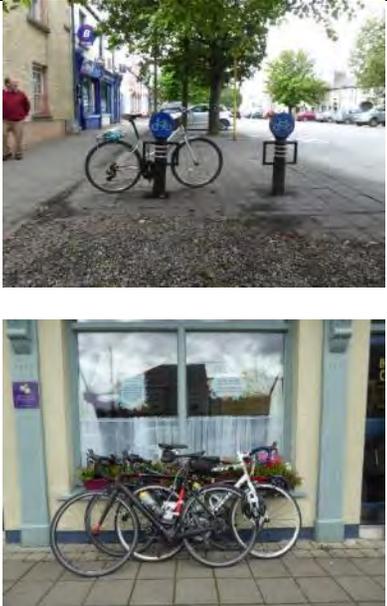
3.15	Cycle Routes & Parking	<p>There is no standard or non-standard cycle parking in either the Market Square or on the route to Dunnes. The only two cycle stands seen in the Public Realm are located at the bus stop beside Boyle Sports. There is a clear need for provision for cyclists and in particular due to the increasing popularity of cycling, its importance for health and wellbeing and in the context of the proposed extension to the Greenway.</p>

<p>BS8300-1:2018 7.1 Cycle parking Cycle parking should be located in a clearly defined area. Cycle stands should contrast visually with the background against which they will be seen. Cycle stands should provide ground level detection for the extent of the stand, in the form of a tapping rail for people who are blind or partially sighted navigating using a white cane, with its underside not higher than 150 mm above ground level, or similar barrier. Where a number of cycle stands are provided, some of the cycle stands should be positioned to allow the parking of adapted cycles, which can be considerably larger than other cycles. This should be taken into account in the positioning of cycle stands clear of pedestrian route widths (see also 8.2.1.3).</p>	2

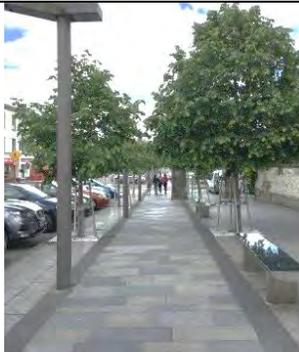
Ref.	Item / Location	Observation	Photo	Relevant Guidance / Recommendation	Priority
4.1	Paving	The new footpath to the north of the road leading to Dunnes Stores is paved with smooth stone flags and is defined by a dark band of paving both sides. Trees and street furniture are grouped within or outside this band. Whilst this keeps the accessible route clear and assists people who are partially sighted, for people who are blind there is no kerb or building line to follow. In wet conditions it was reported that this paving can become very slippy

This should be taken up with the management company responsible, the slip ratings established and remedial measures implemented as appropriate	2

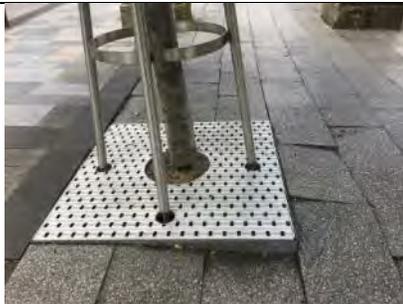
4.2	Hazards on paved areas	In places the flags and tree guards are lifting due to tree roots, creating trip hazards.

BS8300-1:2018 8.2.1.7 Tree grilles <i>COMMENTARY ON 8.2.1.7</i> Tree grilles can be particularly problematic for people using mobility aids such as sticks, canes, wheelchairs or wheeled walking frames, or for people with assistance dogs. Tree grilles should be avoided. Smooth or paved permeable surfaces should be used wherever practicable.	1

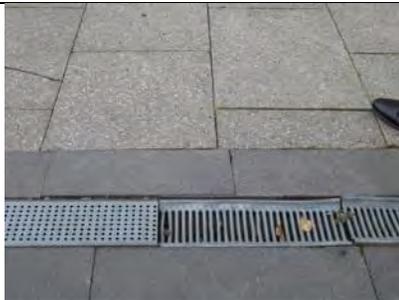
4.3	Drainage Channels	On the south side of road leading to Dunnes there are numerous locations on the footpath where light weight galvanised drainage channel covers have bent or lifted also creating trip hazards.

TGDM 2010: 1.1.3.1 General (h) drainage gratings should be positioned beyond the boundaries of the access route. Where this is not feasible they should be flush with the surrounding surface. Rationale: It is important to minimise the risk of trapping canes or wheelchair wheels;	2

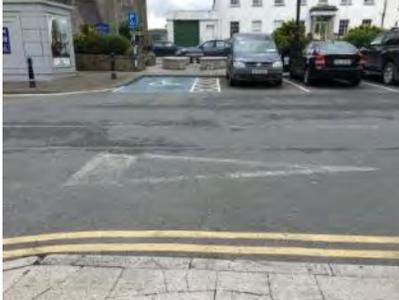
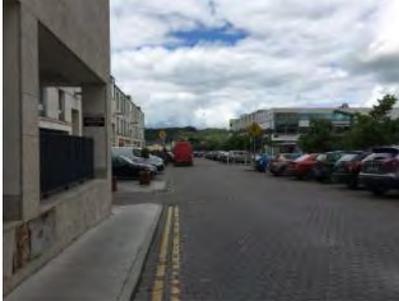
4.5	Paving, routes and dropped kerbs at the Lemon Tree corner	<p>New paving around the Lemon Tree is cracked and uneven. When approaching from the southern end of Market Square eg the Ulster Bank end, there is no means for a wheelchair user to cross the road to the opposite side or to reach any of the commercial units to the south of the new centre without travelling significant distances to cross the road. Similarly a wheelchair user arriving at this point cannot cross to the Public WC Convenience due to the absence of a dropped kerb.</p> <p>To the side of the building the path along the roadway is too narrow at only 1m wide for people to pass either wheelchairs or buggies and the covered walkway terminates in a flight of steps.</p>

See 3.1 above	1

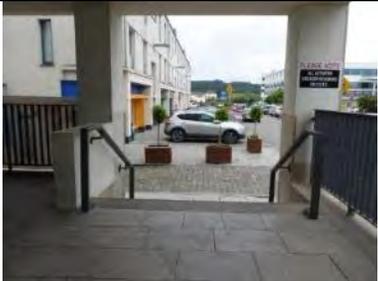
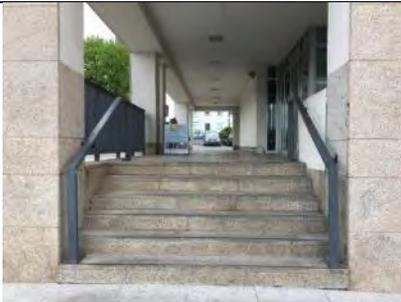
4.6	Steps	The step nosings at the end of the Lemon Tree building are poorly marked. There is a single row of corduroy hazard warning paving approximately 400mm deep instead of 800mm and the handrails do not extend past the bottom as would have been required by Building Regulations.

<p>TGDM2010:</p> <p>1.1.3.5 Stepped Access Routes</p> <p>(h) all step nosings should incorporate a permanently contrasting continuous material on the tread. The material should be between 50 mm and 65mm wide on the tread and should contrast visually with the remainder of the tread (refer to 1.6.4). Rationale: This will</p>	2

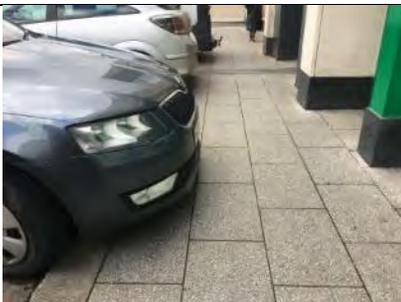
4.8	Path leading towards tourist office	The path on the south side of the road leading towards the tourist office is narrow with various obstacles and parked cars oversailing the kerb.

Improve parking as part of an overall parking and management strategy	2

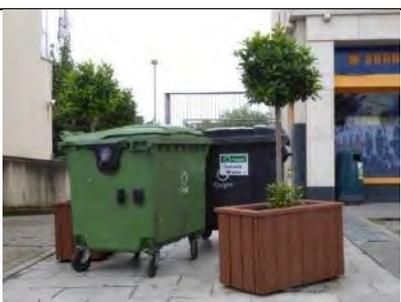
4.9	Eurobins and planters	Eurobins and planters were blocking the access route to the footpath leading to the commercial units and tourist office to the south of the new town centre

See 4.7	1

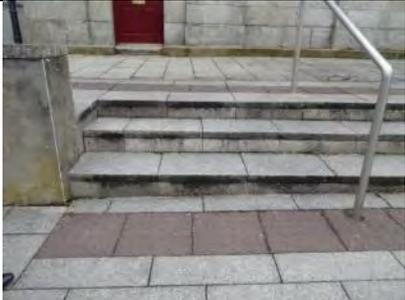
4.10	Steps to south side of Market House / Credit Union Building	The new steps to the south of the Market House have a single row of blister paving slabs 400mm deep at the top and bottom which can easily be stepped over and are not adequate to warn of a hazard. The nosings are also not highlighted.

TGDM2010: 1.1.3.5 Stepped Access Routes (h) all step nosings should incorporate a permanently contrasting continuous material on the tread. The material should be between 50 mm and 65mm wide on the tread and should contrast visually with the remainder of the tread (refer to 1.6.4).Rationale: This will help people with vision impairment appreciate the extent of the stair and identify the individual treads;	2

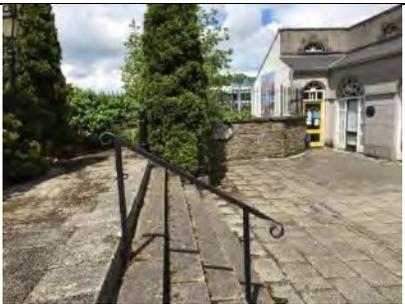
4.11	Steps to rear of Market House	The more historic wide flight of steps to the rear of Market House leading to the Craft Centre have a single central handrail.

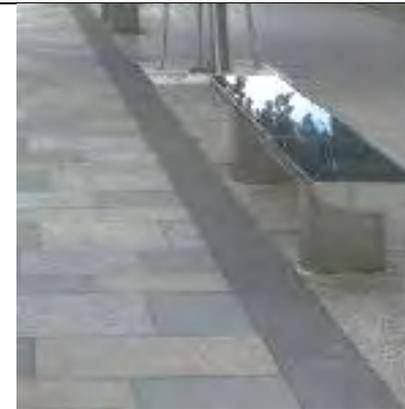
4.12	Bench Seating	Bench seating along the route towards Dunnes is helpful but it has neither arm nor back rests and is finished with a shiny polished surface.

BS 8300 2018:1 10.7 SeatingA choice of seating options should be provided suitable for a variety of users.... a) Where more than one seat...., a variety of seat heights should be provided..... b) For some seats, back support and arm rests should be provided Seating should contrast with the background against which it is seen. It should not have a highly reflective finish.	3

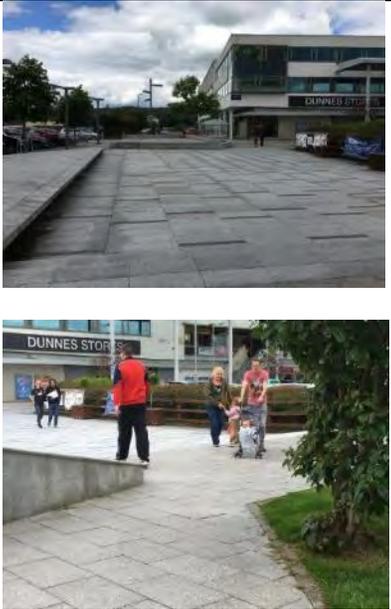
4.13	Plaza at Dunnes	<p>The hard landscaped plaza on the route to Dunnes appears well used by children playing, on trikes, bikes and skateboards. It seems like a missed opportunity not to have provided comfortable seating where older people could sit and watch or even exercise opportunities for older people.</p>

<p>BS8300-1:2018 10.7 Seating <i>Seating can be essential for people in terms of providing somewhere to stop and rest, but can also be a valuable tool in creating a place or space which is welcoming and inviting in which people will choose to spend time.</i></p>	3

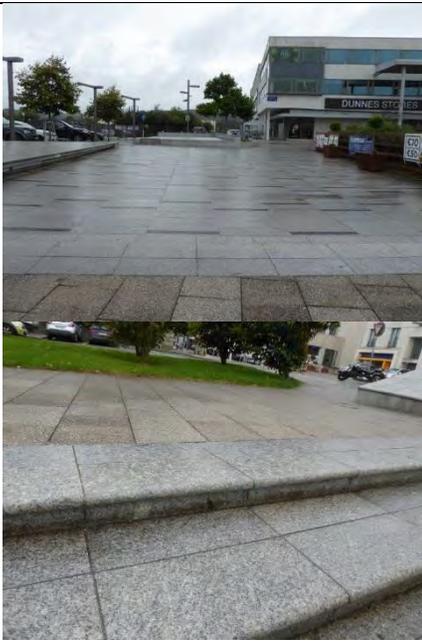
4.14	Plaza at Dunnes	<p>When approaching the plaza from the east side there are two steps which are unmarked, very difficult to detect, and which have no handrails or tactile paving</p>

<p>As these are on an important access route but located in an area that may be privately managed the issue should be raised as a priority with those responsible</p>	1

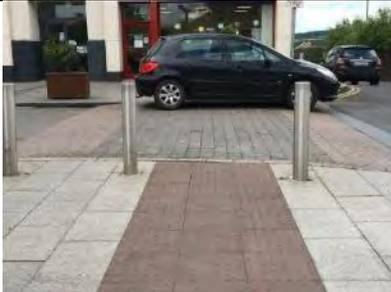
4.15	Crossing at Tourist Office	At the end of the modular paved carriageway there is an uncontrolled crossing point at a raised table. Cars frequently park on the table preventing use of the crossing and severely impeding access for vision impaired people and wheelchair users. In addition a moveable planter box is located in the direct line of travel beyond the car.

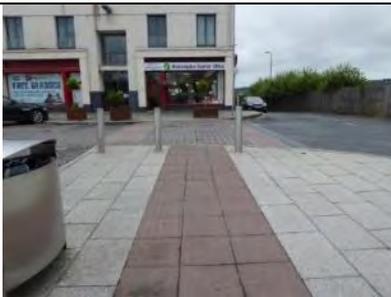
4.16	Colour of tactile paving	The tactile blister paving at the uncontrolled crossing at the tourist office is coloured red which should only be used at controlled crossings. Buff blister paving is required at uncontrolled crossings. The use of blister paving to act as a guidance path, which is what this appears to do, is not recommended

Refer to : DETR Guidance on the Use of Tactile Paving Surfaces. Guidance should be followed carefully. Guidance recommends that local authorities consult local groups representing visually impaired people with regard to any provision of guidance paths. This will ensure that the surface is used to best effect.	2

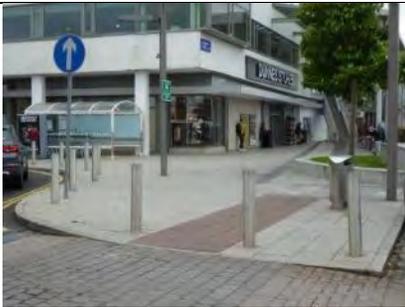
4.17	Bollards- lack of colour contrast	The stainless tubular steel bollards in the new town centre area have limited colour contrast when seen against the light coloured aggregate paving. They also have no contrasting band which limits their visibility in poor lighting conditions.

TGD M 2010: 1.1.3.1 General (e) Wherever bollards are provided they should contrast visually with their background.	2

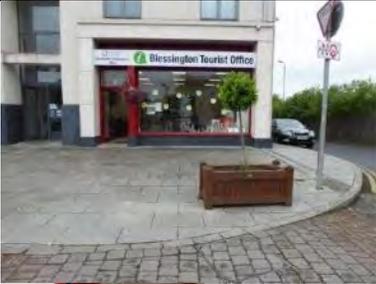
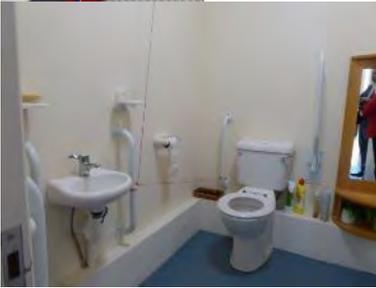
4.19	Tourist Office	<p>The tourist office, despite its location away from the centre of the town and with insufficient signage, is a good facility. Small improvements could be made with minimum effort.</p> <p>The main entrance door has only one row of manifestations, two being a requirement of building regulations.</p> <p>Inside there is good circulation leading to the information/ reception desk with some seating and display shelving around the perimeter. There is a reasonably large WC to the rear for staff use.</p>

<p>By providing some seats with arm rests, making some minor upgrades to the WC and signing that it could be available as a wheelchair accessible WC for visitor use, the facility would become a more welcoming and useful place. In addition consideration could be given to improving physical access to the leaflets and printed information and a sign could indicate which languages are spoken by staff, including possibly Irish sign language. Irish Standard 373 is a new standard developed by the NSAI, with the support of Fáilte Ireland and the National Disability Authority of Ireland (NDA), to help businesses ensure their products and services are more accessible to a wider variety of visitors by improving various types of communication such as written, verbal and electronic. It includes four useful toolkits which provide businesses with training on how to make their services more accessible to a wider customer base.</p>	4

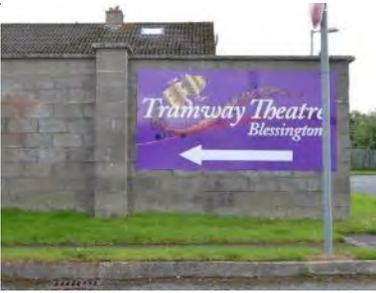
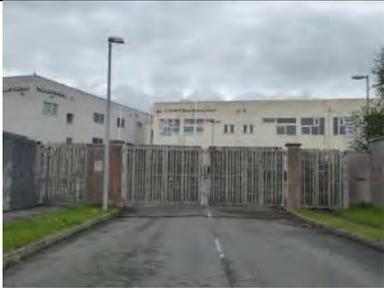
4.20	Route to the Tramway Theatre	<p>Access to the Tramway Theatre at St Mary's Senior National School from the new town is via a very narrow path on one side of the road which terminates in locked gates outside opening hours. There is neither a turning area for cars or signage for pedestrians to indicate an accessible route and opening times. .For people unfamiliar with the area this could result in a wasted journey over difficult terrain.</p>

<p>This should be dealt with as part of an overall upgrade of the New Town Centre area to make it more accessible</p>	3

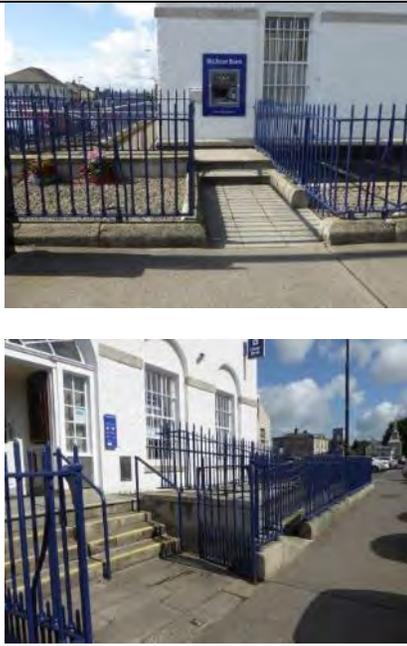
Ref.	Item / Location	Observation	Photo	Relevant Guidance / Recommendation	Priority
5.1	The Ulster Bank	The Ulster Bank has created a ramped and stepped access to an ATM in the gable of the building as well as to the main entrance. The ramp has a steep gradient of up to 1:7 in places and it terminates with an awkward junction at the top landing at the main entrance. Whilst not strictly meeting building regulation standard it has nonetheless created access to both the bank and the ATM, located in an historic and protected structure

TGDM 2010:1 1.1.3.4 Ramped access routes ...The preferred maximum gradient is 1:20 but where site specific constraints require it, ramps not steeper than 1:12 may be provided if individual flights are not longer than 2000 mm	3

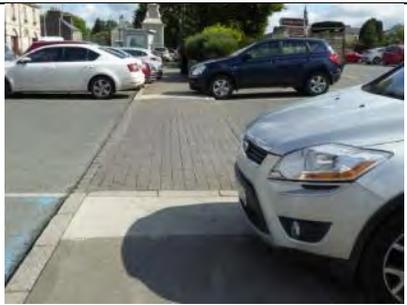
5.2	West side of Main Street	Vehicles also overhang the pavement on the main access route on this side despite there being plenty of space for perpendicular / head-on parking.

The layout, accessibility and urban design of the entire of the Market Square area needs review. See 3.1	1

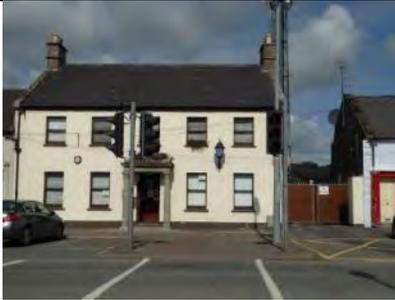
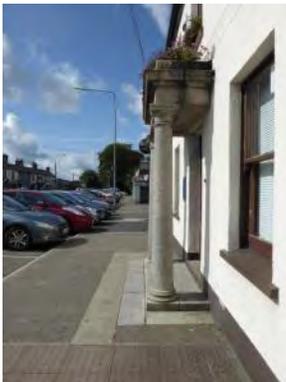
5.3	Garda Station	<p>There is no designated accessible parking bay at the Garda Station and no wheelchair access into the station. There are three low step at the entrance. The inside of the building was not inspected but it appeared that space in the entrance lobby was quite restricted.</p>

<p>As a public building the Garda station should be accessible as required under the Disability Act 2005. OPW should be requested to advise on how it is intended to achieve compliance</p>	1

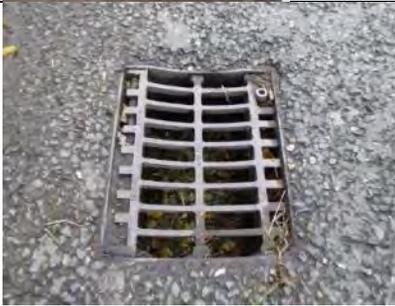
5.4	Drainage Gratings	<p>A number of drainage gratings throughout the town were found to be located within access routes with open slots which measured 40mm x 160mm and are in line with the direction of travel. Slots of this size can catch sticks, wheels and walking aids.</p>

<p>BS 8300-1:2018 8.2.1.5 Drainage channels Slots in gratings (in pedestrian access routes) should be not more than 13mm wide and should be set at right angles to the dominant line of travel</p>	3

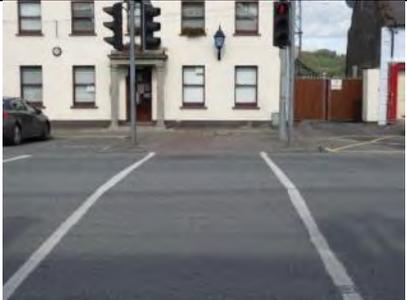
5.6	Controlled crossing at Kilbride Road junction	The controlled crossing at the junction with the Kilbride Road has an audible signal and red blister paving both sides. The red paving is worn and it is hard to distinguish the colour from the surrounding paving. The crossing is timed to give approximately 6 seconds before turning orange for a crossing of approximately 9/10m in width. The same applies to the timing of the controlled crossing at Boyle Sports

<p>Age Friendly Ireland Guidelines state that 1 in 3 adults aged 65 -74 years and three in five adults over 75 years walk slower than 1.2m per second. Hence a crossing of 9m should allow 11 seconds to cross.</p>	1

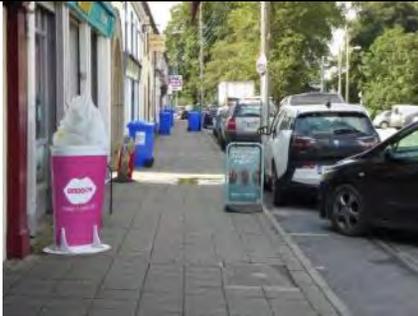
5.7	Pavement obstructions between AIB and McGreal's	The stretch of pavement between the AIB and McGreal's and the end of commercial units is heavily used, narrow and frequently blocked by signs, sandwich boards and bins.

Improvement management of sandwich boards and bins would greatly improve this relatively narrow stretch of pavement	1

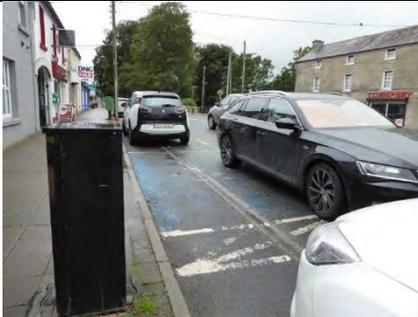
5.8	Parallel parking near the Office Shop	A designated accessible parallel parking bay near the Office Shop and McGreal's is only 2.4m wide x 4.7m long with an 800 space between it and the adjacent bay and no dished kerb to get on to the pavement. The road markings are also completely faded.

As this designated bay serves a significant number of commercial premises and services along this stretch of road it should be enlarge to facilitate mini-buses and correctly laid out with safe zones leading to a dished kerb	1

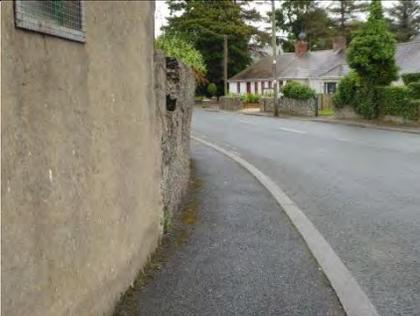
5.9	Footpath on north side of Kilbride Road	On the north side of the Kilbride Road the footpath narrows to approximately 1m in width making it impossible for two people to pass without stepping on to the roadway

Increase to minimum standards as part of an overall upgrade of pedestrian routes	2
5.10	Hazards on footpath on south side of Kilbride Road	On the footpath leading to the old health centre the surfaces are rough and hazards such as this lamp post are located in the middle of the path

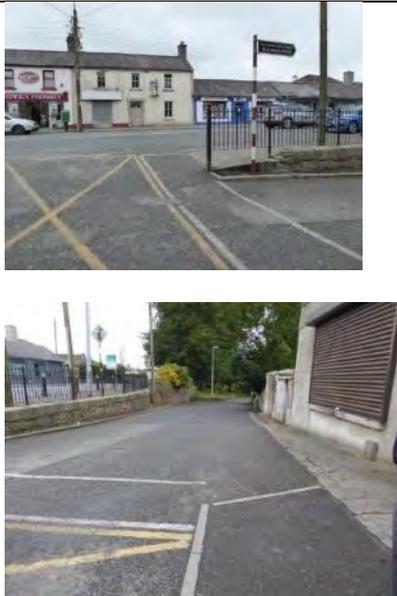
Ref.	Item / Location	Observation	Photo	Relevant Guidance / Recommendation	Priority
6.1	Ramped Path to side of the Old Naas Road	At the end the Old Naas Road there is a steep ramp at a gradient of between 1:7 and 1:8 between the path and the roadway / access route to the path outside Dempsey's with an equally difficult cross-fall at the intersection

TGD M 2010: Max ramp gradient is 1:12 on accessible routes, with handrail support. Consider redesign of entire corner	2
6.2	St Joseph's Hall	Access to St. Joseph's Hall is also very difficult due to the steep gradient but is within the private realm so was not considered

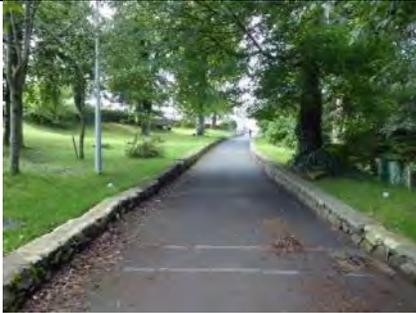
6.3	Dempsey's Lane	The pleasant walking route through the trees between Dempsey's and the Punchestown Road could possibly be exploited more for its amenity value

Consider providing seating in a sunny area and possibly some exercise equipment	3

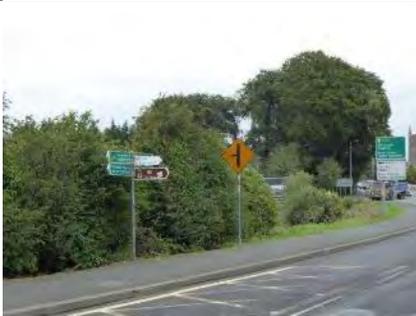
6.4	Punchestown / Naas Road junction	At the turn to the Naas Road the kerb dishing on the Blessington side of the junction is extremely steep with a gradient of between 1:4 and 1:8.

Improve gradient	2

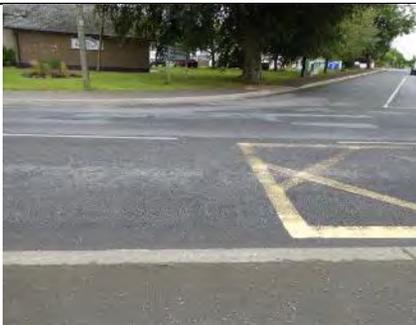
6.6	Troopersfield junction	The crossings on the Troopersfield road are good but there is no crossing when approaching from the west side of the main road.

Provide crossing point with dished kerbs and tactile paving	1

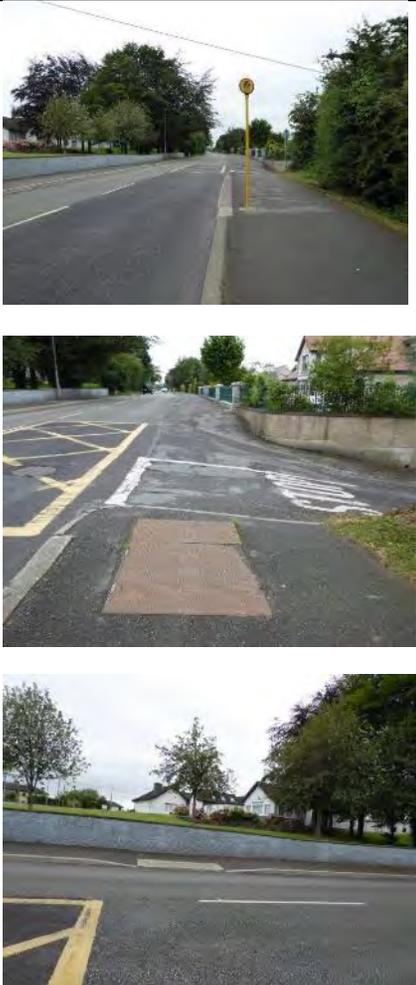
<p>6.7</p>	<p>Bus Stop at Troopersfield</p>	<p>Between the bus stop and footpath on the west side of the road at Troopersfield and the Further Education and Training Centre there is neither a controlled or uncontrolled crossing</p> <p>To reach a dished kerb it is necessary to go southwards towards Baltinglass and across a very steep gradient of 1:4.5 and rough surface before reaching a point where one can cross to a dropped kerb on the east side.</p>

<p>Provide a safe crossing point to give more direct access from the west side to Troopersfield, the road to the start of the Greenway and the Further Education and Training Centre</p>	<p>1</p>
------------	----------------------------------	--	---	--	----------
