**Street Route Accessibility Audit
For
Blessington & District Forum**

Accessibility Audit

BLESSINGTON MAIN STREET, CO WICKLOW

For Blessington & District Forum

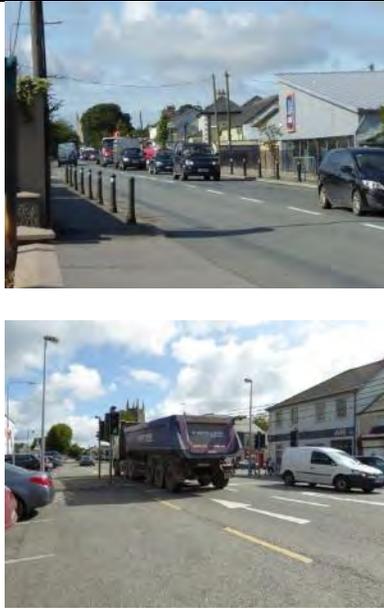
Ref.	Location	Observation	Photo	Recommendation	Priority
7.1	Throughout Main Street	Traffic through the town was at all times heavy with large numbers of heavy goods vehicles

Diverting through traffic and / or traffic calming measures are essential if the urban environment around the main street is to be improved, made safer and more inclusive for both residents and visitors	2
7.2	Throughout Main Street and the New Town Centre	The reversing of cars parked perpendicular to the main street tended to slow traffic but was also quite hazardous.

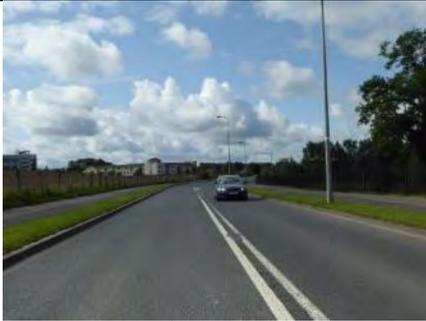
7.3	Relief Road	Traffic on the partially complete inner relief road appeared to be light at almost all times and there was no signage to indicate this could be a route for some through traffic

Consider if it is possible in the short term to divert through traffic away from the Main Street from Aldi via Oak Drive and back on to the N 81 at the Naas Road junction.	2

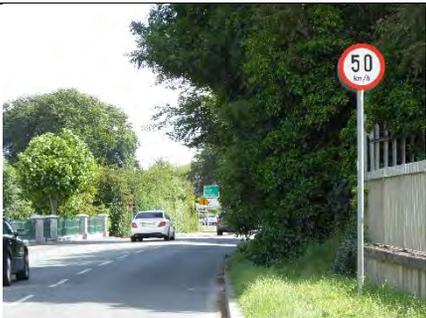
7.4	Speed Limit	The existing speed limit of 50km per hour through the centre of the town is excessive, particularly considering the width of the road, the numbers crossing, schools, elderly people and the historic environment. 5 out of 10 pedestrians hit by a car travelling at 50km/hr will die as opposed to 1 out of 10 hit by a car travelling at 30km/hr. (DMURS)

Local Authorities have powers to impose special speed limits of 30km/hour in designated areas eg in built-up areas and around schools. Consideration should be given to this as a possible short term measure until traffic calming and other measures are in place.	2
