Underwater Archaeological
Impact Assessment, Avoca
River, Arklow Flood Relief
Scheme Licence No. 17D0078
(ADCO, Brady, 2020a)

**Underwater Archaeological Impact Assessment
Avoca River, Arklow Flood Relief Scheme
17D0078**

31/03/2021

ARUP for Wicklow CC

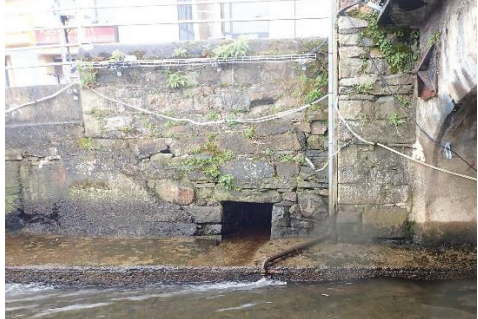
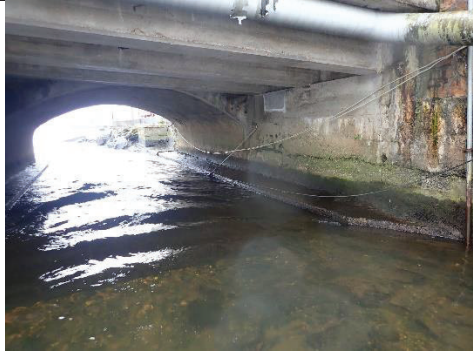
Item	Description	Image
South Abutment	The south abutment extends either side of the bridge but the stonework is only exposed on the downstream side as the bridge widening works present layers of concrete formwork on the upstream side. A 1m-long straight-walled buttress extends downstream from the base of the bridge to the bridge

Item	Description	Image
	<p>parapet above. The upper courses of the buttress are reworked to accommodate the openwork guard rail. The buttress in turn is keyed into the river wall that extends downstream from there.</p>

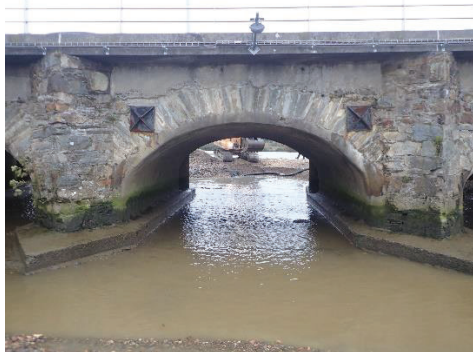
<p>Arch 3</p>	<p>As per Arch 1, metal tie rods are inserted through both sides of the arch. The arch is 4.79m wide</p>

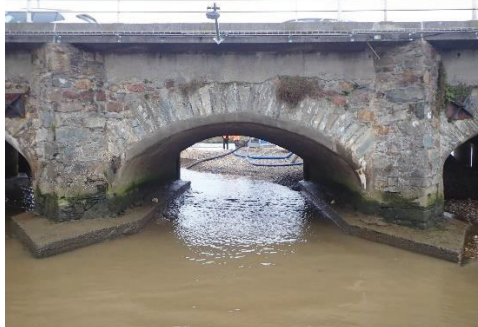
Item	Description	Image
Pier 3	While the arch ring is behind the cutwater, the stones of the cutwater above the arch ring appear to be keyed into the spandrel. The pier is 1.7m wide	As above
Arch 4	There are no tie rods inserted through Arch 4. The arch is 4.9m wide

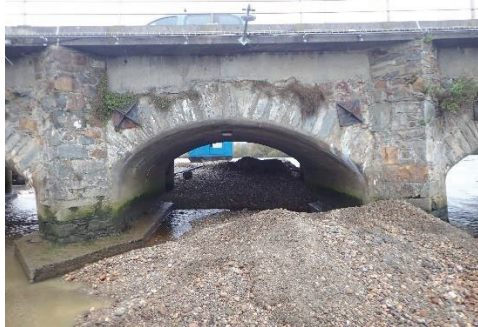
Pier 4	The pier is 1.51m wide	As above
Arch 5	A metal tie rod is inserted on either side of the arch. The arch is 4.82m wide

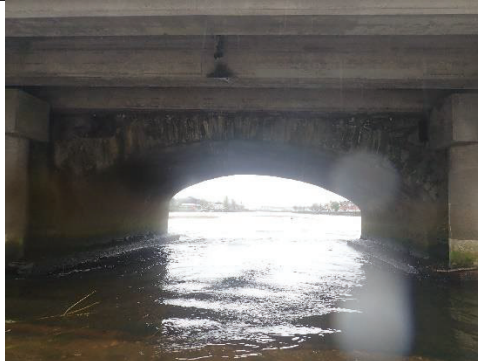
Pier 5	The pier is 1.65m wide	As above
Arch 6	A metal tie rod is inserted on either side of the arch. The arch is 6.98m wide

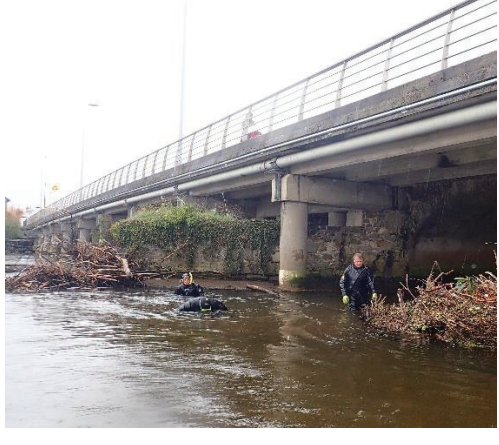
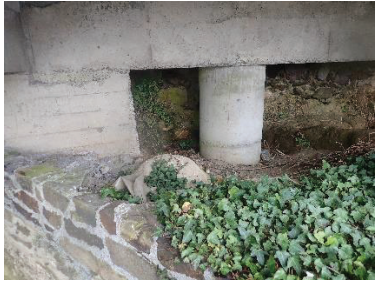
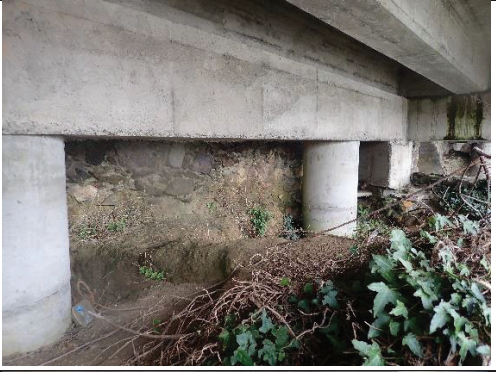
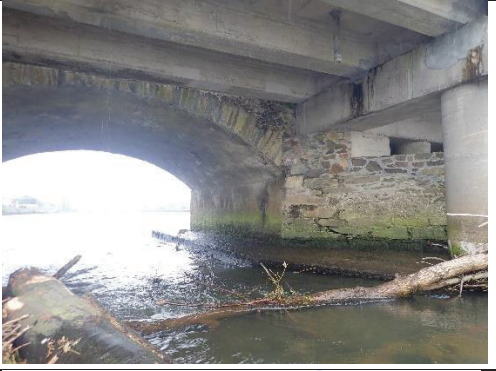
Pier 10	<p>The large central pier lacks a downstream cutwater and its upstream cutwater extends several metres beyond the widened bridge footprint. It otherwise shares much in common with the construction of the other piers. As presented today, the cutwater does not reach the parapet and the interior of the cutwater is filled with soil. Two concrete piles are driven through the body of the cutwater. The pier is 9.86m wide</p>

<p>North-facing elevation of upstream cutwater</p>

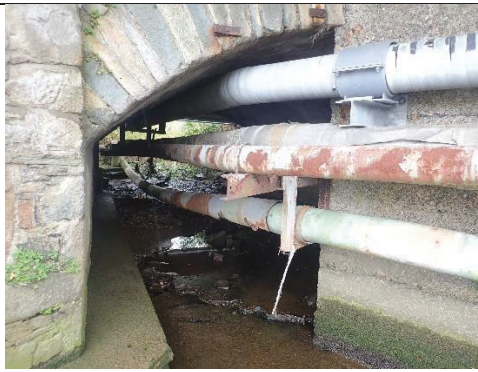
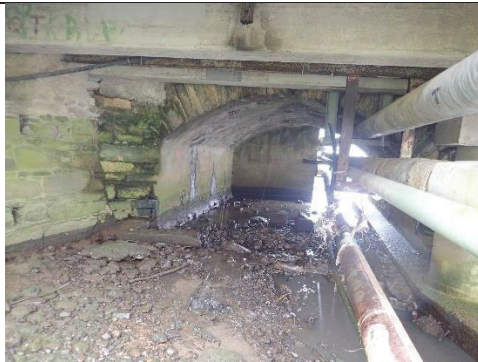
Pier 18	The pier is 1.67m wide	
Arch 19	Arch 19 accommodates the service pipes to the former NET/IFI factory in Shelton Abbey. In doing so, a concrete wall is constructed across the north side of the downstream opening to hold the service pipes, as indicated on the accompanying image. The arch is 4.31m wide

The second image shows the arch from the upstream side

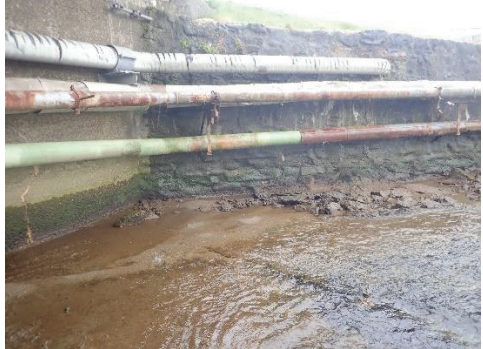
Item	Description	Image
North Abutment	The north abutment on the downstream side of the bridge is masked by a concrete-built wall that was added in the twentieth century to take the NET/IFI service pipes. However, it appears that the stone wall of North Quay may have merged with the original abutment that now lies buried from view.

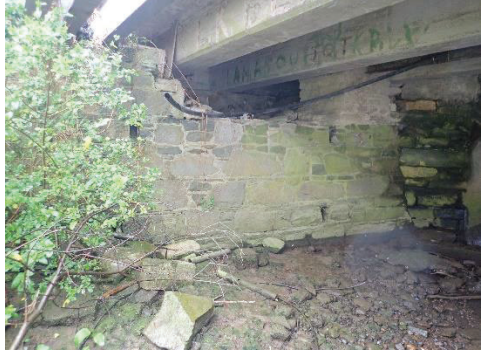
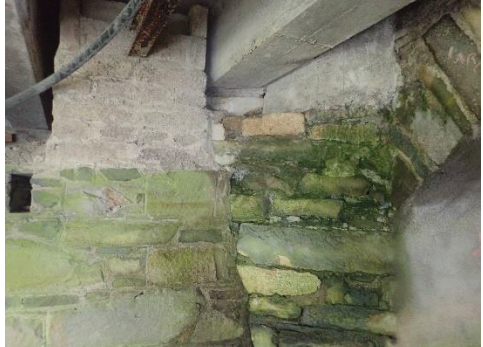
The upstream side of the bridge today has a stone retaining wall that is built against the cutwater of Arch 19/Pier 19. The retaining wall was built after the bridge arch and pier, suggesting again that the original return of Pier 19 and the associated north abutment is not visible today but lies buried in the reclaimed land to the north.

Detail view showing the phasing of wall construction against Pier 19, upstream side.

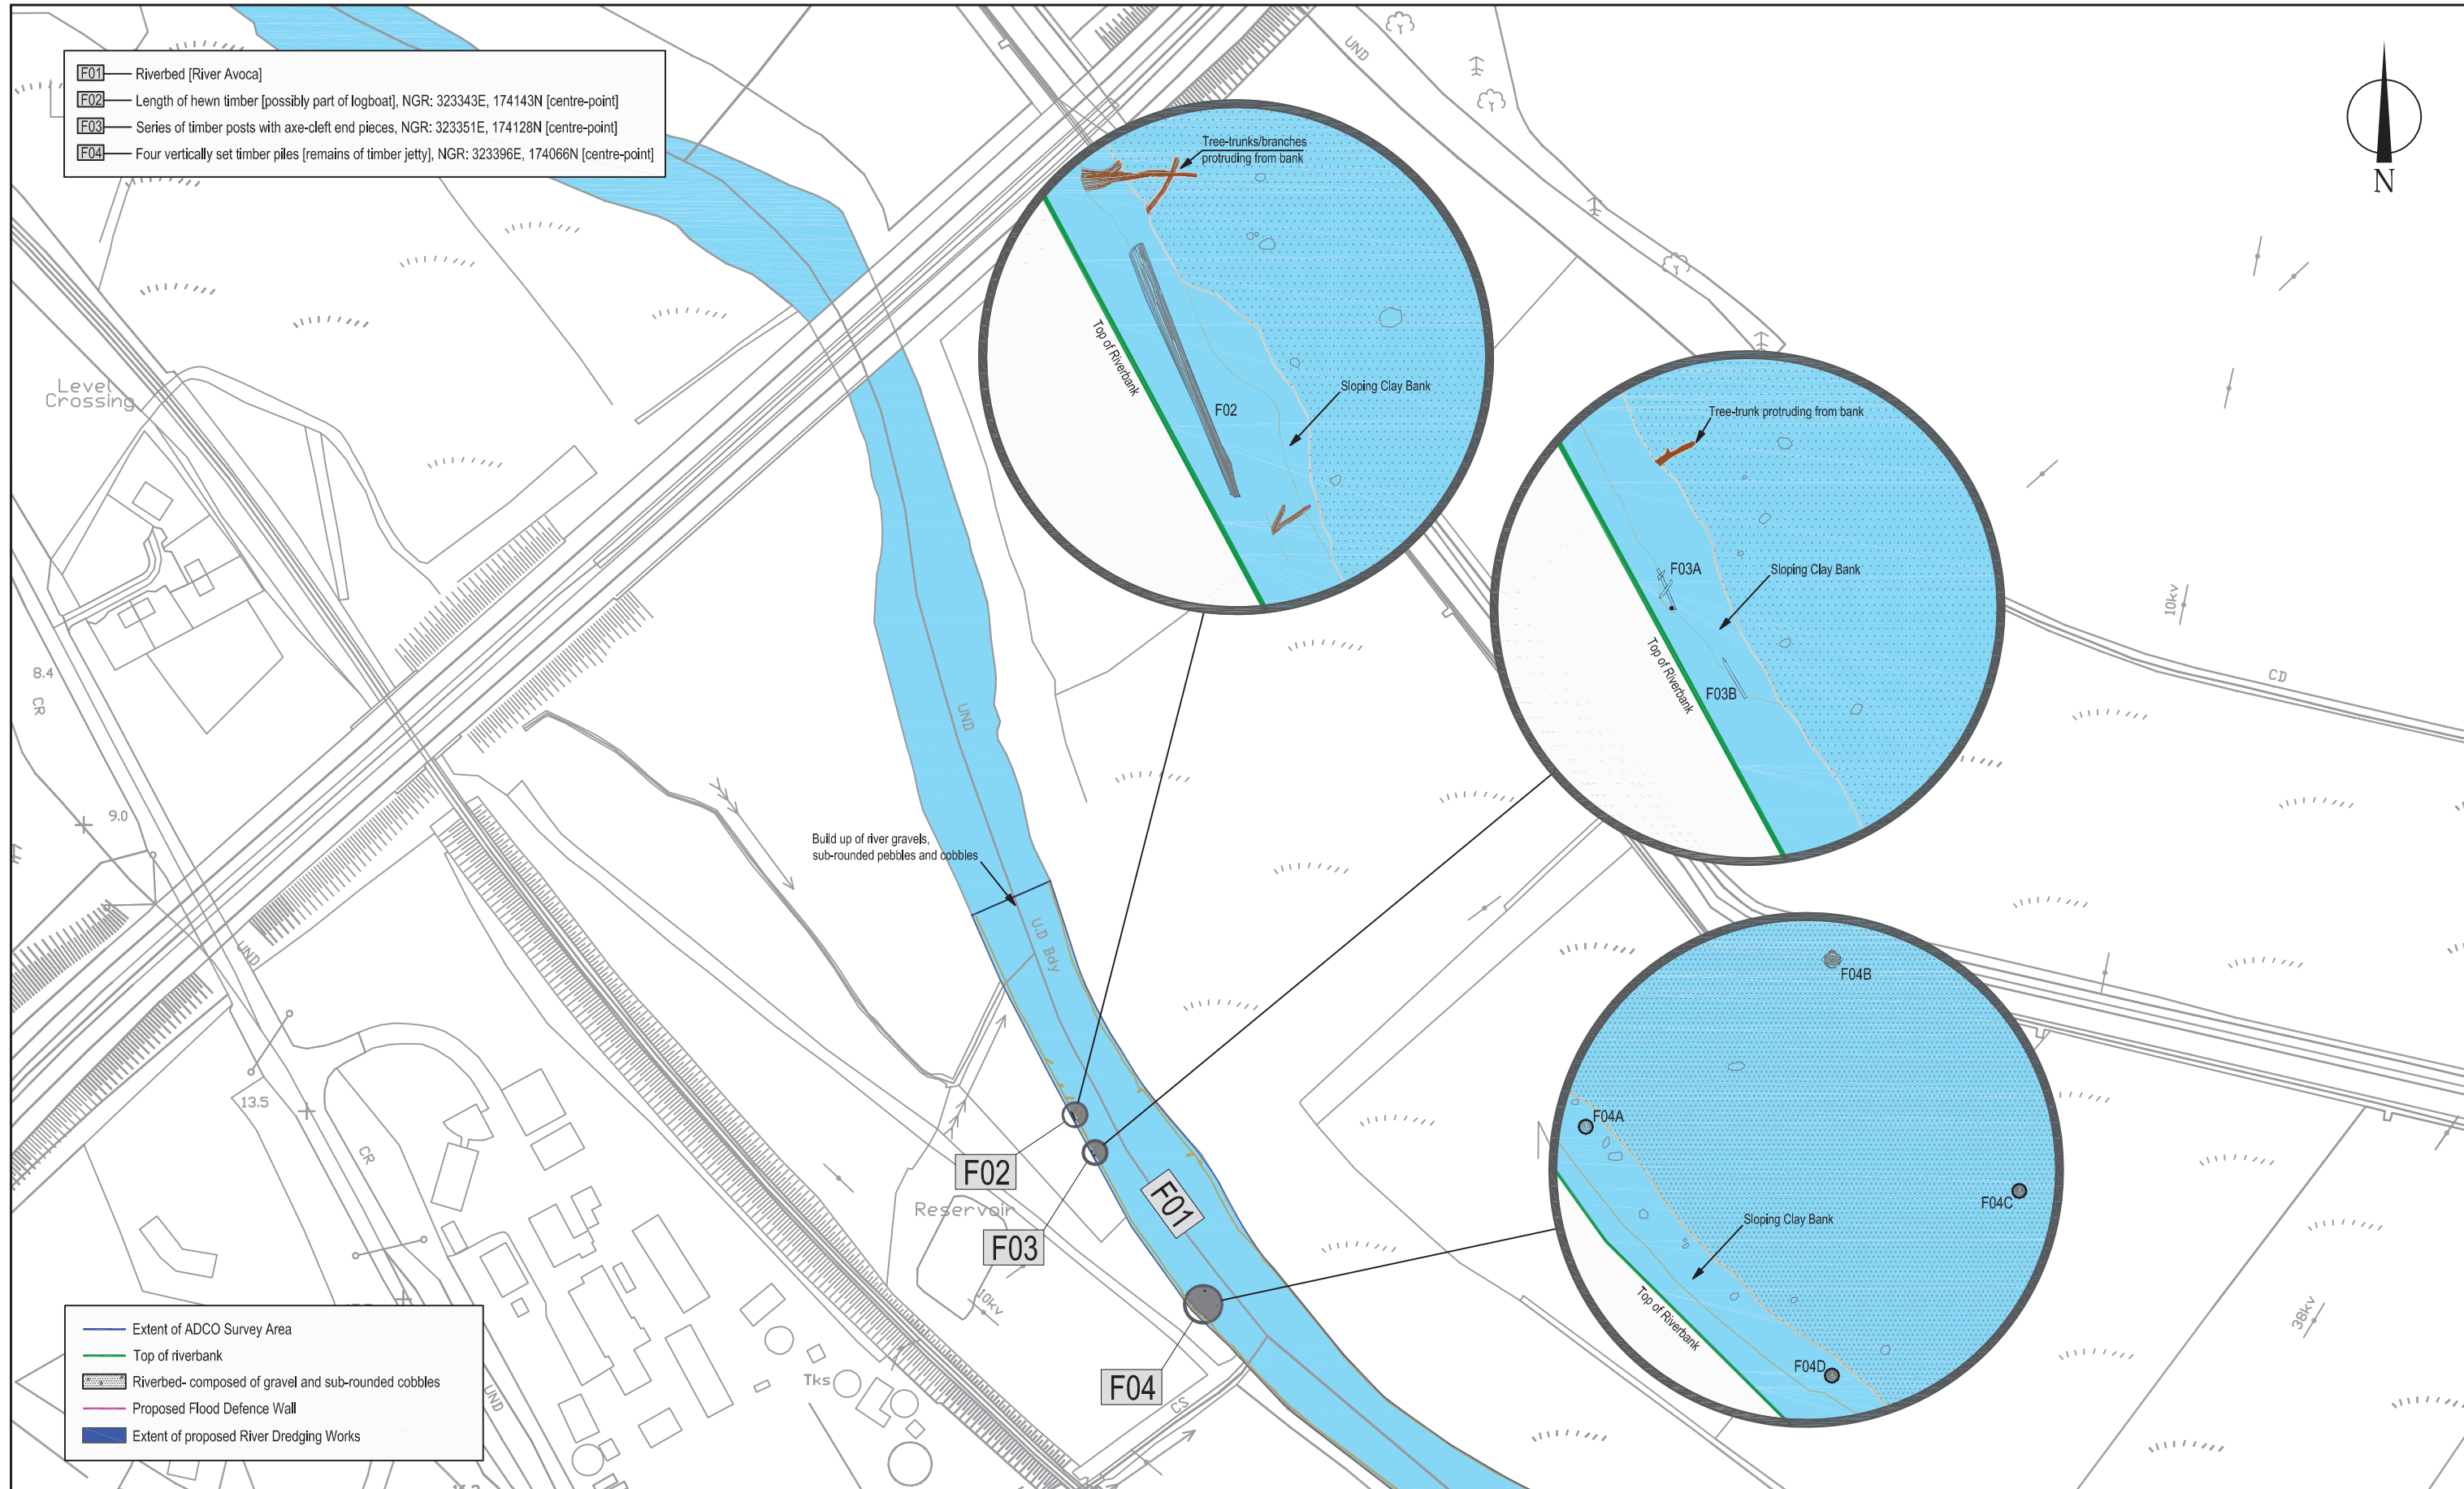
A3	Job/Exc No. 17D0078	Compiled by R.Bangerter	CAD reference Arklow_2018	Client ARUP/ Wicklow County Council
	Date 01.03.21	Scale 1:2500/ 1:100	Drawing No. Figure 7	Project UAIA, Arklow Flood Relief Scheme

Title
 Figure 7- Figure showing location and extent of Features F02-F04, positioned along the southern bank of the River Avoca, close to start of ADCO Survey Area; c.1.5m upstream of Arklow Bridge.

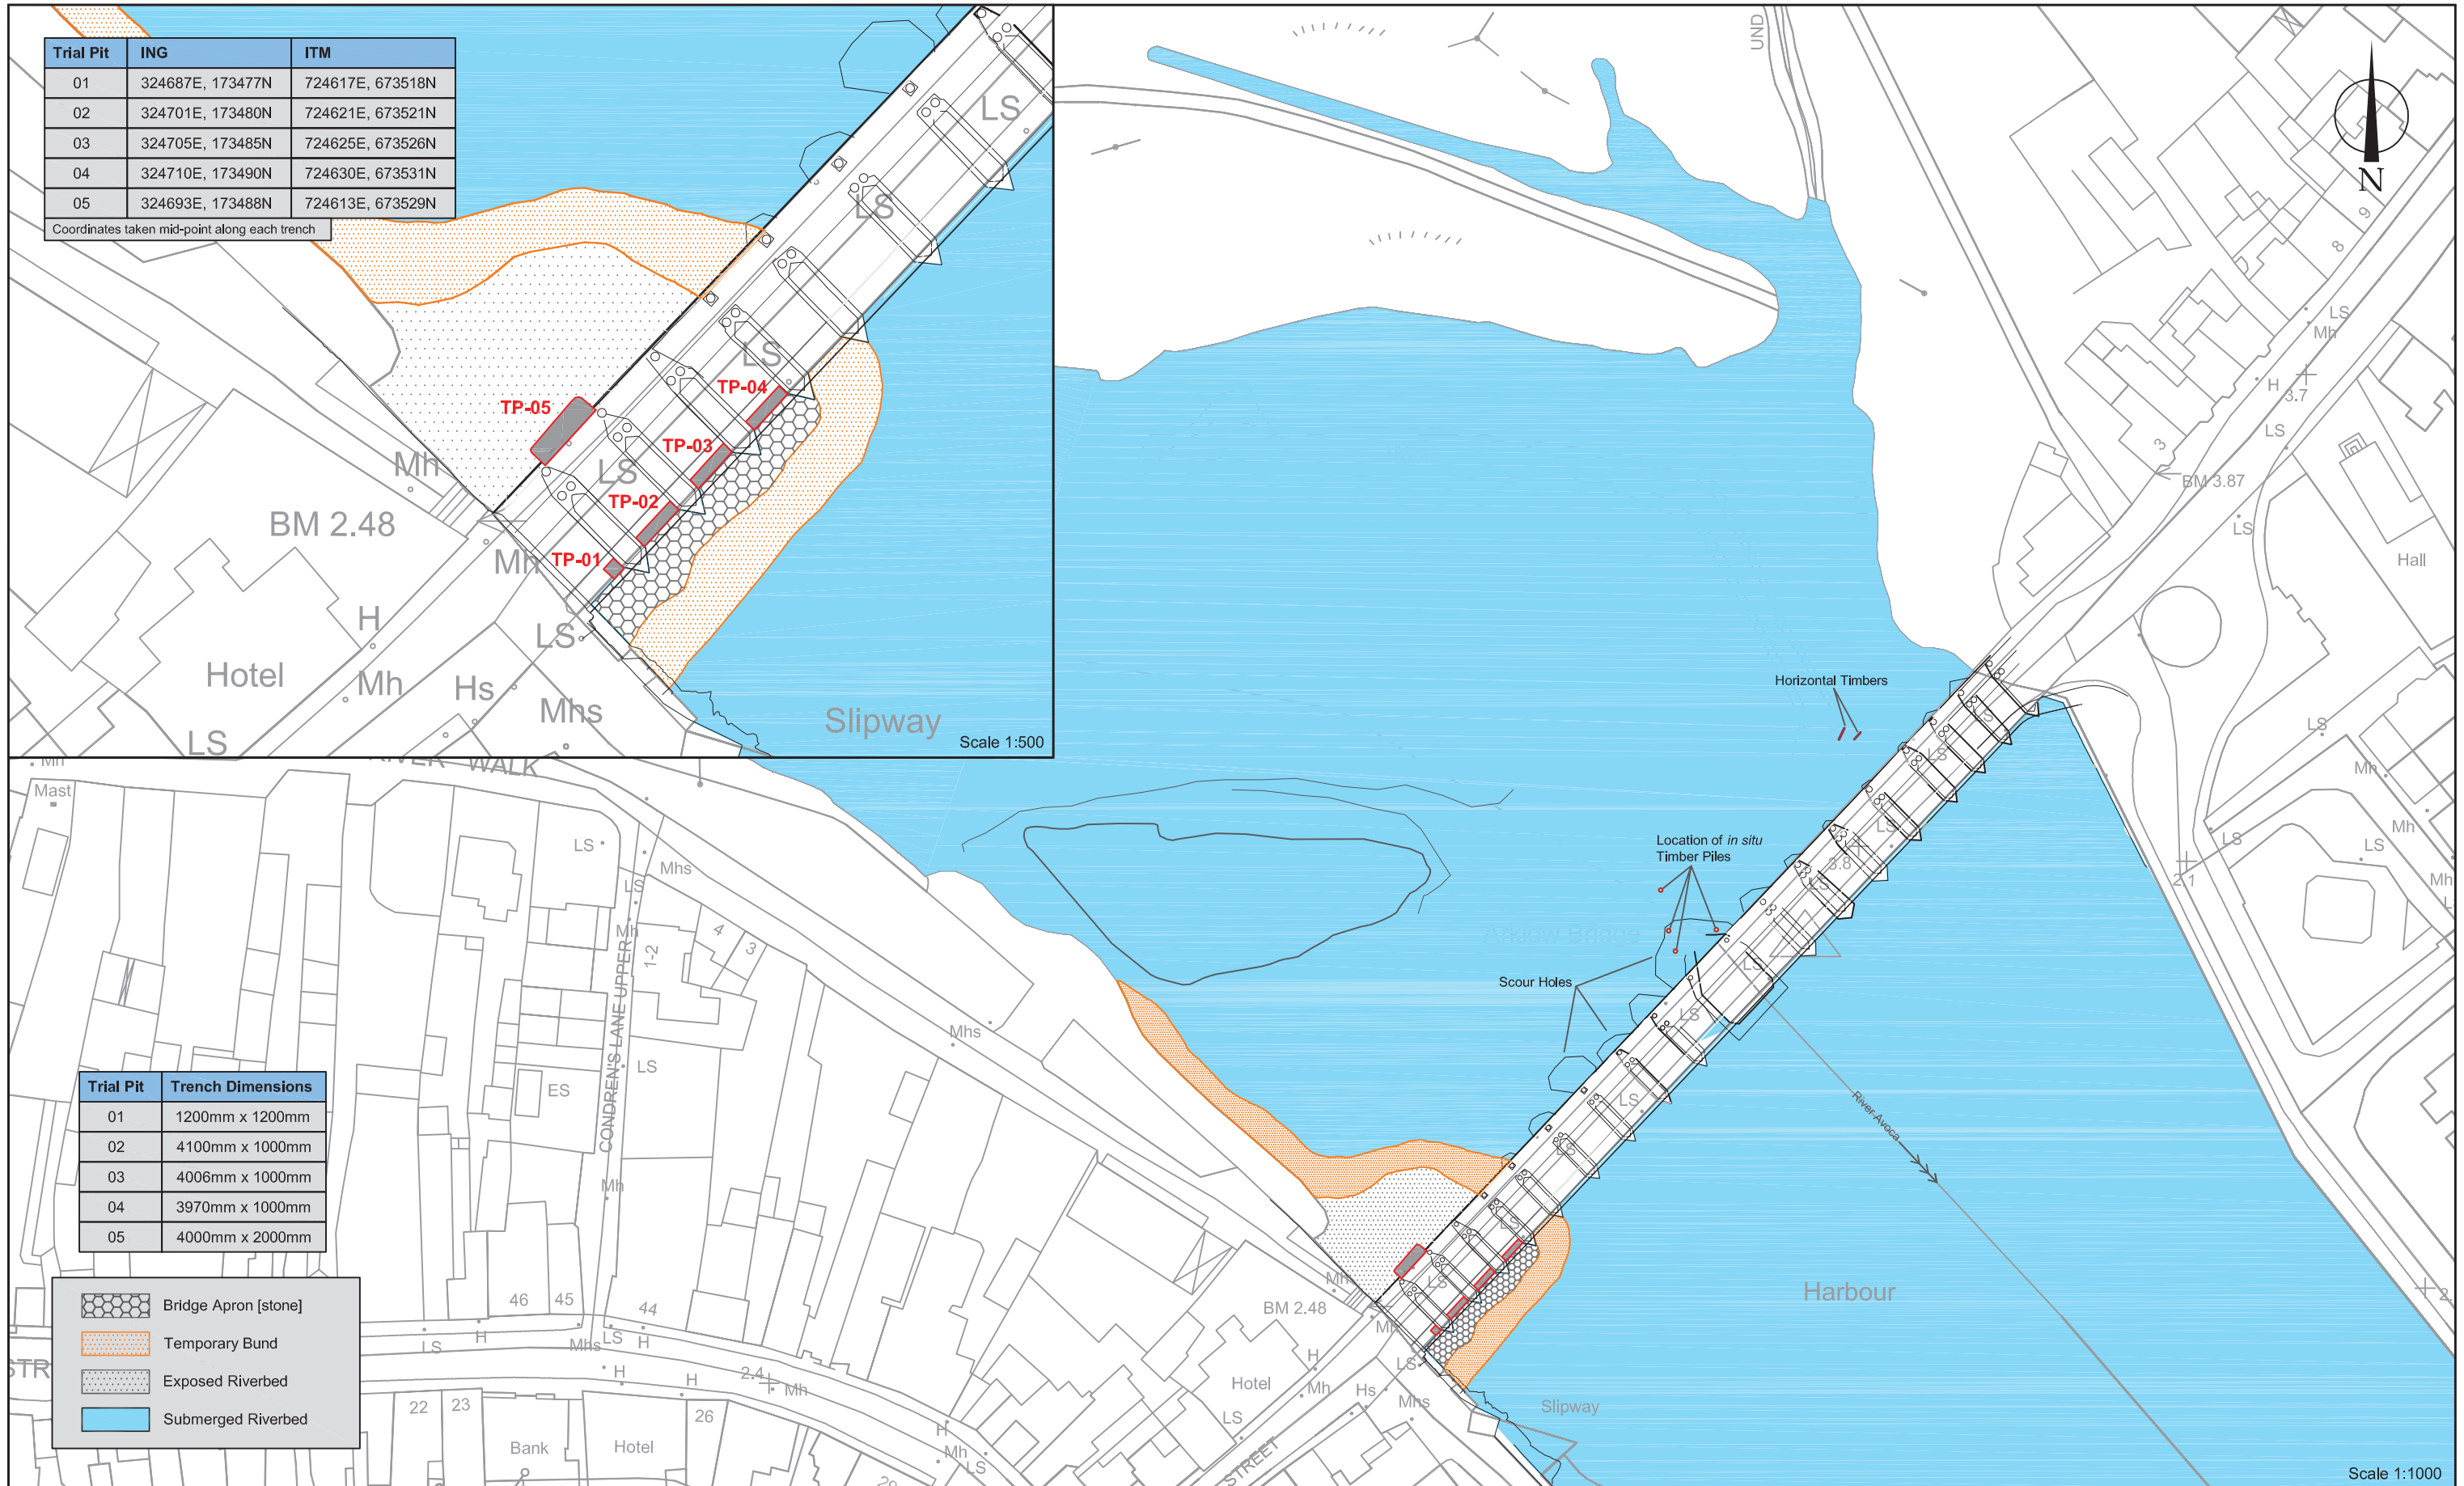
Title
Figure 10- Location of Geotechnical Trial Pits along footings/ foundations of Arklow Bridge.

bridge arches 1, 2 and 3. The work focused on the south end of the bridge, centred at ITM 724627E 673529N (Figure 10).²⁶

While certain variations occurred in each of the downstream trial pits completed in 2019, the following pattern was observed overall:

The findings at the bridge piers either side of the stone apron present additional insight. A concrete surround is added to the stone piers and postdates the stone apron, representing modern underpinning works. Removal of the apron at the bridge piers revealed a sequence of timbers in four of the seven instances. The timbers comprise mostly round-sectioned soft woods, but some rectangular-sectioned pieces were also observed (Plate 64). The timbers represent starling piles. Such timbers were used as a protective measure against scour and were set around the base of bridge piers. In one instance (Pier 1, Trial Pit TP-02) it was possible to observe the stone that is inside the line of starlings, and this is interpreted as evidence for the plinth of the bridge pier.

There was no rock outcropping observed in the 700mm–1.2m-deep trial pits.

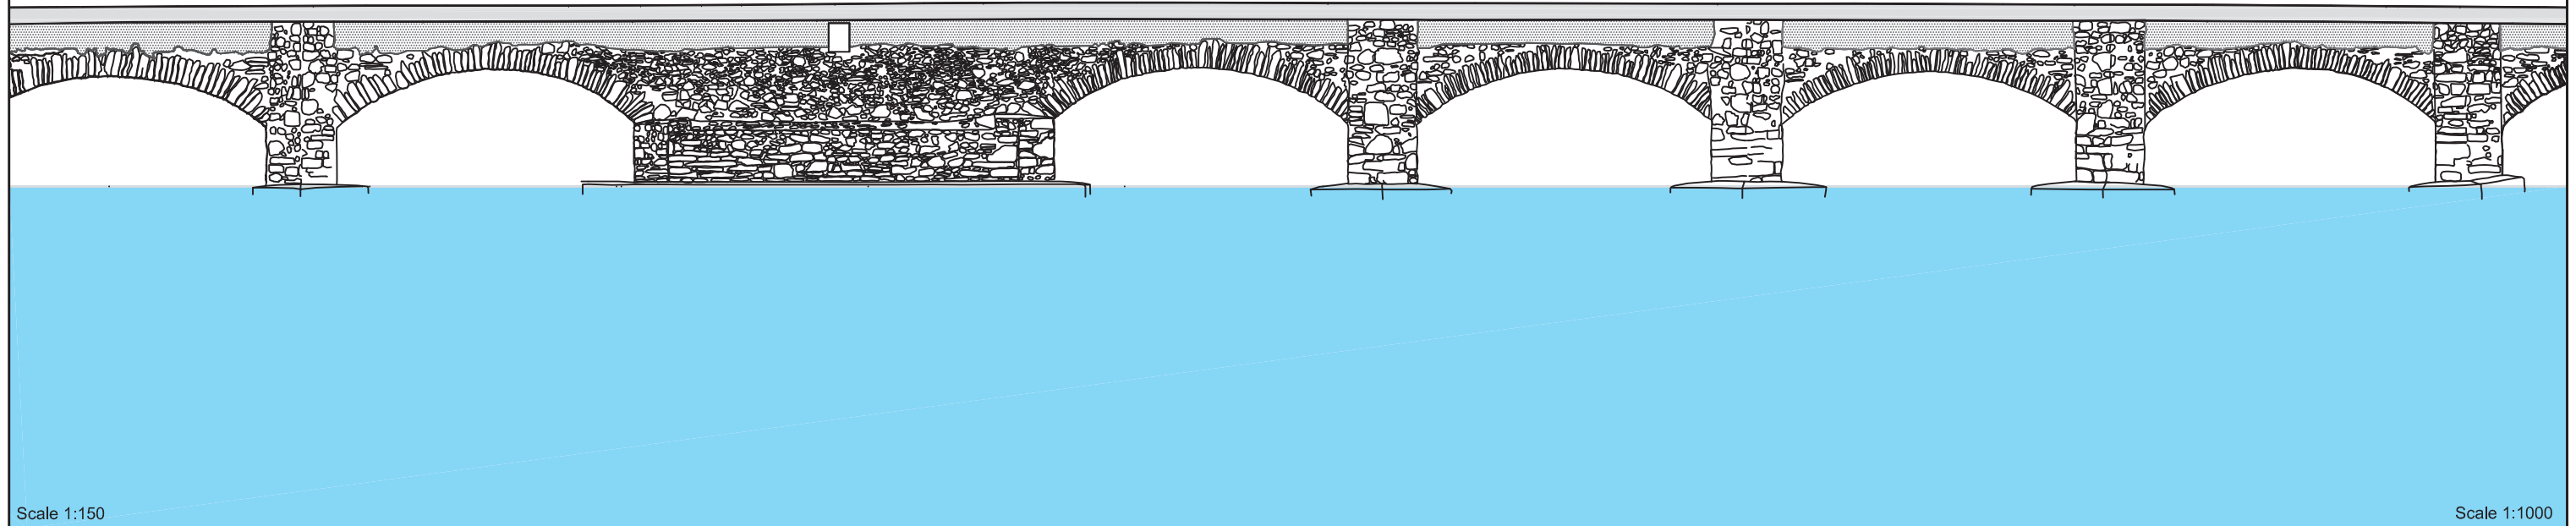
Downstream Elevation

Notes [Survey data for bridge elevation gathered by ADCO using Total Station, DGPS, and Laser Scanning.].	A3	Job/Exc No. 17D0078	Compiled by R.Bangerter/ D.Copeland	CAD reference Arklow_FRS	Client ARUP/ Wicklow County Council	Title Figure 11- Sample Elevation on downstream side of Arklow Bridge [location as indicated in thumbnail].
		Date 18.08.20	Scale 1:150/ 1:1000	Drawing No. Figure 11	Project UAIA, Arklow Flood Relief Scheme

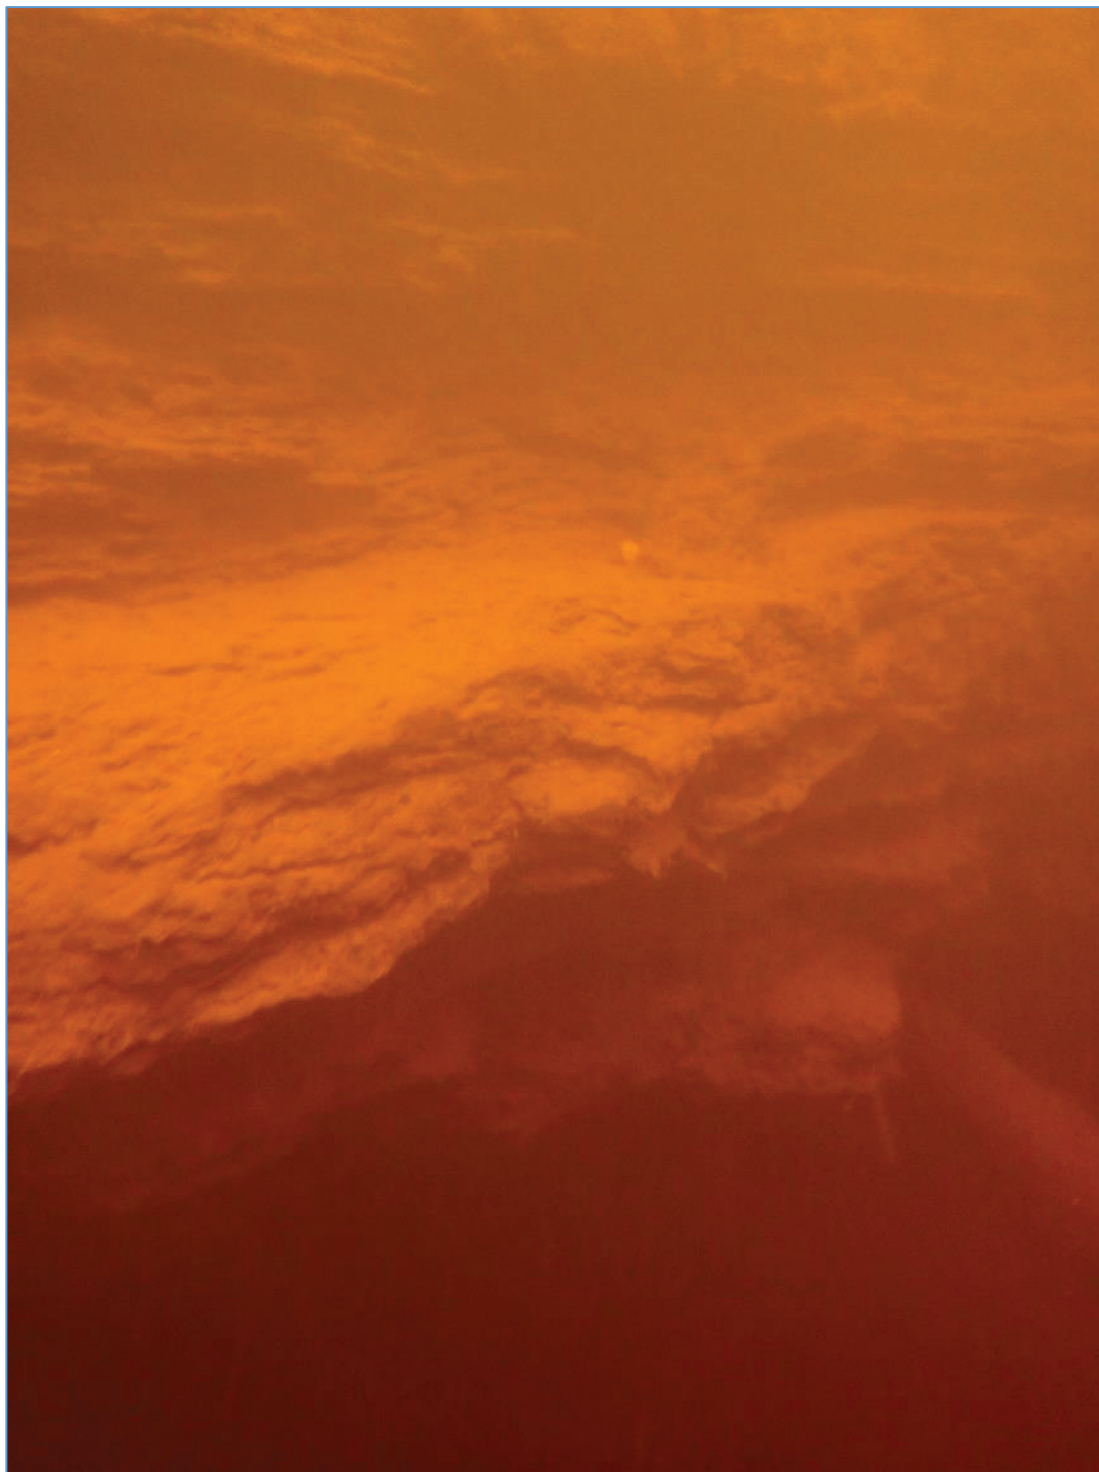
Plate 16: Underwater image of the shelving bedrock that is exposed on the south bank close to Arklow Castle.

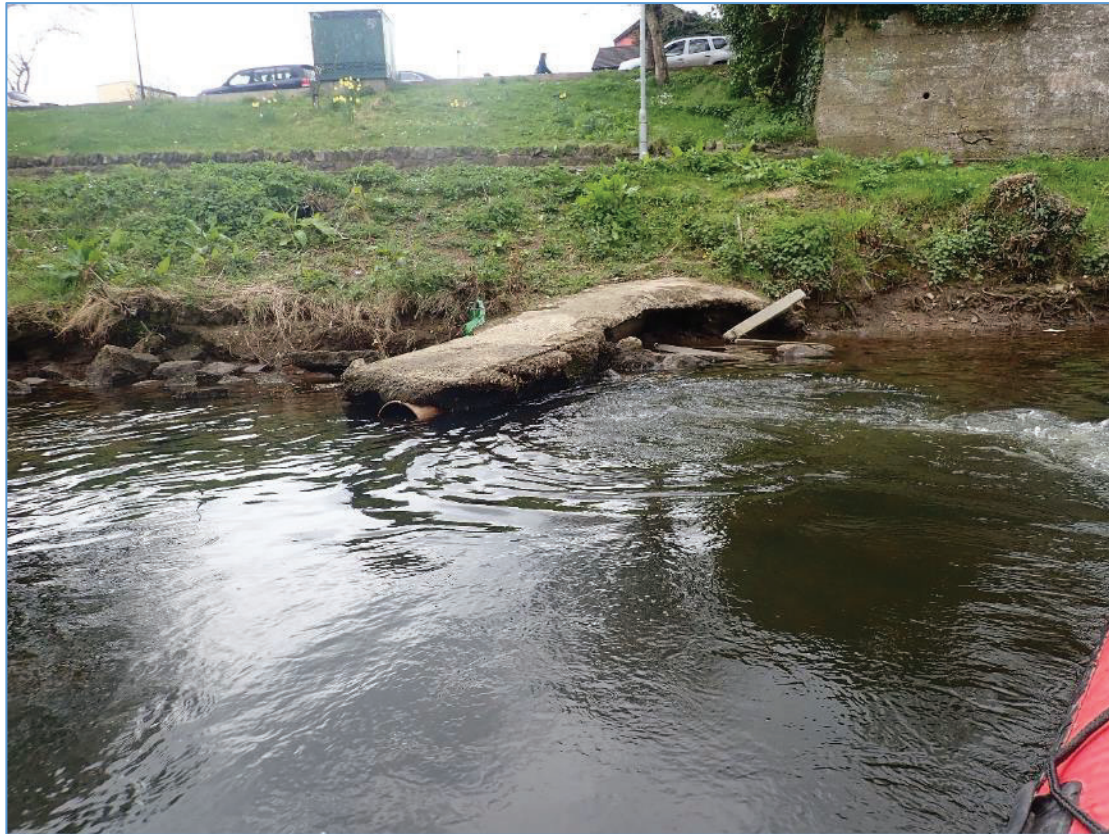
Plate 17: Outfall entering the river from the south bank above Arklow Bridge.

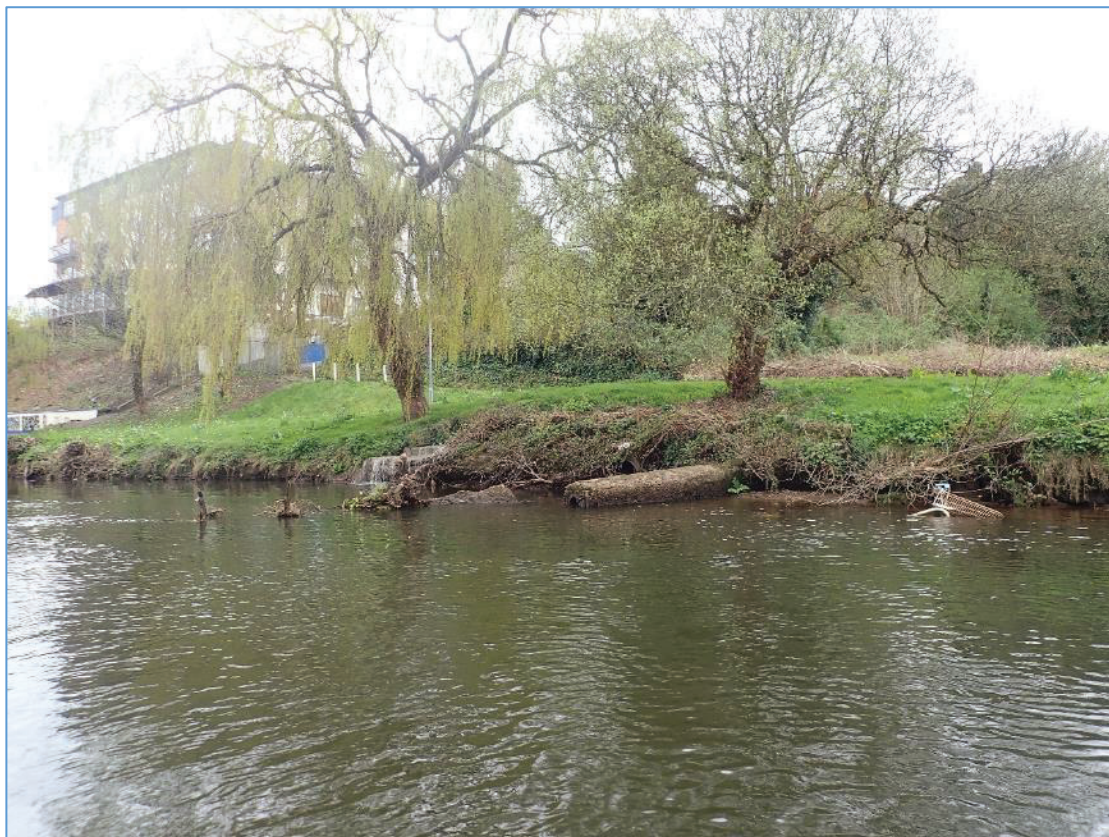
Plate 18: Outfall entering the river from the south bank above Arklow Bridge.

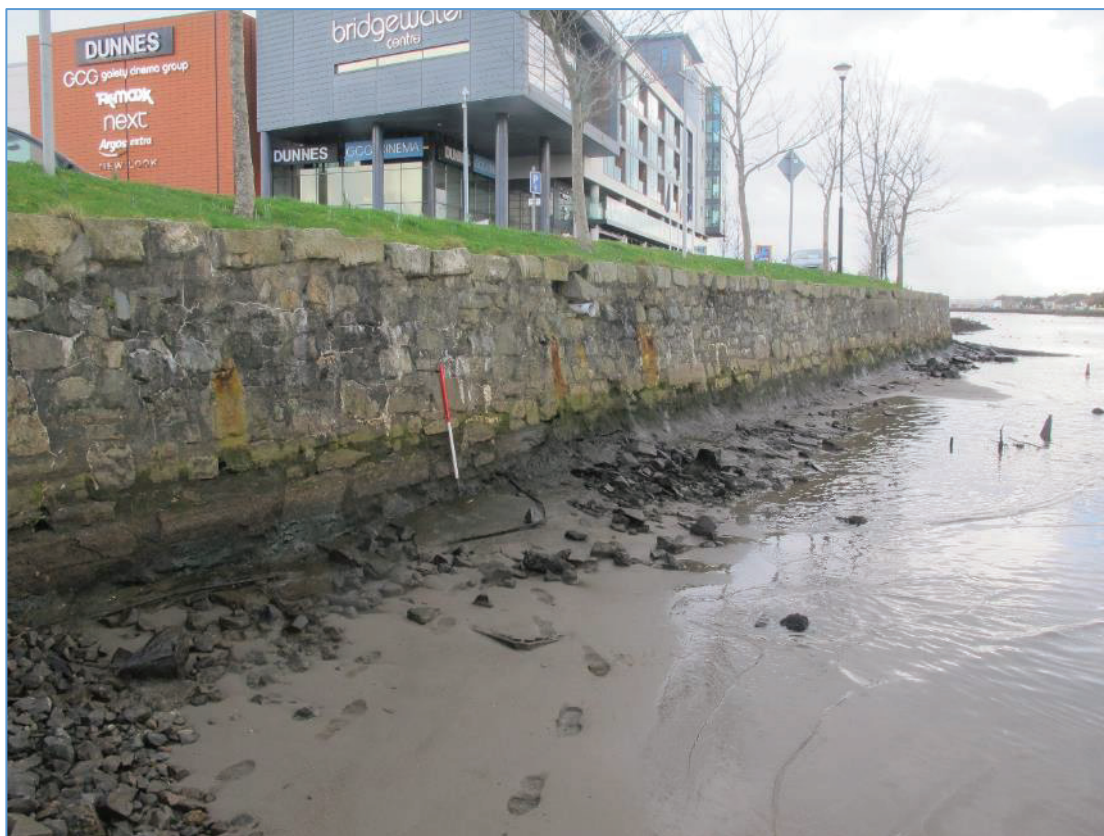
Plate 21: Close-up view of the stone retaining wall of North Quay.

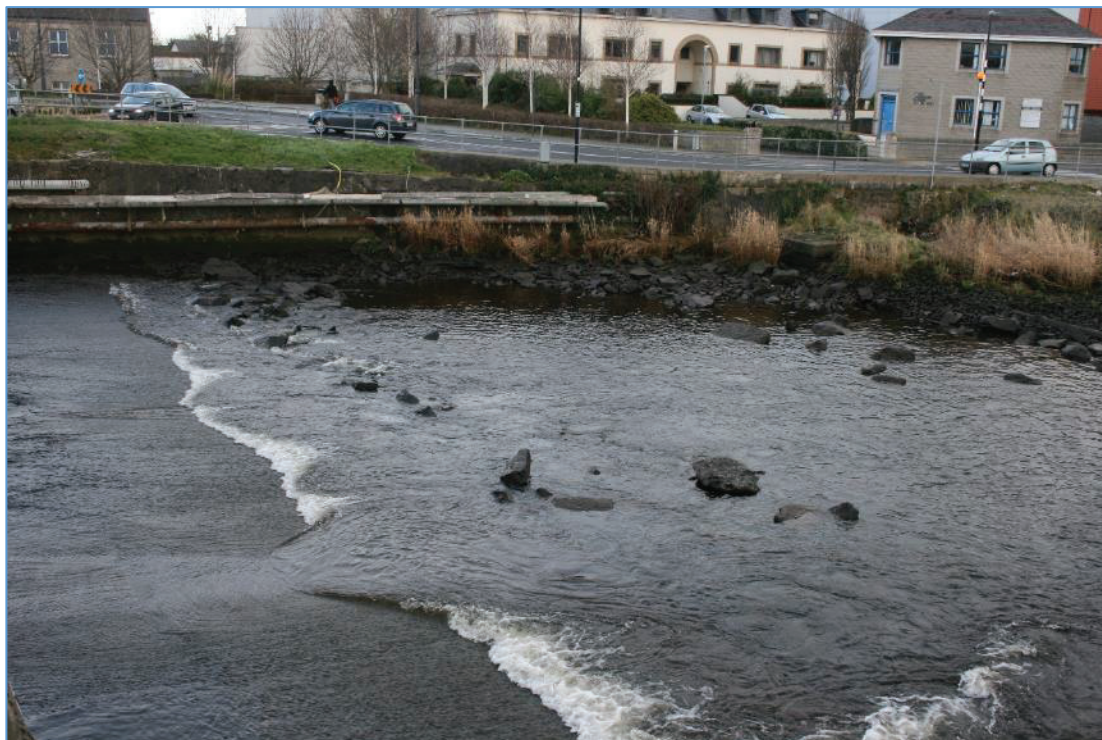
Plate 23: View looking across to North Quay, showing the service pipes to the former NET/IFI factory carried on the wall.

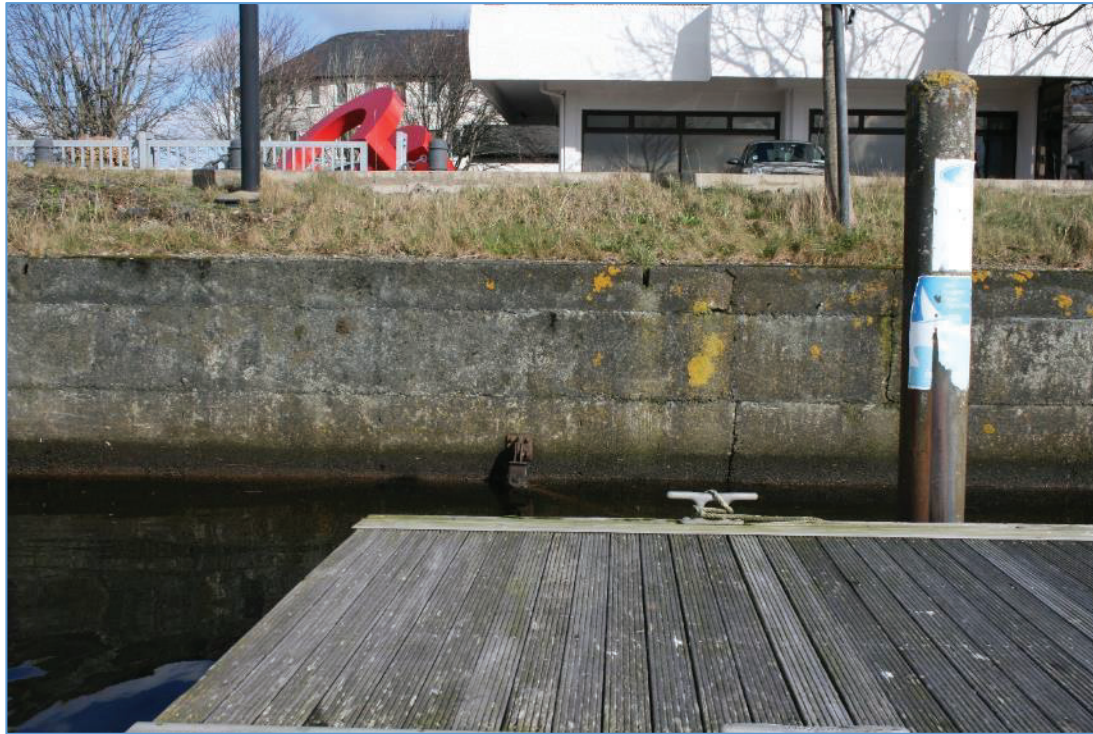
Plate 25: A concrete caisson solution marks the North Quay between the sailing club and the marina.

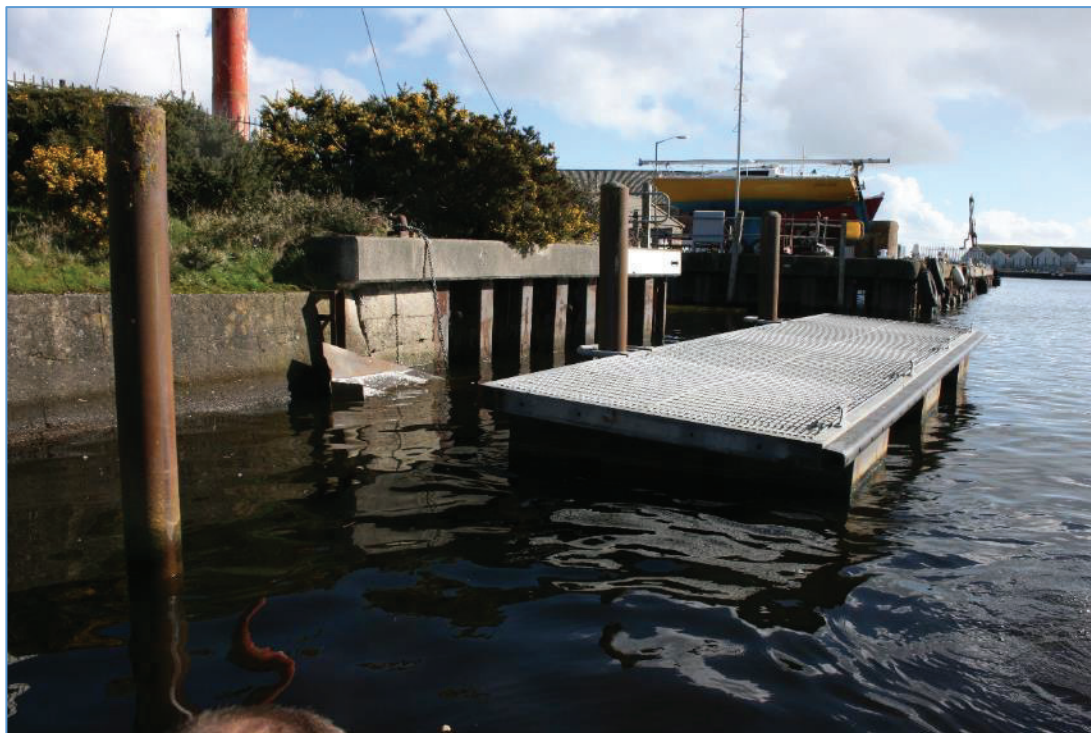
Plate 27: At the marina, the concrete caissons are replaced by sheet-piling capped with a concrete deck.

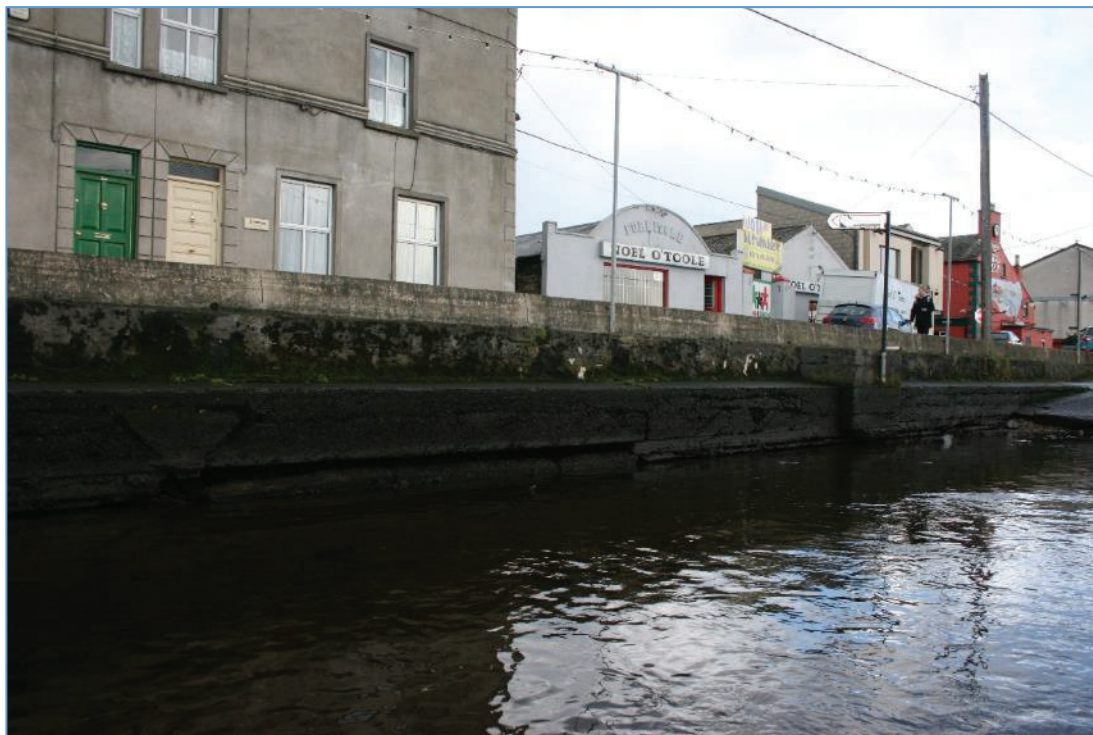
Plate 31: View along South Quay showing the stone wall and later concrete additions.

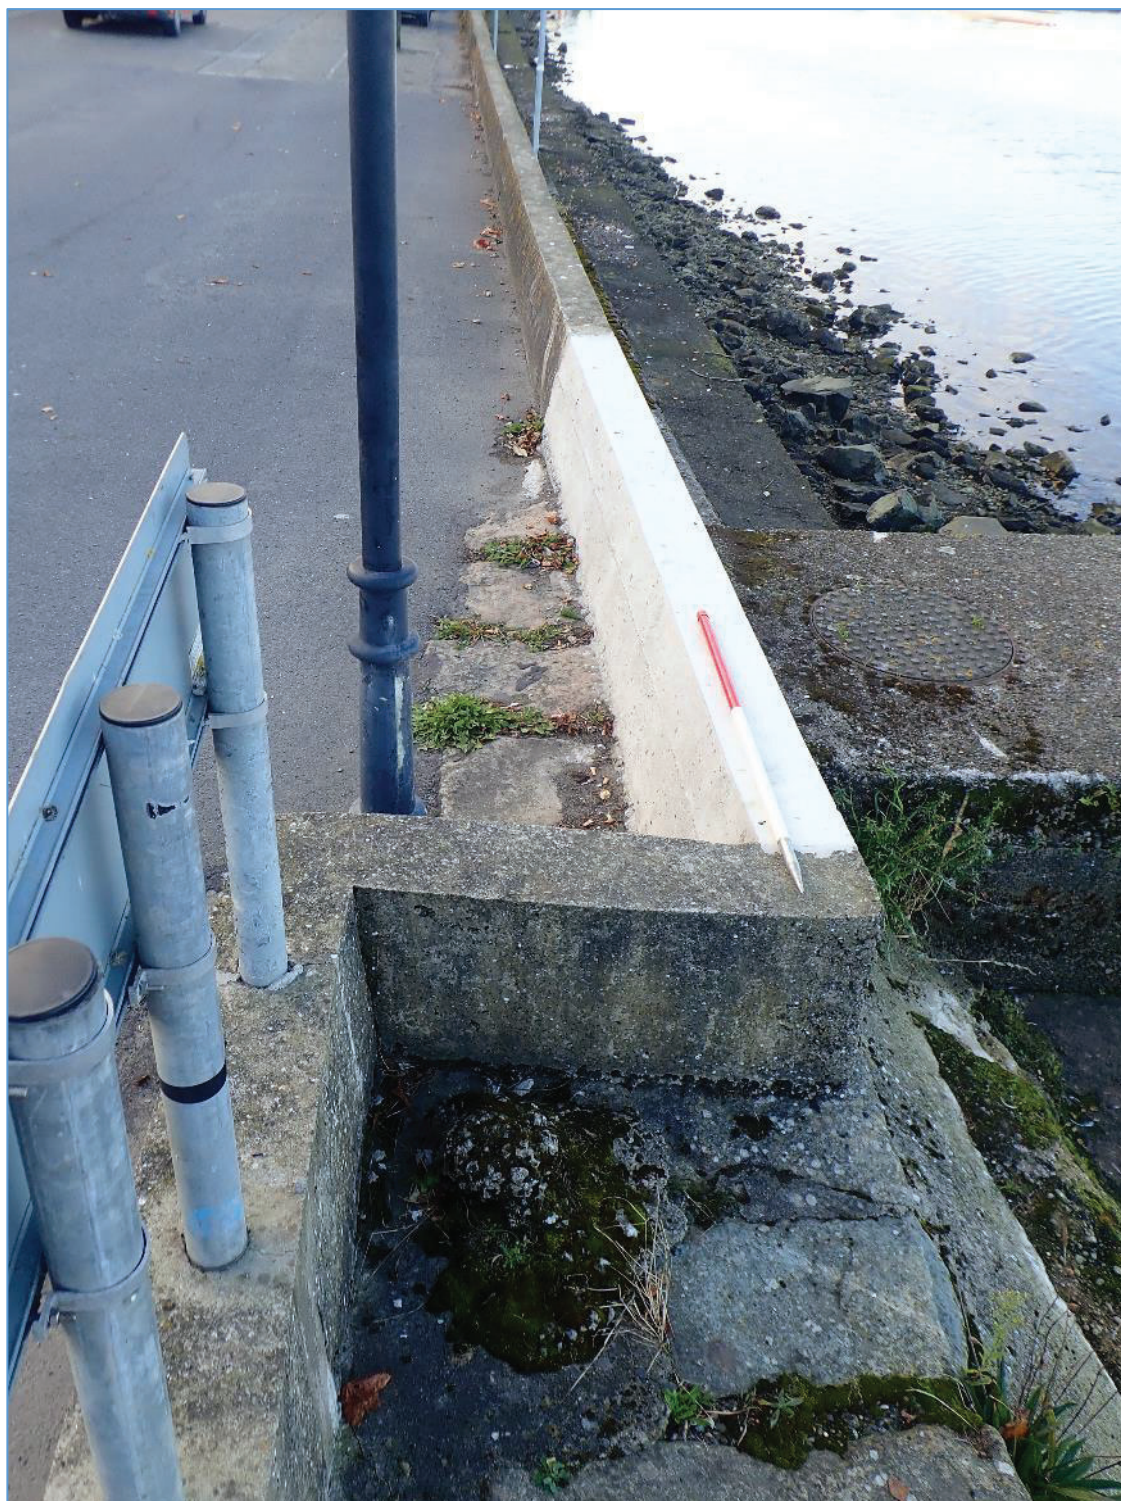
Plate 33: View on South Quay looking upstream from where the stone quay becomes buried under modern concrete.
