Underwater Archaeological
Impact Assessment, Avoca
River, Arklow Flood Relief
Scheme Licence No. 17D0078
(ADCO, Brady, 2020a)

**Underwater Archaeological Impact Assessment
Avoca River, Arklow Flood Relief Scheme
17D0078**

31/03/2021

ARUP for Wicklow CC

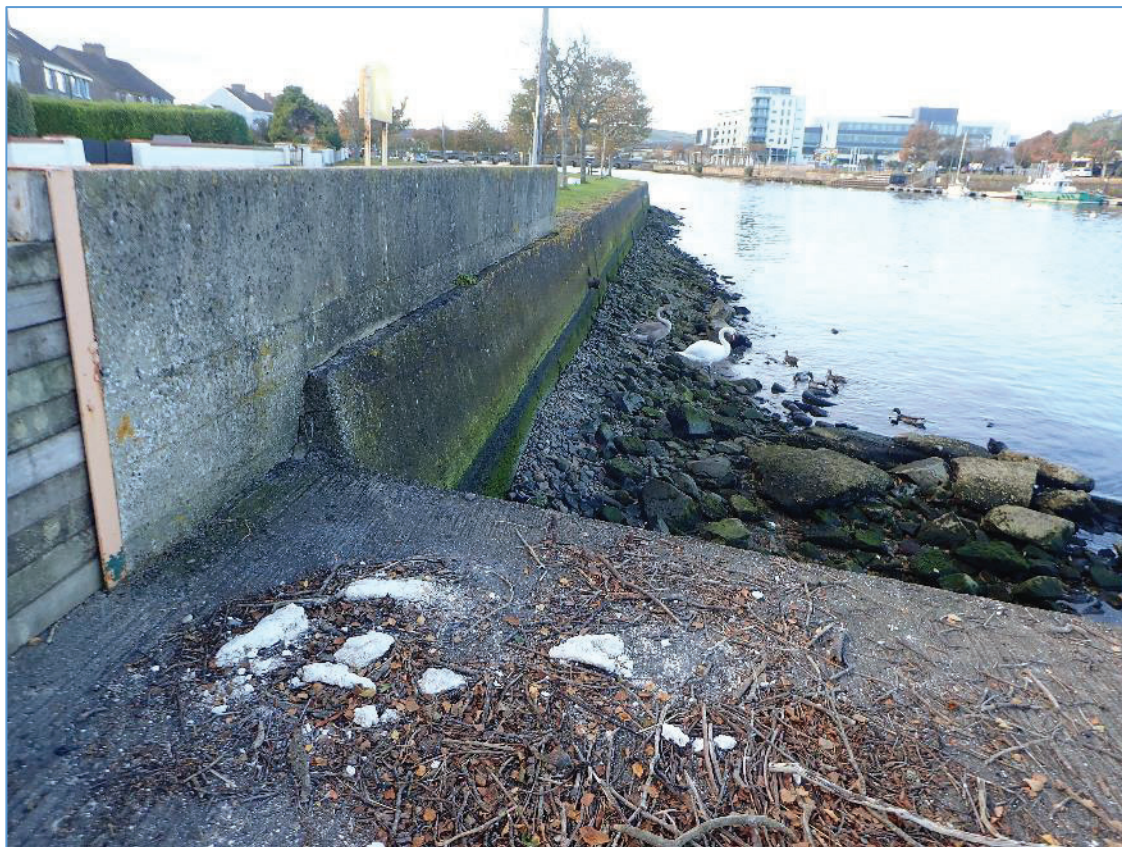
Plate 38: View from boatyard slipway looking upstream, showing the convergence of South Quay and its later concrete rendering.

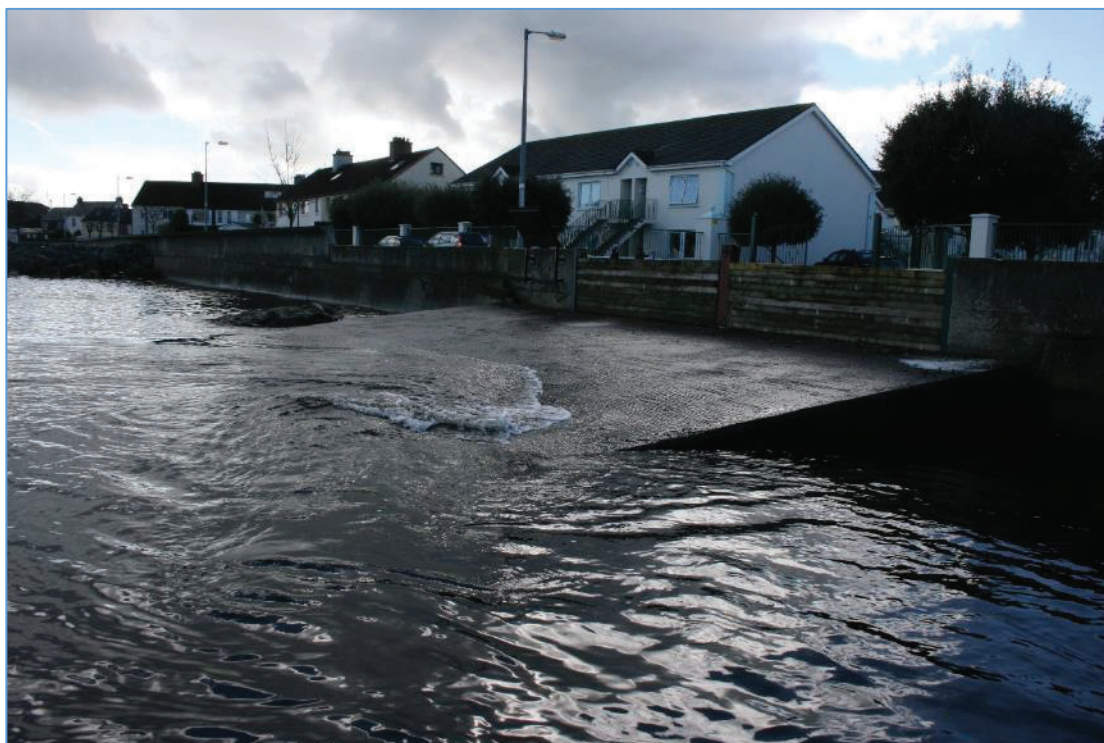
Plate 39: View looking southwest and downstream at the concrete-covered slipway that formerly served as the slipway for a boat-building yard that is recorded on the OS 1911 map.

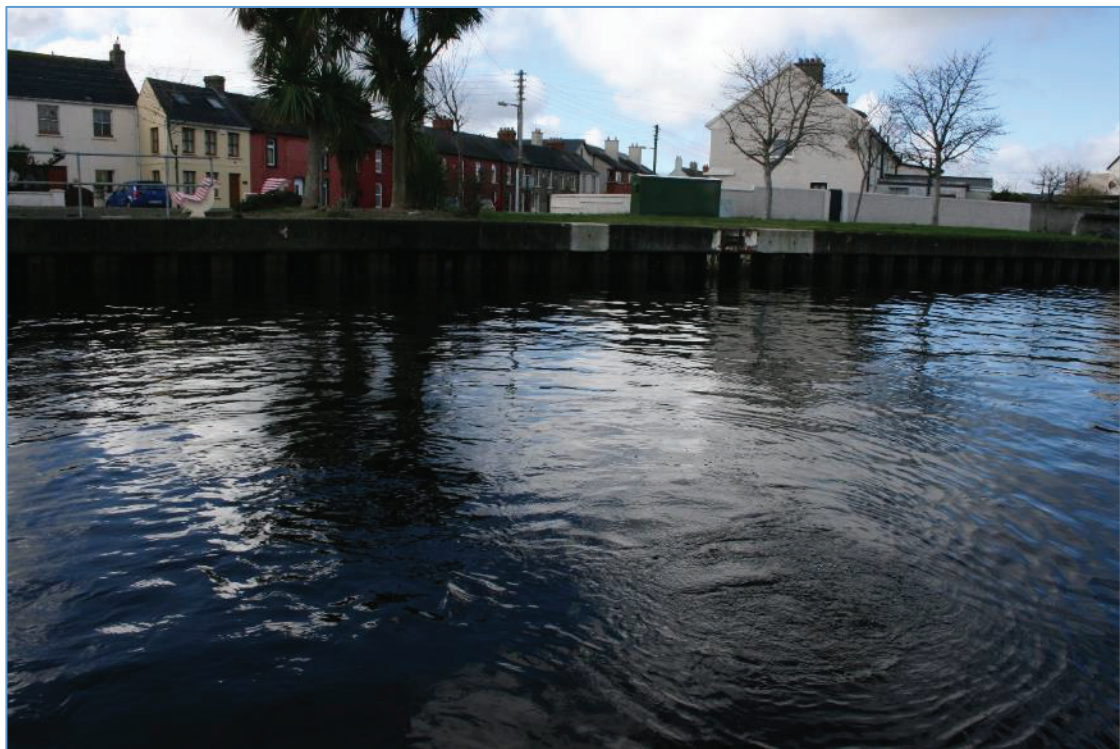
Plate 41: View of sheet-piling that defines the lower reaches of South Quay.

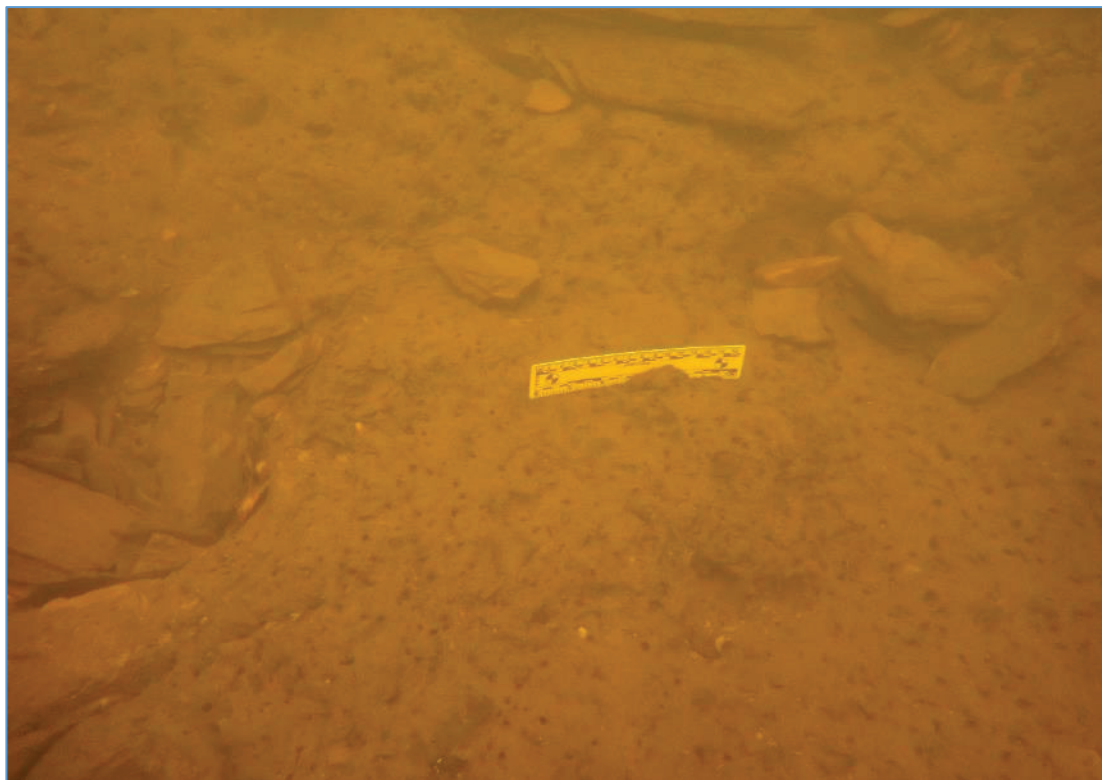
Plate 43: Underwater shot showing the nature of the clay riverbed stratum exposed upstream of Arklow Bridge.

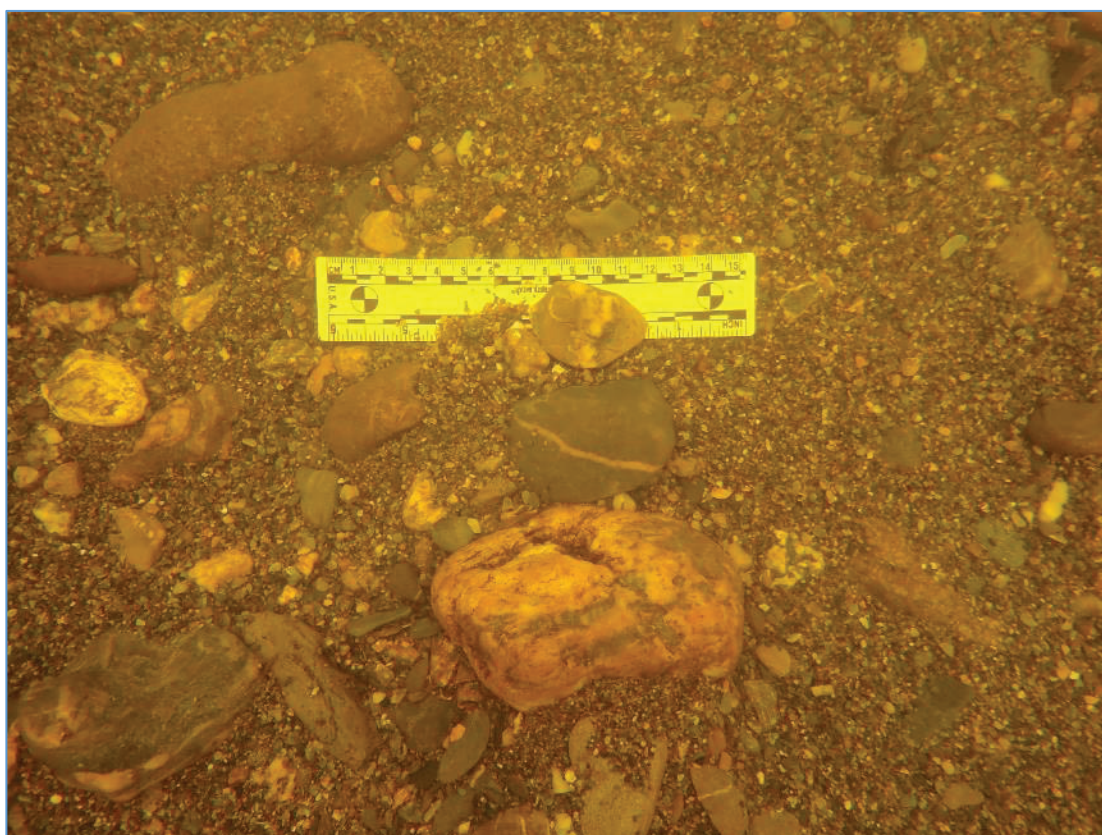
Plate 44: Underwater shot of the river bed surface approximately 100m upstream of Arklow Bridge.

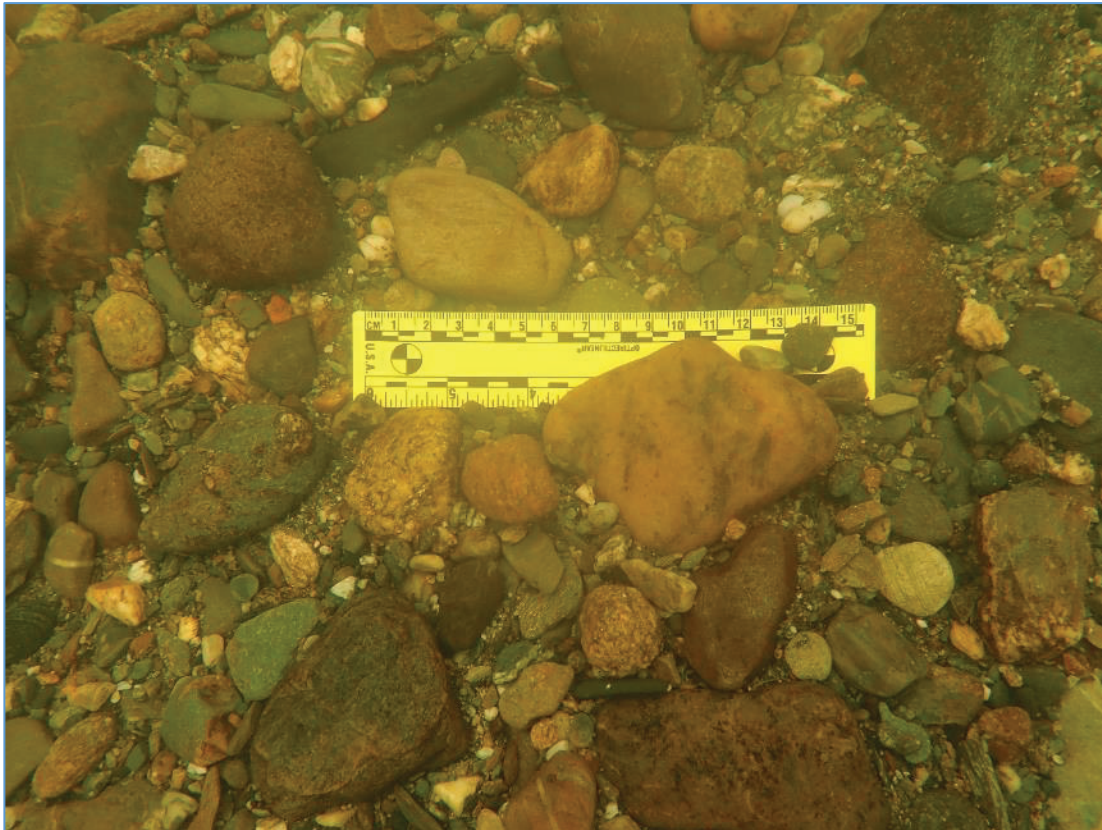
Plate 45: Underwater shot of the river bed surface approximately 5m upstream of Arklow Bridge

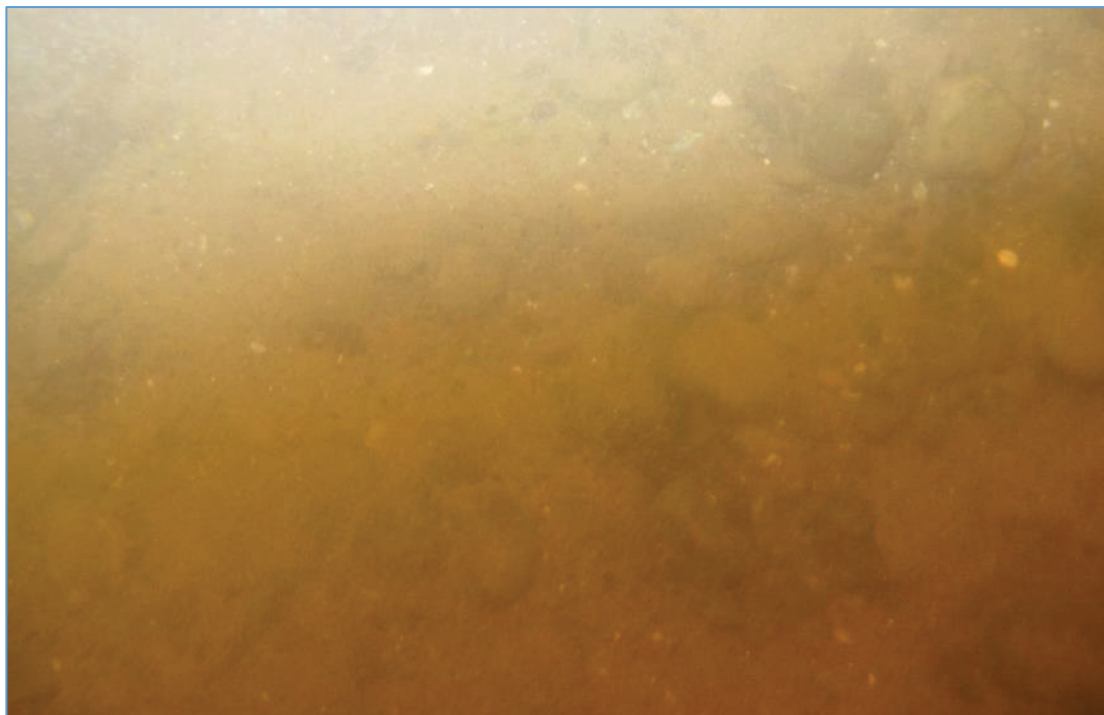
At the downstream end of the survey area, the riverbed surfaces is a silty sand, allowing for 50cm penetration by hand, with rounded pebble inclusions (Plate 47). There are some light ripples but the surface is otherwise flat and featureless. Close to the South Quay, leaf litter and dirt abound close to an outflow pipe. In the area upstream of the marina on North Quay and opposite the boat-building slipway on South Quay, the riverbed is noticeably dirty and a mobile almost 'soupy' sediment lies above the silty sand surface. In mid-channel there is a slight elevation, which is the remnant of the slightly higher ground or sand bar recorded on the 1911 OS map, and may belie the presence of the former timber breakwater. Some sherds of white ware ceramic were observed, of no significant age. Red brick fragments, ceramic sherds, shells and tree branches were observed in this area, highlighting the activity associated with the slipway and its past use.

Plate 47: Underwater shot capturing the typical riverbed surface at the downstream limit of the FRS, showing a silty sand matrix with small stone and pebble inclusions. The poor visibility is due to the finer silt and dirt carried in suspension.

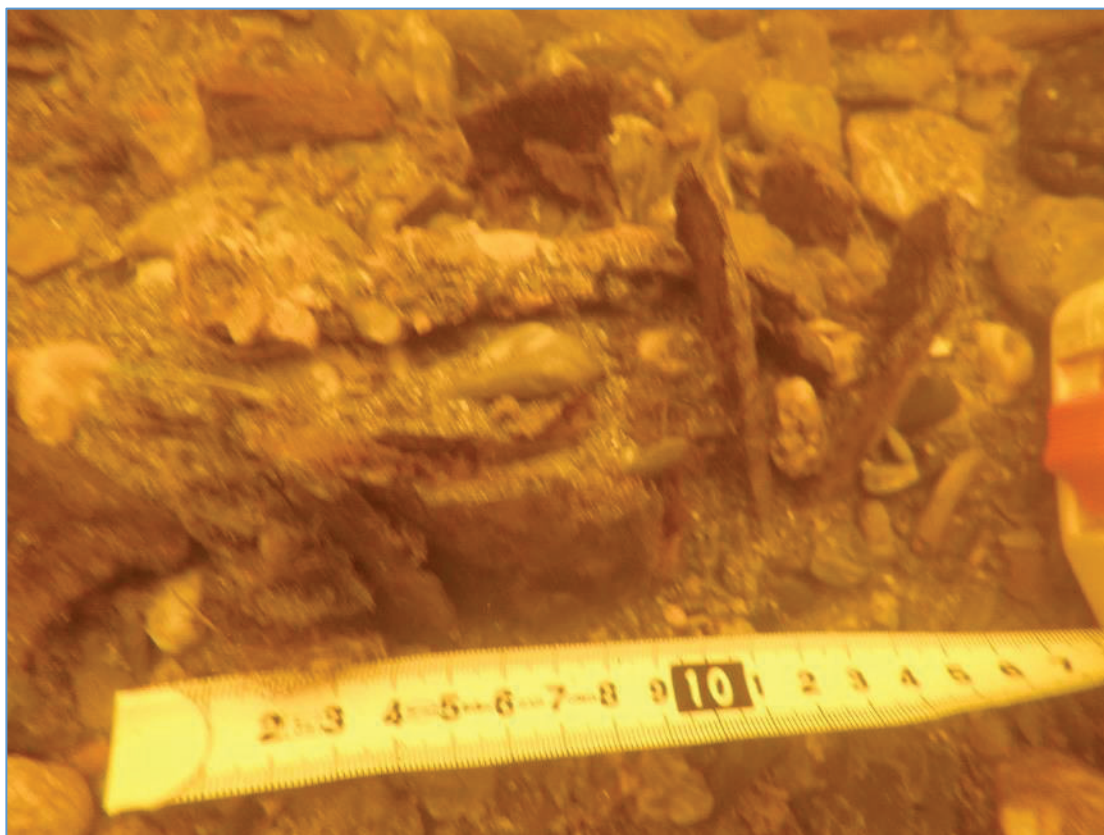
A series of four small stakes are evident, protruding from the clay river bank, close to and downstream of F01. Tool marks on the stakes suggest that an axe was used to cleave their pointed ends (Plate 48). Sizes range between 400mm and 700mm length, diameter 40mm-45mm.

Plate 48: Underwater shot showing sequence of small stakes, F03.

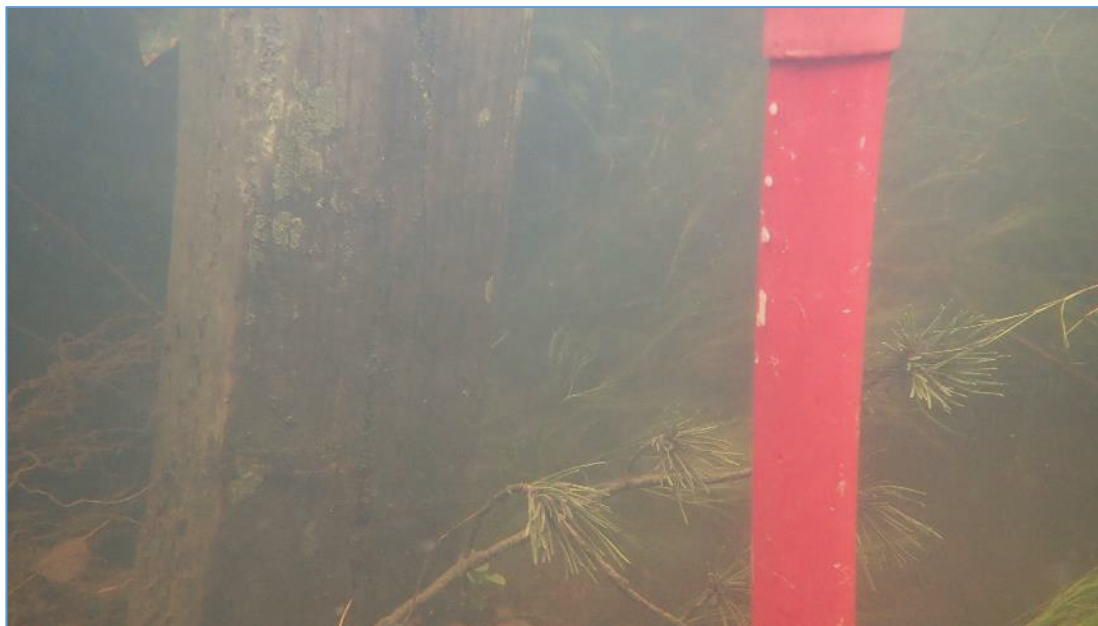
A series of four timber posts, two of which are located at the foot of the clay river bank, and two of which are located 3m into the river channel. Three of the timbers are round in section, and a fourth (the Northeast timber) is rectangular in section (Plate 49). It is probably the remains of a jetty feature of recent date.

Plate 49: Underwater shot showing rectangular-sectioned post, part of F04.

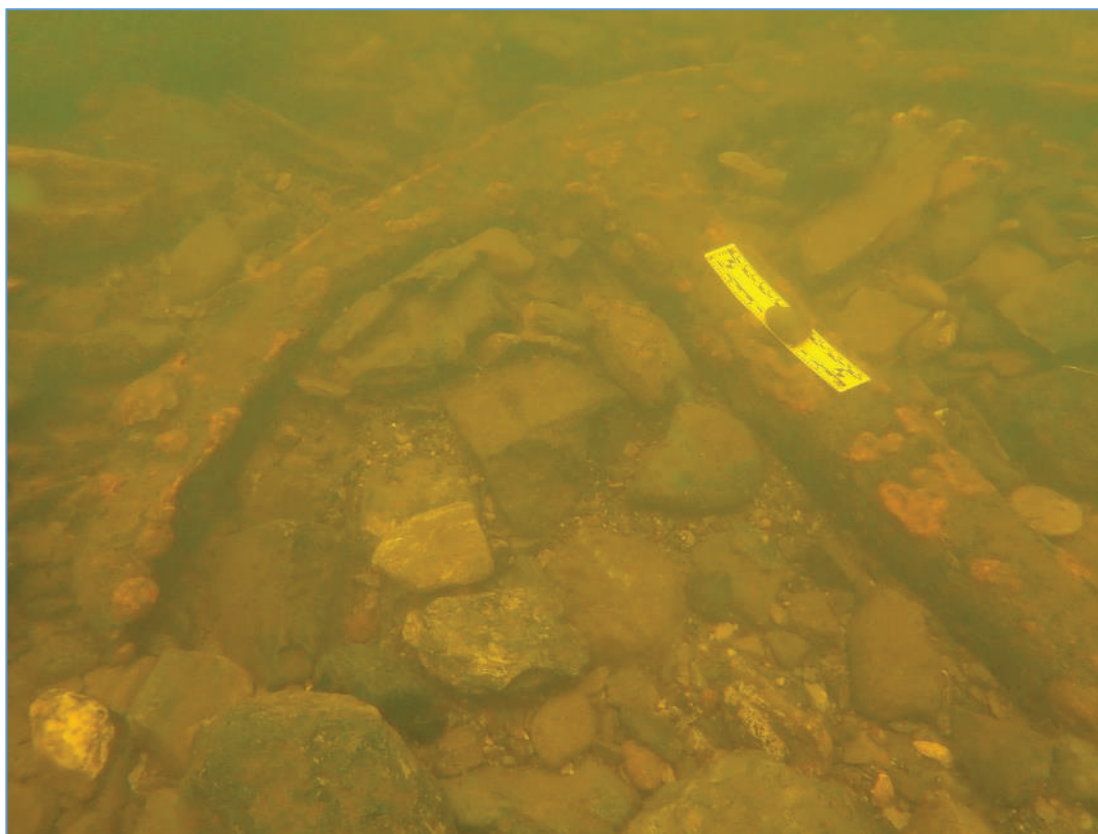
A discarded anchor of nineteenth-century date was recorded close to a length of open-link chain, beside the south bank at the start (west end) of the Riverwalk (Plate 50).

Plate 50: Underwater shot of anchor, F07.

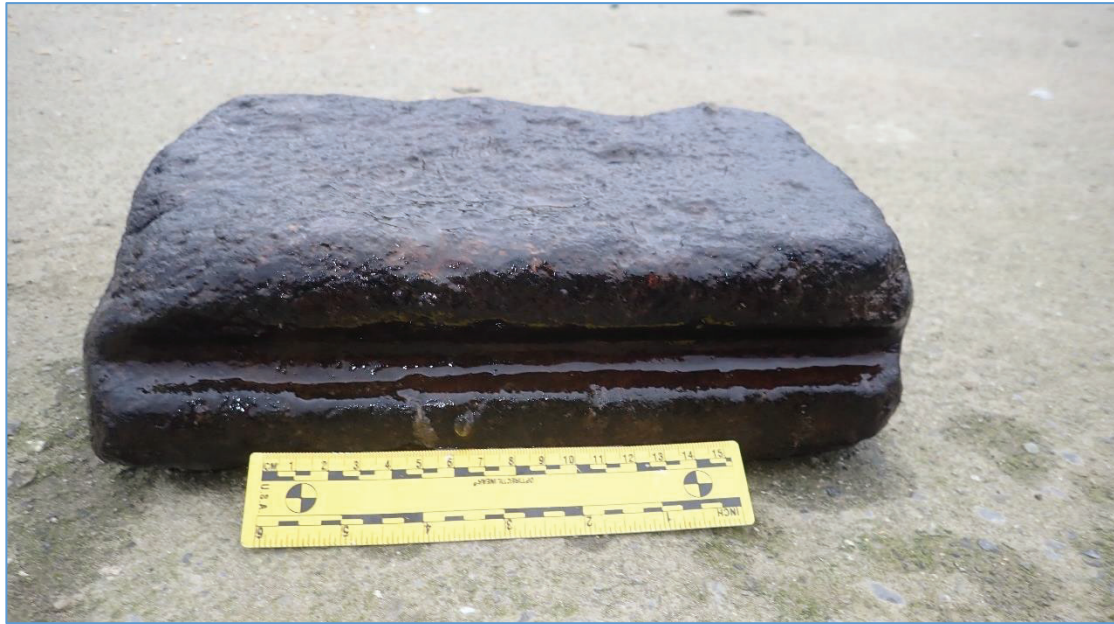
Measured on average 200mm long by wide and 110mm thick (Plate 53). One of the blocks retains a recessed channel on one long edge side.

Plate 53: View of limestone block, F09.

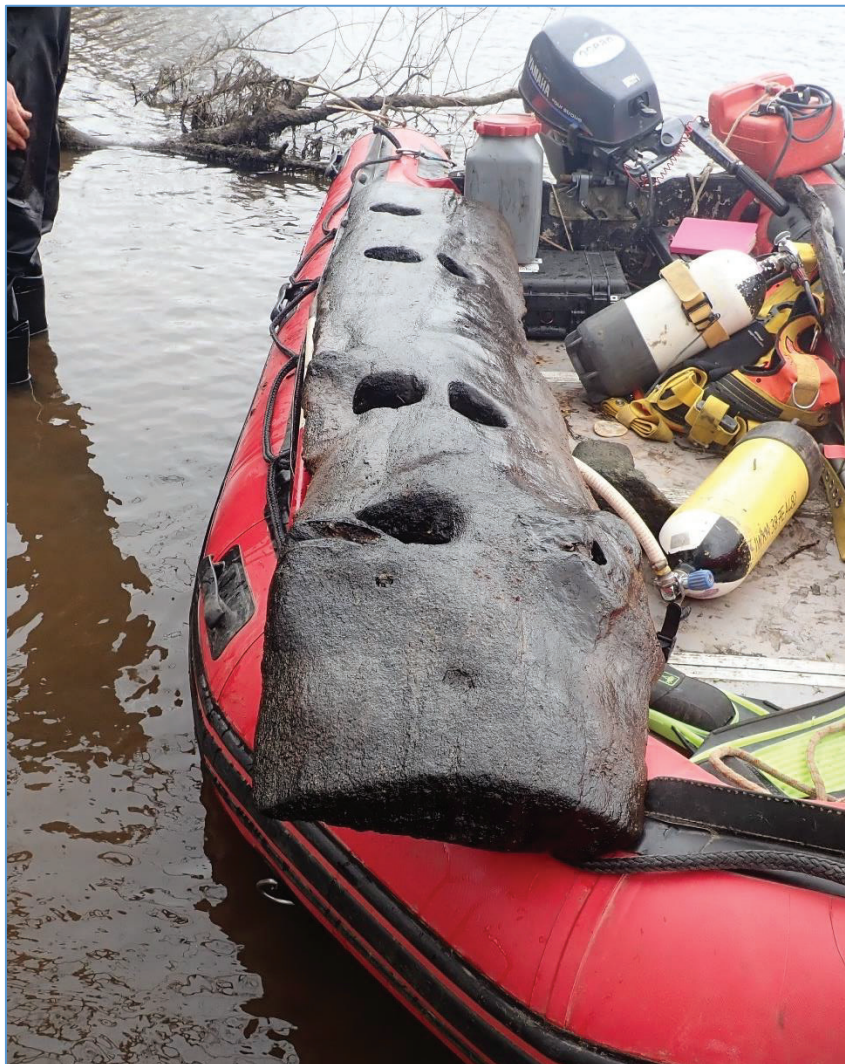
A shaped timber that is semi-circular in cross-section and retains several cut holes along its length (Plate 54).

Plate 54: View of timber, F10.

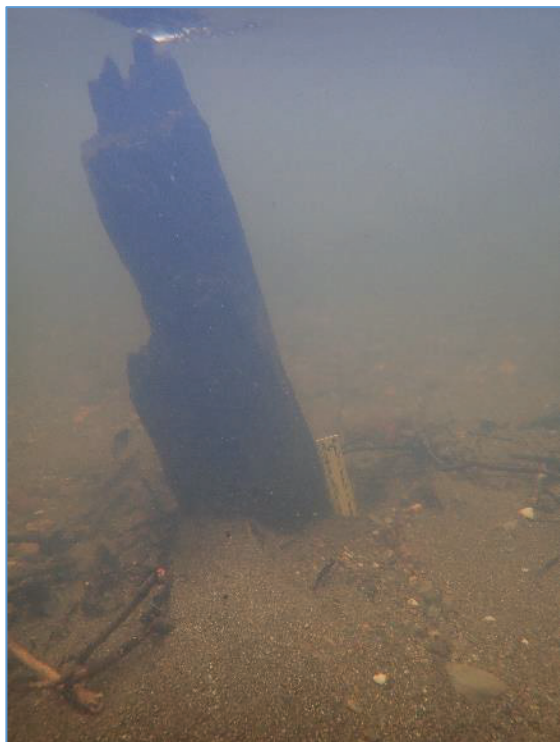
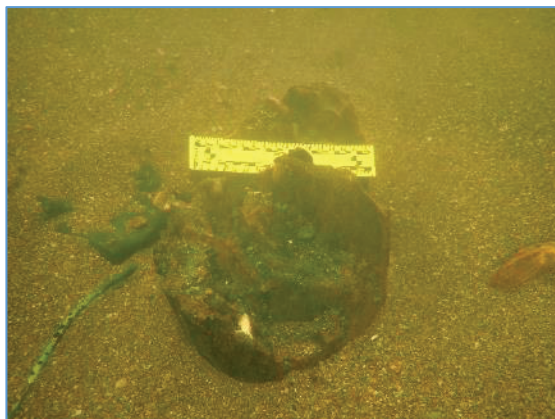
Five other elements, F13–F17, are clustered together upstream of the large central pier. The timbers represent vertical posts. F13 is a cut piece that is rectangular in section (Plate 55). F14–F17 are softwood piles that are round in section (Plates 55–56). F15 and F16 occur closest to the bridge pier and are exposed within a scour pocket that has developed next to the pier.

Plate 55: Underwater shots of timbers F13 and F14.

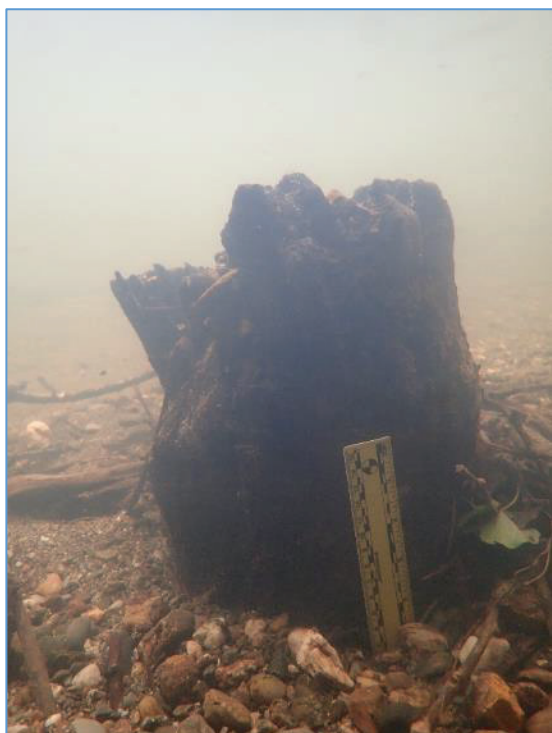
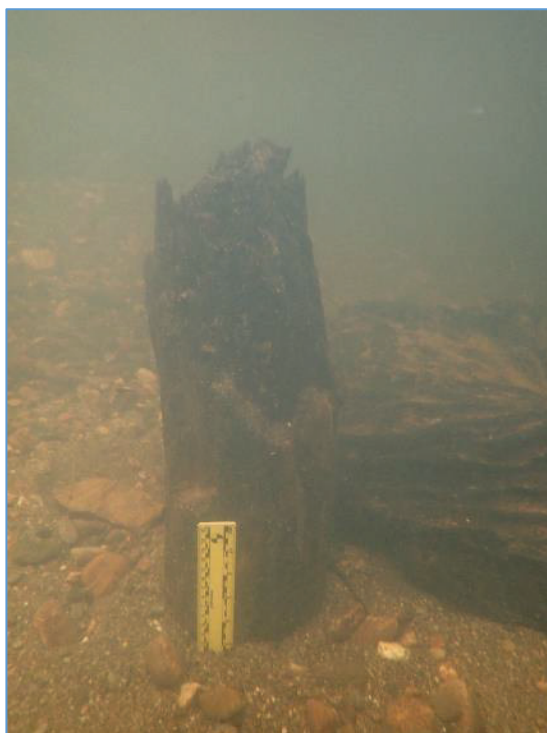
Plate 56: Underwater shorts of Timbers F15 and F16.

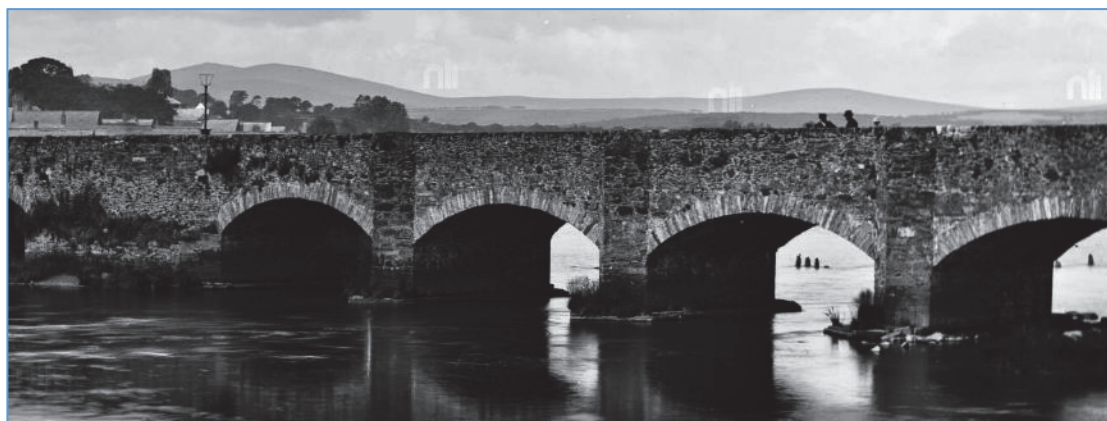
The location of these elements is indicated on an historical photograph of the bridge taken from downstream (Plate 57). The photograph shows a line of three timbers in one cluster that would be in keeping with some of the cluster represented by F13–F17, with a second grouping to the right approximates with the position of F11 and F12.

Plate 57: Detail of Arklow Bridge photographed by Robert French (1841-1917) (Plate 10), showing timber posts lying upstream of the bridge on its east side.

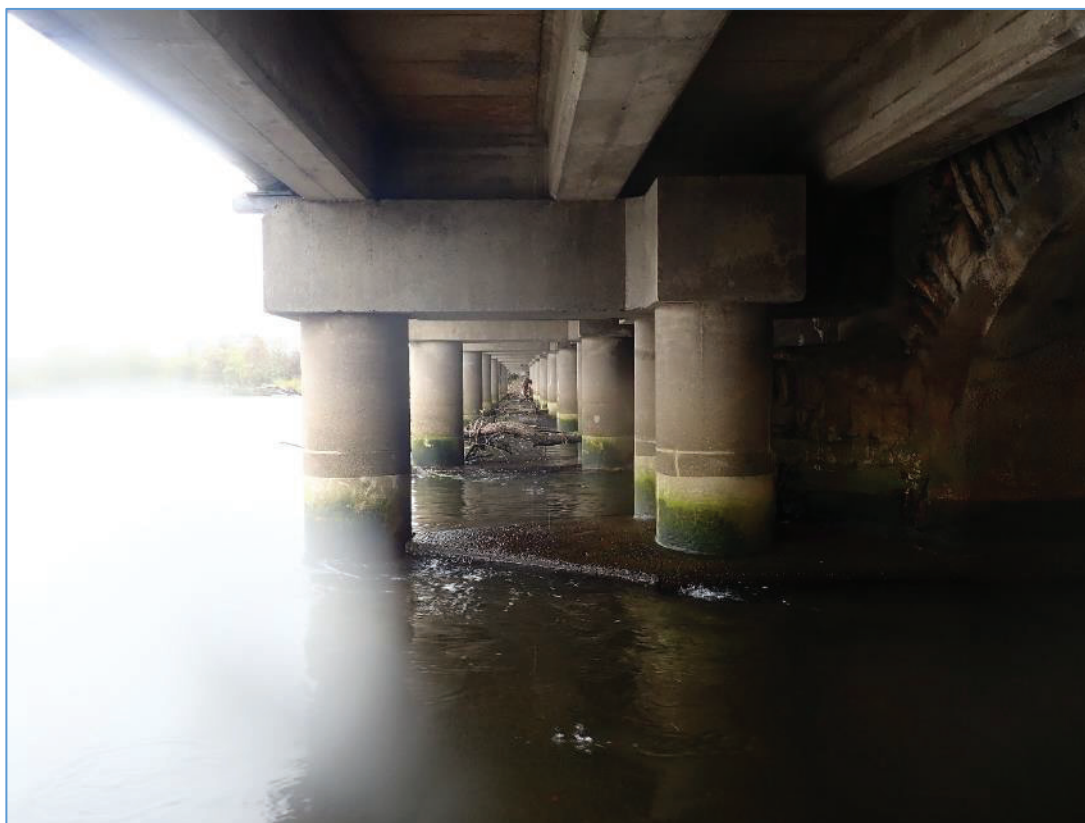
The widening of the bridge on its upstream side is a rather functional addition that is placed directly against the earlier stonework (Plates 60–63). It is supported by sets of three concrete piles forming small triangular plans that perhaps mimic the upstream cutwaters. The entire addition is bedded in a thick concrete apron, and scour holes are evident consistently upstream of the steel piles (as indicated on Figure 10).

Plate 60: View looking North across the base of Arklow Bridge, showing the 1960s addition to widen the structure.

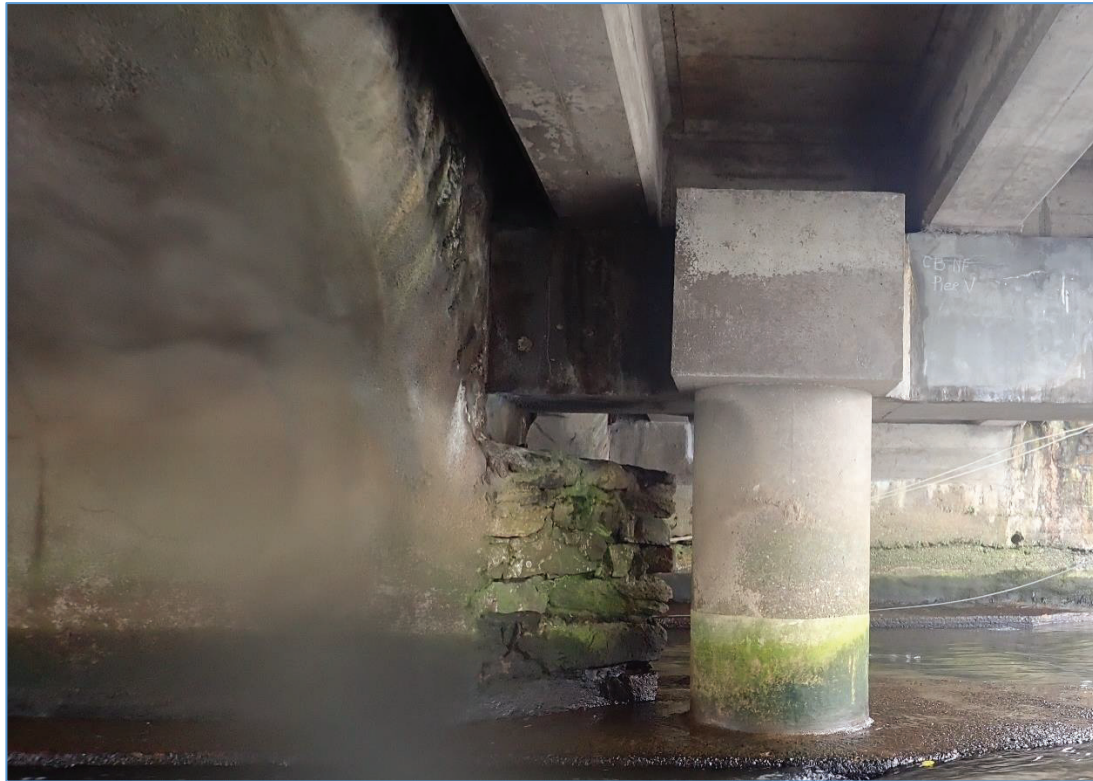
Plate 61: View looking South at the junction of the 1960s work with the upstream façade of the stone bridge.
