**ARCHITECTURAL HERITAGE
ASSESSMENT
OF
“CHOLERA HOUSE”,
GREENHILLS ROAD,
WICKLOW**

BALLYGUILMORE ACTIVE TRAVEL SCHEME

ON BEHALF OF: WICKLOW COUNTY COUNCIL

JULY 2023

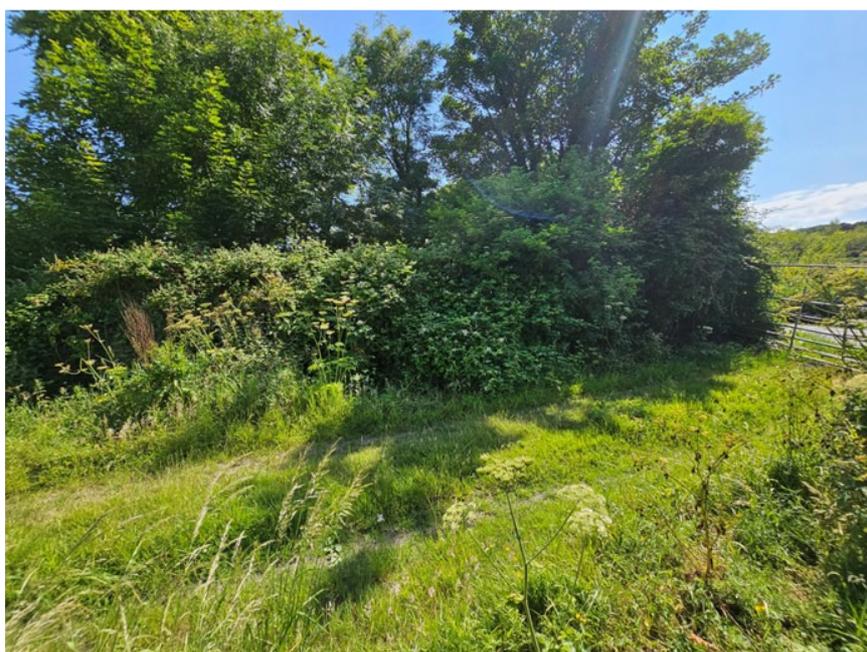
Plate 2: View toward Cholera House from the north, within the field

The Cholera House is located near the north-western corner of a field, to the south of a gateway and access leading from Greenhills Road to the field. The photograph below indicates the dense growth of ivy, brambles, elder and other vegetation on and around the remnants of the building. Dense coverage of ivy conceals much of the remaining walls, while the brambles and other vegetation restrict movement in the vicinity of the ruin. As noted above, the listing in the record of protected structures states that “Up to c.1990’s (*sic*) it had a corrugated roof and was used as cattle sheds.” No remnants of corrugated iron were noted on the site and nothing remains of the roof.
