Arklow Bridge, Structural
Report on Existing Masonry
19 Arch Bridge and advice
Regarding Impacts of Proposed
Flood Alleviation Scheme on
Bridge

Conservation Engineering Report Arklow Bridge, Arklow, Co Wicklow

April 2021

Issue 4

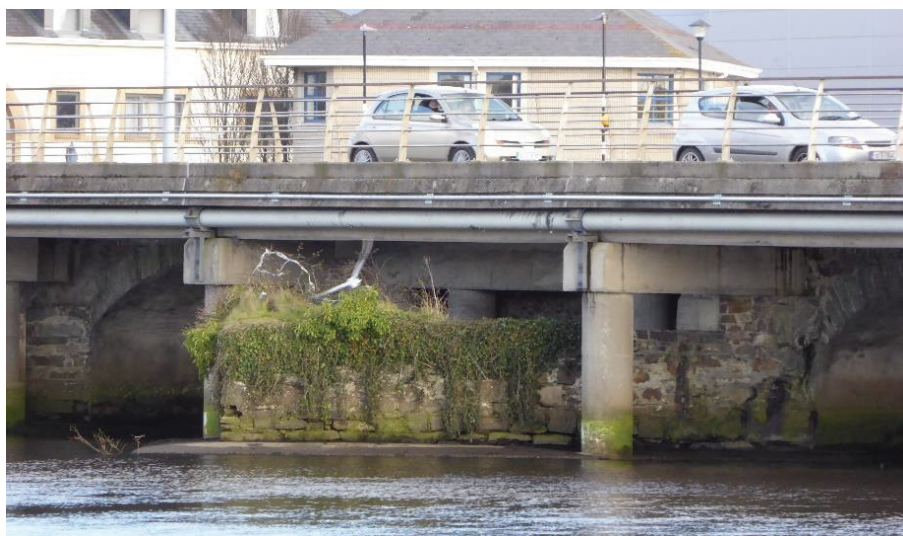
Central pier of historic bridge over sailed by later bridge. Photo c/o CourtneyDeery

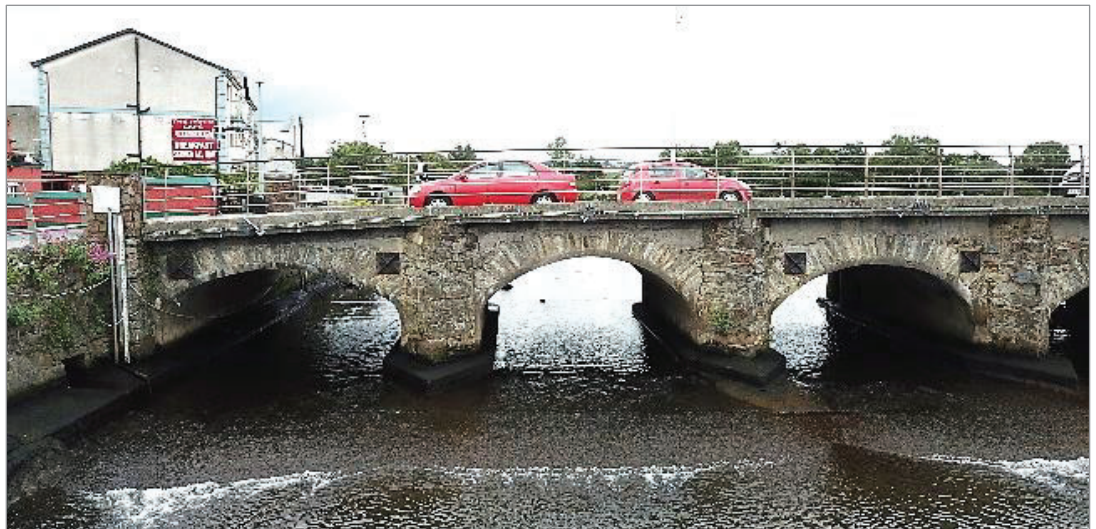
*Typical arch detail showing concrete downstream apron and pattress plates and also just visible spray concrete to underside of arches.
Photo c/o Brady Shipman*

Archaeological findings include evidence for an historic stone apron between the piers, comprising stone blocks set in mortar. While this detail exists under each arch it is mostly buried under a later concrete skim. Downstream there is a later concrete apron.

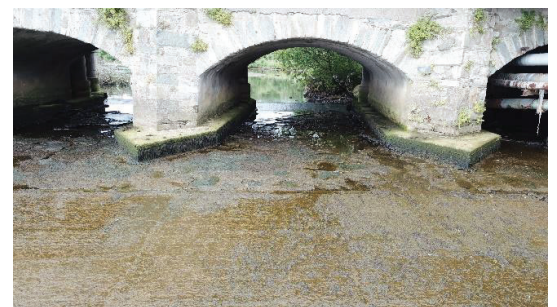
The detail to the riverbed between piers and to some areas of the front and rear apron consists of carefully interlocking stones as anti-scour. In many places this was observed to be well executed however, under a number of arches it is largely buried under a later concrete skim. This may be original to the bridge construction however the ADCO report following the trial pits executed to the 4 southern arches late 2019 indicates that the bedding around these stones contains detritus from mid to late C20th. This could possibly be associated with repair works carried out as part of the widening of the bridge in the 1960's.

Downstream is a later concrete apron, sometimes this extends between the piers.

This historic detail should be retained wherever the proposed scheme allows.

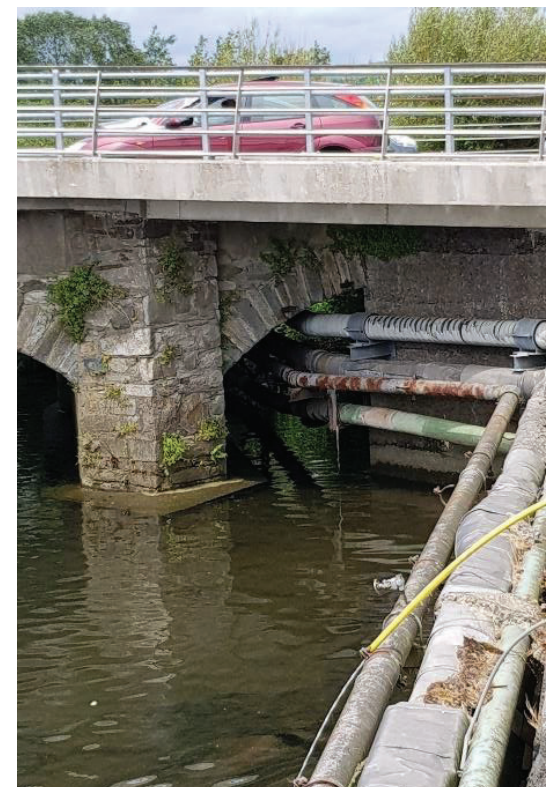
The underside of arch No19 is completely filled with services. Whilst relocating these services is not part of the flood alleviation works consideration should be given to removing obsolete services and diverting all other utilities to allow maintenance of the bridge and improve the aesthetic of this protected structure.

The location of these services and the size of arch No19 make it unviable to excavate in this area and of little benefit for flood alleviation works. The riverbed is to be retained at current level with its original anti-scour blocking retained intact.

Existing services run through Arch 19 and whilst their re-location is not part of this flood alleviation scheme, their removal longer term should be considered thus allowing proper repair and maintenance and visual enhancement of the historic structure.

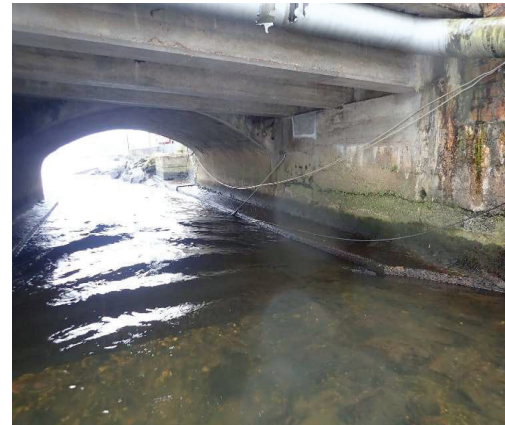
South Embankment and Span No1

Note large random shaped stone blocks in river bed at each and every arch. Most of these will be excavated out of the river bed as part of the river bed lowering scheme. The opportunity in span 1 and 19 presents itself to reinstate in span 1 above new sewer and retain and

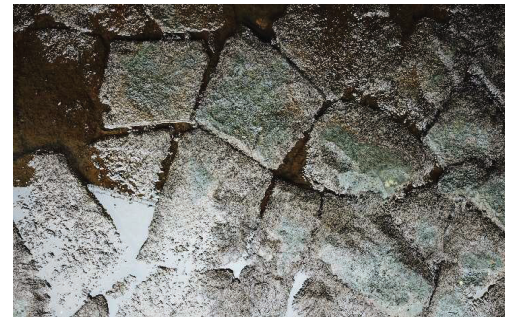
South Bank - west, upstream side. This bank will be altered as part of the process of inserting new Main sewer.

These blocks to the base of the river are likely to be long stones placed point down to form interlocking anti-scour bed. However those excavated 2019 to arches 1-4 were quite shallow and possibly from non original works. Nonetheless this detail should be reinterpreted where arch 1 now becomes filled with new main sewer insertion. This detail should be reinstated over new sewer at original bed level.

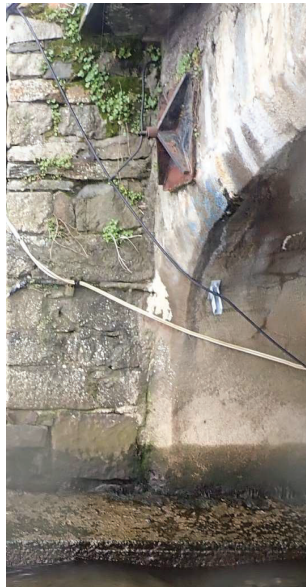
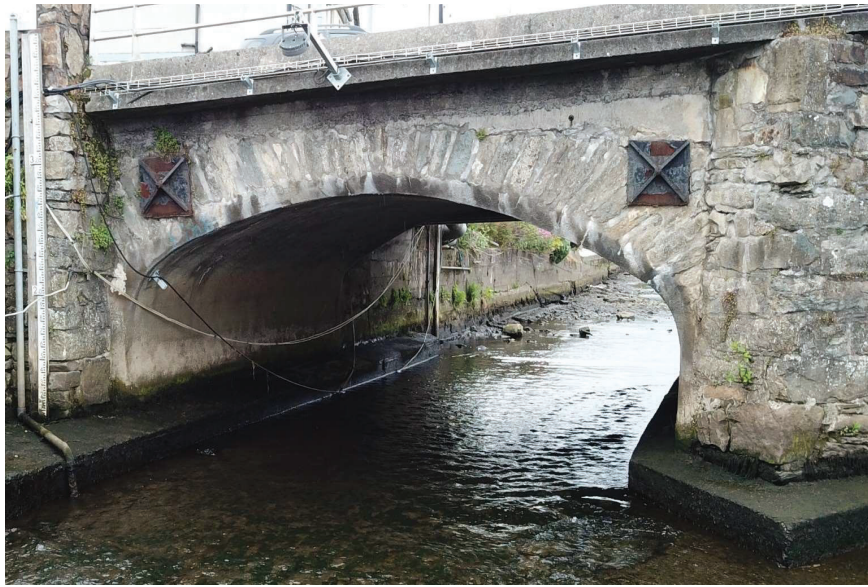
Pattress tie plates to arches 1; 3; 5 and 6

Pattress plates appear to be of welded steel section rather than Ductile or wrought iron. Works may be coincidental with the 1959 widening works.

Condition of these plates needs to be checked and new paint system applied at minimum. The difficulty will be confirming the condition of the hidden faces against the stonework and the bar running through the bridge. Recommendations - gain closer inspection to assess condition and exact make-up, and also any building of masonry behind plates.

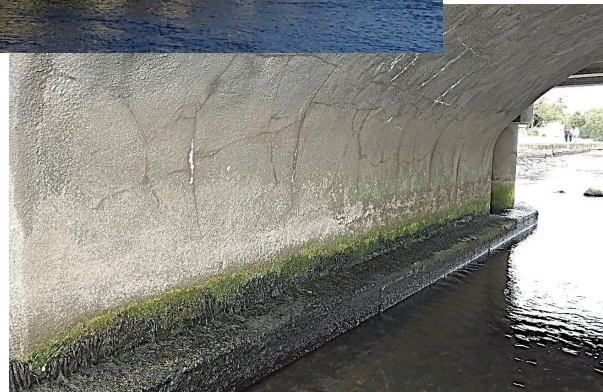
Underside of arch concrete sprayed - possible during the masonry works in 1982 or the later the Larson works of 2013, now crazing. All loose and crazed render should be removed to allow close inspection of original fabric and repair by re-packing all empty, leached out mortar joints.

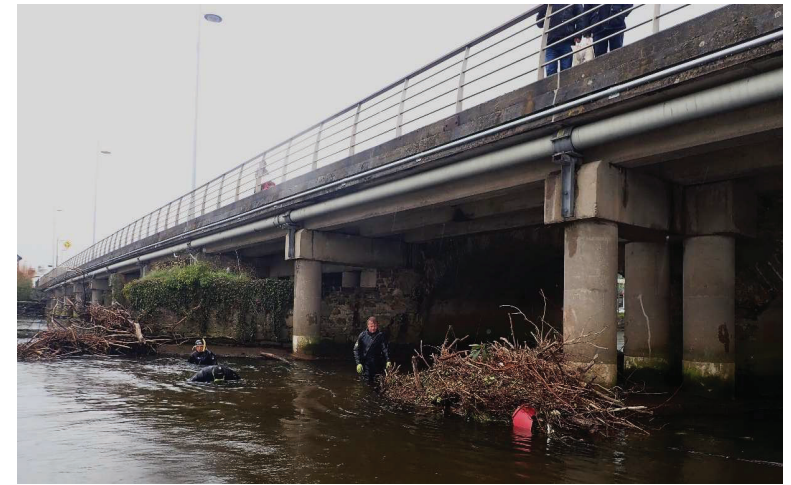
Attrition from floating debris is damaging stonework. Tree trunks etc catch between newer piers and historic masonry.

Proposed new debris trap upstream should alleviate this issue

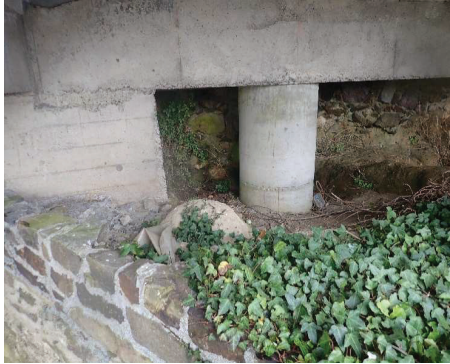
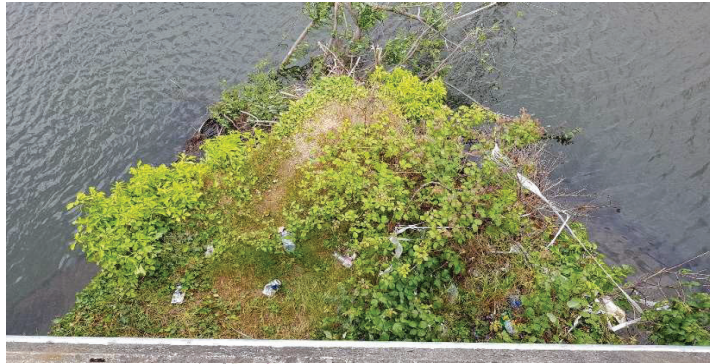
Significant vegetation growth including woody stemmed plants.- This extent of vegetation implies that significant erosion to the masonry has occurred and is ongoing. The vegetation needs to be eradicated and masonry repairs including a new capping detail installed. It is likely that a significant depth of capping stone work needs to be carefully recorded, removed and reinstated in mortars as specification

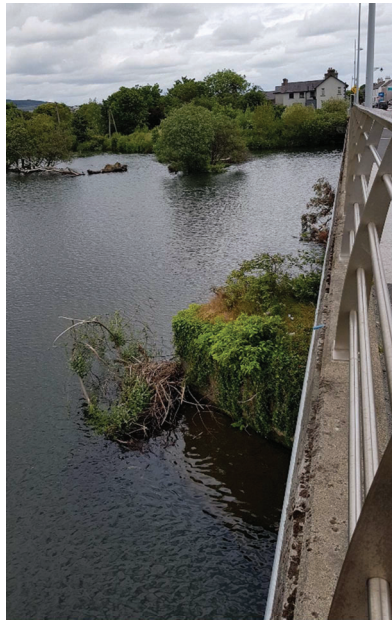
Central Pier - west

Vegetation growth on masonry requires containment. This growth is a clear indicator that repointing at minimum is required

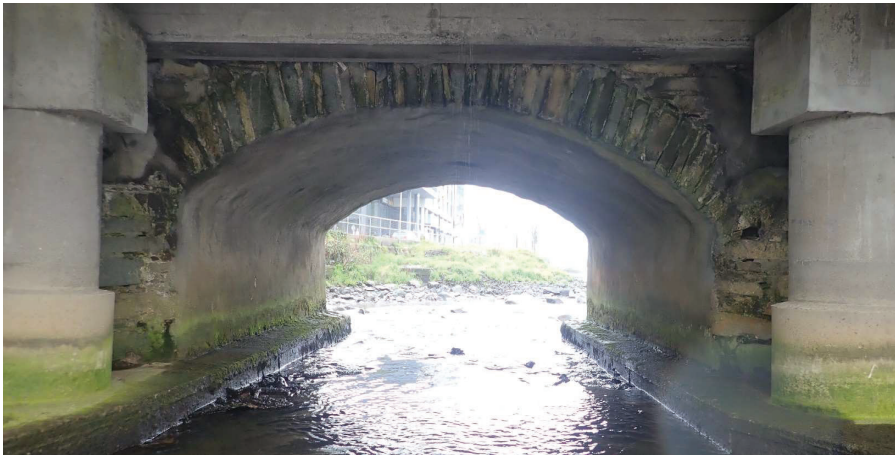
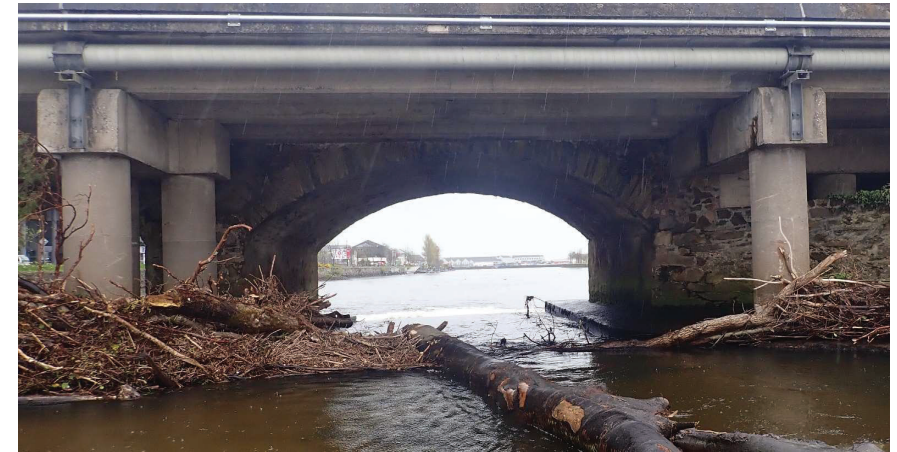
Mortar erosion from upstream face of masonry requires re-pointing

Attrition from floating debris is damaging stonework.
 Tree trunks etc catch between newer piers and historic masonry.
 New works should include measures to prevent such
 The proposed new debris trap upstream should alleviate this issue

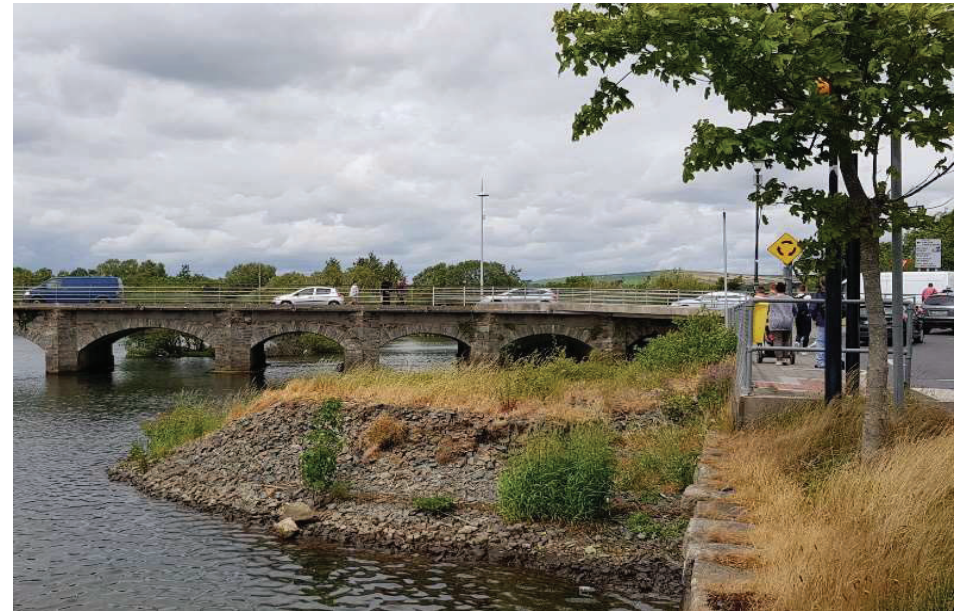
Down stream debris build up impedes progress of flood waters and should be regularly removed

River bank quay stonework could be greatly enhanced by weed removal and re-seating / pointing
