Appendix 11.3

Architecture and Cultural Heritage Inventory

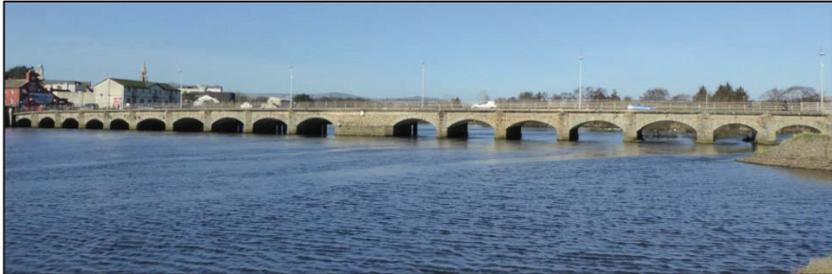
Identification No. and Legal Status	RPS (A26) and NIAH 16322046
Townland	Avoca River
Site Type	Arklow Bridge
Description	<p>19 arch stone built road bridge over the Avoca River, built c.1755. The bridge has a large central pier with cutwaters to both the north and south sides of the other smaller piers. The arches have roughly dressed voussoirs with areas covered in cement render. The low parapet is also cement rendered and is topped with a c.1960s replacement metal railings.</p> <p>Bridge widening works have altered the appearance of the upstream elevation and have masked the original stonework behind three concrete columns. The bridge is impressive in magnitude and size and in its position over the River Avoca and as such remains a valuable and impressive element in the street and river scape of Arklow Town.</p>
Sources	Field inspection and cartographic analysis, NIAH, RPS CORA Report 2021 (Appendix 11.8), ADCO Report 2020 (Appendix 11.6)

<p>Arklow Bridge view to the west</p>

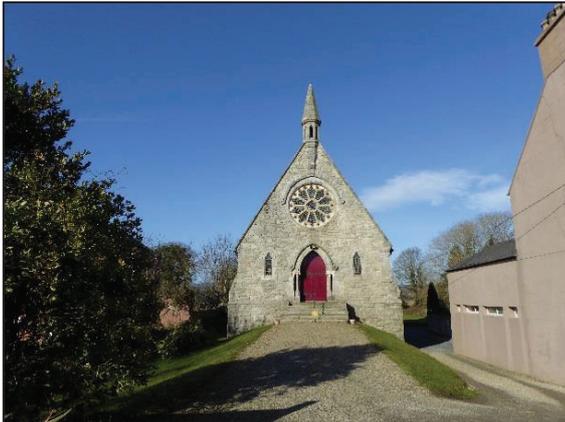
Legal Status	RPS A31 and NIAH 16322074
Townland	Ferrybank
Site Type	Church
Description	Detached five bay single storey gable ended Gothic style Methodist church built c. 1860. The church is rectangular in plan, with the façade finished in uncoursed rubble stone with dressed stone to the openings. The church is set back from the line of the road with the grounds to the front enclosed with decorative cast-iron railings with matching carriage gateway. To the rear is a garden, now used as a play area and the boundary is formed by an earthen embankment approximately 1.5m high, topped with trees and scrub.
Sources	Field inspection and cartographic analysis, NIAH, RPS and Arklow & Environs Local Area Plan 2018
Impact of scheme	There is no direct impact to the structure or grounds. The proposal to place an earthen embankment to the rear of the structure will have an indirect impact to the visual setting of the structure. However, it must be noted that these works will benefit this architectural heritage structure by protecting it from flooding in the future.

<p>View to front elevation of the Methodist Church</p>

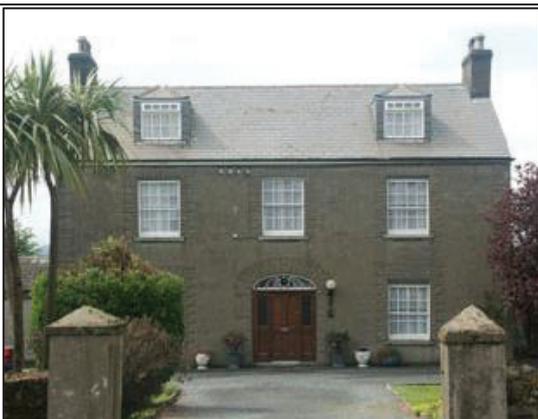
Legal Status	NIAH 16322075
Townland	Ferrybank
Site Type	House now identified as Sheltonville Surgery
Description	Detached three bay, two storey house built c.1850-60 with two modern hipped roof dormers to the front. The large front garden has been replaced by a carpark for the surgery, enclosed by a low roadside rubble stone wall. The structure has been altered over time with replacement uPVC windows, additions to the rear and side and replacement roof. It still remains a good example of a mid -19 th century residence.
Sources	Cartographic analysis, site inspection, NIAH
Impact of scheme	There is no direct impact to the structure or grounds. The proposal to place an earthen embankment to the rear of the structure will have an indirect impact to the visual setting of the structure. However, it must be noted that these works will benefit this structure by protecting it from flooding in the future.

<p data-bbox="539 616 1149 649">Front elevation prior to becoming a commercial premise.</p>

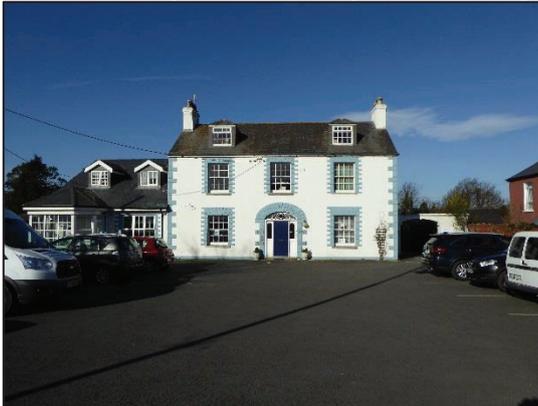
<p data-bbox="539 1064 1244 1097">Structure now acts as a doctor's client with carparking to the front</p>

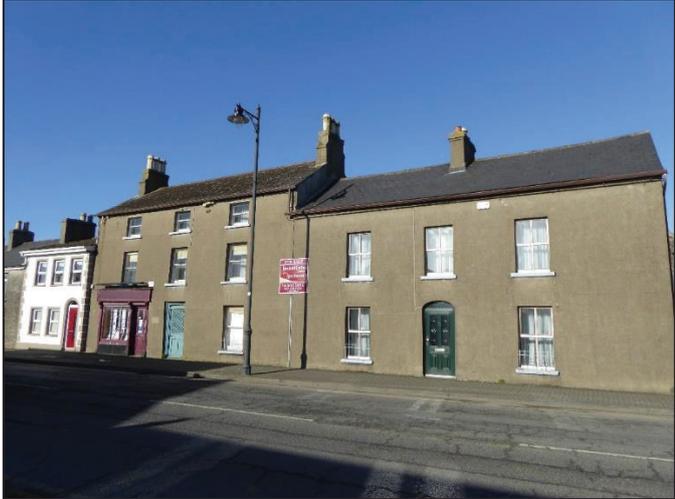
Legal Status	NIAH 16322076
Townland	Ferrybank
Site Type	House, shop retail outlet.
Description	Terraced three-bay three-storey house, built c. 1850-1870. The façade is finished in unpainted lined render and a later inserted shopfront (Raymond Gaffney & Sons (now relocated)) to the south of the entrance door adds interest to the streetscape.
Sources	Site inspection and cartographic analysis, NIAH
Impact of scheme	There is no direct impact to the structure or grounds. The proposal to place an earthen embankment to the rear of the property plot will have an indirect impact to the visual setting of the structure. However, it must be noted that these works will benefit this structure by protecting it from flooding in the future. The drainage channel to the rear of the proposed plot will be moved westwards to the other side of the embankment.
Asset criteria	Medium
Magnitude of impact	Low
Significance of impact	Negative, Slight and Permanent impact

<p>View of commercial premises, fronting onto Ferrybank Road</p>
--------------------------	---

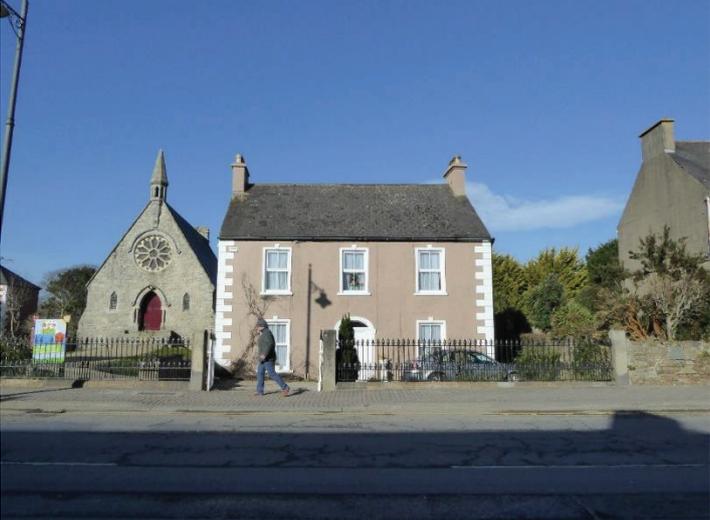
Legal Status	NIAH 16322073)
Townland	Ferrybank
Site Type	The Old Manse - house
Description	Detached three bay, two-storey house, built c. 1860. The façade is finished in painted lined render with incised quoins and moulded surrounds to the openings. Pitched roof with rendered chimneystacks. It is a well-preserved Victorian House.
Sources	Field inspection and cartographic analysis, NIAH
Impact of scheme	Indirect impact by the placement of an earthen berm outside the rear boundary of the property.
Asset criteria	Medium
Magnitude of impact	Low
Significance of impact	Negative, Slight and Permanent impact
Proposed mitigation	Any impact to the setting caused by a visual alteration to the rear of the boundary by the proposed work will be offset by landscaping and screening works that will assist in blending in the new works. There is also a significant positive impact due to the prevention of flooding in the future.

Front elevation of the Manse House
Legal Status	NIAH 16322072
Townland	Ferrybank
Site Type	House, 20 Ferrybank
Description	End of terrace three-bay, two-storey with central doorway house, built c.1890-1905.
Sources	Site inspection and cartographic analysis, NIAH
Impact of scheme	Indirect short-term impact due to the presence of SC1 outside and to the west of the property plot.
Asset criteria	Medium
Magnitude of impact	Low
Significance of impact	Negative, Slight and Short Term impact.
Proposed mitigation	Any visual alteration to the rear of the boundary by the presence of the compound will be screened in the short term by a 2.4m high security fencing of solid hoarding. Once the construction works have been completed, this area will be planted with native woodland, shrubs and grass resulting in a Positive, Moderate and Long term Impact. There is also a significant positive impact due to the prevention of flooding in the future.

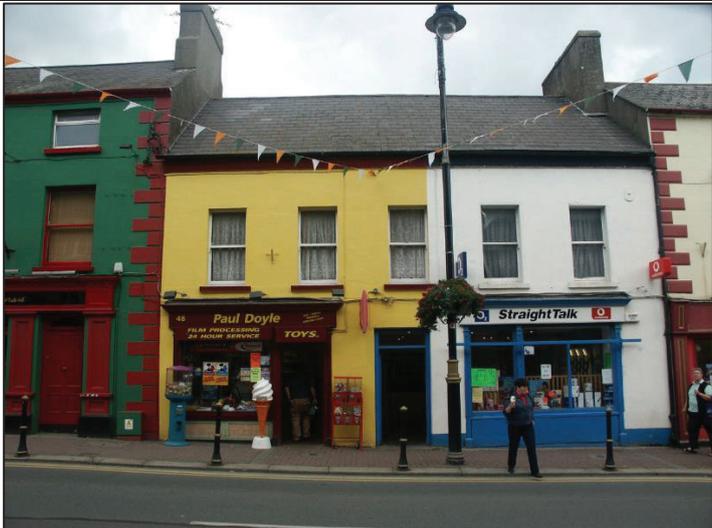
Legal Status	NIAH 16322034 RPS A22
Townland	Arklow
Site Type	House/retail unit
Description	Terraced five-bay two-storey former house, built c.1840, now in use as two shops. The façade is finished in painted render, whilst the pitched roof is slated and has a large, rendered chimneystack to the east. To the ground floor are two non-identical timber shopfronts of c.1880, with the centrally located former house doorway now acting as the entrance to the shop to the east.
Sources	NIAH
Impact of scheme	There is no direct impact to the structure or grounds. The drainage works will have a temporary, not significant impact during the construction stage.
Asset criteria	Medium value.
Magnitude of impact	Negligible
Significance of impact	Negative, Not Significant, Temporary impact.
Proposed mitigation	No mitigation required - any impact to the visual setting of the street scape and structures will be temporary in nature.

View of premises, fronting onto Main Street.
--	--

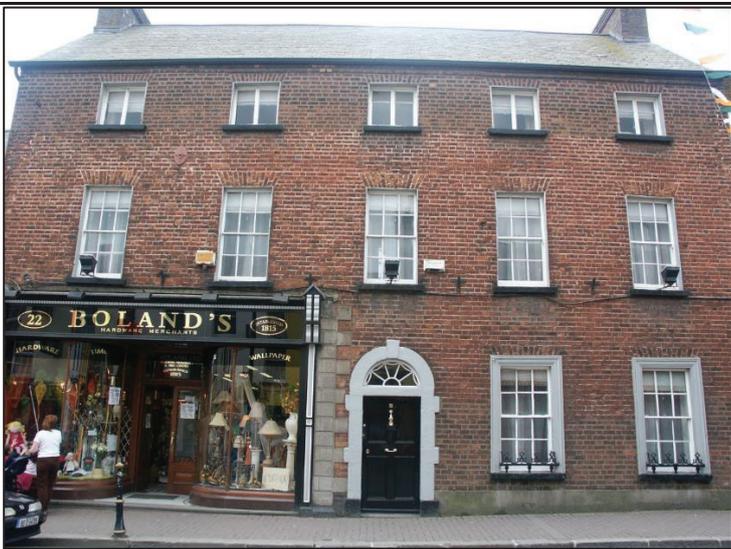
Legal Status	NIAH 16322035 RPS A23
Townland	Arklow
Site Type	House/retail unit
Description	Terraced five-bay three-storey house, built c.1760, with shopfront insertion of c.1900. The façade is in brick with a granite base course, granite 'quoins' to the shopfront, and painted stone surrounds to the other ground floor openings, whilst the exposed section of the gabled east elevation is rendered. The pitched roof is slated and has brick chimneystacks. The centrally positioned entrance consists of a panelled timber door with semi-circular fanlight with 'spider web' tracery, all encased with a Gibbsian painted stone surround. Windows are flat-headed and have six over six timber sash frames, with replacement timber casement frames to the smaller second floor windows, and painted stone sills to all. The ground floor windows each have a decorative cast-iron cheval-de-frise.
Sources	NIAH
Impact of scheme	There is no direct impact to the structure or grounds. The drainage works will have a temporary, not significant impact during the construction stage.

<p>View of premises, fronting onto Main Street.</p>

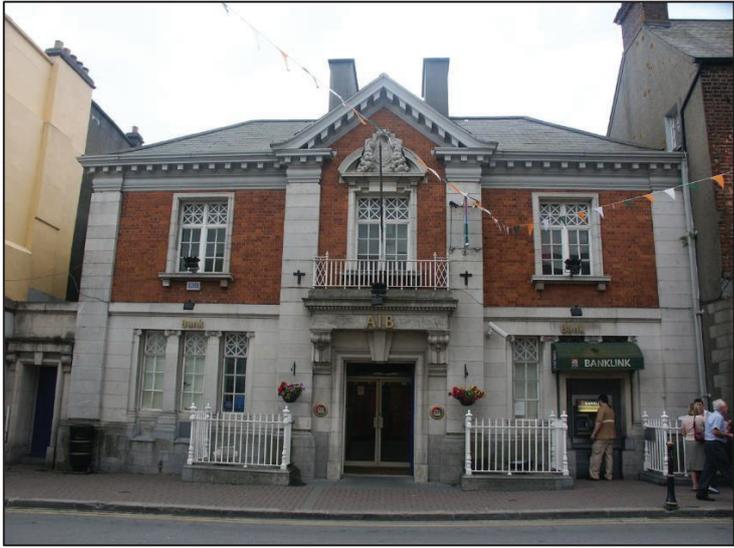
Legal Status	NIAH 16322048 RPS A28
Townland	Arklow
Site Type	Bank/financial institution
Description	End-of-terrace three-bay two-storey Queen Anne Revival style bank, built 1914. The symmetrical front elevation, which has a central full-

height gabled projection, is finished ashlar limestone to the ground floor level and brick to the upper level, but with Giant order pilasters, upper floor window surrounds and eaves course also in limestone. The slated hipped roof has an overhang supported on dentils, and two rendered chimneystacks. The entrance is to the projection and consists of a panelled timber door with moulded surround with keystone. Above the entrance is a stone balcony with simple but decorative iron railings, with the balcony supported on decorative moulded brackets. Looking over the balcony is a window topped by a large broken curved pediment which includes an ornate moulded date panel flanked by cornucopiae.
Sources	NIAH
Impact of scheme	There is no direct impact to the structure or grounds. The drainage works will have a temporary, not significant impact during the construction stage.
Asset criteria	Medium value.

<p>View of premises, fronting onto Main Street.</p>

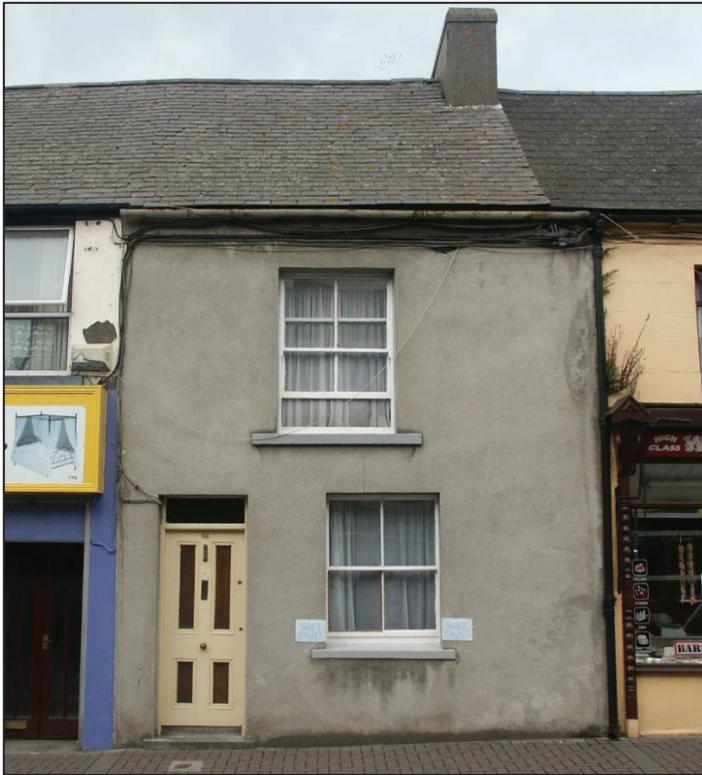
Legal Status	NIAH 16322036
Townland	Arklow
Site Type	House
Description	Terraced two-bay two-storey house, built c.1840. The façade is finished in unpainted render whilst the pitched roof is slated and has a rendered chimneystack. The entrance consists of a panelled timber door with plain rectangular fanlight. The windows are flat-headed and have two over two timber sash frames, and painted stone sills. Cast-iron rainwater goods.
Sources	NIAH
Impact of scheme	There is no direct impact to the structure or grounds. The drainage works will have a temporary, not significant impact during the construction stage.
Asset criteria	Medium value.
Magnitude of impact	Negligible

<p>View of house, facing onto Main Street.</p>

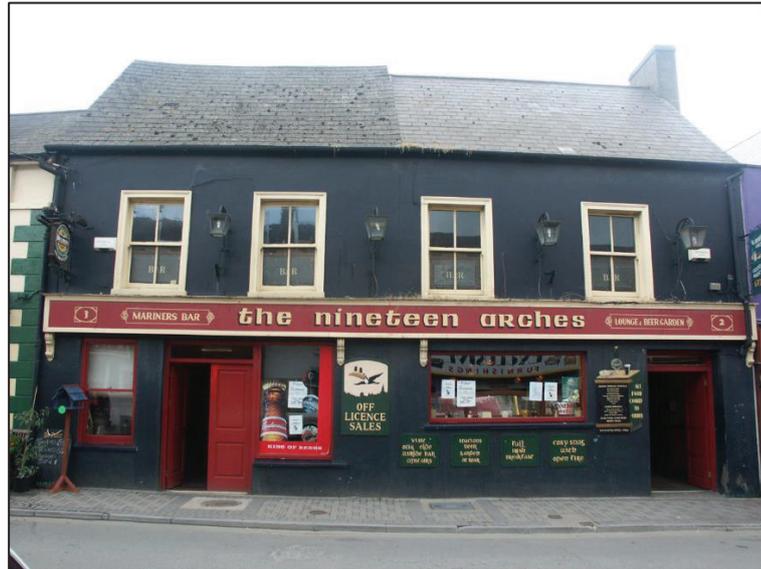
Legal Status	NIAH 16322044 RPS A38
Townland	Arklow
Site Type	House/public house
Description	Terraced four-bay two-storey former pair of houses, built c.1840, now in use as a public house with largely late 20th-century pub front. The façade is finished in painted render, with moulded surrounds to the first floor windows. The pitched roof is in two sections, that to the south slightly taller and covered in artificial slate, that to the north covered in natural slate; there is a rendered chimneystack to the north side also. To the ground floor there are two entrances to the pub. That to the south side is larger and has a timber double door, rectangular fanlight and large sidelight, whilst that to the north is similar in style but without the sidelight. There is a broad fixed light flat-headed pub window between the doorways, and a flat-headed window to south with a plain timber sash frame. The first floor windows are also flat-headed and each has a timber sash frame, two over two.

View of premises, facing onto Main Street.

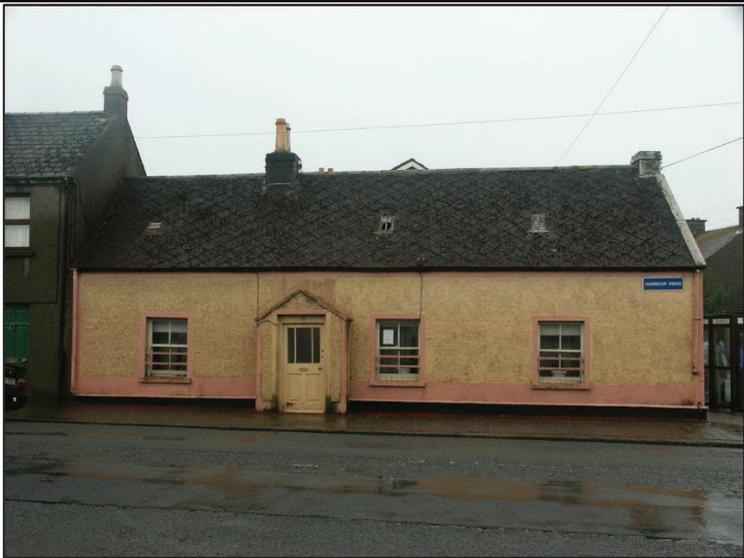
<p>View of house, fronting onto Harbour Road.</p>

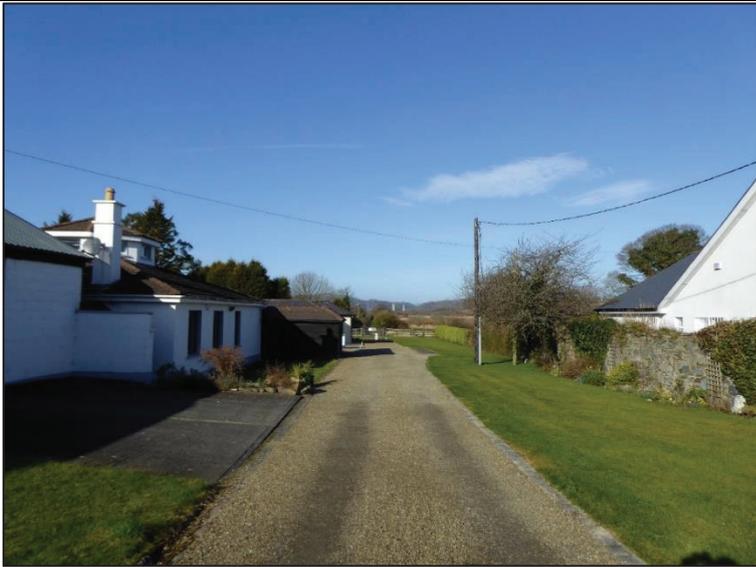
The causeway through the marsh area is a raised flat-topped embankment with deep drainage ditches on either side. The causeway is overgrown with vegetation.
Sources	Site inspection and cartographic analysis
Impact of scheme	Direct impact to a small section of the raised causeway through the marsh
Asset criteria	Low
Magnitude of impact	Low
Significance of impact	A Negative, Slight, Permanent impact. will take place to the causeway in the area where the proposed embankment crosses it. Access will be provided across the embankment.
Proposed mitigation	Record the stratigraphy of the section of raised causeway by photography and survey.
Approx. distance from development	0m
Photograph

<p>Former laneway to Shelton Abbey now in private property.</p>

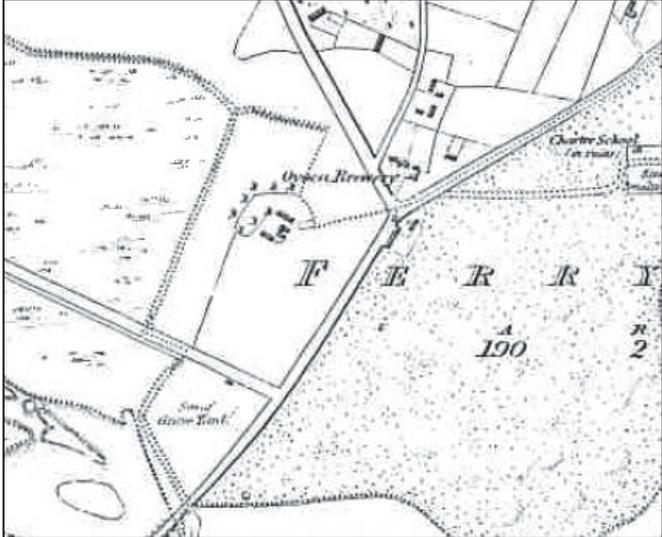
<p>First edition six-inch OS mapping</p>
Sources	Cartographic analysis
Impact of scheme	There will be a direct impact on the below ground features revealed by test excavation (Appendix 11.9 , Red Arc Consulting) at the proposed location of SC1. Even though the area has experienced a great amount of disturbance due to dumping, in situ below ground cut features indicating archaeological activity were identified.
Asset criteria	Medium
Magnitude of impact	Medium
Significance of impact	Negative, Moderate and Permanent impact.
Proposed mitigation	Archaeological investigation of the area in the form of topsoil stripping as an archaeological exercise will take place to reveal if further previously unrecorded features, are present in the area proposed for SC1. Subject to agreement with the statutory authorities excavation will take place of any newly revealed features.
Approx. distance from development	Within the proposed development area

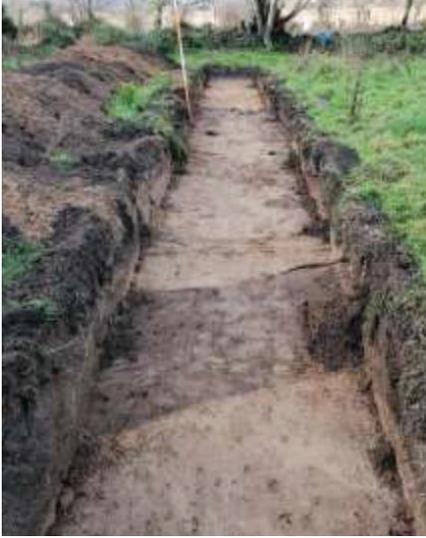
<p>Test Trench 4 at SC1 (Appendix 11.9, RedArc Consulting, Plate 3.4)</p>

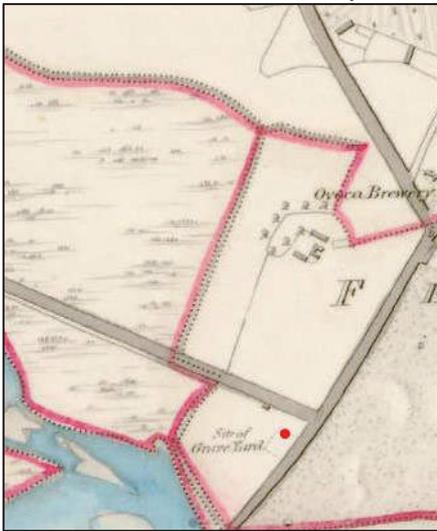
<p>First edition six-inch OS map showing the line of the townland boundary in red</p>
Sources	Cartographic analysis
Impact of scheme	The location of the embankment and site compound SC1 will partly impact this townland boundary. The boundary remains as a tree lined boundary in places but has been removed in sections also. Test excavation (Appendix 11.9) revealed a number of possible postholes which may have an association with the townland boundary.
Asset criteria	Low
Magnitude of impact	Medium
Significance of impact	Negative Moderate, and Permanent impact
Proposed mitigation	Archaeological investigation and monitoring of this area will take place, if any feature is revealed associated with the former boundary it will be recorded and photographed.

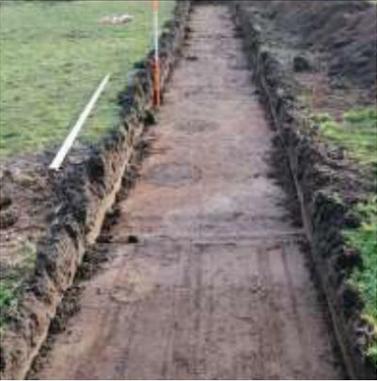
<p>Test Trench 5 (Appendix 11.9, RedArc Consulting, Plate 3.5)</p>

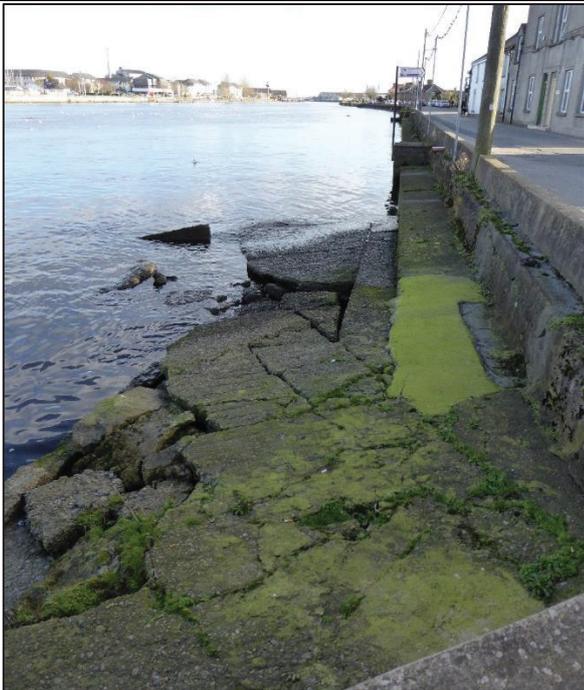
Townland	Ferrybank/ Marsh
Site Type	Former slip way structure
Description	This site is not named or shown on any OS edition mapping. It presents as a former slip way now broken up on a quay known as 'Coal Quay'. It appears to a concrete structure and is not in use.
Sources	Cartographic analysis and site inspection
Impact of scheme	River Access 7 (RA7) will remove this structure
Asset criteria	Low
Magnitude of impact	Medium
Significance of impact	Negative, Moderate and Permanent impact
Proposed mitigation	Photographic and descriptive record will take place prior to the removal of the structure. Archaeological monitoring will take place during the removal process.
Approx. distance from development	Within the scheme
Photograph

<p>Former Slipway Coal Quay</p>

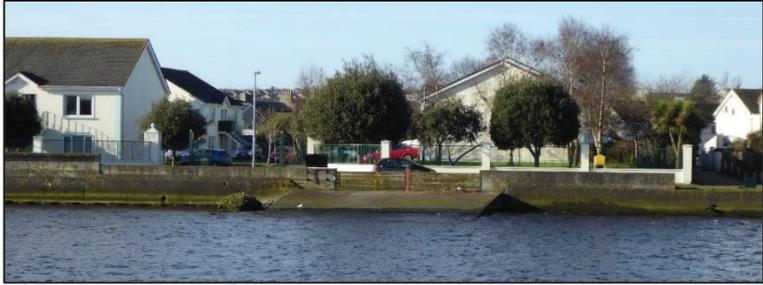
<p>View from the North Quay to the South Quay showing the slipway</p>

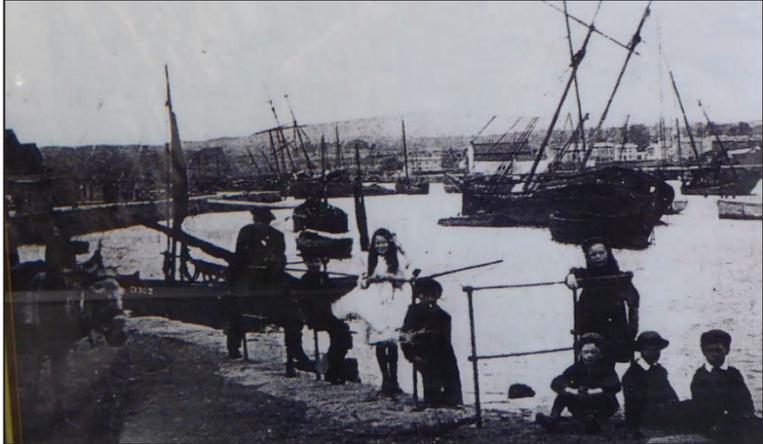
<p>Photo taken c.1910 looking up river from Harbour Road, on the left is the launching slipway of the Tyrrells boat building yard and high sheds. Courtesy of the Maritime Museum of Arklow.</p>

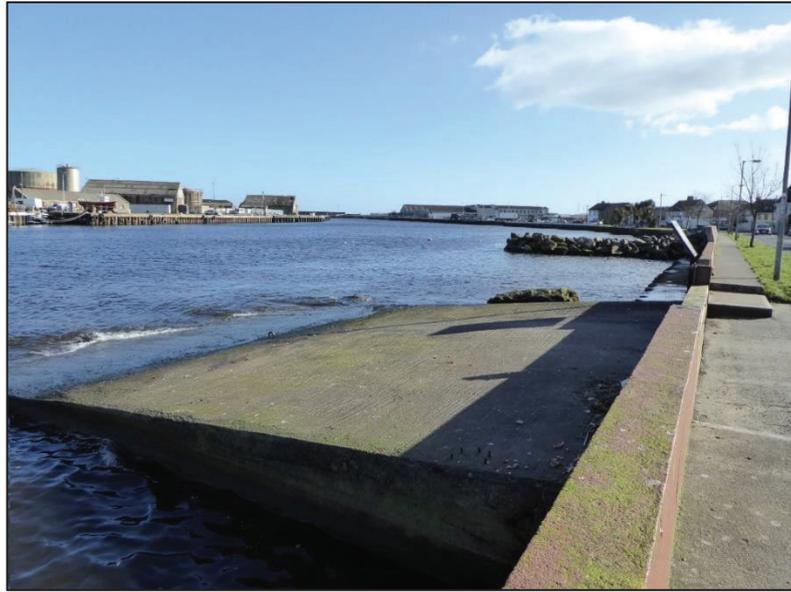
View of the slipway looking east

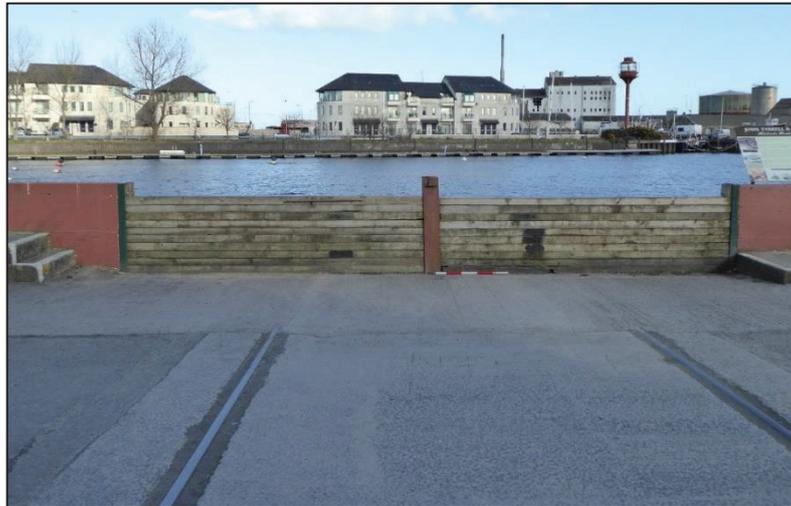
Boat lines across the road to the slip way, protected by a wooden demountable.

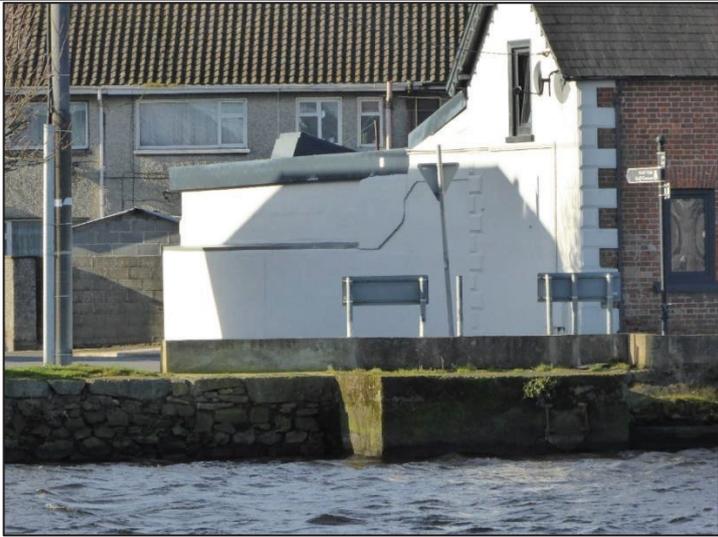
<p>View to the South Quay showing the original rubble stone walling visible from the junction of South Green and South Quay and to the west of this the quay rendered with cement.</p>

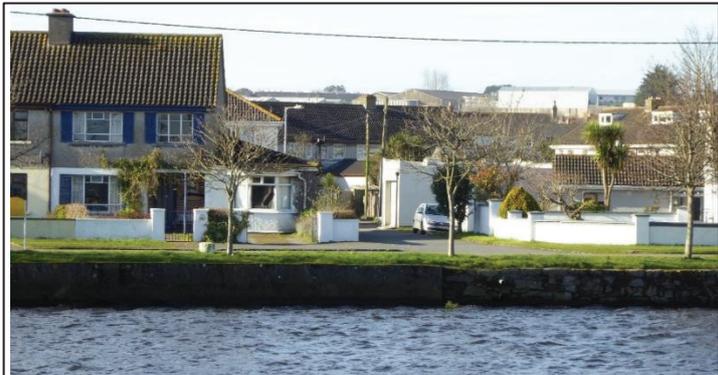
View to South Quay showing the difference from original quay walling and where the wall has already been altered and cement rendered in the past.

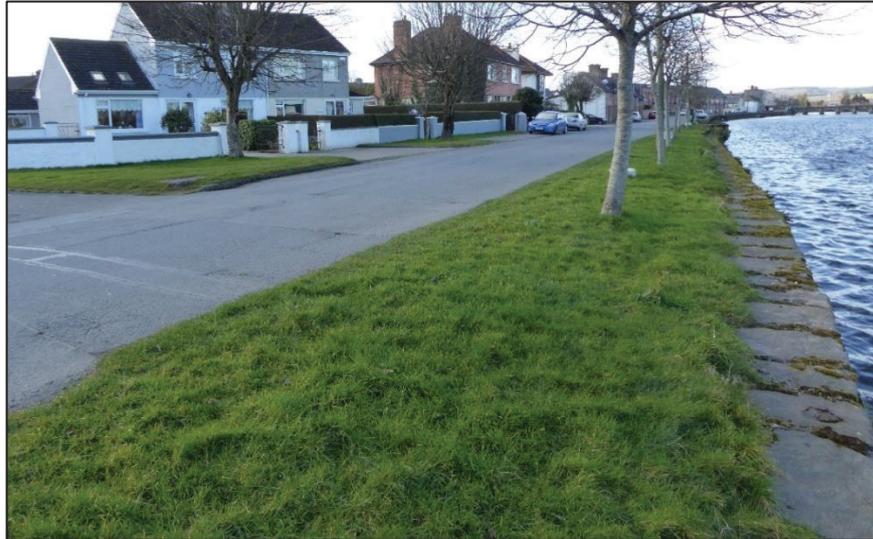
View to the west along the south quay – showing the original stone capping

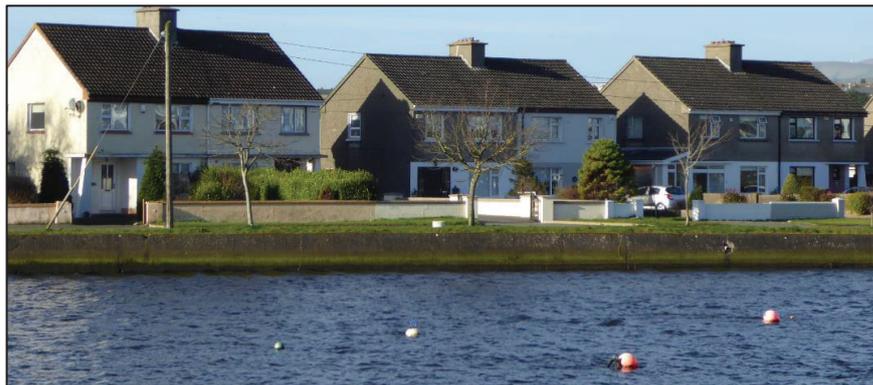
Section of South Quay wall to be retained by the proposed scheme

Sources	Cartographic analysis, site inspection.
Impact of scheme	Direct impact
Asset criteria	Medium
Magnitude of impact	High
Significance of impact	Negative, Significant and Permanent impact will take place to the south quay wall. Sections of the quay wall will be encased within the new wall. It is proposed to consolidate and repair a section of the exposed stone wall and present this, potentially reinstating a 100m section of stone walling to a better condition than currently exists. The residual impact proposal will have a positive effect in consolidating the quay wall.
Proposed mitigation	<p>The proposed works will form a modern solution to flooding at Arklow and help protect dwellings and structures located along South Quay. There is also the opportunity to create a coherent structure that is reflective of the past industrial and shipping heritage while functional from a flood relief perspective.</p> <p>Different mitigation strategies will apply along the length of the quay wall. Where possible the wall, will be preserved in situ and encased by a sheet pile wall to the front over which a raised footpath and freeboard will be constructed.</p> <p>Where the quay wall is obscured and already encased in concrete or has other additions such as a low plinth attached to the top. It is anticipated that the quay wall will be left in situ and retained behind the sheet pile wall. Where interventions are required, a monitoring archaeologist will undertake a photographic and written record as part of the construction programme. As this section of the quay wall is essential hidden, monitoring will occur as works are scheduled and as areas are revealed.</p> <p>Where the quay wall is already exposed (approx. 74m, South Green – The Green, South Quay), this section of wall will be subject to advance contract works in the form of a rectified photographic record and detailed recording by an appropriate specialist.</p> <p>It will be possible to present the exposed quay wall for a distance of 35m – this section of walling will be consolidated and repaired according to best conservation practice measures. Further to this, it appears that for the next 65m the wall and cap stones are encased in a cement render that is currently failing in places. It is proposed to clean this back, remove the failing cement and expose the original quay wall. Allowing a presentation of approximately 100m of original stone quay wall (see Drawing no. 1041).</p>

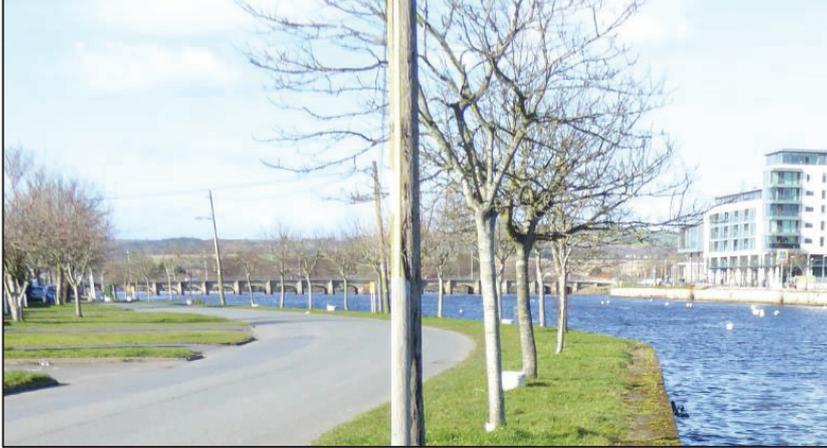
<p>View west showing the stone mooring posts</p>

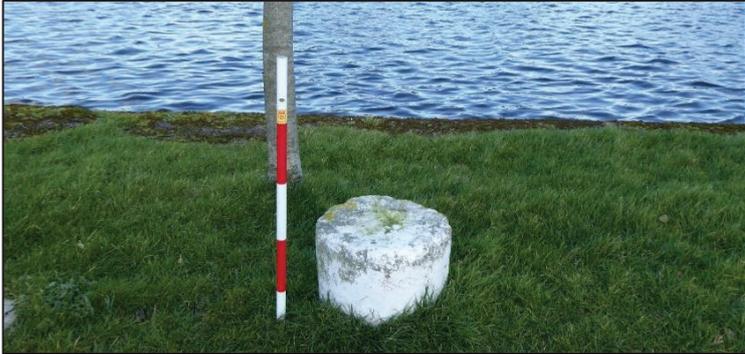
<p>Detail of a mooring stone</p>

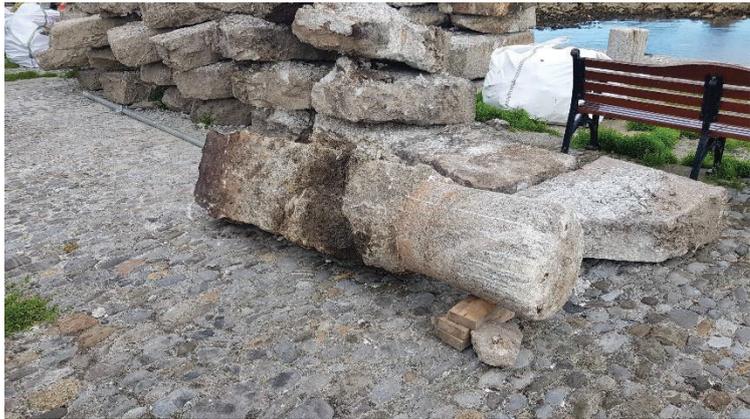
<p>An example of an excavated mooring stone showing the below ground foundation (courtesy Lisa Edden, CORA)</p>
--	---

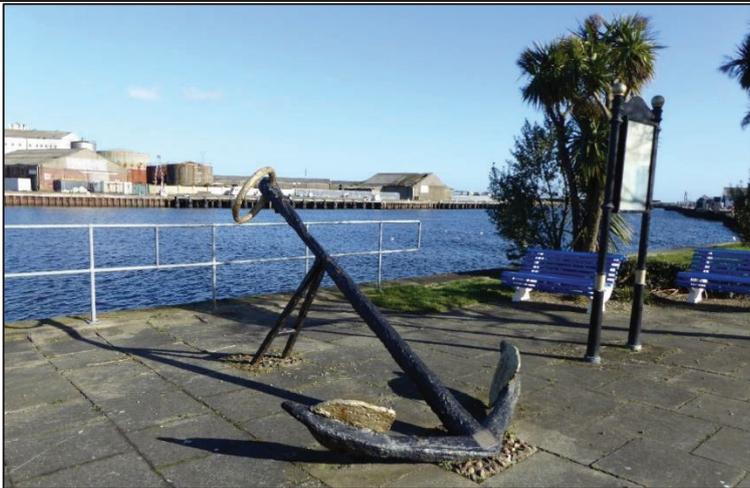
Existing seated amenity area along the South Quay, quay consists of concrete plinth at ground level supported by sheet piles with railings in front of the seated area.
--	---

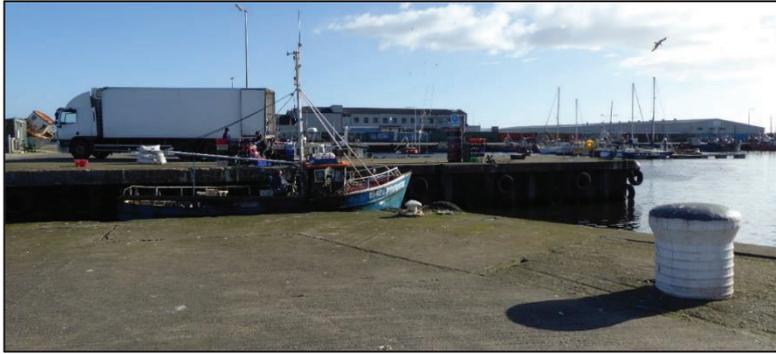
<p>View to metal bollard</p>

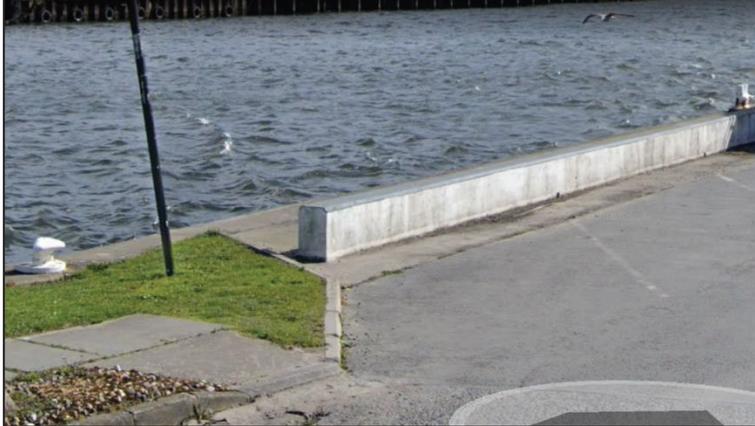
<p>Two of the metal mooring points, facing northeast</p>

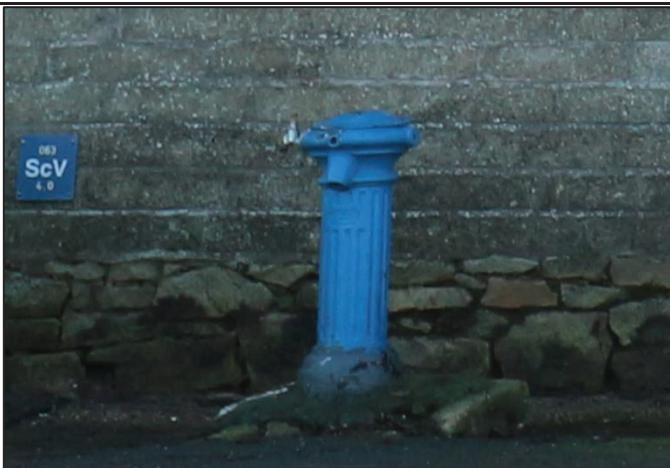
<p>Water pump, fronting onto South Quay.</p>

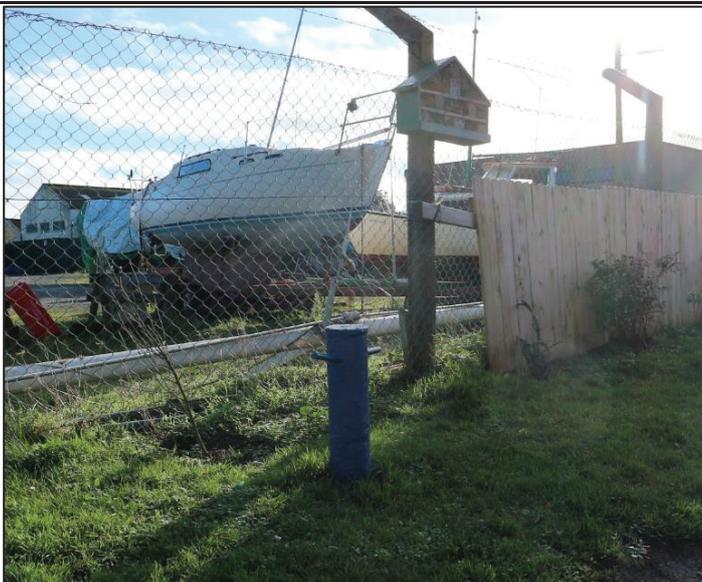
Identification No.	AH13
Legal Status	None
Townland	Tinahask Lower
Site Type	Metal bollard
Description	Metal bollard.
Sources	Site inspection.
Impact of scheme	There is no direct impact to the structure. The drainage works will have a temporary, not significant impact during the construction stage.
Asset criteria	Low value
Magnitude of impact	Negligible
Significance of impact	Negative, Not Significant and Temporary impact.
Proposed mitigation	Feature to be identified to contractors, if necessary, protection measures such as localised hoarding can be put in place to protect it in situ.
Approx. distance from development	Works will take place approximately 5m west of the feature.
Photograph

<p>View of metal bollard on South Quay.</p>

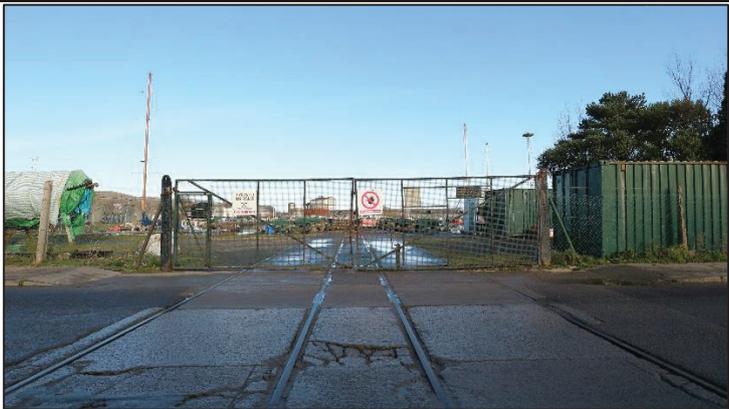
Identification No.	AH15
Legal Status	None
Townland	Tinahask Lower
Site Type	Boat rails
Description	Rails leading from a former ship-building yard at Arklow Docks on the Dock Road, traversing the road and on the quayside jetty.
Sources	Field inspection
Impact of scheme	Trenching for the drainage works will traverse these rails.
Asset criteria	Low value
Magnitude of impact	Medium
Significance of impact	Negative, Moderate and Temporary impact.
Proposed mitigation	Remove rails prior to construction, store at an agreed location with the authorities, archaeologically monitor the drainage works and re-instate the rails upon completion of the works and the resurfaced road.

<p>View of boat rail traversing Dock Road at the South Docks</p>

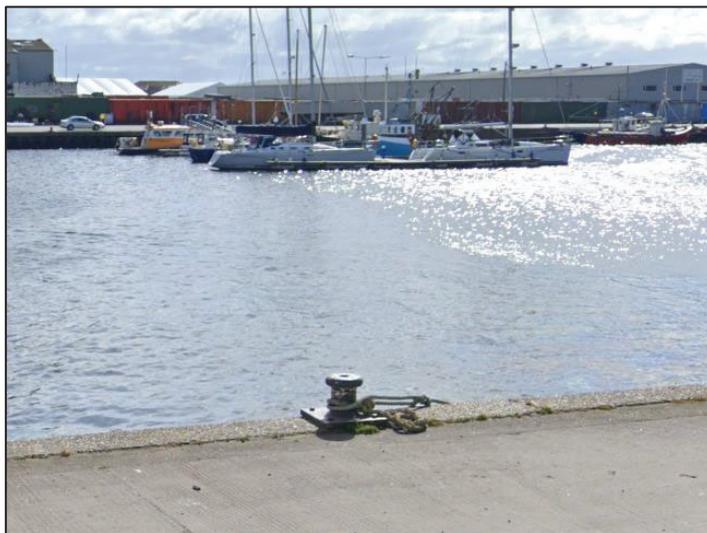
Identification No.	AH16
Legal Status	None
Townland	Tinahask Lower
Site Type	Mooring points
Description	A mix of six metal and concrete mooring posts (approximately placed at 10m intervals) are located along south quay. These present as either small, metal mushroom-shaped bollards, or wide, white concrete posts. They are set on the edge of the quay wall.
Sources	Site inspection.
Impact of scheme	There is no direct impact to the structures or grounds. The drainage works will have a temporary, not significant impact during the construction stage.
Asset criteria	Low
Magnitude of impact	Negligible
Significance of impact	Negative, Not Significant and Temporary impact.
Proposed mitigation	Mooring point to be identified to contractors as features of heritage interest. No further mitigation required.
Approx. distance from development	Works will take place approximately 5m west of the mooring points.

View of metal mooring point on South Quay.

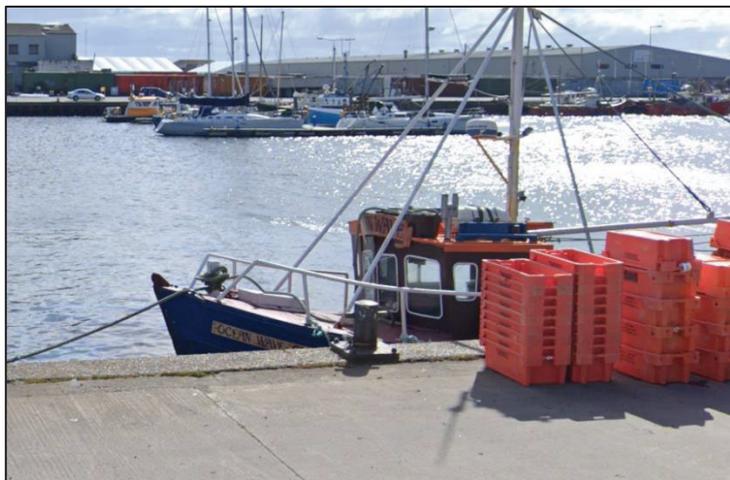
View of metal mooring point on South Quay.

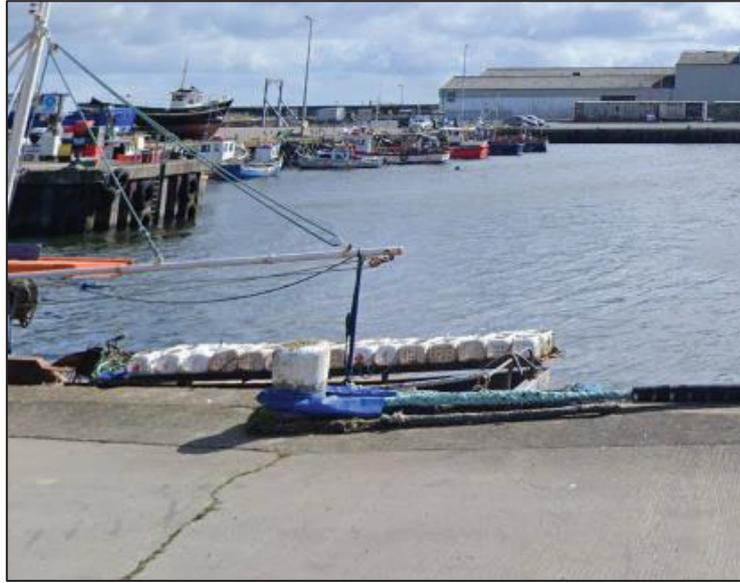
View of concrete mooring point on South Quay.

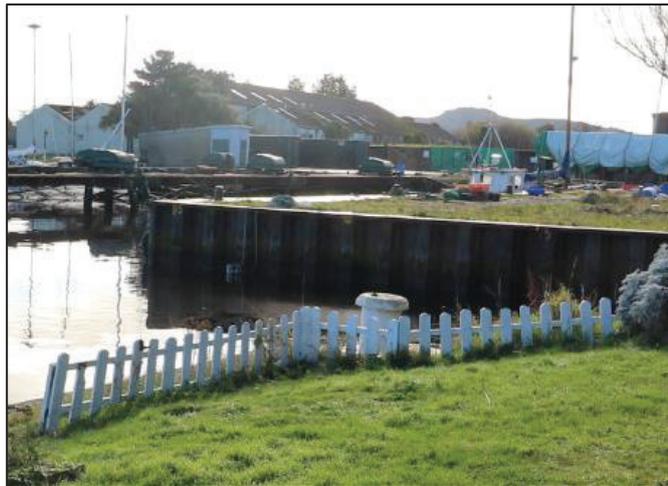
View of concrete mooring point on South Quay.
