Blessington Architectural Conservation Area Appraisal

Project: Architectural Conservation Appraisal & Designation

Client: Wicklow County Council

Location: Blessington, Co. Wicklow

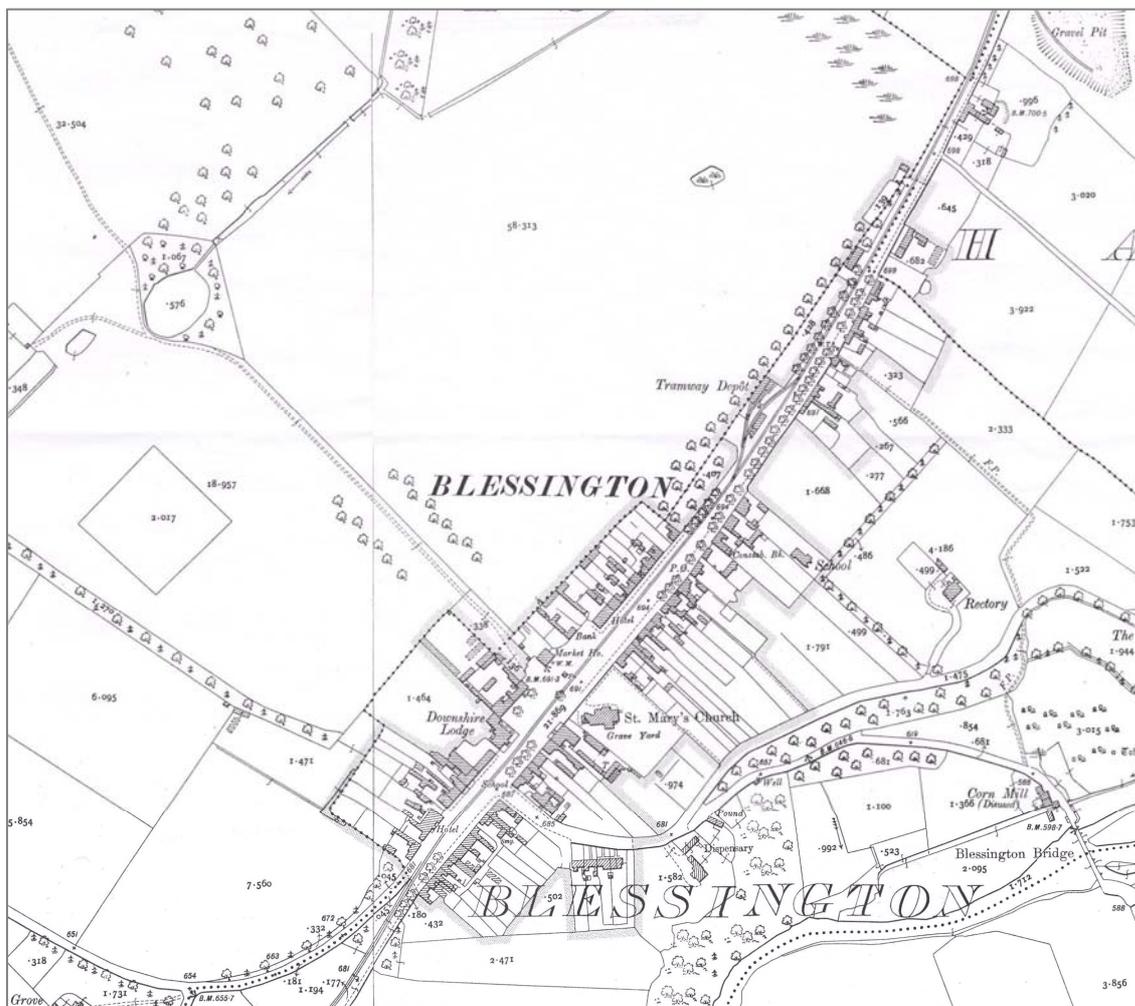
Figure 8 Detailed section of 1908 Ordnance Survey Map of Blessington (Scale of 1: 2,500)

By 1908, the town's commercial strength is indicated by the introduction of a bank and the "Smithy" is noted. This again highlights the agricultural nature of the area, reliant on horse-power, and the location of the blacksmith was through stone-carved inverted horseshoe arch still present (dated 1852) on the south-east of the Main Street.

One of the other major changes and paradoxes is the fact that by this date, Blessington was served by a steam tramway to Dublin, which began operating from the town to Terenure in 1888. The tramway depot is noted on the map, albeit short-lived. Sadly, the tram ceased on 31 Dec 1932, and the Tramway Depot to the west of the Main Street is completely gone. The tram was replaced by a bus service.

There are few other changes evident from the ordnance survey maps. The former “dispensary and hospital” now seems to be called “Beech Grove”, which probably coincides with its conversion to residential use. Finally, the corn mill is now noted as “disused”, again charting the changing nature of local economic activity.

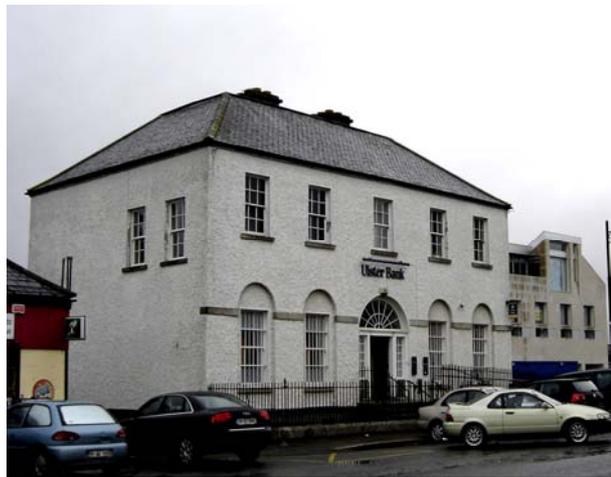
A detached, five-bay, two-storey former house, dating to circa 1830. The building was converted to a hotel in the later nineteenth century and became a bank on 1918. The building is finished in roughcast render and has an arcaded feature of shallow niches within which the windows are located on the ground floor. The central doorcase is a round-arched surround with a glazed fanlight and sidelights with a timber panelled door. Six-over-six pane timber sash windows with stone sills. Hipped slate roof with a pair of chimneys.

Figure 9 Former Downshire Lodge (Ulster Bank), Main Street

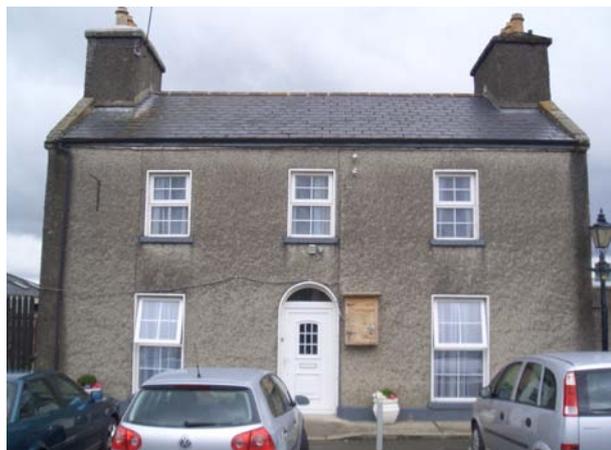
Detached, three-bay, two-storey house, built c.1830. Finished in roughcast render with recently installed uPVC windows and door (original were timber sliding sashes and panelled door). Stone sills and stone barge boards with a pitched, man-made slate roof with large, roughcast-rendered chimneys with terracotta pots to each gable. Longer ground-floor windows give elegant proportions.

Figure 10 House on Market Square, Main Street

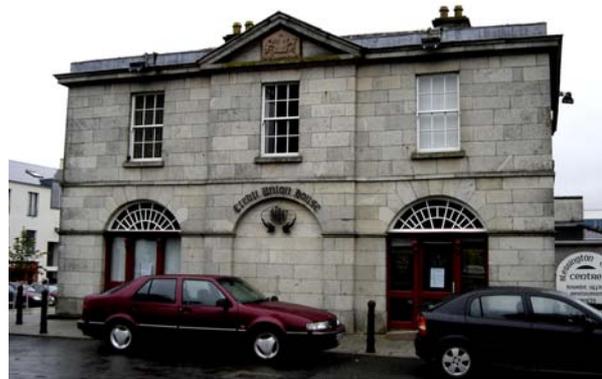
Figure 11 Former Market House (Credit Union House), Main Street

Detached, three-bay, two-storey, former market house, built c.1820, now in use as a credit union. The building is constructed in ashlar granite with a strong course articulating the change from first to second storey. To the centre of the front elevation (to the south-east) is an advanced, pedimented, gable-fronted bay with the Downshire coat of arms in relief within the pediment.

Three round-headed niches on the ground floor on each elevation, some of which have entrance doorways. Front elevation has two timber and glazed doors with glazed fanlights above. Timber, six-over-six pane timber sash windows with stone sills. Evidence of original timber shutters inside.

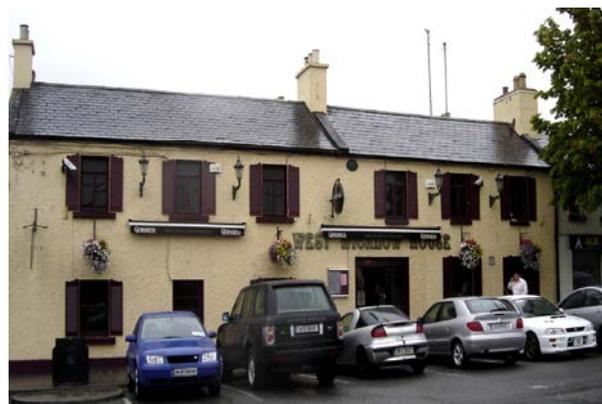
End-of terrace, six-bay, former pair of 3-bay houses, now joined together, built c.1830. The houses were converted to a bar in the later nineteenth century and later converted to a public house. The replacement front door is set within a wide, flat-headed opening. Rouchcast-rendered façade on smooth-rendered plinth. Painted stone sills with modern windows with vertical opens and timber shutters affixed to the exterior. Man-made slate roof with stone barge boards and rendered chimneys to gables of original properties. Roller canopies affixed to the exterior.

Figure 12 West Wicklow House, Main Street

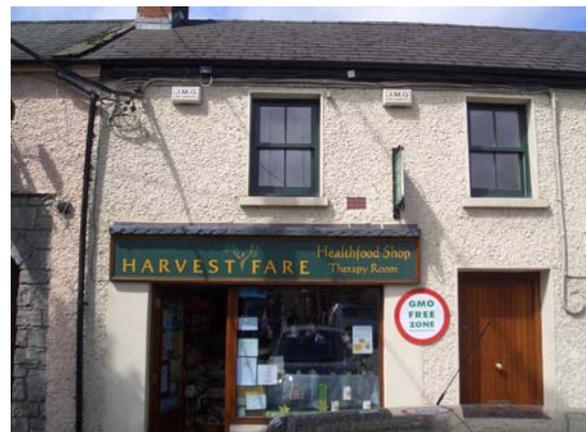
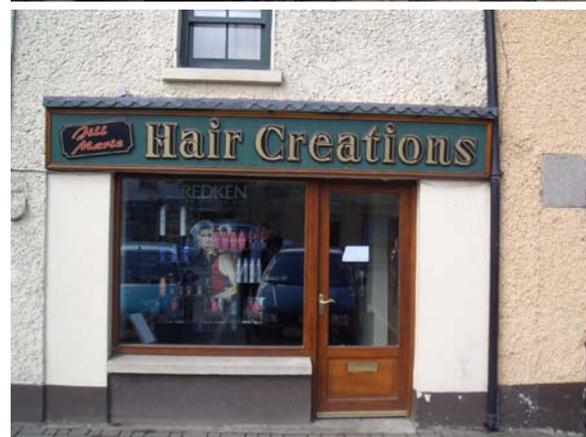
Terraced, three-bay, two-storey former house, built c.1840, now in use as a pair of shops. Roughcast-render, with smooth-rendered plinth. Two-over-two pane timber windows with two-over-two pane appearance with painted stone sills and central timber door, dating to c.2000. Pair of shopfronts with painted timber fascia, timber and glazed door and plate-glass shop window, dating to c.2000. Man-made slate roof with chimneys to gables.

**Figure 14 Harvest Fare & Hair Creations,
Main Street**

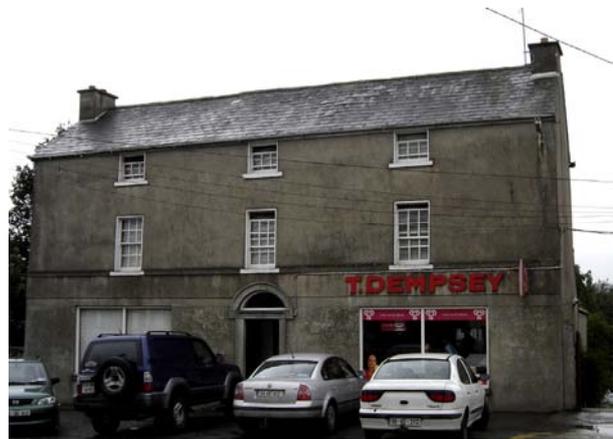
Detached, three-bay, three-storey former house, built c.1790, now in use as a shop with apartment above. Finished in smooth render with a sill course to the first floor windows. Timber, panelled central door with fanlight over with moulded surround. This door is flanked by 2 large plate-glass windows. Six-over six-pane timber sliding sash windows to the first floor and three-over-three pane sashes to the attic storey. Pitched slate roof with rendered chimneys to gables.

Figure 15 T. Dempsey, Main Street

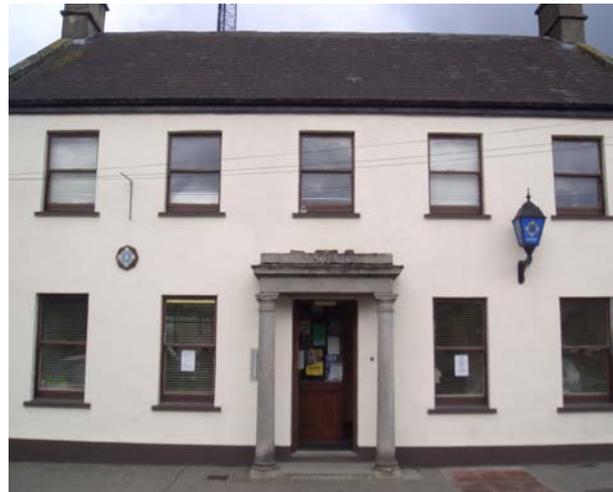
End-of-terrace, five-bay, two-storey former house, built c.1830. The building is finished in smooth render with timber and glazed central door (c.1990). Projecting, flat-roofed stone portico over door supported on Tuscan order columns. Timber casement windows with stone sills. Pitched slate roof with rendered chimneys to gables and stone barge boards.

Figure 16 Blessington Garda Station, Main Street

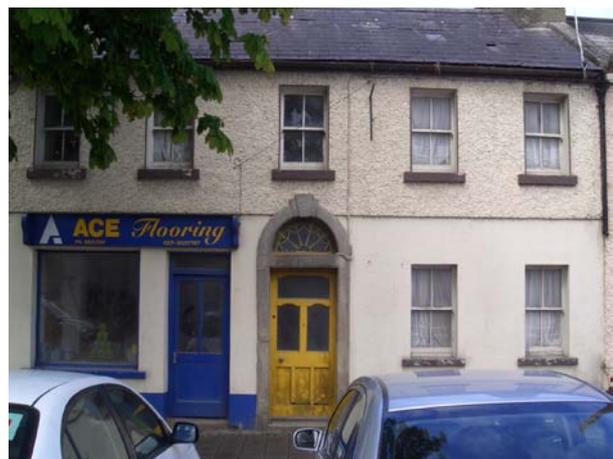
Terraced, five-bay, two-storey former house, built c. 1790, now in use as a house and shop. Smooth-rendered ground floor and roughcast-rendered first floor. Timber panelled door with glazed radial fanlight set within fine dressed-stone doorcase with keystone. Two-over-two timber sliding sash windows with painted stone sills. Modern shop frontage inserted into two bays of ground floor with large plate-glass window and timber paneled door and fascia, dating to c.1990. Pitched slate roof with rendered chimneys.

Figure 17 Ace Flooring, Main Street

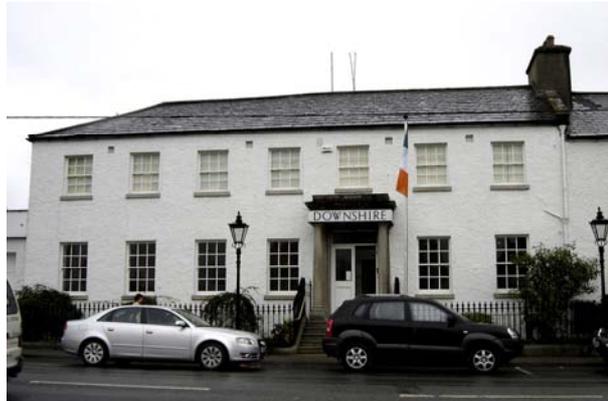
End-of-terrace, seven-bay, two-storey over basement former house, built c.1820, latterly in use as a hotel and now in use as a gallery. Finished in roughcast render. Off-centre front door accessed up stone staircase with projecting stone portico. Six-over-six time sliding sash windows throughout with stone sills and evidence of internal shutters. Slate roof with rendered chimney to south gable. Single-storey extension to north gable

Figure 18 Downshire Arms, Main Street

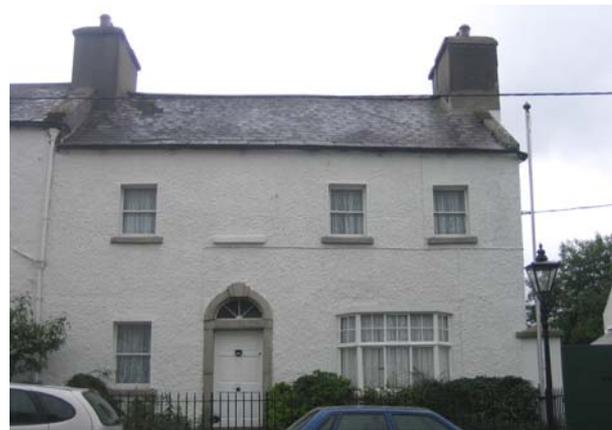
End-of-terrace, four-bay, two-storey former house, built c.1830. Roughcast rendered with round-headed doorcase with dressed stone surround with protruding keystone and segmental-headed fanlight. Timber panelled door with blind window above. End two bays on ground floor have been modified into canted bay window, c.1940. Ground and upper floor windows with single-pane timber sliding sash and stone sills. Slate roof with rendered chimneys. Small front garden and railing to street.

Figure 19 House (adjacent to Downshire Arms), Main Street

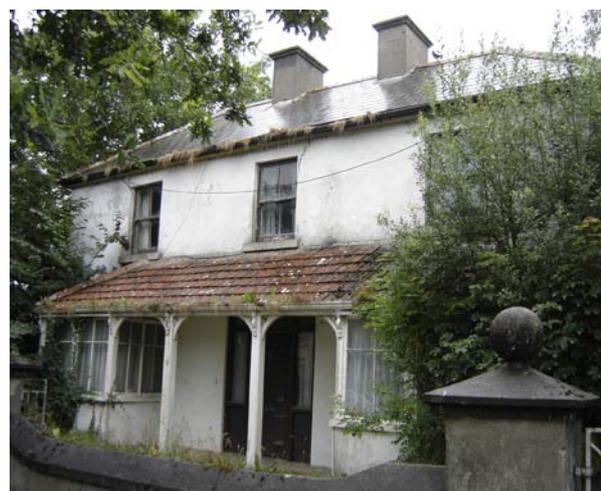
Detached, three-bay, two-storey house, built c.1910. To the ground floor is an almost full-width hipped roof projection which provides a sheltered porch and covers two canted bay windows. Rendered walls. Timber sliding sash windows to upper floor with narrow central comes. And stone sills Evidence of timber shutters inside. Timber central door with glazed sidelights. Hipped man-made slate roof with pair of rendered chimneys.

Figure 20 House, Main Street (north end)

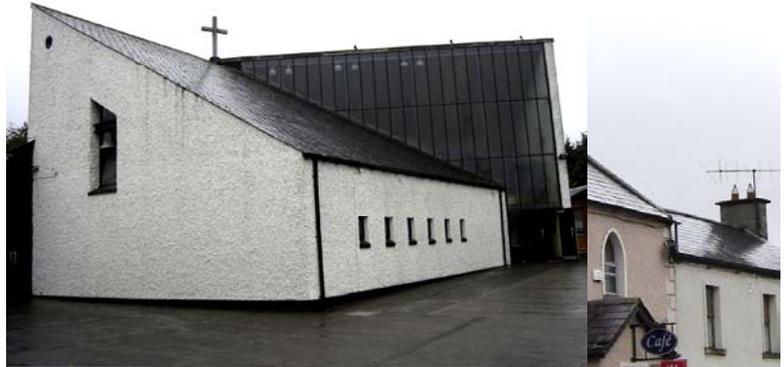
Detached, multiple-bay, single-storey, Roman Catholic church, built in 1981. The building is L-shaped in plan with two large mono-pitch roofs set at right angles to each other. The door is set within a flat-headed opening within a small, lean-to porch. Roughcast rendered exterior with small windows. One pitch of roof comprises entire fixed glazed area. Bell mounted on external gable.

Figure 21 Church of Our Lady, Main Street

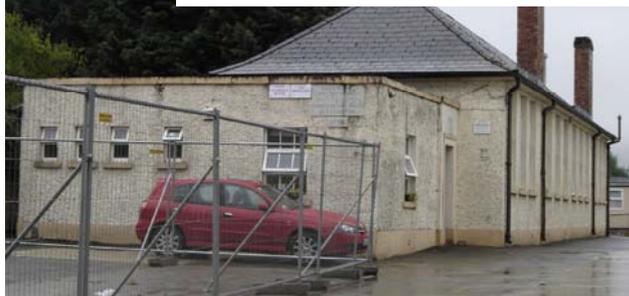
Semi-detached, three-bay, two-storey former school, built c.1830, now in use as a restaurant. Roughcast rendered with smooth-rendered block-and-start quoins. Advanced, gable-fronted,

Figure 22 Blessington National School, Main Street

ted central porch with replacement timber door to side. Flat-headed window frames to ground floor and pointed-arched to first floor, all with stone sills. Separate entrance doorway to side gable, inserted c.1995. Man-made slate roof with rendered chimneys to gables.

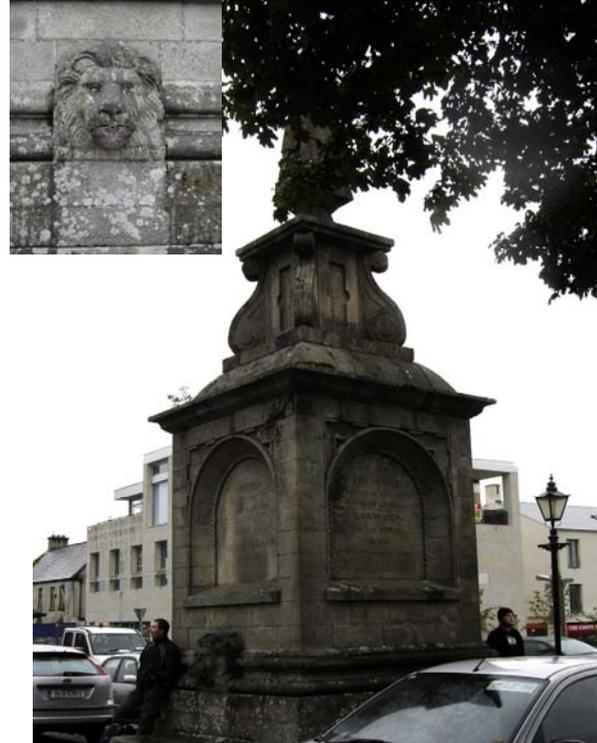
The monument comprises a large square ashlar block of granite with recessed, round-headed niches to all four elevations surmounted by a decorative pinnacle. There are moulded string courses above the base and the pinnacle rests on a block with a stone volute at each corner. There is a stone trough located to the south-east elevation of the monument with a lion head holding the water spout in his mouth above.

Figure 24 Boyle Monument, Market Square, Main Street

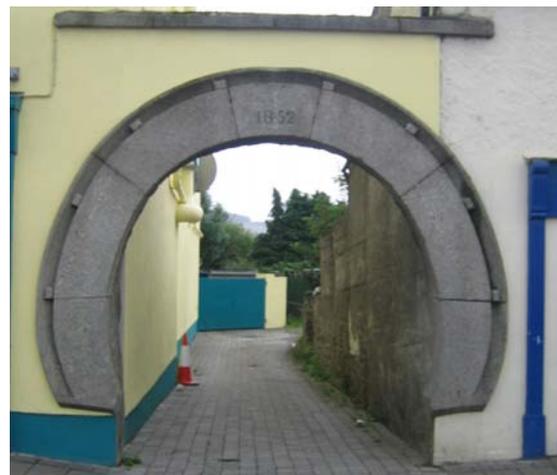
This archway is a very fine example of the earliest type of advertising, with the decoration of the inverted horseshoe in dressed granite illustrating the services that were carried out within. Carved with date “1852” in the keystone, the archway is situated within a terrace of buildings and provide access to a laneway.

Figure 25 Stone Archway to Former Blacksmith, Main Street

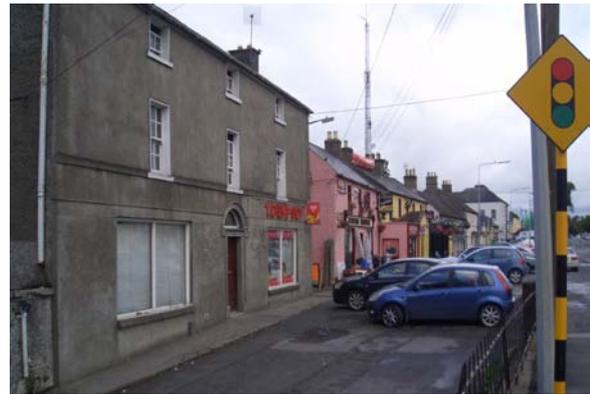
- (i) Undulating roofline;
- (ii) Strong building line;
- (iii) Gable-ended properties
- (iv) Regular chimneys, breaking up the expanses of slate roof;
- (v) Natural materials – slate, stone and timber;
- (vi) Details such as multi-paned windows, most particularly original sliding sash windows, of which few remain;
- (vii) Original timber doors - particularly those with original glazed fanlights, of which few remain;
- (viii) Carriage arches, particularly where these are retained in their original state/usage;
- (ix) Individual buildings of note;
- (x) Street furniture, some of which is original and some modern but sympathetic.

Figure 28 Various Views of the Streetscape in Blessington ACA

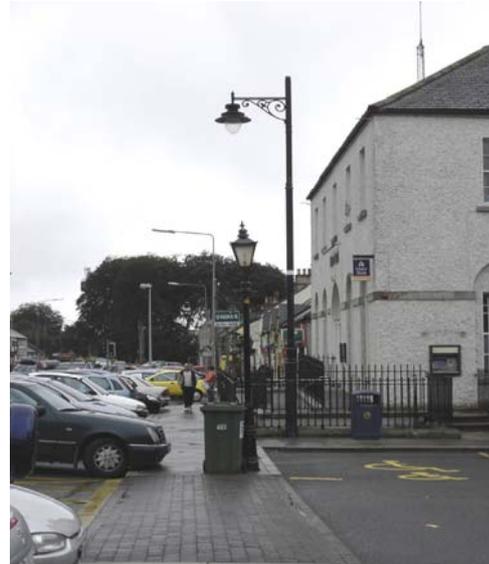
Figure 29 An example of the visual clutter generated by various types of lamp standards. Within a short space on the Main Street, there are 4 types of public lighting, visible in this photo above

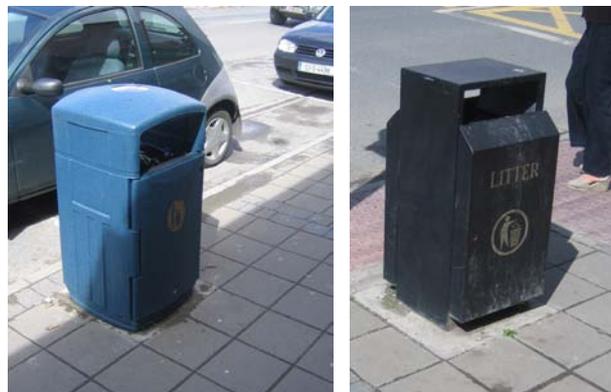
Figure 30 Two types of litter bins along the Main Street - different colours and materials

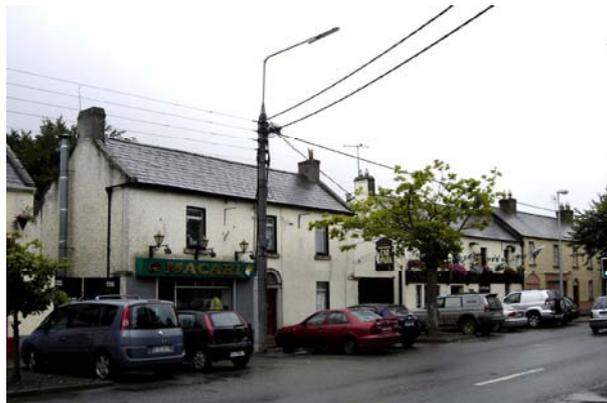
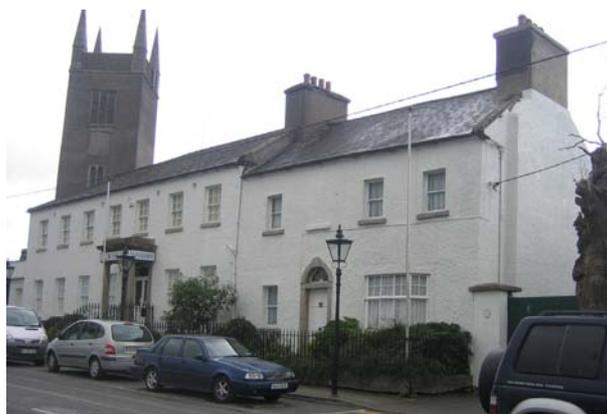
The orientation of almost all buildings on the Main Street is towards the street. The few exceptions to this are the churches and the more modern buildings, which use an offset angle of orientation to the street to give them more prominence and allow for a setback from the buildings line.

Figure 31 Various Views of the Streetscape in Blessington ACA

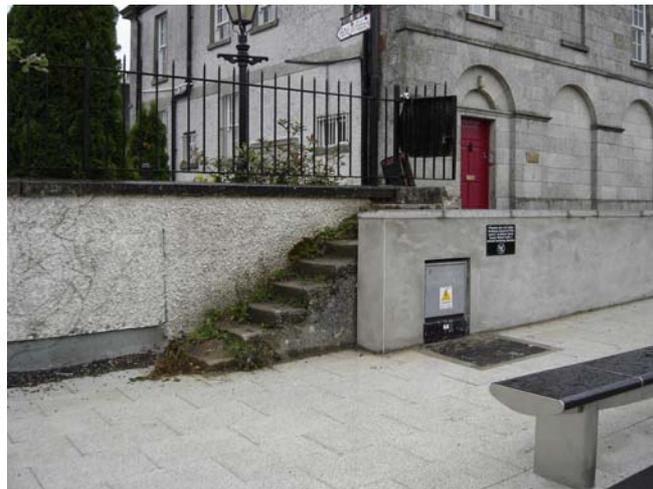
Figure 32 An area of not particularly successful interface between the old Market Square (and former Market House) and the new civic plaza, Main Street

The square has recently changed considerably with the addition of the civic plaza to the rear in the context of the Cooke Hill development. While this newer civic plaza has not been included in the ACA, it should be noted that the interface between these two areas is of great importance, both for the ACA and for the statement that this area makes about the town and its legibility, permeability and attractiveness.

The dominance that the Ulster Bank building, Tourist Office and Credit Union enjoyed has been altered and their stature within the Square appears to have been diminished, due to the sheer change in scale from this older square to the new civic plaza.

The treatment of the old Town Square needs to be addressed separately in a sympathetic means, through an urban improvement scheme or a village design statement.

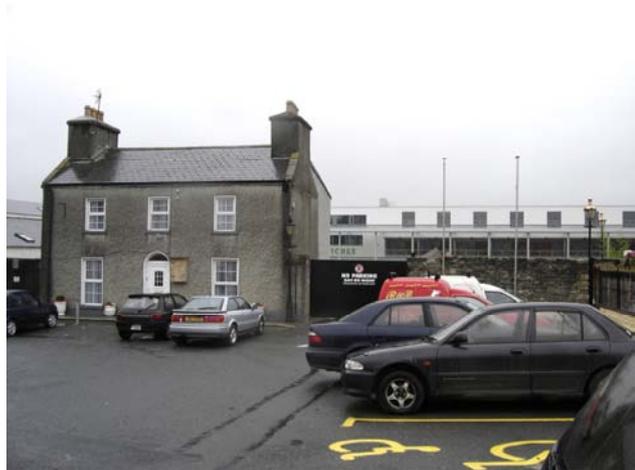
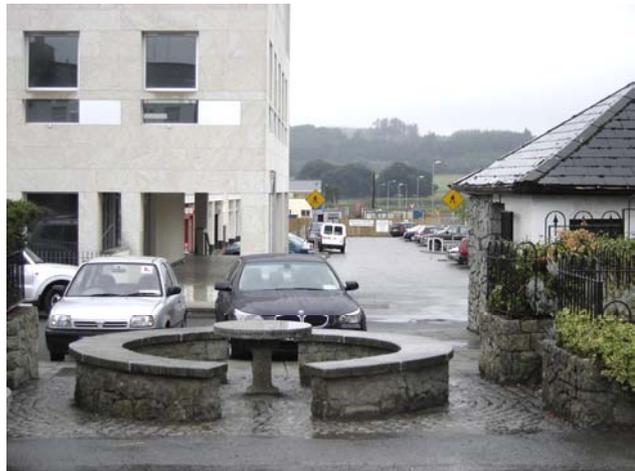
Figure 33 Two areas for improvement in the Town Square: the interface between old and new

There is a pair of telephone boxes very inappropriately located in the centre of the Town Square, which are ugly, damaged and out of place. They obstruct views towards the square and its fine buildings. Relocating these phone boxes or replacing them with a more stylish or more discrete alternative would be of benefit.

The removal of the toilet block would considerably open the views from the Main Street towards the new Civic Plaza and would also have the effect of opening up the market square.

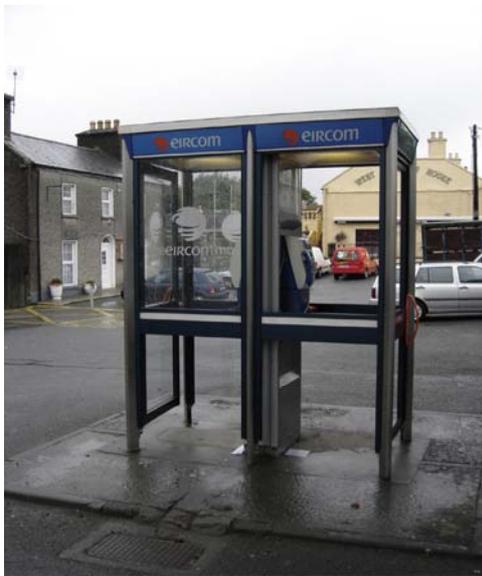
Figure 34 Pair of phone boxes inappropriately located in the Town Square

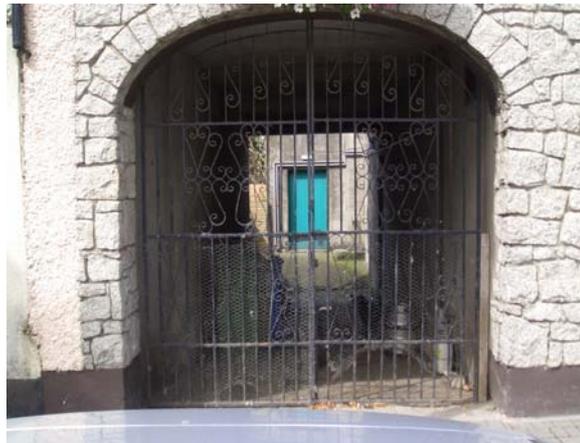
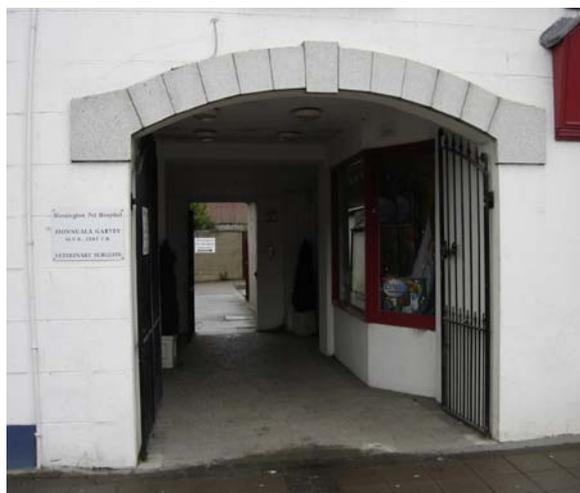
Normally segmental-headed or flat-headed these are normally erected in roughly-dressed stone that would have been rendered. Some have dressed stone heads or keystones. This motif has been used in more modern erections as a means of enclosing an access or laneway (below).

Figure 35 Examples of Carriage Arches on Main Street

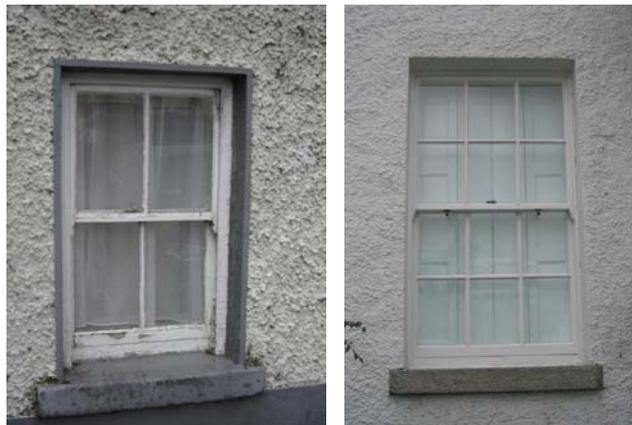
Figure 36 Attractive timber sash windows of the type to be retained and encouraged in the Blessington ACA

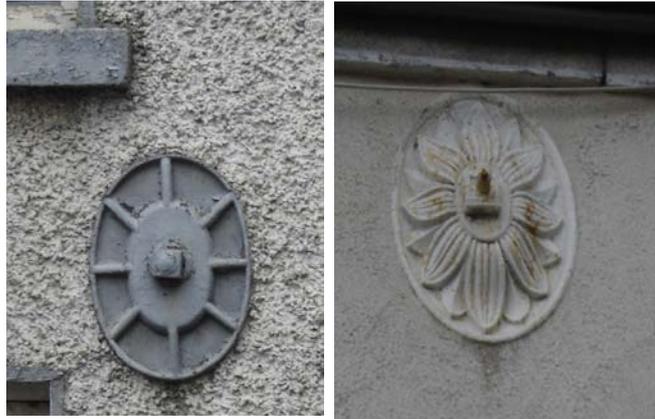
Figure 37 Two examples of utilitarian elements that are also decorative - ends to reinforcing ties on building facades

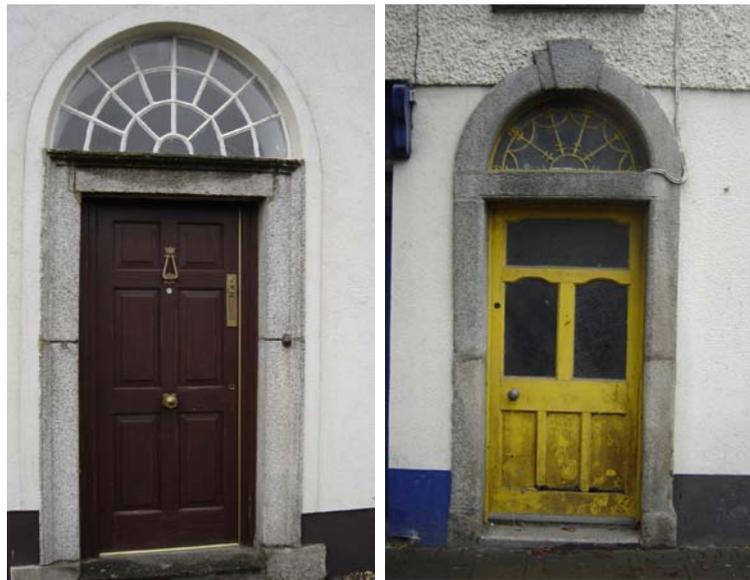
Figure 38 Two examples of fine doorcases in the Blessington ACA

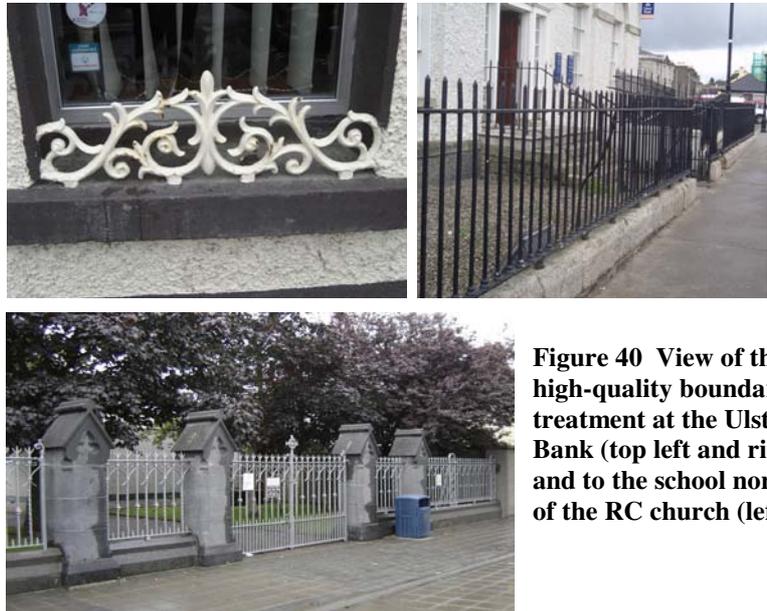
Figure 40 View of the high-quality boundary treatment at the Ulster Bank (top left and right) and to the school north of the RC church (left)

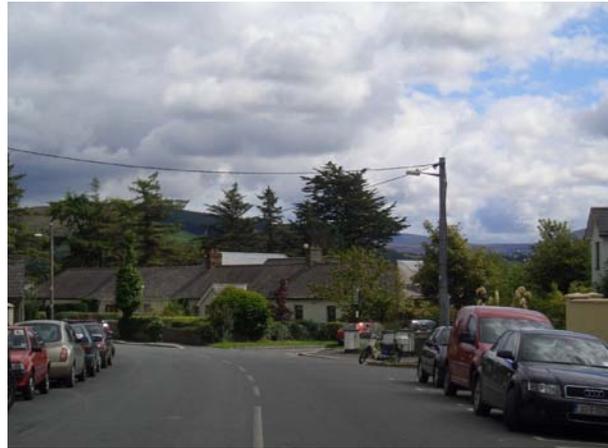
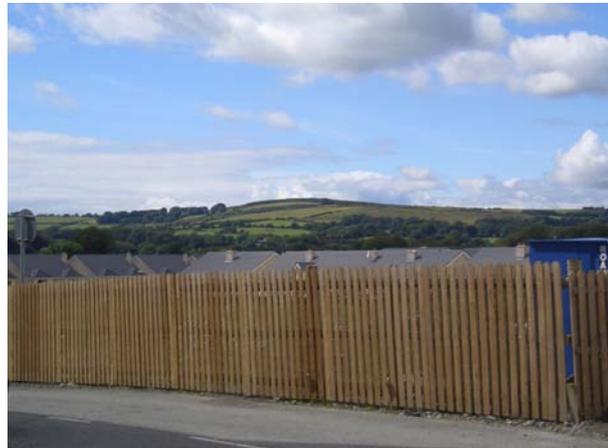
Figure 43 View from Kilbride Road junction (above) and view from the new town centre (below)

Figure 46 shows the existing view from the junction of the Main Street with the Kilbride Road (above). Removal of selected trees behind the old cottages would open up a greater view of the surrounding landscape. The wooded hills surrounding the town would come into view and form an impressive backdrop. Removal of Eircom/ESB pole and wires would also be necessary in creating this view.

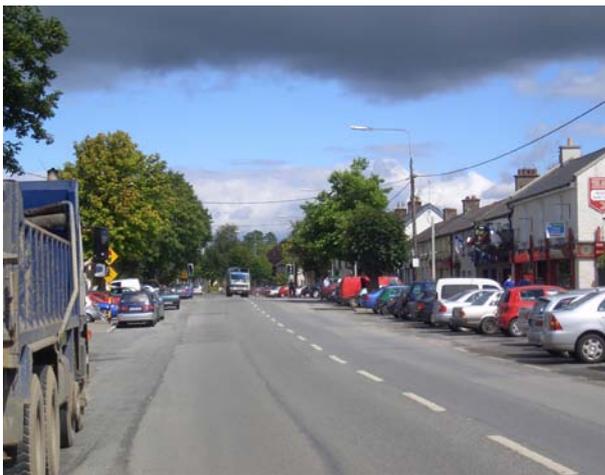
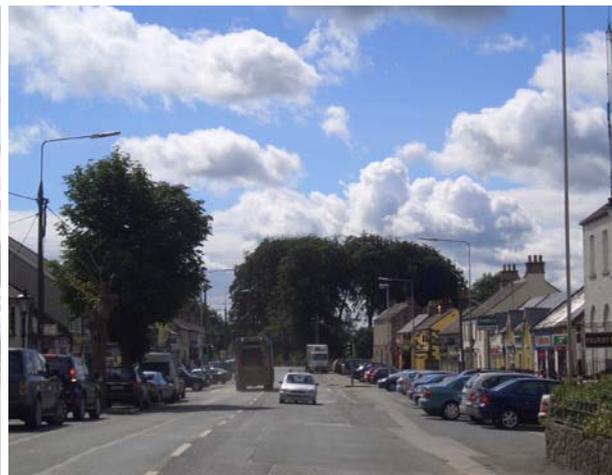
Figure 44 View north on Main Street (left) and view south on Main Street (right)

Figure 45 shows views to the north and south along the Main Street from the centre of the town. These photos give a good indication of the closed nature of the views from within the proposed ACA area. Both views north and south are blocked by mature trees and the curving nature of the existing roadway. The terraced nature of the built form closes the views up and down the street even further. From both viewpoints no view is presented of the surrounding landscape or of the Poulapoucha Reservoir.

Figure 44 also highlights the interface of the new town centre and civic plaza with existing development. New development that will obscure existing views towards the surrounding hills should be prevented. There are currently panoramic views of the landscape from this viewpoint. In order to enhance these, views attention would need to be paid to building heights of new developments surrounding the town to ensure they do not impinge upon these panoramic views.

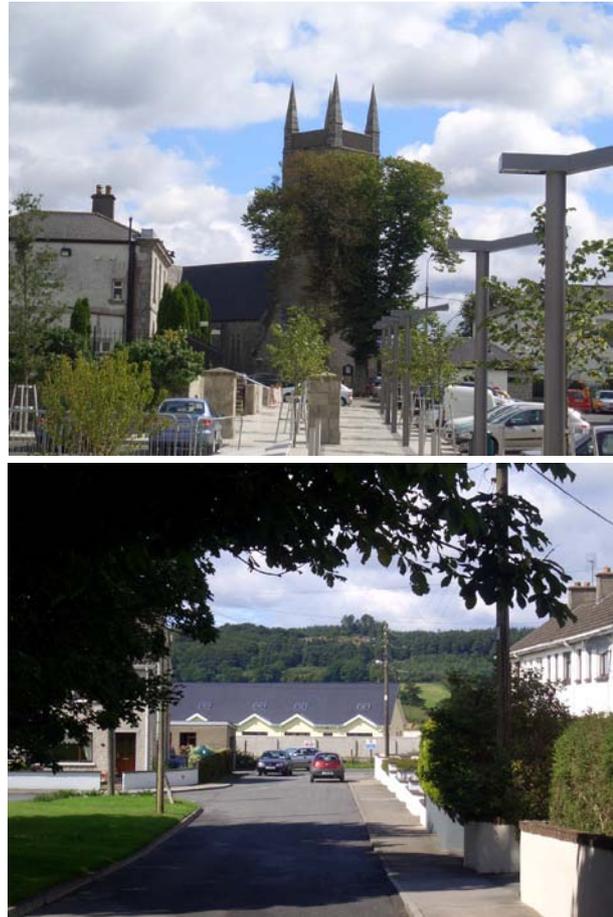
Figure 45 View types to be Protected

The consideration of the visual amenity should form part of any consideration for development proposals within this ACA. The advantages for the proposed ACA within the town are that most new development occurring cannot be viewed from the town centre due to the existing built form and mature trees present. Opportunities exist to create and enhance certain framed views of the surrounding scenic landscape.

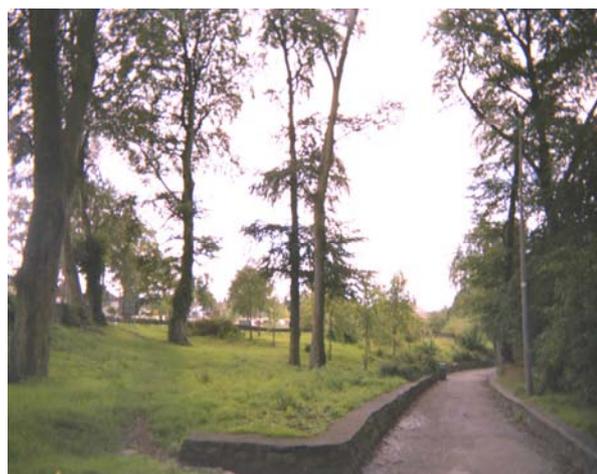
Figure 47 Pocket Park at Main Street/ Naas Road

Although located on the southern fringe of the Blessington ACA, this park consists of mature Beech and Lime trees, which act as an attractive screen/boundary between the existing town centre and new development occurring at this end of the town. The

A public path runs through the space connecting the Nass Road with the town centre. Some street furniture is present, consisting of park benches and public lighting. This would be classified as a passive space - serving as a connection between the town centre and the new housing estates located in the Nass Road area.

Improvements could be made by the addition of more traditional style street lights, more park benches and better overall maintenance.

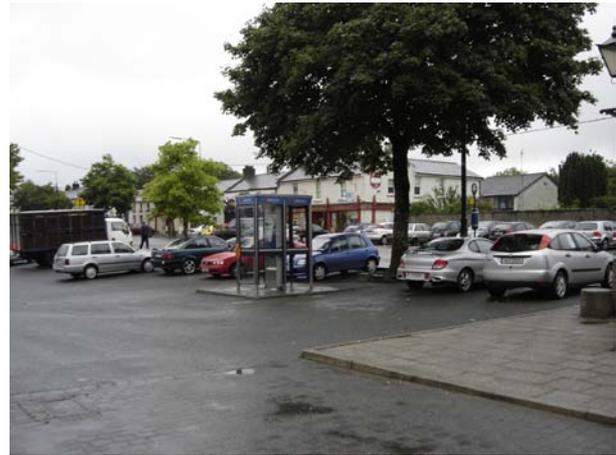
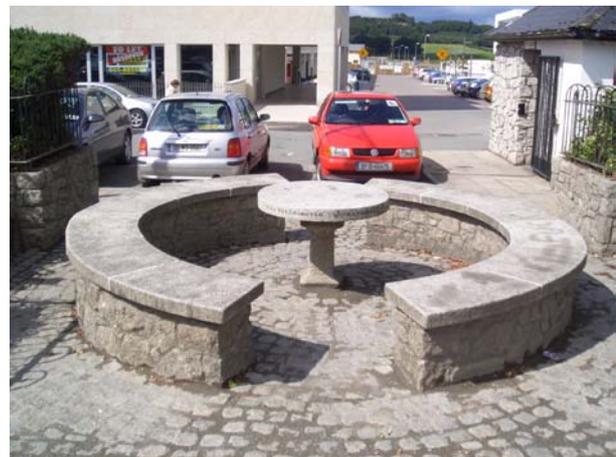
Figure 49 View of Town Square from Main Street

This public open space is situated in Market Square at the centre of town, across the road from the Protestant Church. The space consists mainly of hard landscaping with some landscape features interspersed around a public monument. The monument is currently under repair.

This space is characterised by hard landscaping, and is more urban in character. Features include traditional style lamp posts, street trees, attractive tree grates and large planters. An attractive seating area is located at the centre of this space (see view above). Car parking is permitted, but no clear parking spaces are marked out. This area would be classified as an active public space.

This space is pivotal and of significant importance to the Blessington ACA. Not only is the Town Square physically located in the centre of the ACA, it is also the pivot or hub around which the Main Street ACA is situated, and is a significant point of reference. This square had undergone some improvements some years ago, and would now benefit greatly from some attention that would integrate the new, modern civic plaza better with this space that represents the historic commercial and civic importance of this town, and this square in particular.

Improvements to space could be made by restricting/prohibiting parking, using all similar types of street furniture and improving the paving details in the area. There is no order to the location of landscape features within the space.

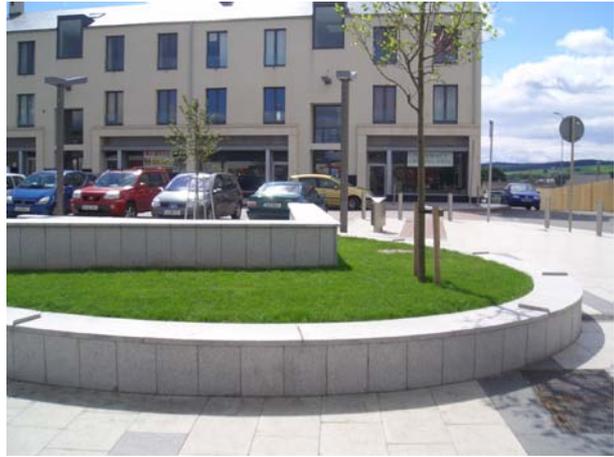
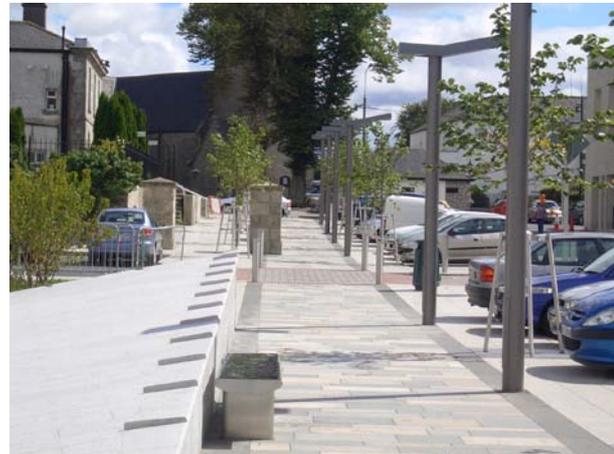
Although significant design input has gone into the development of this square, there is maybe too much emphasis placed on the landscape features. This space seems to be cluttered, and suffers from the use of many different colours and types of material in the paving alone.

Figure 50 Civic Plaza to the rear of the Town Square, off Main Street

Further improvements could see the integration of this space better with the Town Square, including the selection of a more muted palette of street furniture and materials, which would allow the architecture to be placed against a user-friendly backdrop and congregation space, rather than the historical architecture vying for visual prominence with the newer surface treatment.

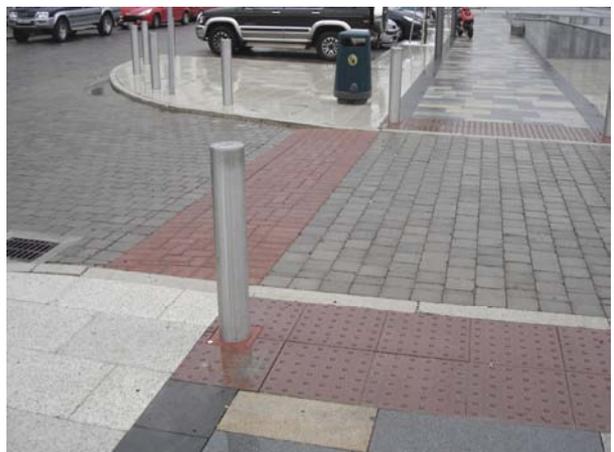
Figure 51 An example of the various types of paving, materials and colours in the new civic plaza, Main Street
